Central Kowloon Route

Yau Ma Tei East

Contract No. HY/2014/08

Monthly EM&A Report No. 1

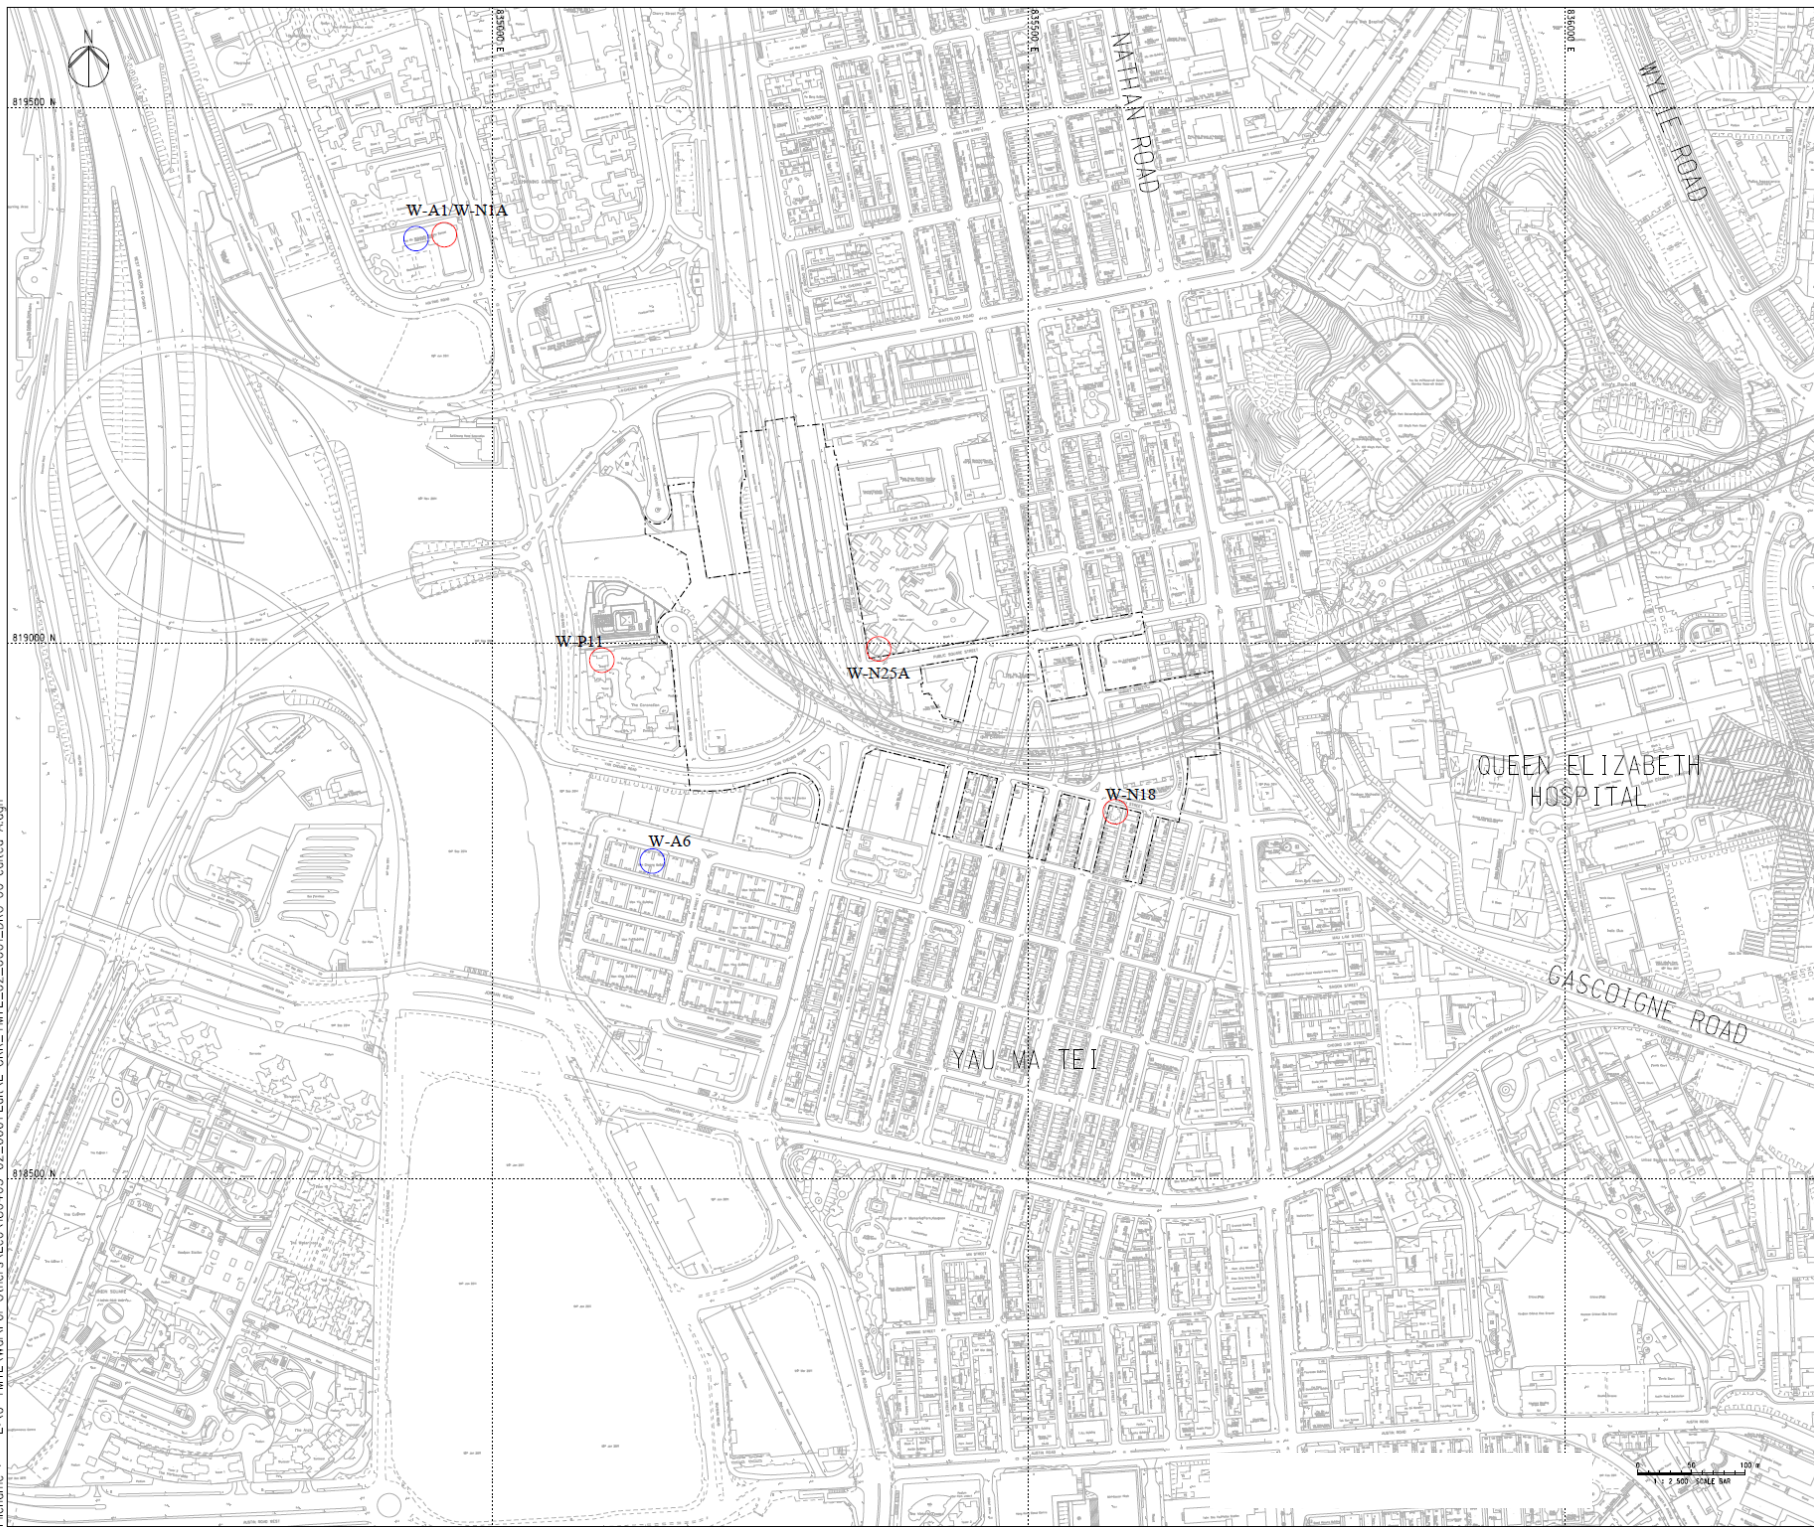
Location Plan of Noise and Air Quality Monitoring Station

- 4.4.1. During the site visit, both of the original proposed dust monitoring locations were rejected due to the condition at The Coronation was not favorable for monitoring and the access was declined by the management office of Hong Kong Community College (HKCC) of PolyU. Two alternative air monitoring stations Yau Ma Tei Catholic Primary School (Hoi Wang Road) and Man Cheong Building had been proposed by ET and approved by IEC. 2 designated air monitoring locations were identified and agreed with IEC and EPD. Details of air monitoring stations are described in Table 4.3. The location plan of air quality monitoring stations is shown in Appendix K.
