Central Kowloon Route

Yau Ma Tei East

Contract No. HY/2014/08

Monthly EM&A Report No. 40

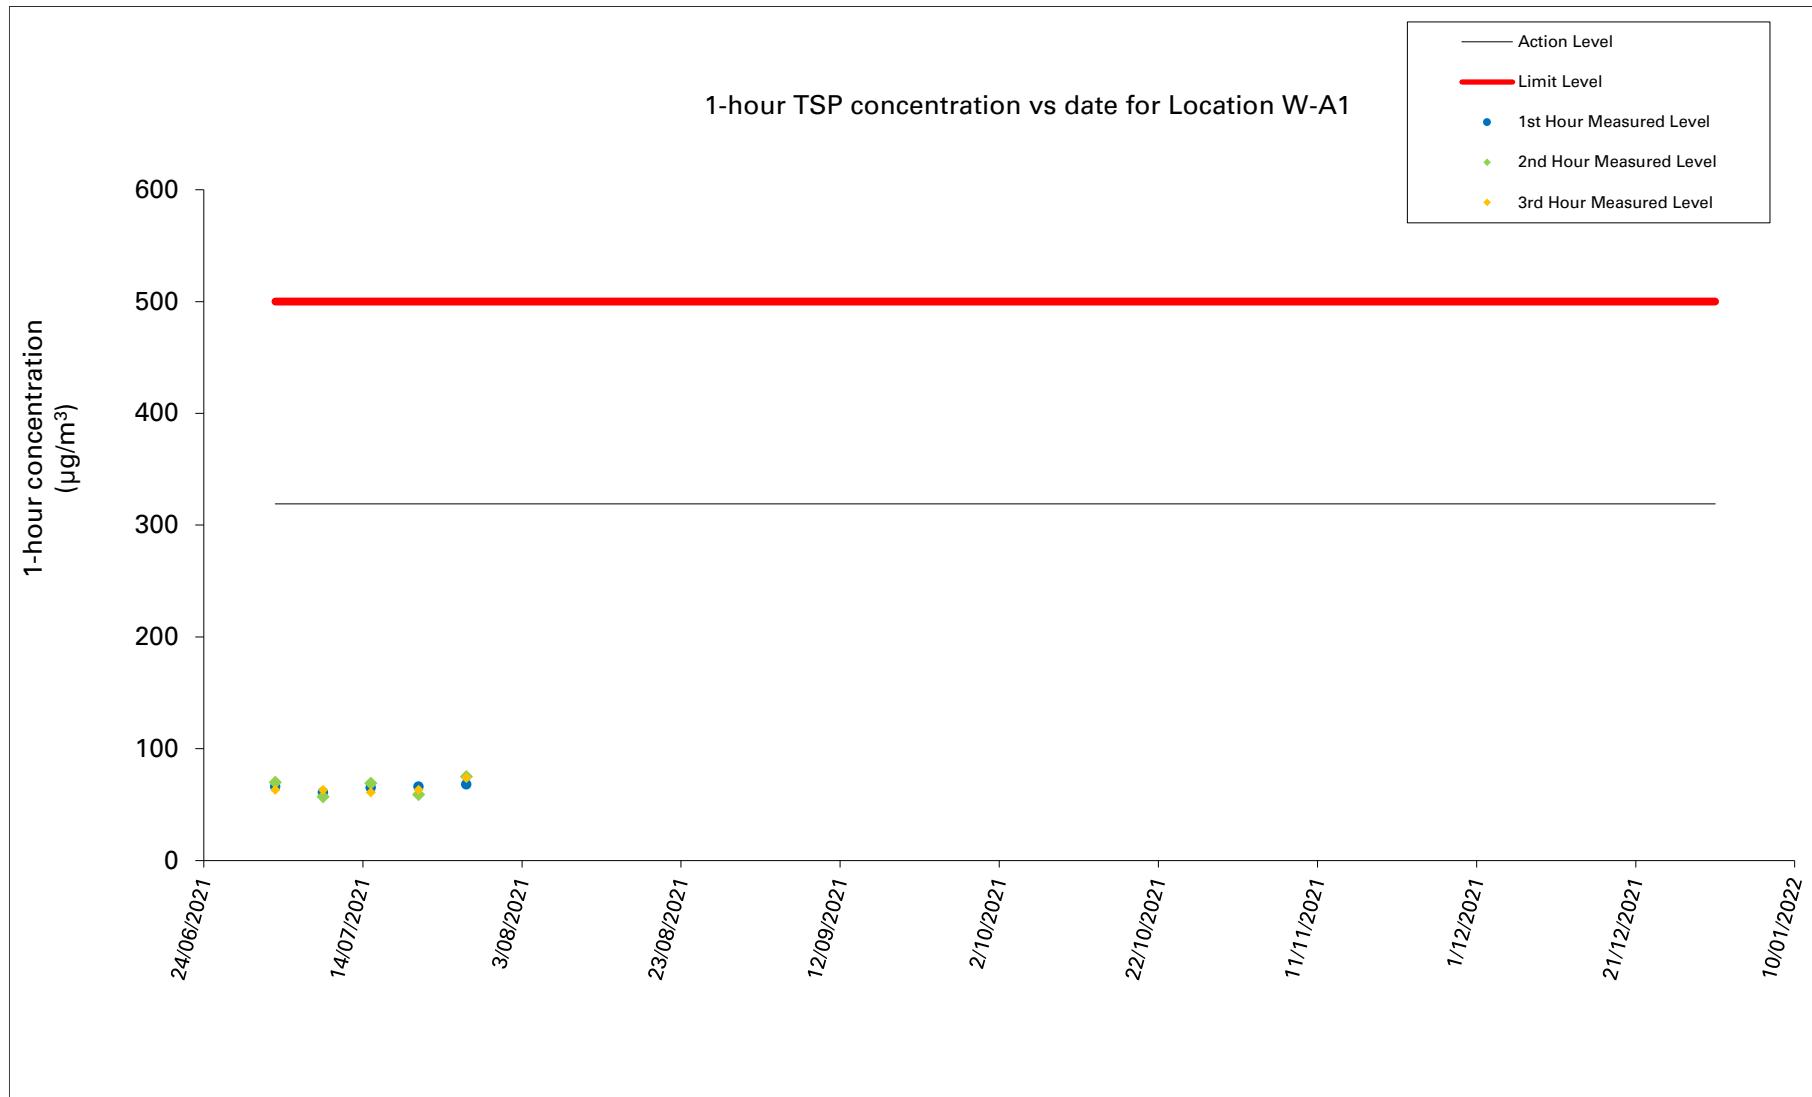
Figure 1: Graphical Illustration of Measured 1-hour TSP ($\mu\text{g}/\text{m}^3$) Levels at W-A1

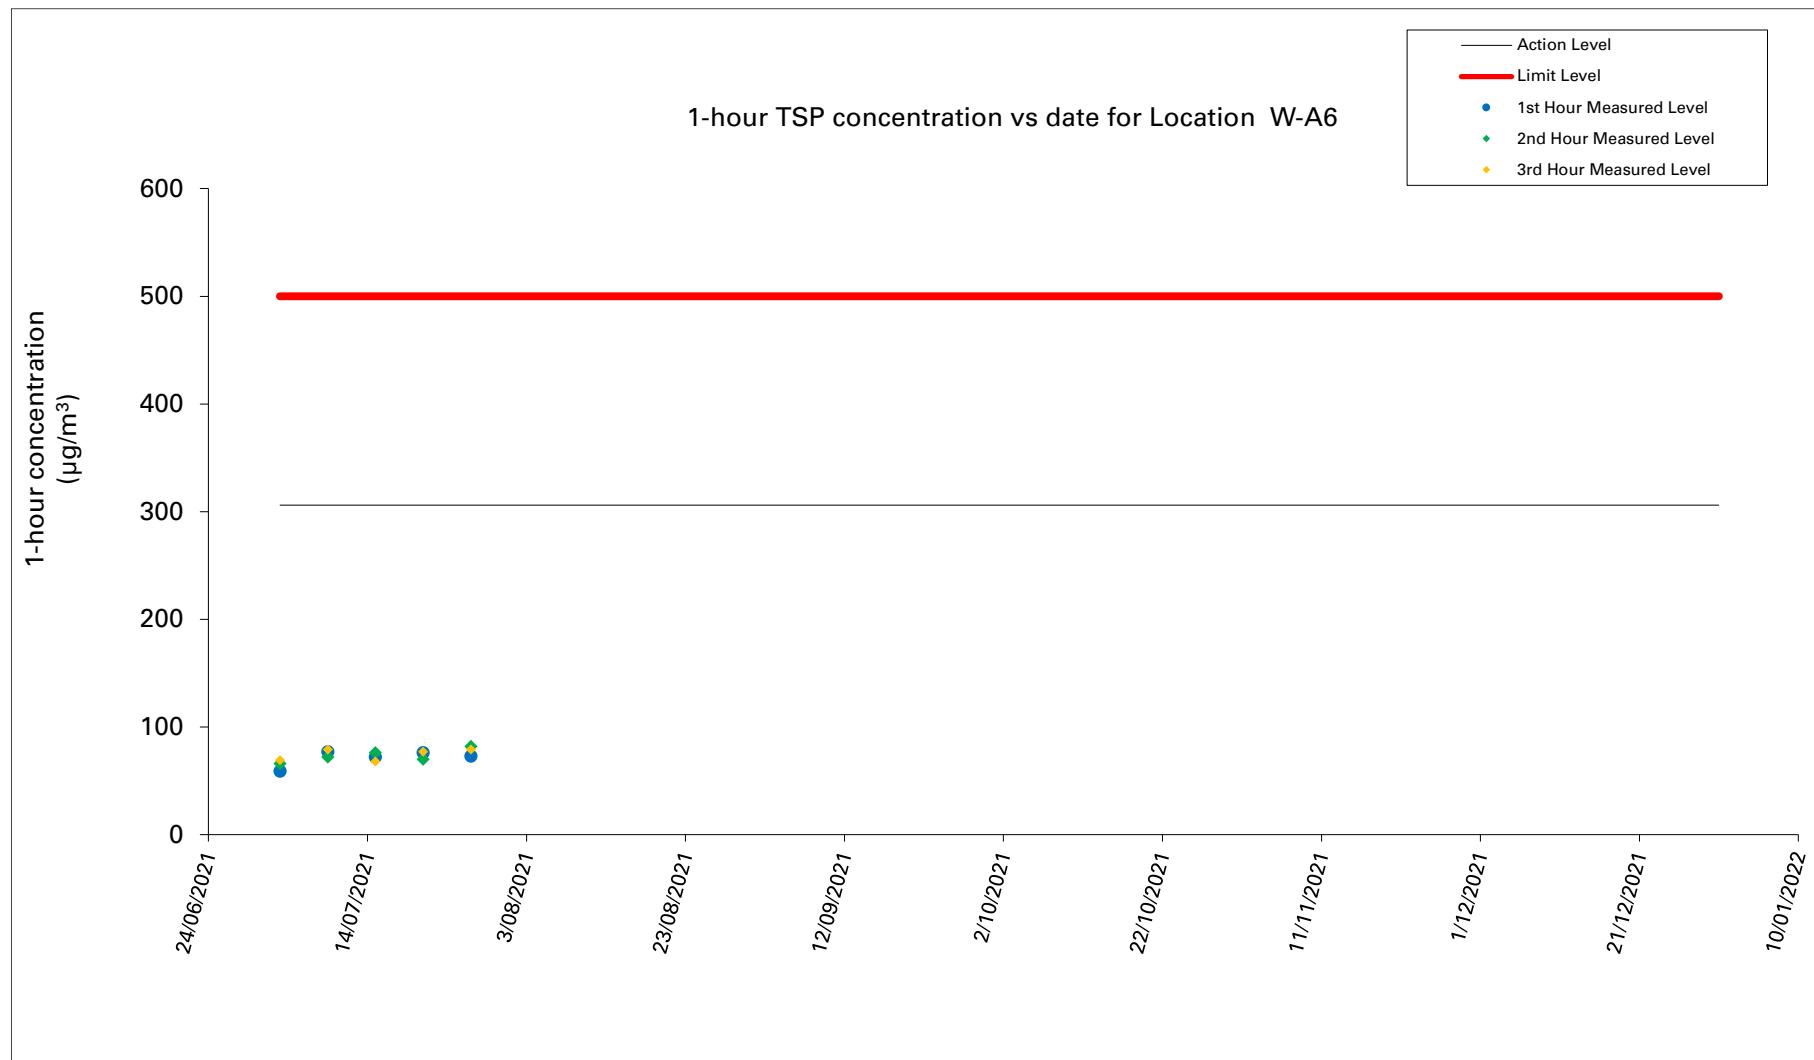
Figure 2: Graphical Illustration of Measured 1-hour TSP ($\mu\text{g}/\text{m}^3$) Levels at W-A6

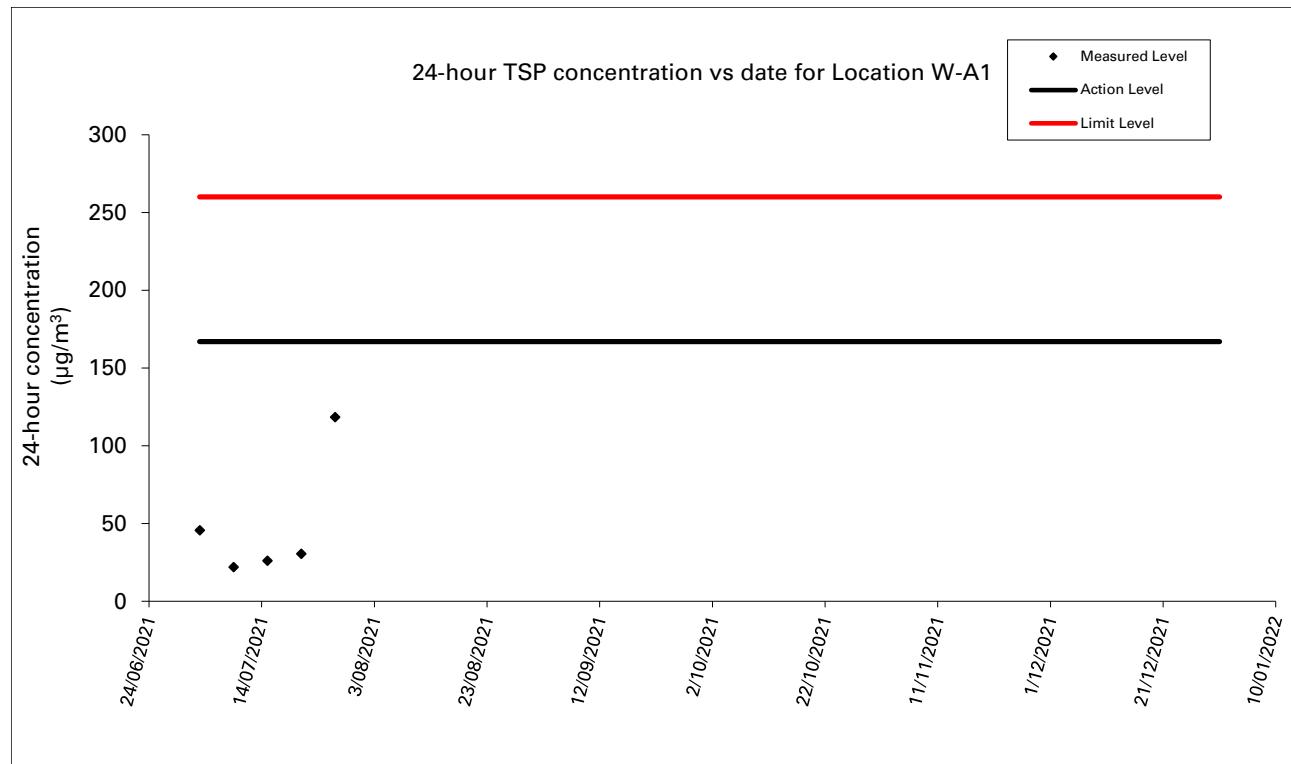
Figure 3: Graphical Illustration of Measured 24-hour TSP ($\mu\text{g}/\text{m}^3$) Levels at W-A1

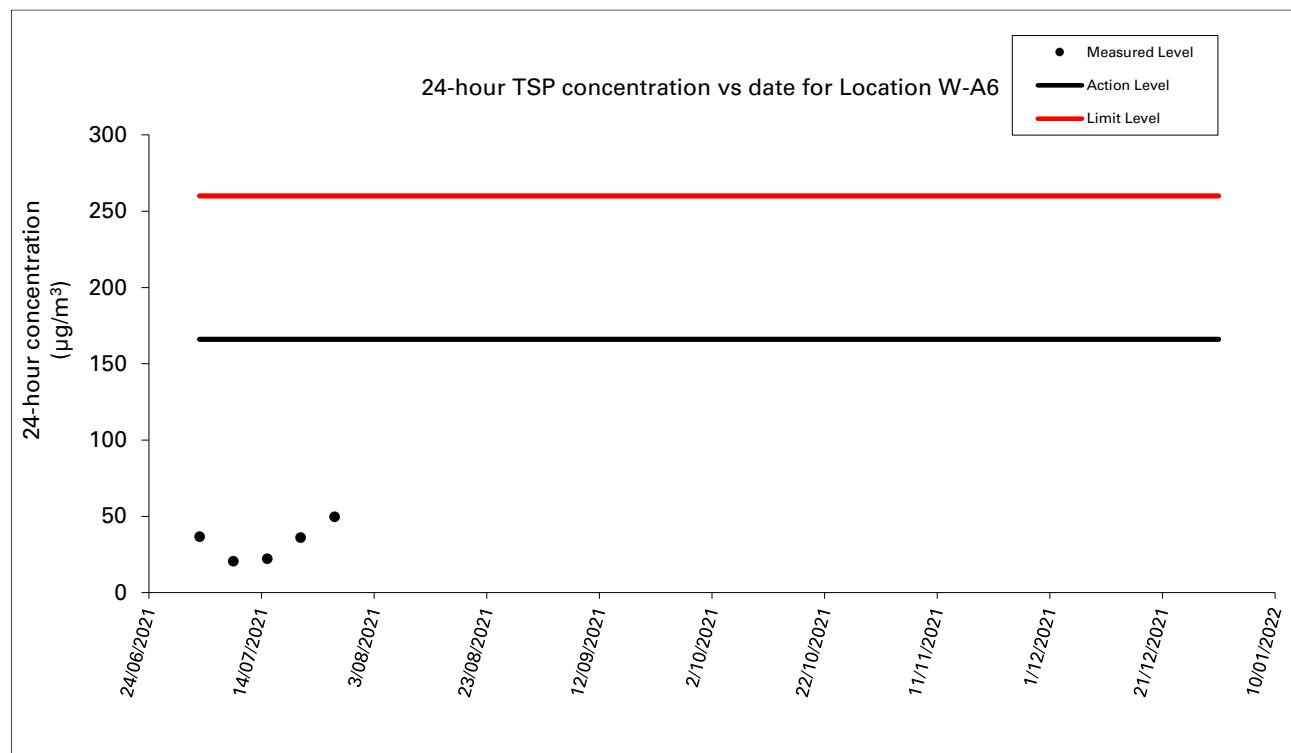
Figure 4: Graphical Illustration of Measured 24-hour TSP ($\mu\text{g}/\text{m}^3$) Levels at W-A6

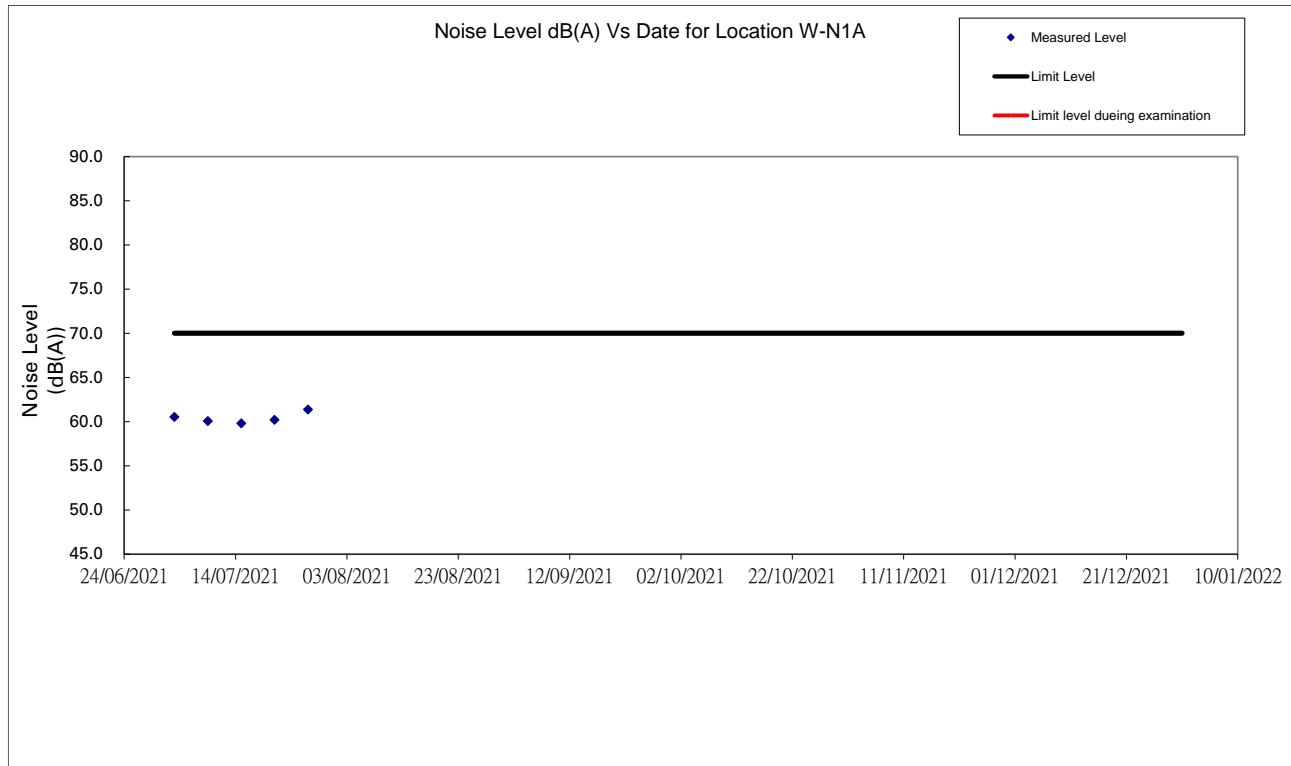
Figure 1: Graphical Illustration of Measured Noise Levels at W-N1A

Remark: No examination was at W-N1A in the reporting month so limit levels for all monitoring days were 70 dB(A).

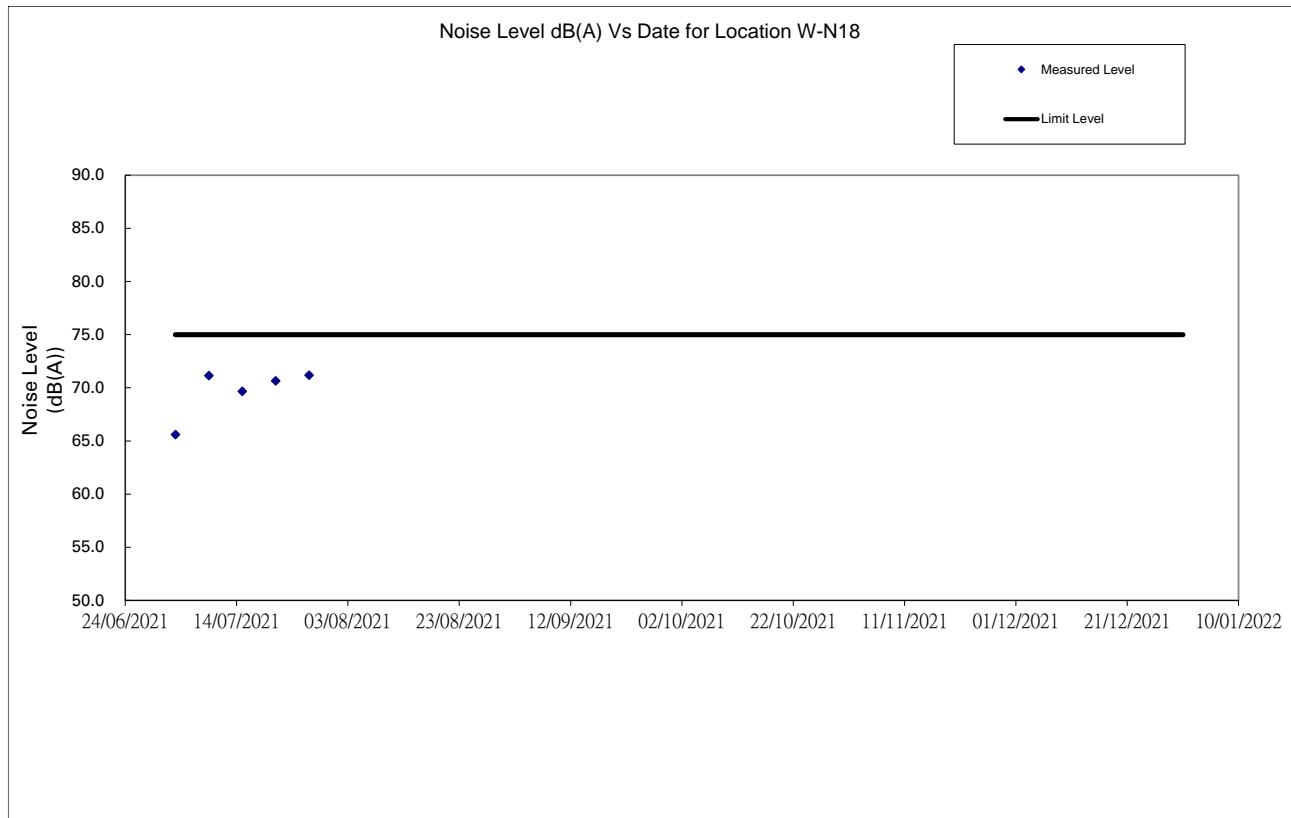
Figure 2: Graphical Illustration of Measured Noise Levels at W-N18

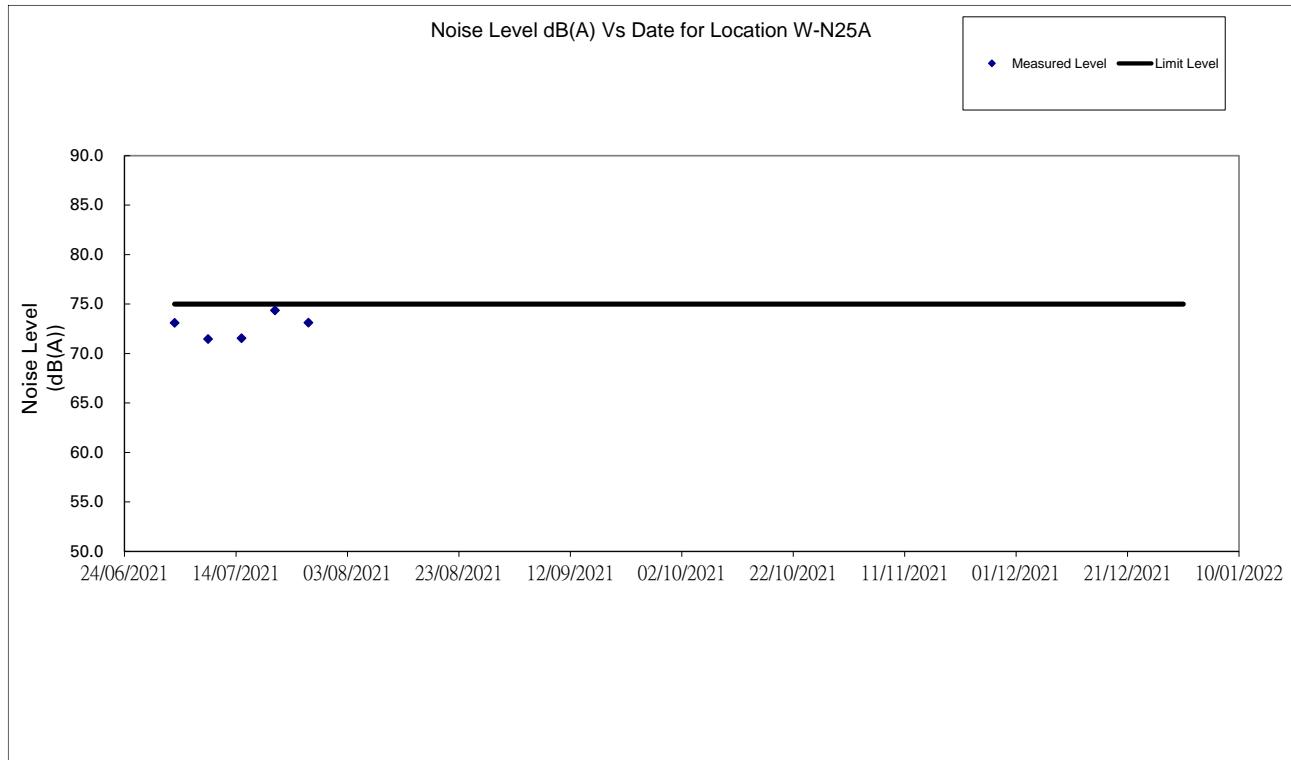
Figure 3: Graphical Illustration of Measured Noise Levels at W-N25A

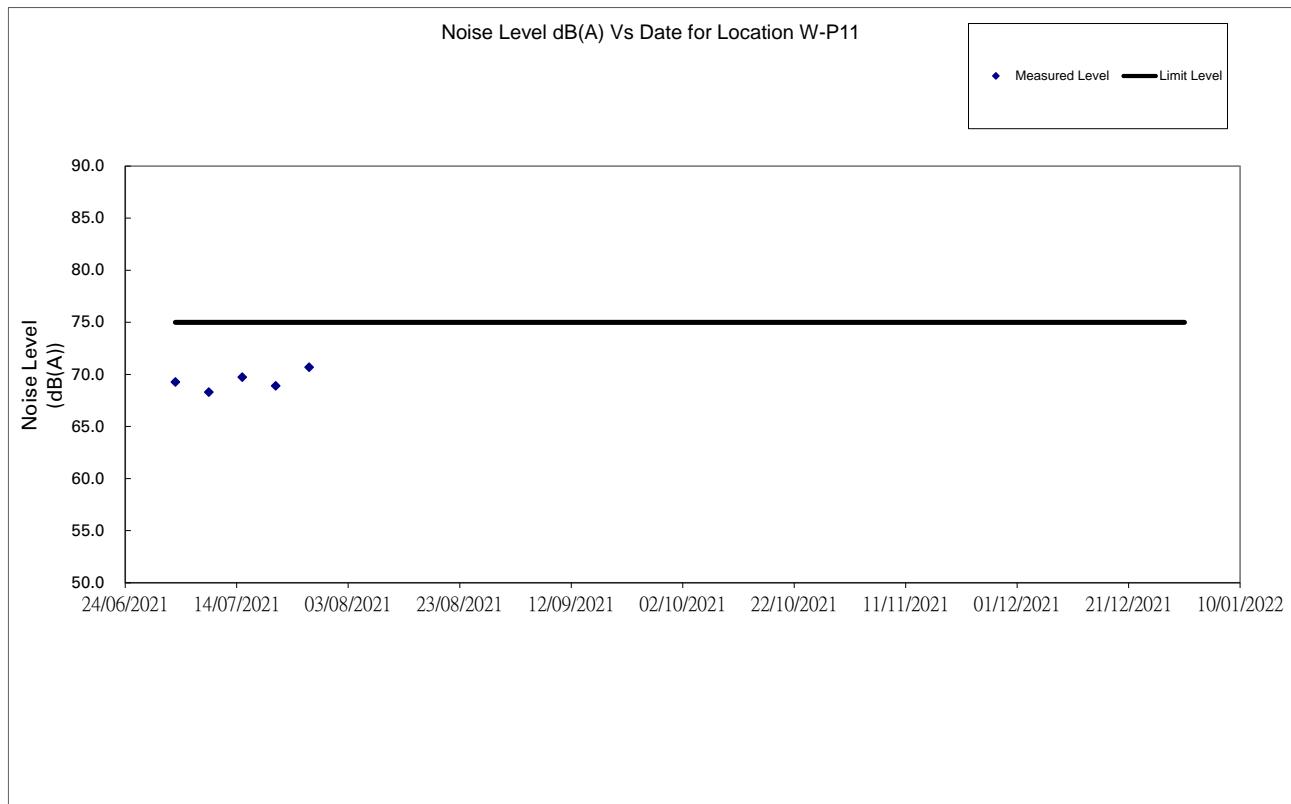
Figure 4: Graphical Illustration of Measured Noise Levels at W-P11
