**Central Kowloon Route**

**Ho Man Tin Access Shaft**

**Contract No. HY/2014/09**

Monthly EM&A Report No. 6

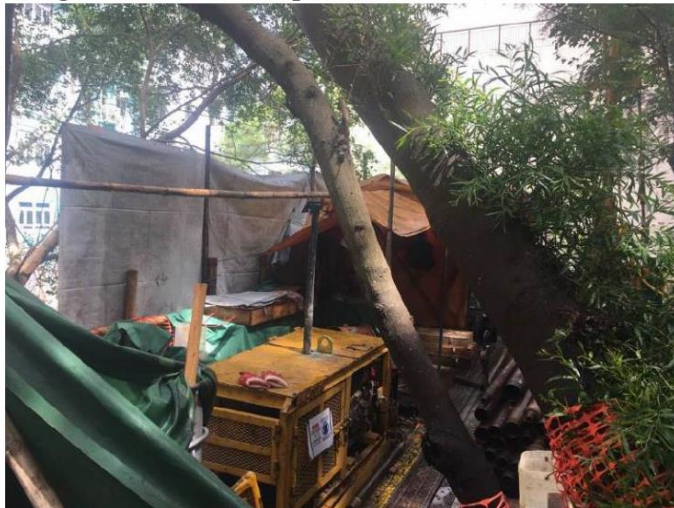
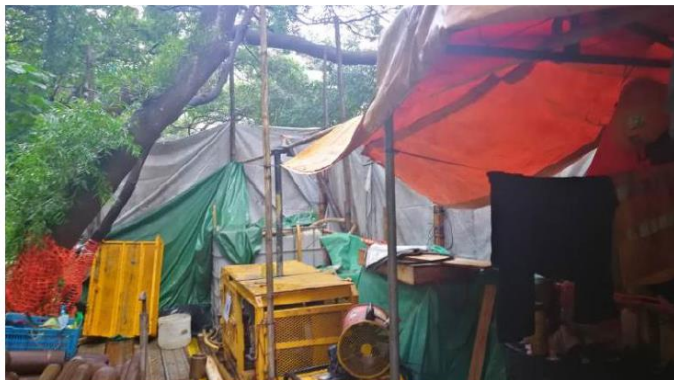
**Mitigation Measures implemented on Site**

- Switch off noisy equipment not in use;
- Noise barriers were installed oriented to NSR, which mitigate the noise to NSR and screen off the direct eye-sight to minimize the nuisance to the nearby resident.
- Enhance the regular maintenance and inspection for the equipment
- Keep residents informed of planned construction activities which may cause potential noise nuisance so that they can expect the inevitable noise impact;
- Nishimatsu will minimize the noisy activity before 9am; and
- Undertake site training to promote good site practice to avoid unnecessary noise disturbance.
