Central Kowloon Route

Yau Ma Tei West

Contract No. HY/2014/20

Monthly EM&A Report No. 27

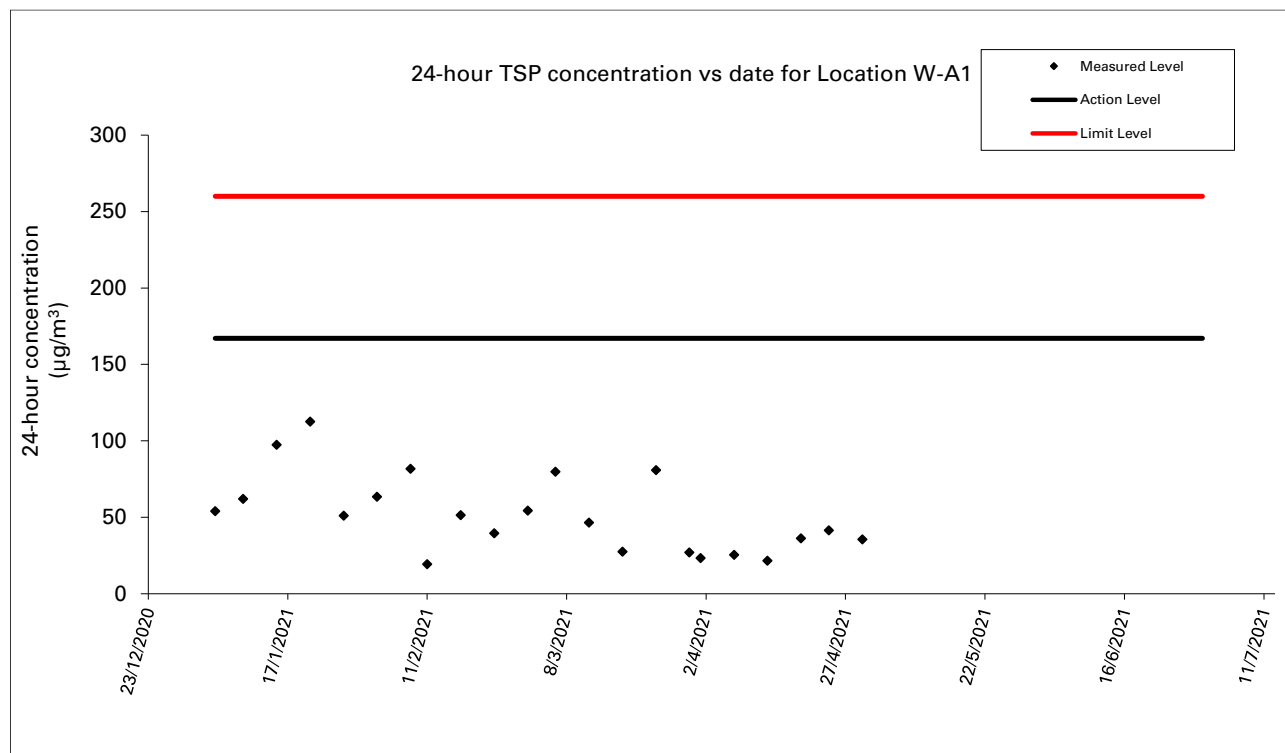
Figure 3: Graphical Illustration of Measured 24-hour TSP ($\mu\text{g}/\text{m}^3$) Levels at W-A1

Location: Yau Ma Tei Catholic Primary School (Hoi Wang Road) (W-A1)
Monitoring date: 1, 7, 13, 19, 24, 30 April 2021
Parameter : TSP 24-hour
Other Factors Nearby traffic

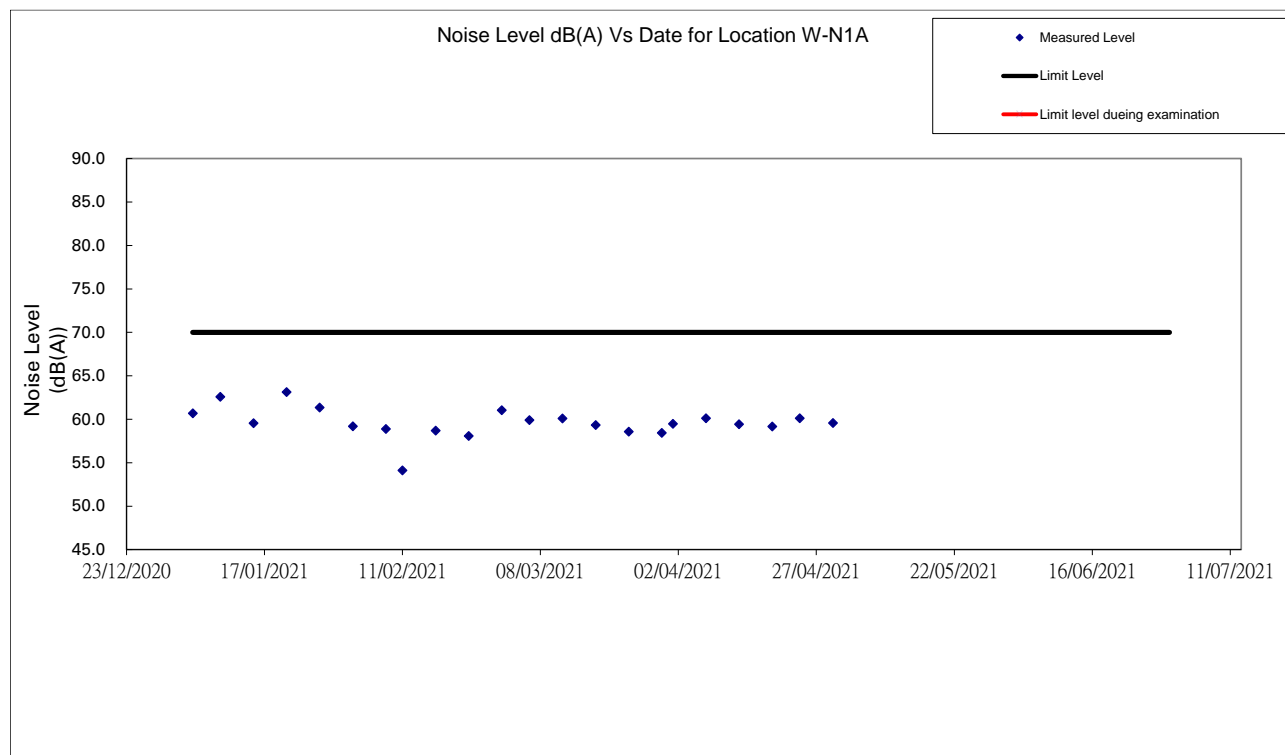
Figure 1: Graphical Illustration of Measured Noise Levels at W-N1A

Date	Weather	Start Time	-	End Time	L_{eq}	L_{10}	L_{90}	Wind speed (m/s)
01/04/2021	Sunny	12:23	-	12:53	70.4	73.5	67.4	1.9
07/04/2021	Sunny	13:04	-	11:15	68.3	70.4	65.5	2.8
13/04/2021	Sunny	10:23	-	10:53	71.8	73.5	66.9	2.1
19/04/2021	Sunny	15:04	-	13:30	68.9	71.0	65.3	4.4
24/04/2021	Cloudy	10:48	-	11:18	69.5	71.3	67.2	3.9
30/04/2021	Sunny	11:55	-	16:30	71.1	70.2	66.8	1.4
