Highways Department

**Agreement No. HMW  
5/2009 (EP) Traffic  
Improvements to Tuen  
Mun Road Town Centre  
Section**

Monthly Environmental  
Monitoring and Audit  
Report - October 2013

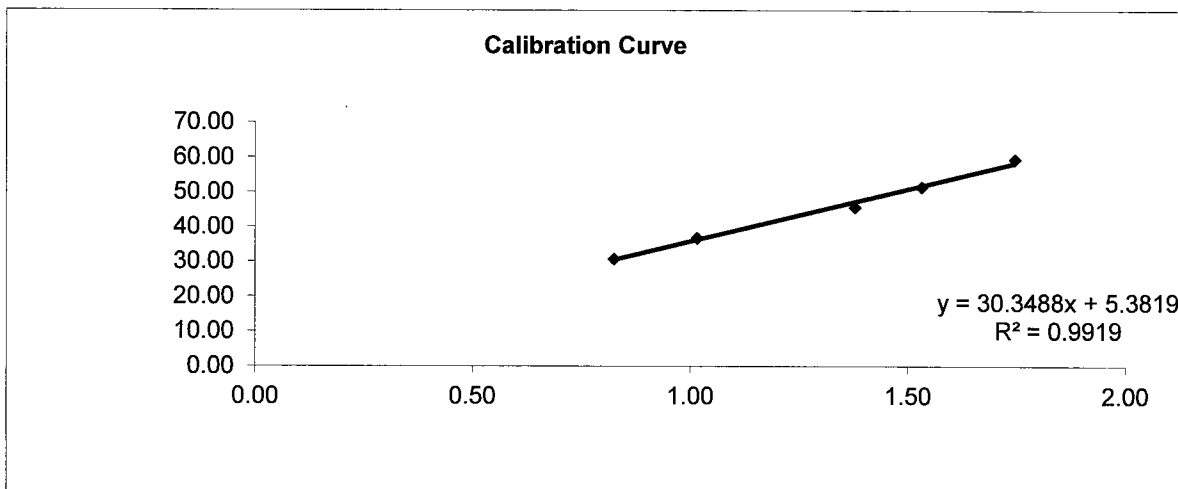
**Linear Regression**

Sampler slope (m) : 30.3488  
 Sampler intercept (b) : 5.3819  
 Correlation coefficient (R<sup>2</sup>) : 0.9919

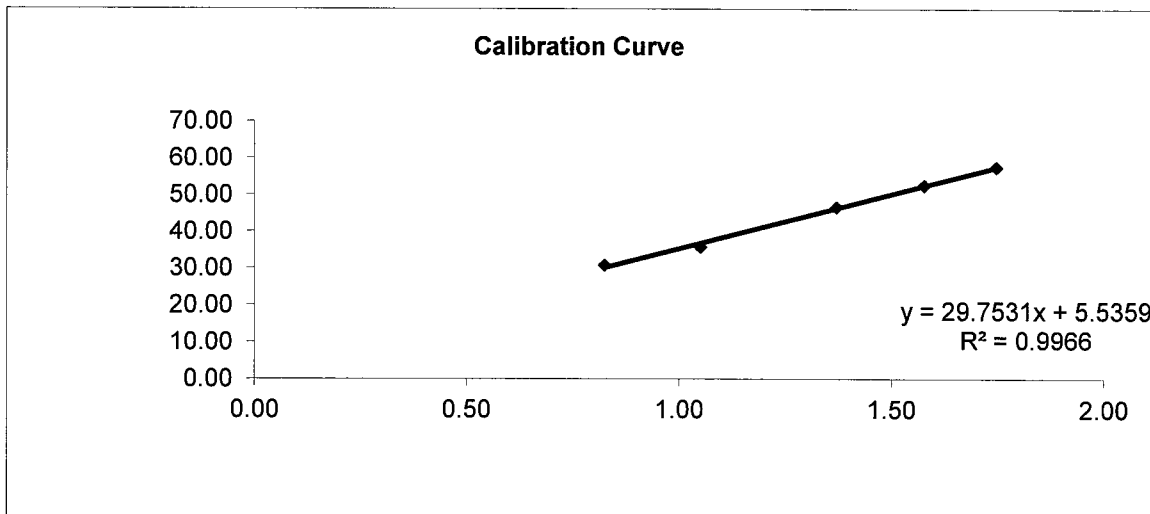
**Linear Regression**

Sampler slope (m) : **29.7531**  
 Sampler intercept (b) : **5.5359**  
 Correlation coefficient (R<sup>2</sup>) : **0.9966**

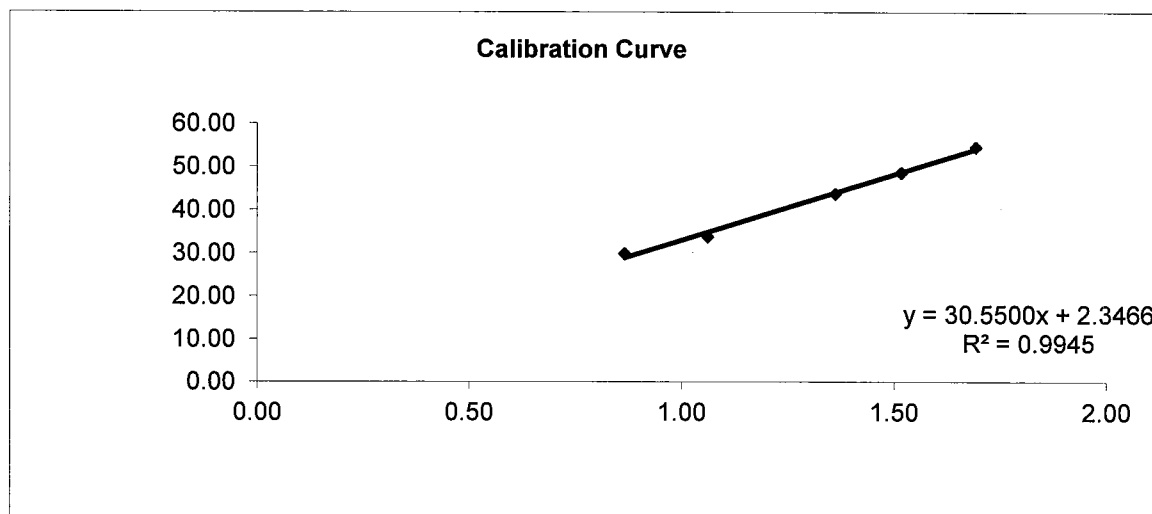
### Linear Regression

**Sampler slope (m) :** 30.5500  
**Sampler intercept (b) :** 2.3466  
**Correlation coefficient (R<sup>2</sup>) :** 0.9945
