**KWAN ON CONSTRUCTION CO. LTD.**

**Contract No. YL/2009/01  
Hang Hau Tsuen Channel  
at Lau Fau Shan**

**Monthly Environmental Monitoring and Audit Report  
November 2011**

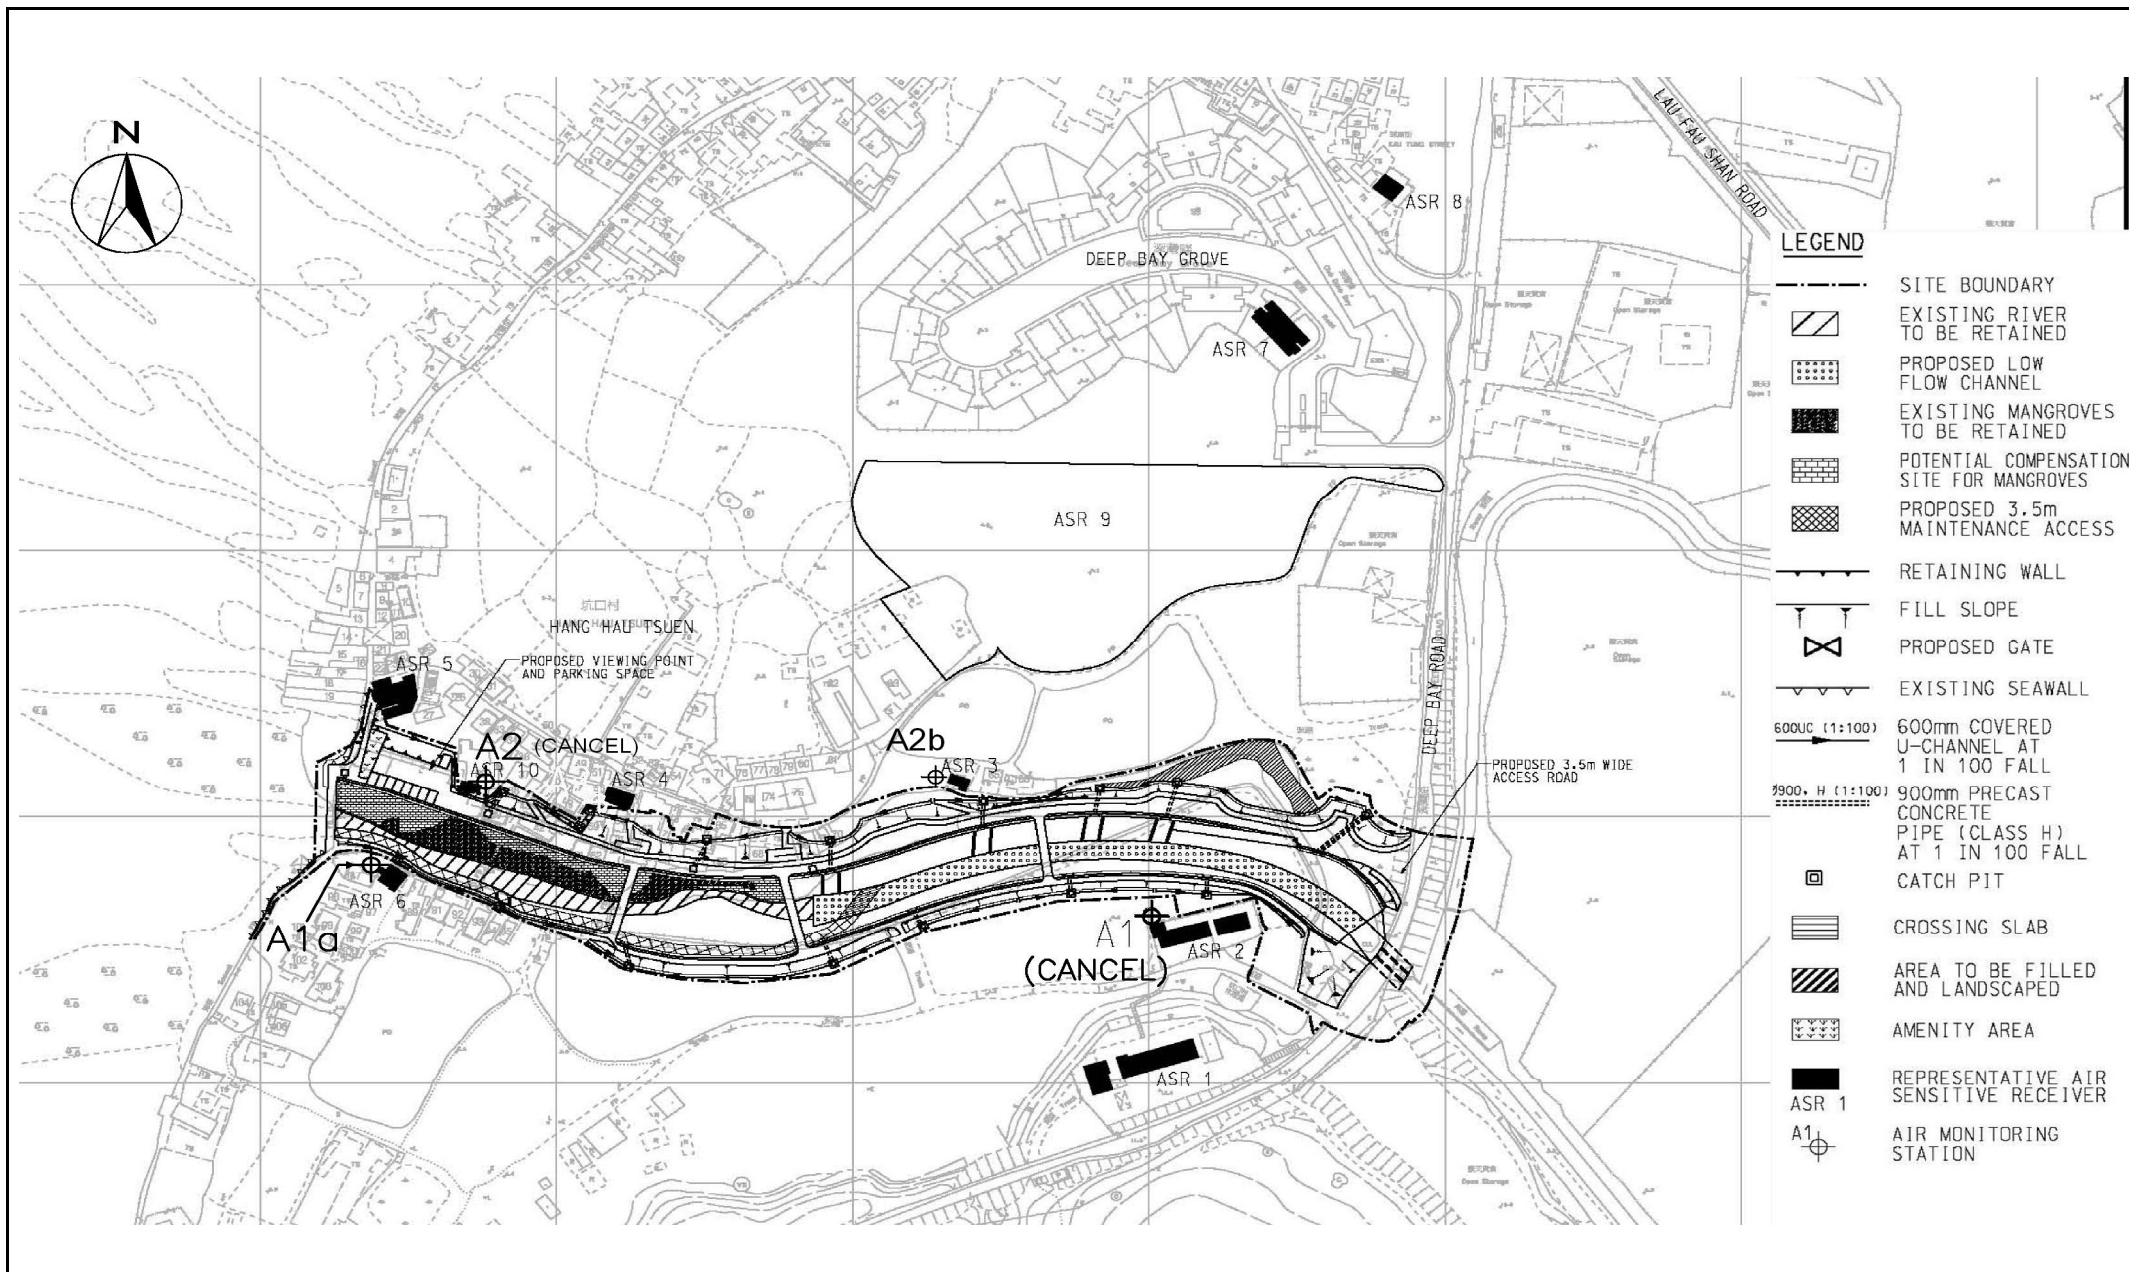
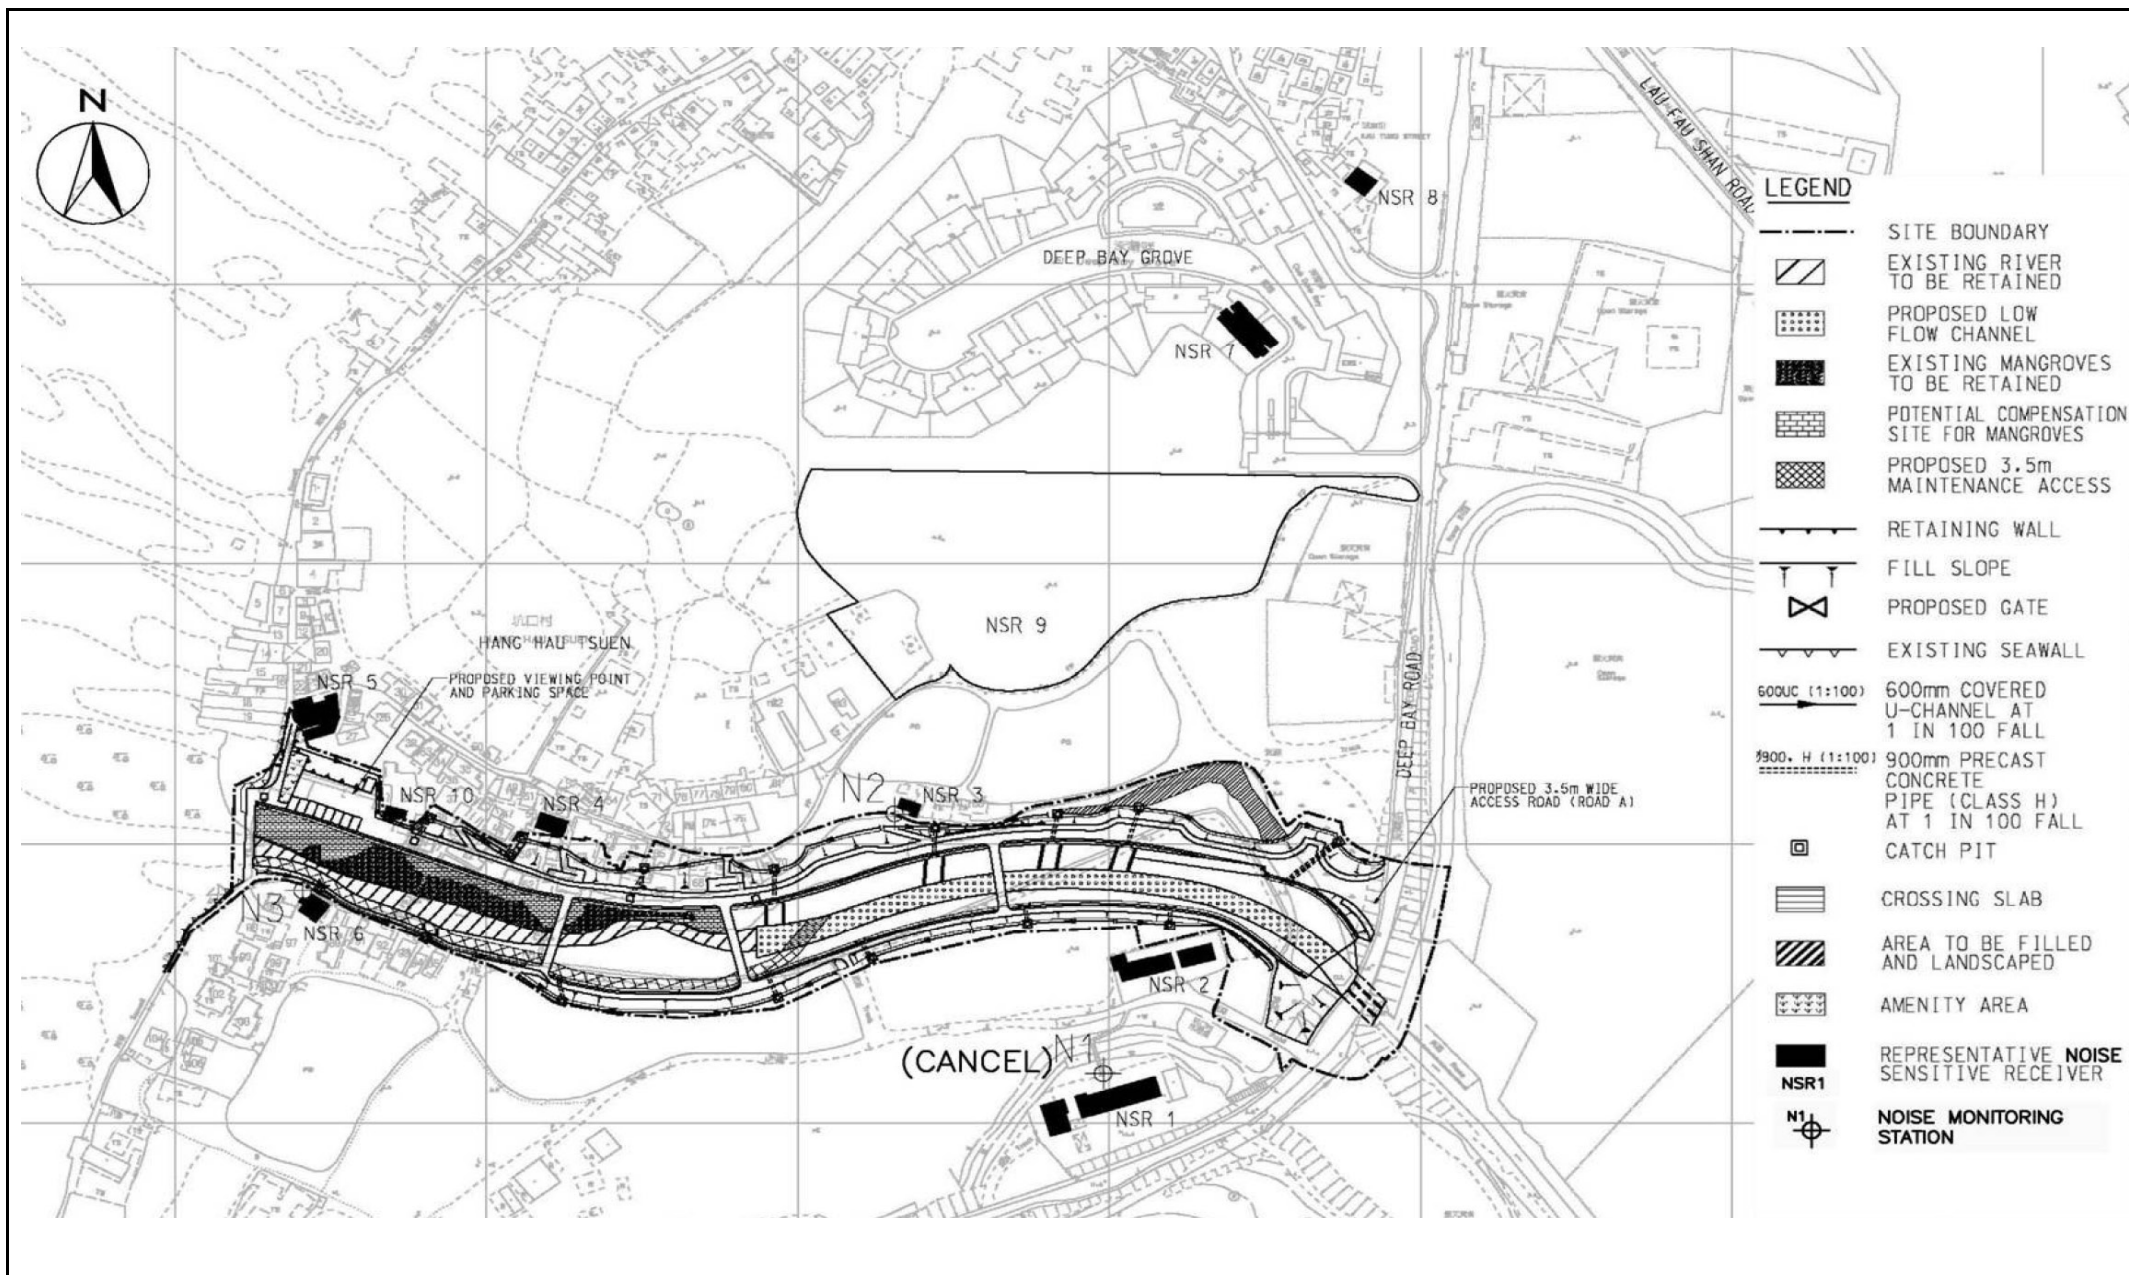
WQM	EASTING	NORTHING
W1	816023.3	836095.5
W2	815791.5	836276.6
W3	815673.7	836076.8
W4	*	*
W5	816390.9	836039.1
W6	815496.6	836713.5
W7	815174.0	835484.9

\* Mobile station subject to the location of the works within the channel.

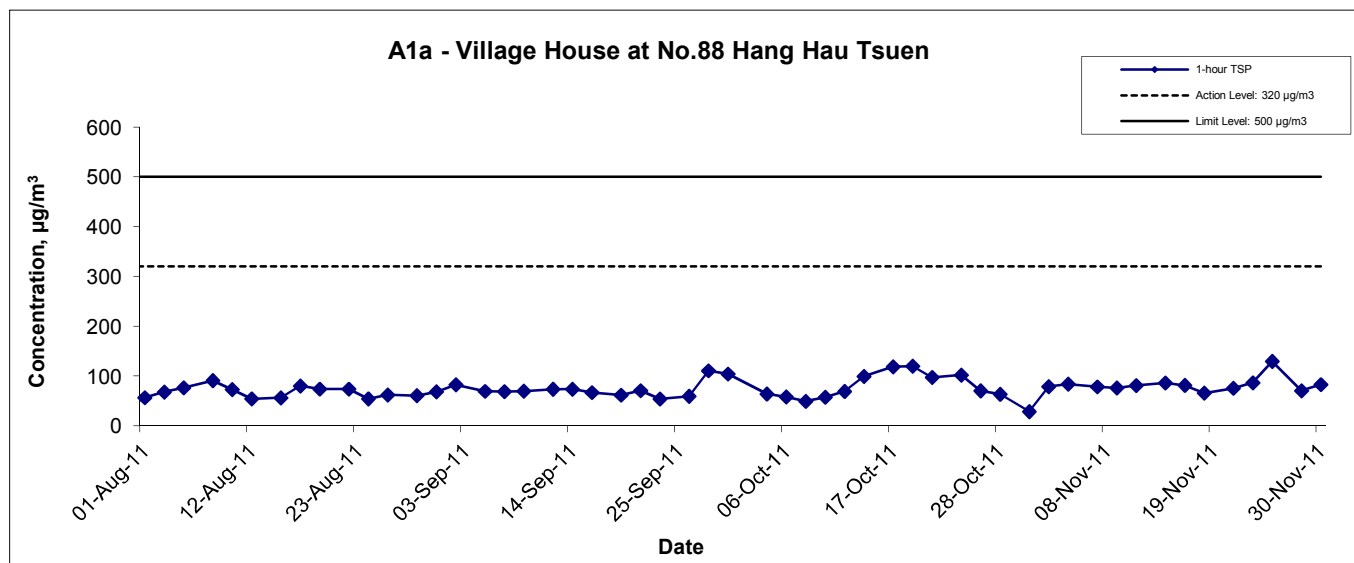
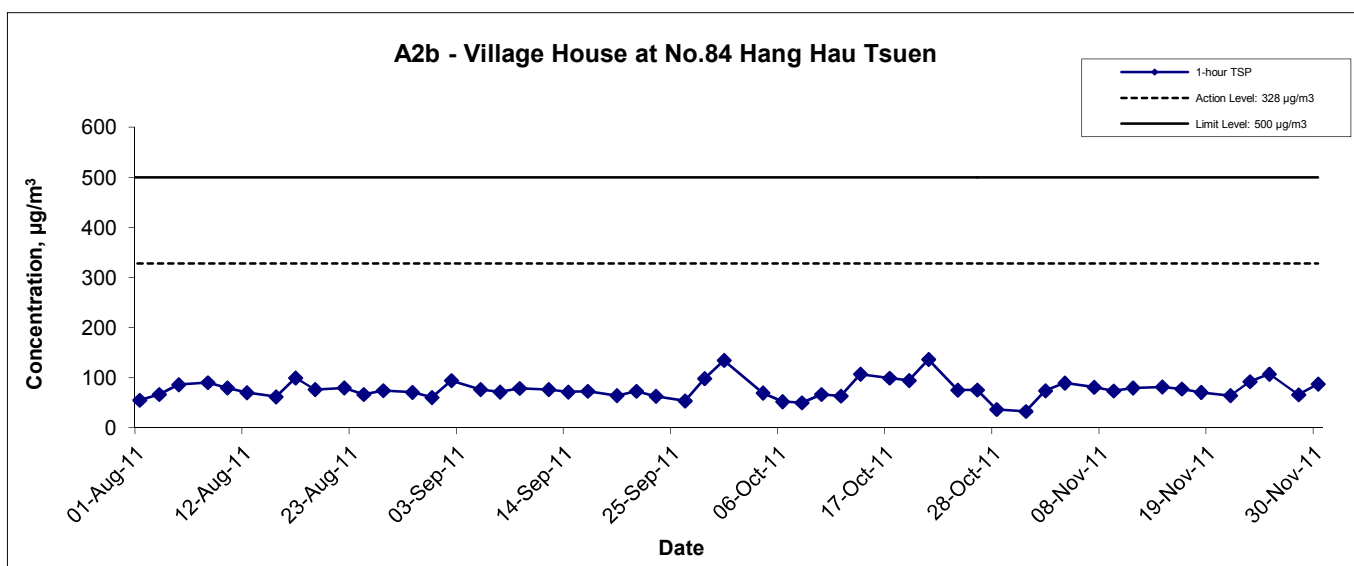
## 1-hr TSP Concentration Levels

Title	Contract No. YL/2009/01	Scale	Project No.	CINOTECH
	Hang Hau Tsuen Channel at Lau Fau Shan	N.T.S	MA0002	
Graphical Presentation of 1-hour TSP Monitoring Results		Date	Appendix	
		Nov 11	E

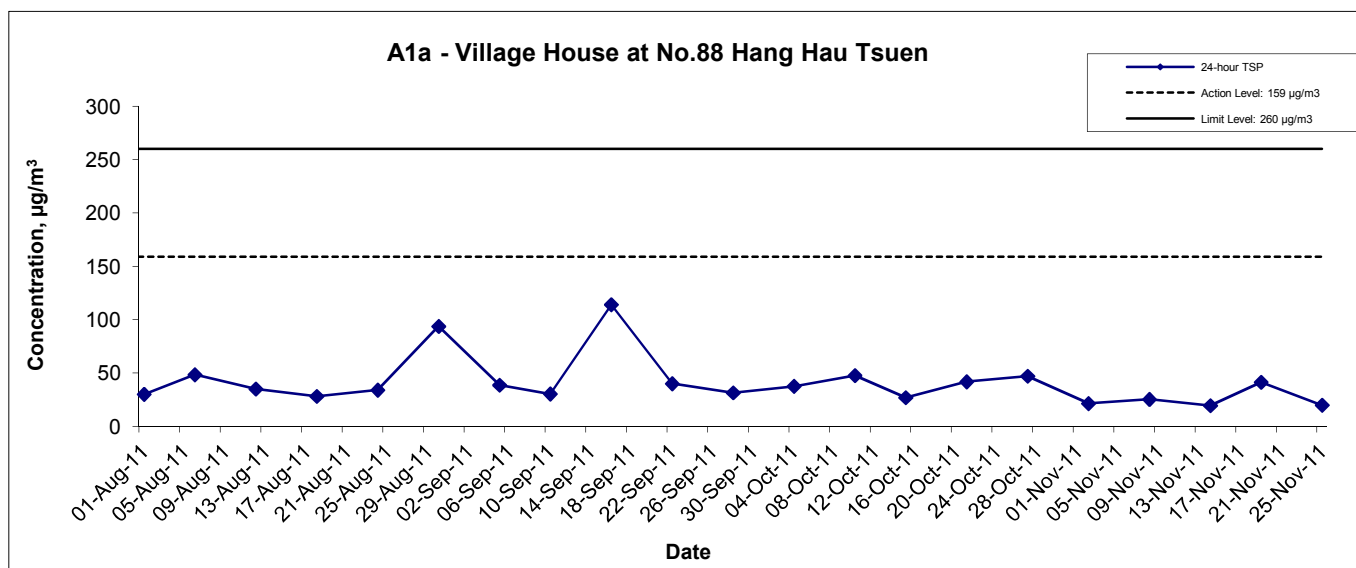
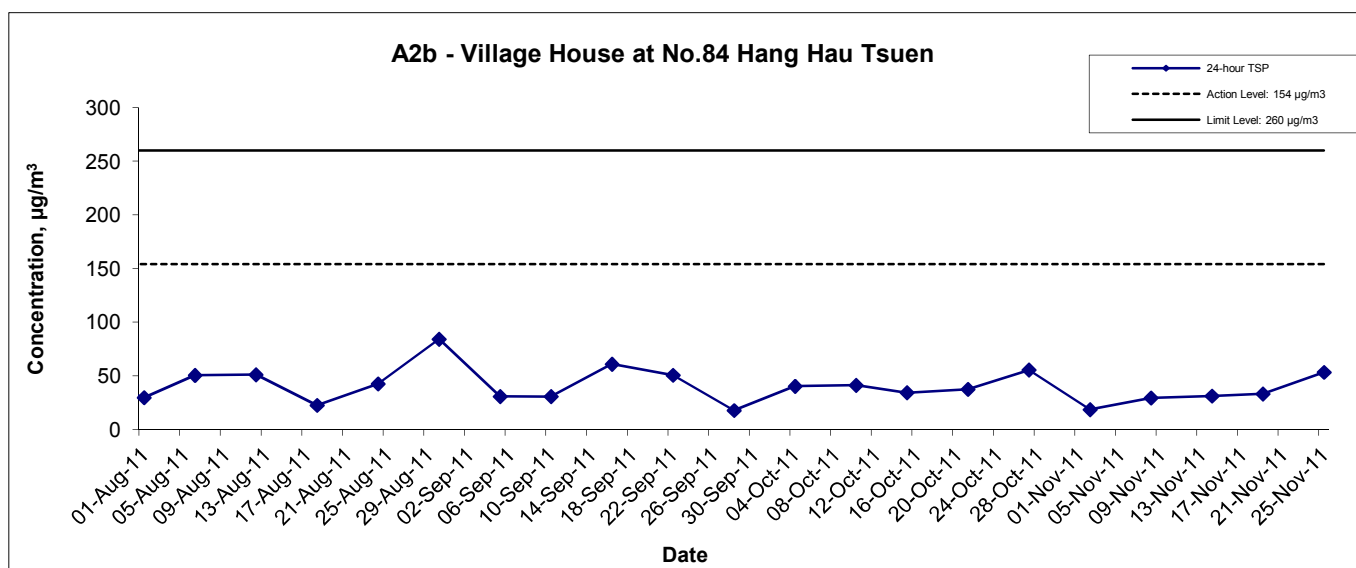
## 24-hr TSP Concentration Levels

Title	Contract No. YL/2009/01 Hang Hau Tsuen Channel at Lau Fau Shan	Scale N.T.S	Project No. MA0002	CINOTECH
	Graphical Presentation of 24-hour TSP Monitoring Results	Date Nov 11	Appendix F

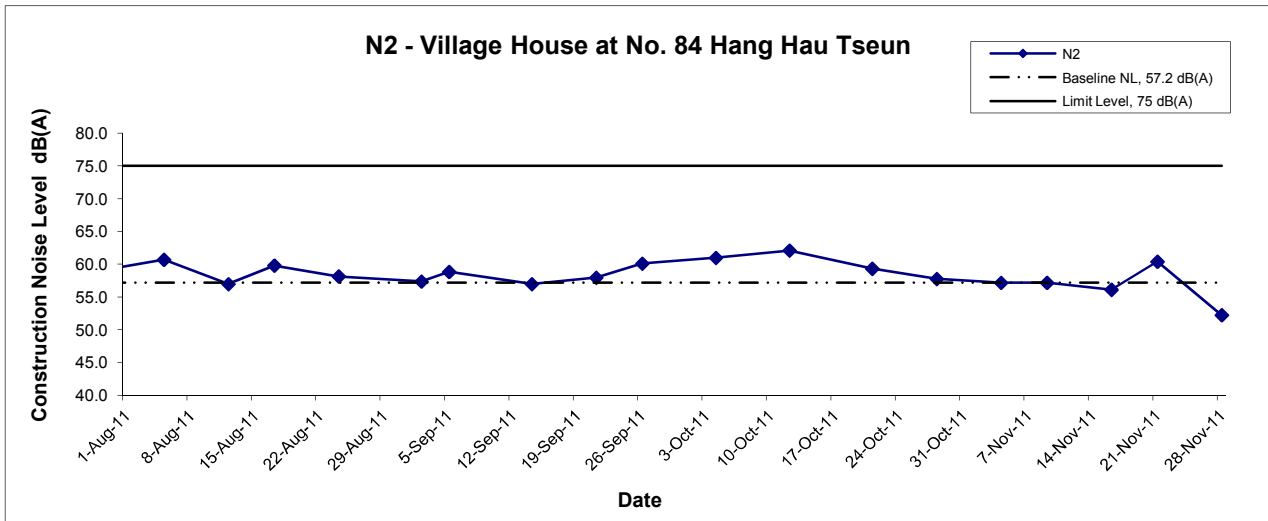
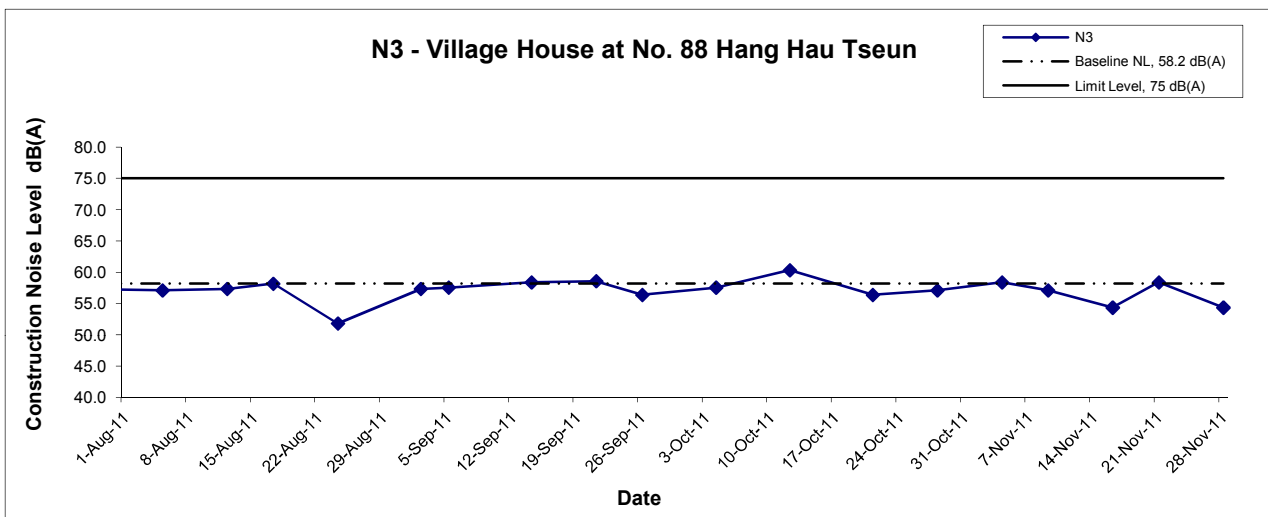
## Noise Levels

Title	Contract No. YL/2009/01	Scale	Project No.	CINOTECH
	Hang Hau Tsuen Channel at Lau Fau Shan	N.T.S	MA0002	
	Graphical Presentation of Construction Noise Monitoring Results	Date	Appendix	
		Nov 11	G

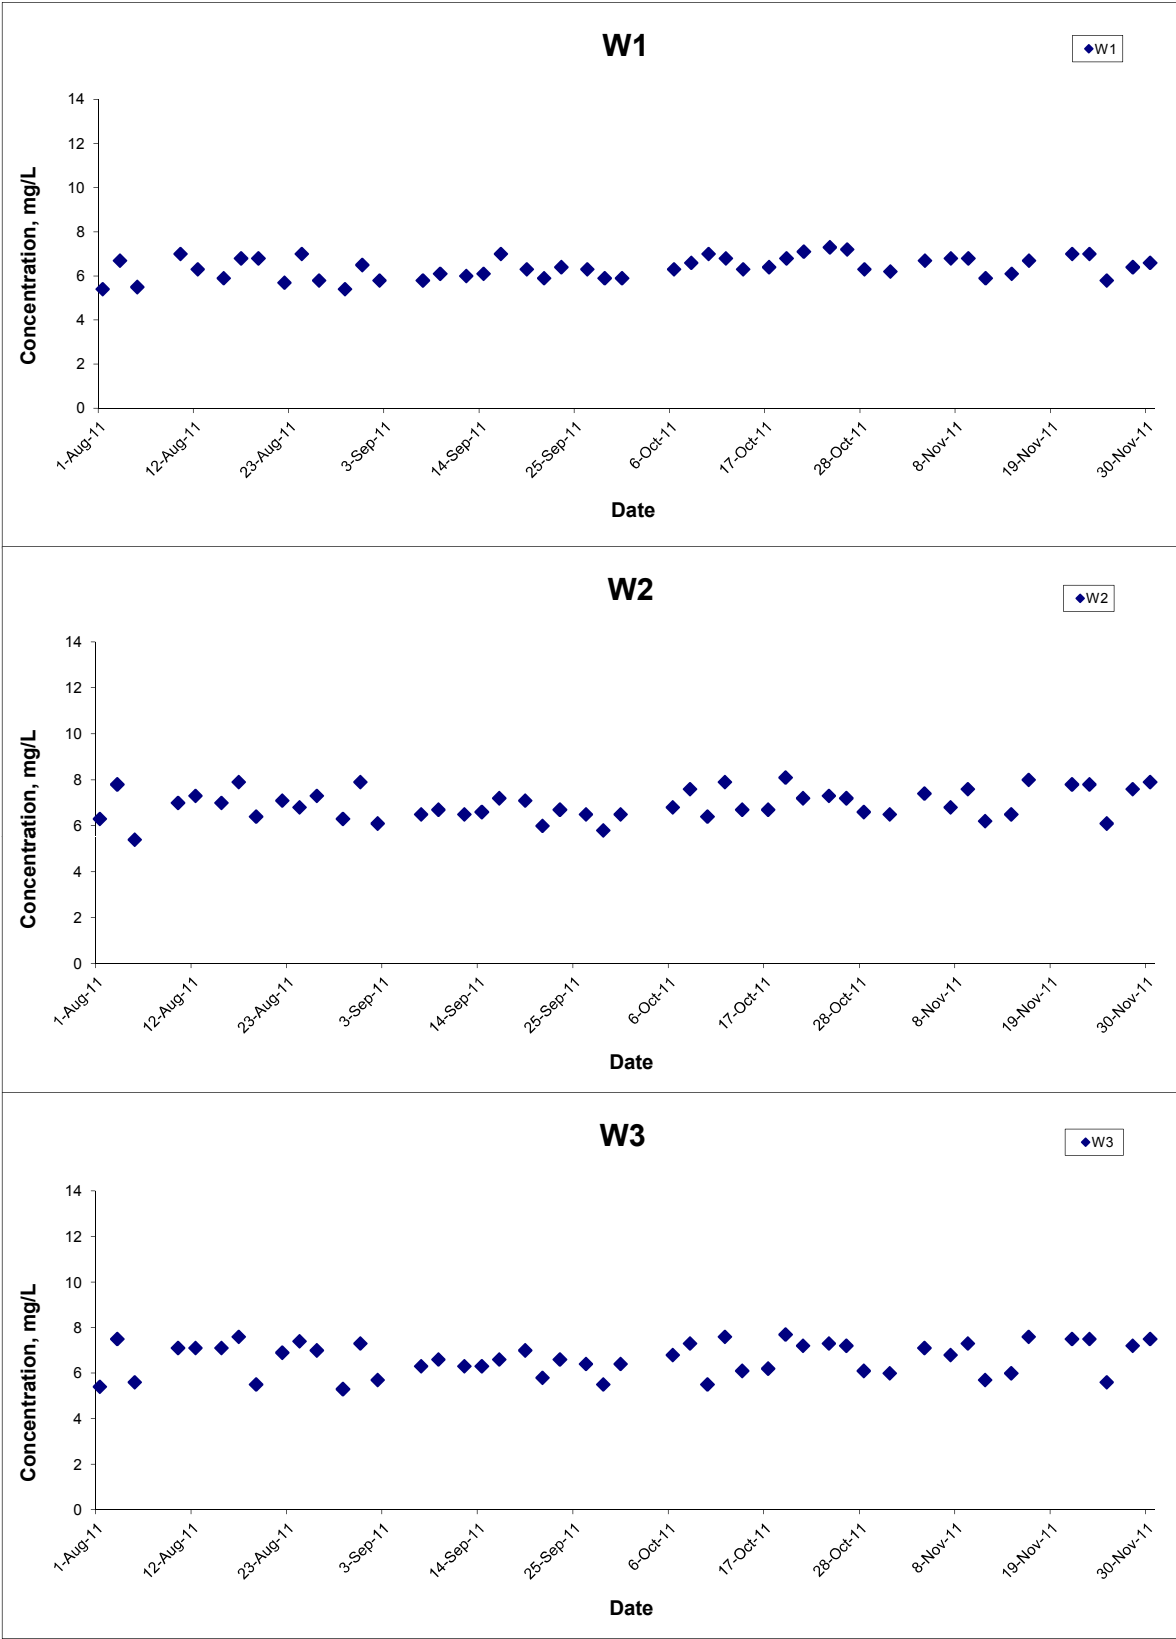
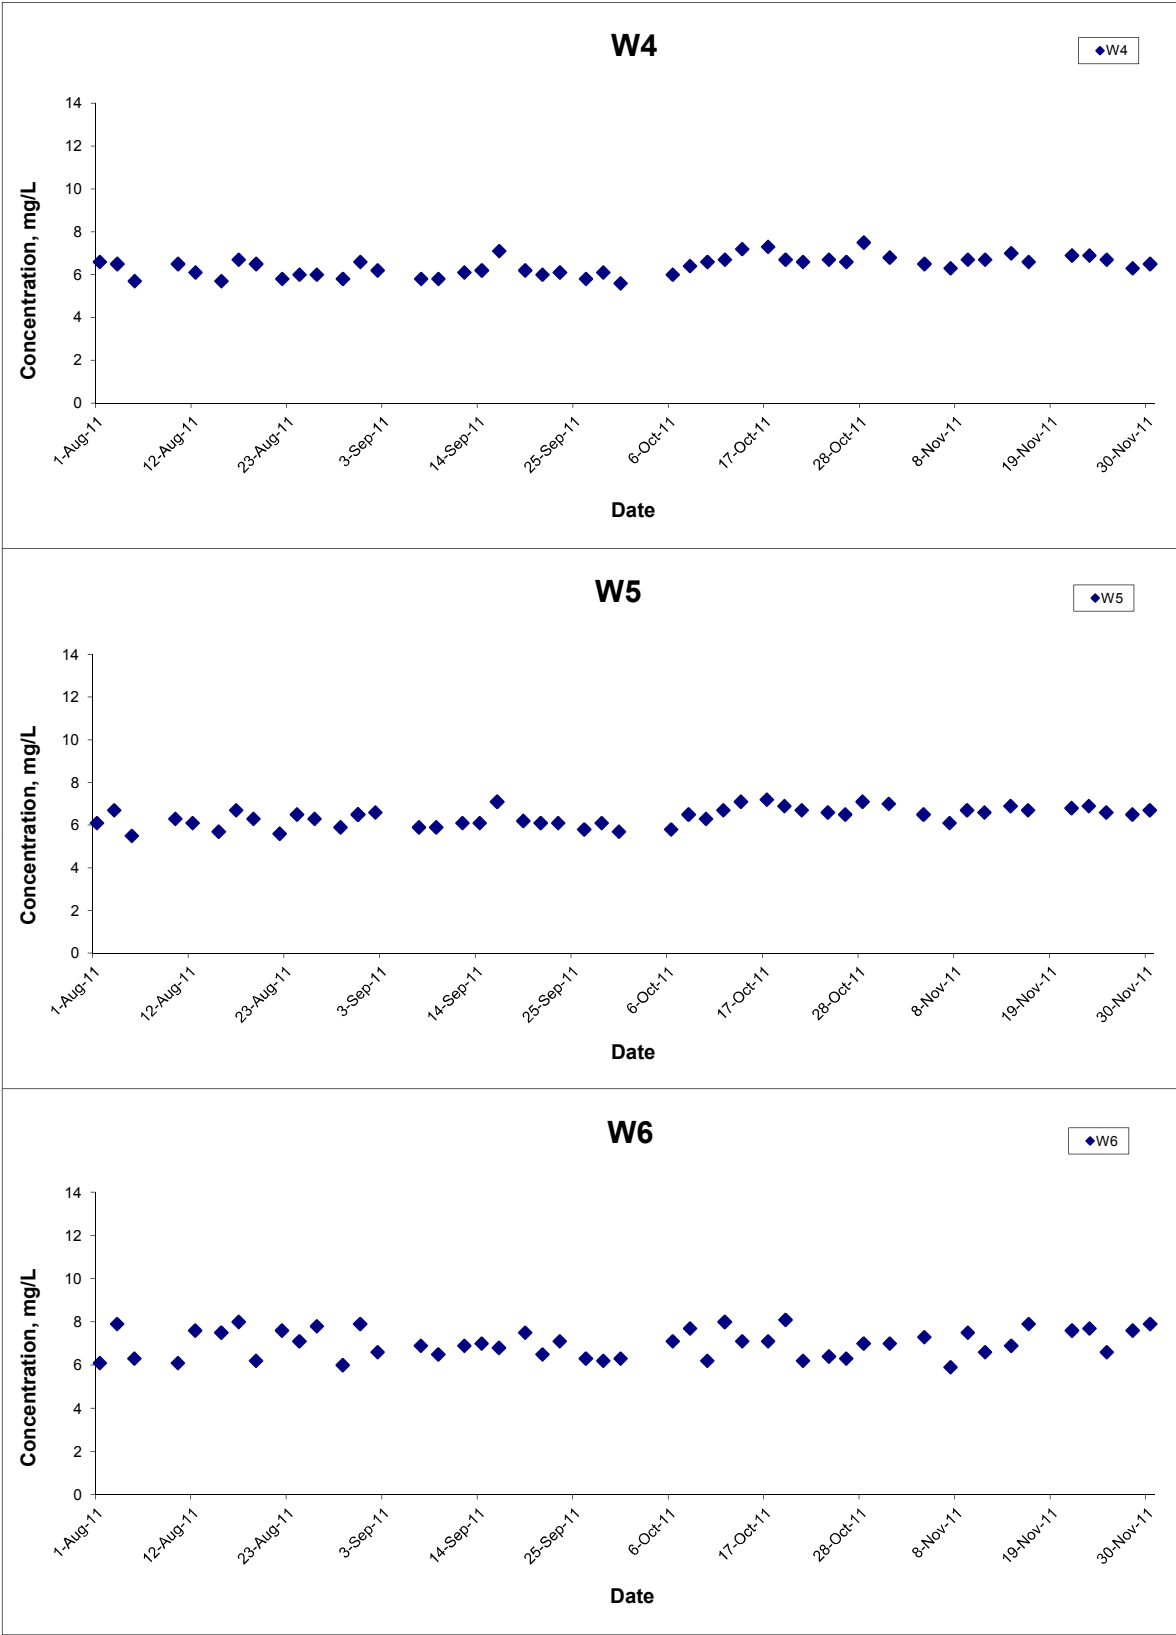
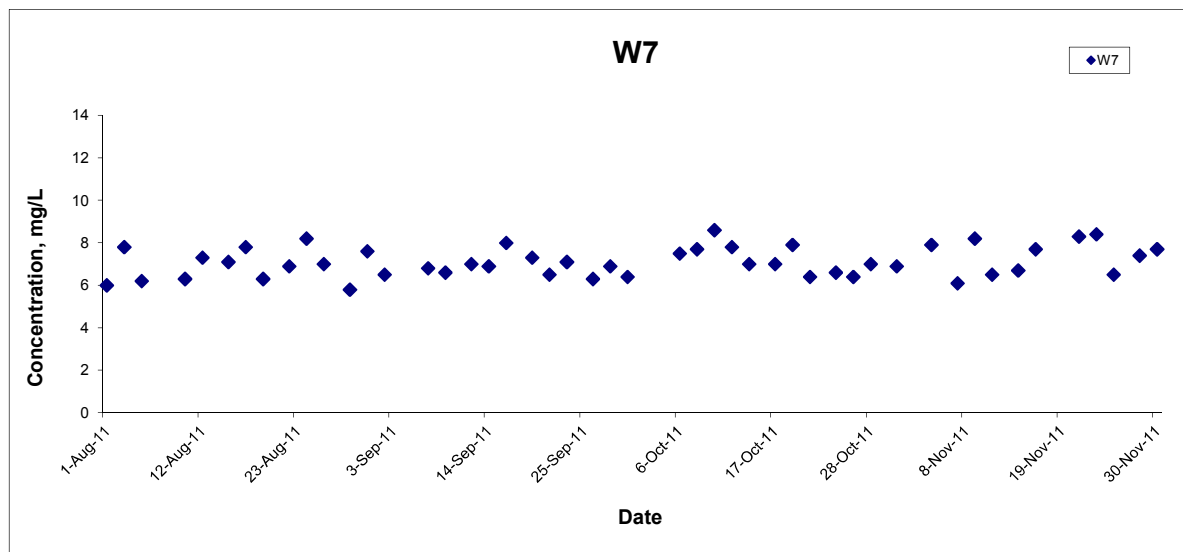
### Dissolved Oxygen (Surface & Middle) at Mid-Ebb Tide

Title Contract No. YL/2009/01 Hang Hau Tsuen Channel at Lau Fau Shan Graphical Presentation of Water Quality Monitoring Results	Scale N.T.S	Project No. MA0002

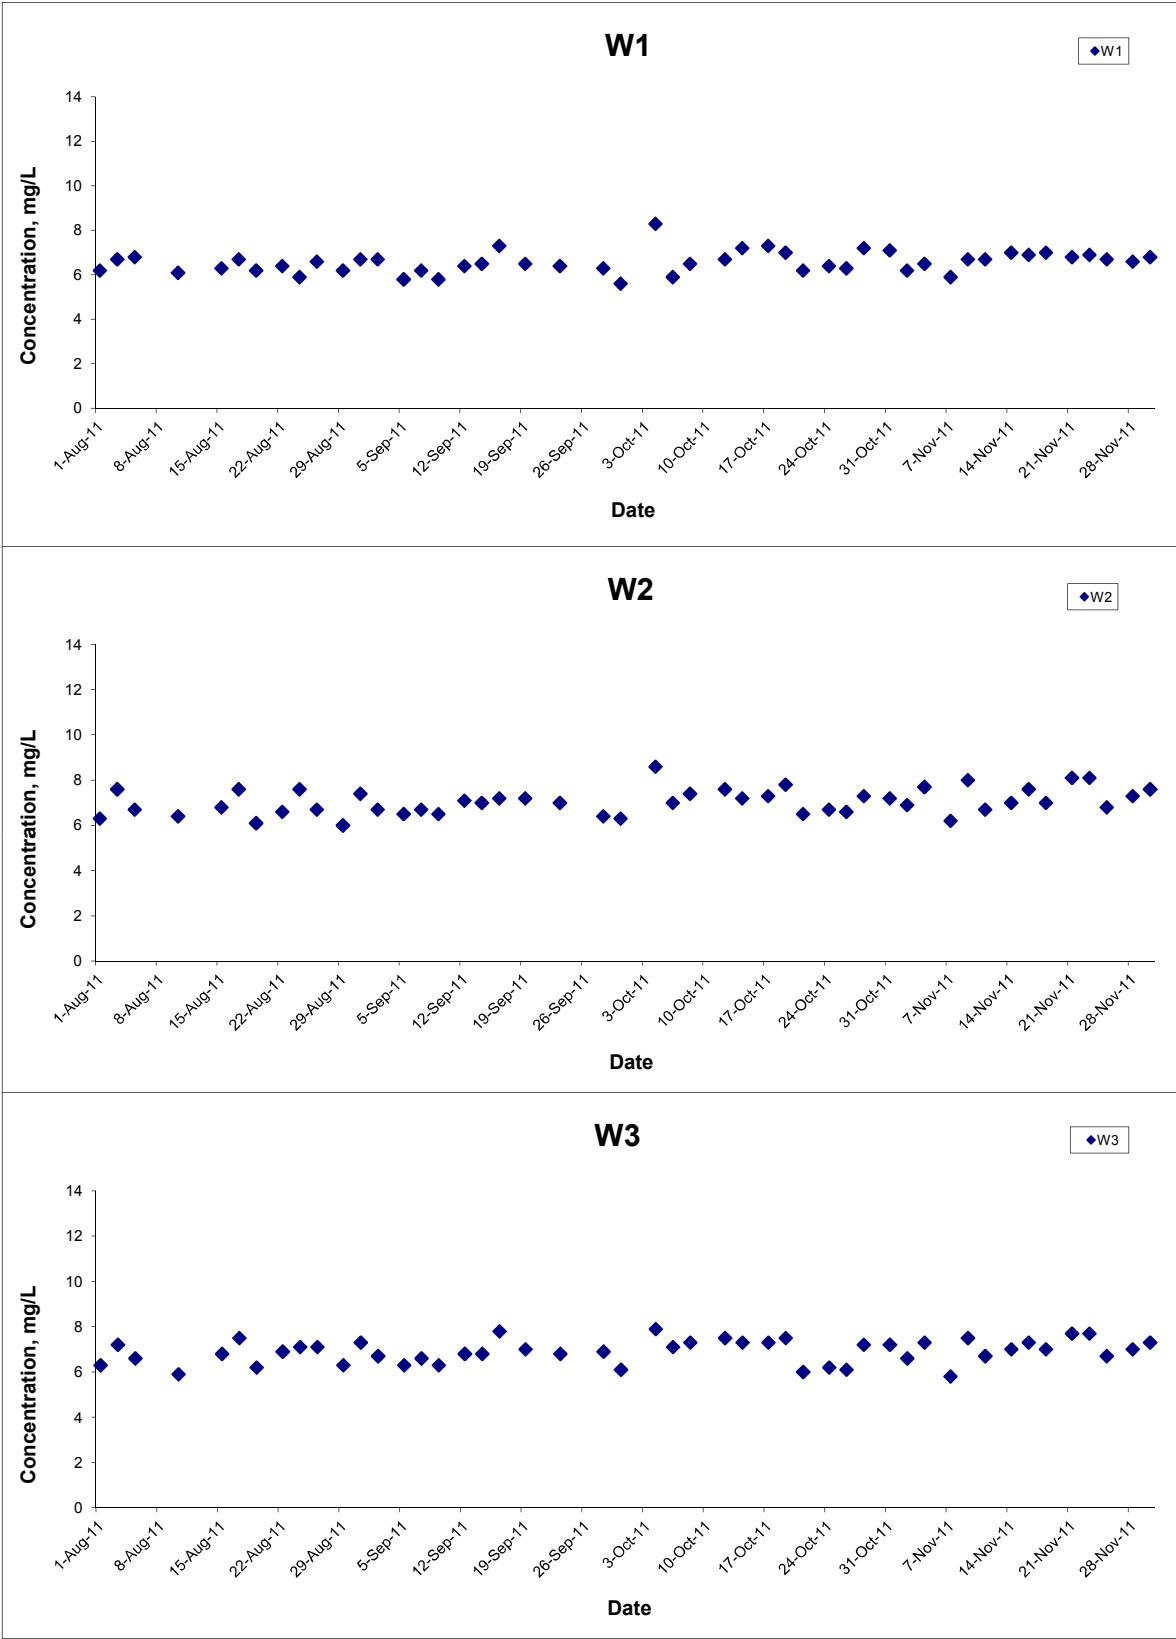
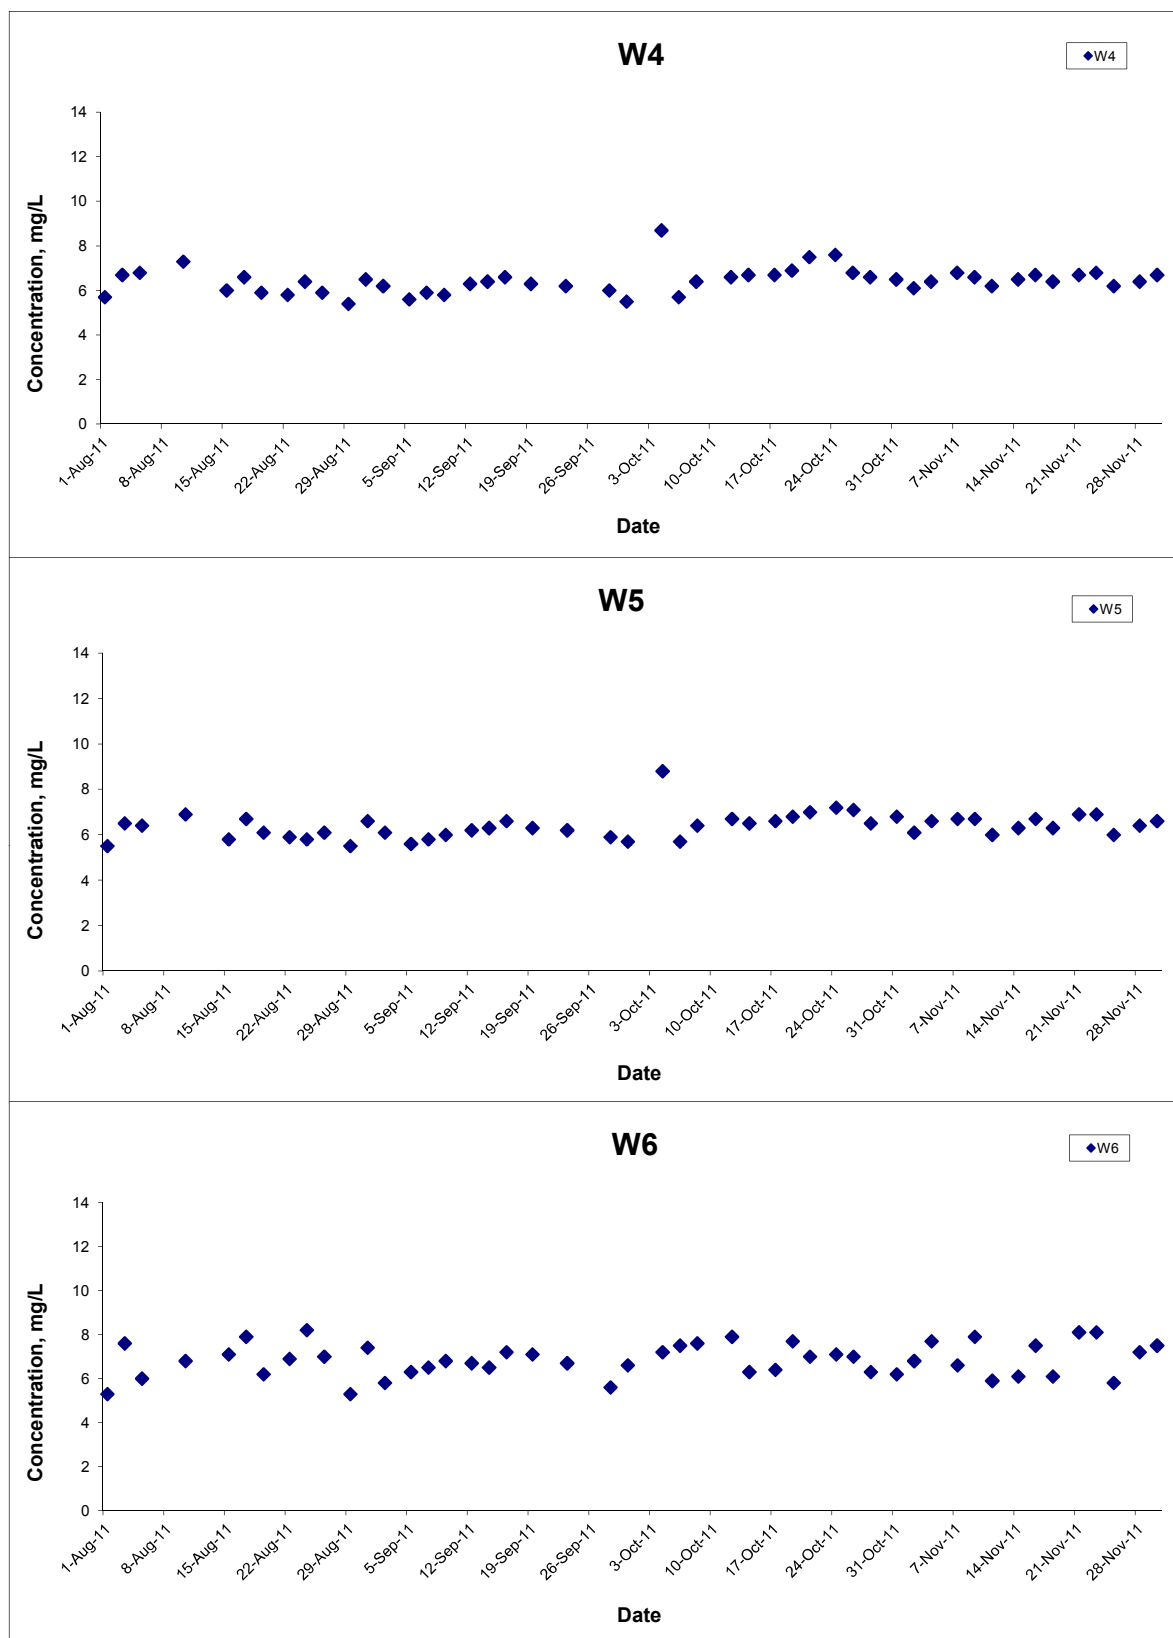
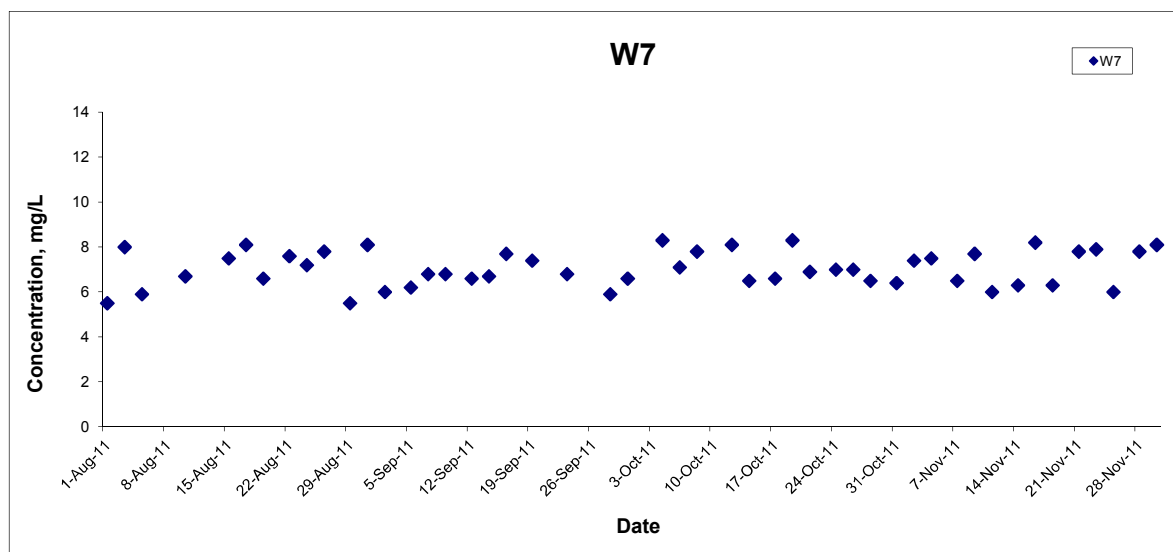
## Dissolved Oxygen (Surface & Middle) at Mid-Flood Tide

Title Contract No. YL/2009/01 Hang Hau Tsuen Channel at Lau Fau Shan Graphical Presentation of Water Quality Monitoring Results	Scale N.T.S	Project No. MA0002
