**KWAN ON CONSTRUCTION CO. LTD.**

**Contract No. YL/2009/01  
Hang Hau Tsuen Channel  
at Lau Fau Shan**

**Monthly Environmental Monitoring and Audit Report  
November 2011**

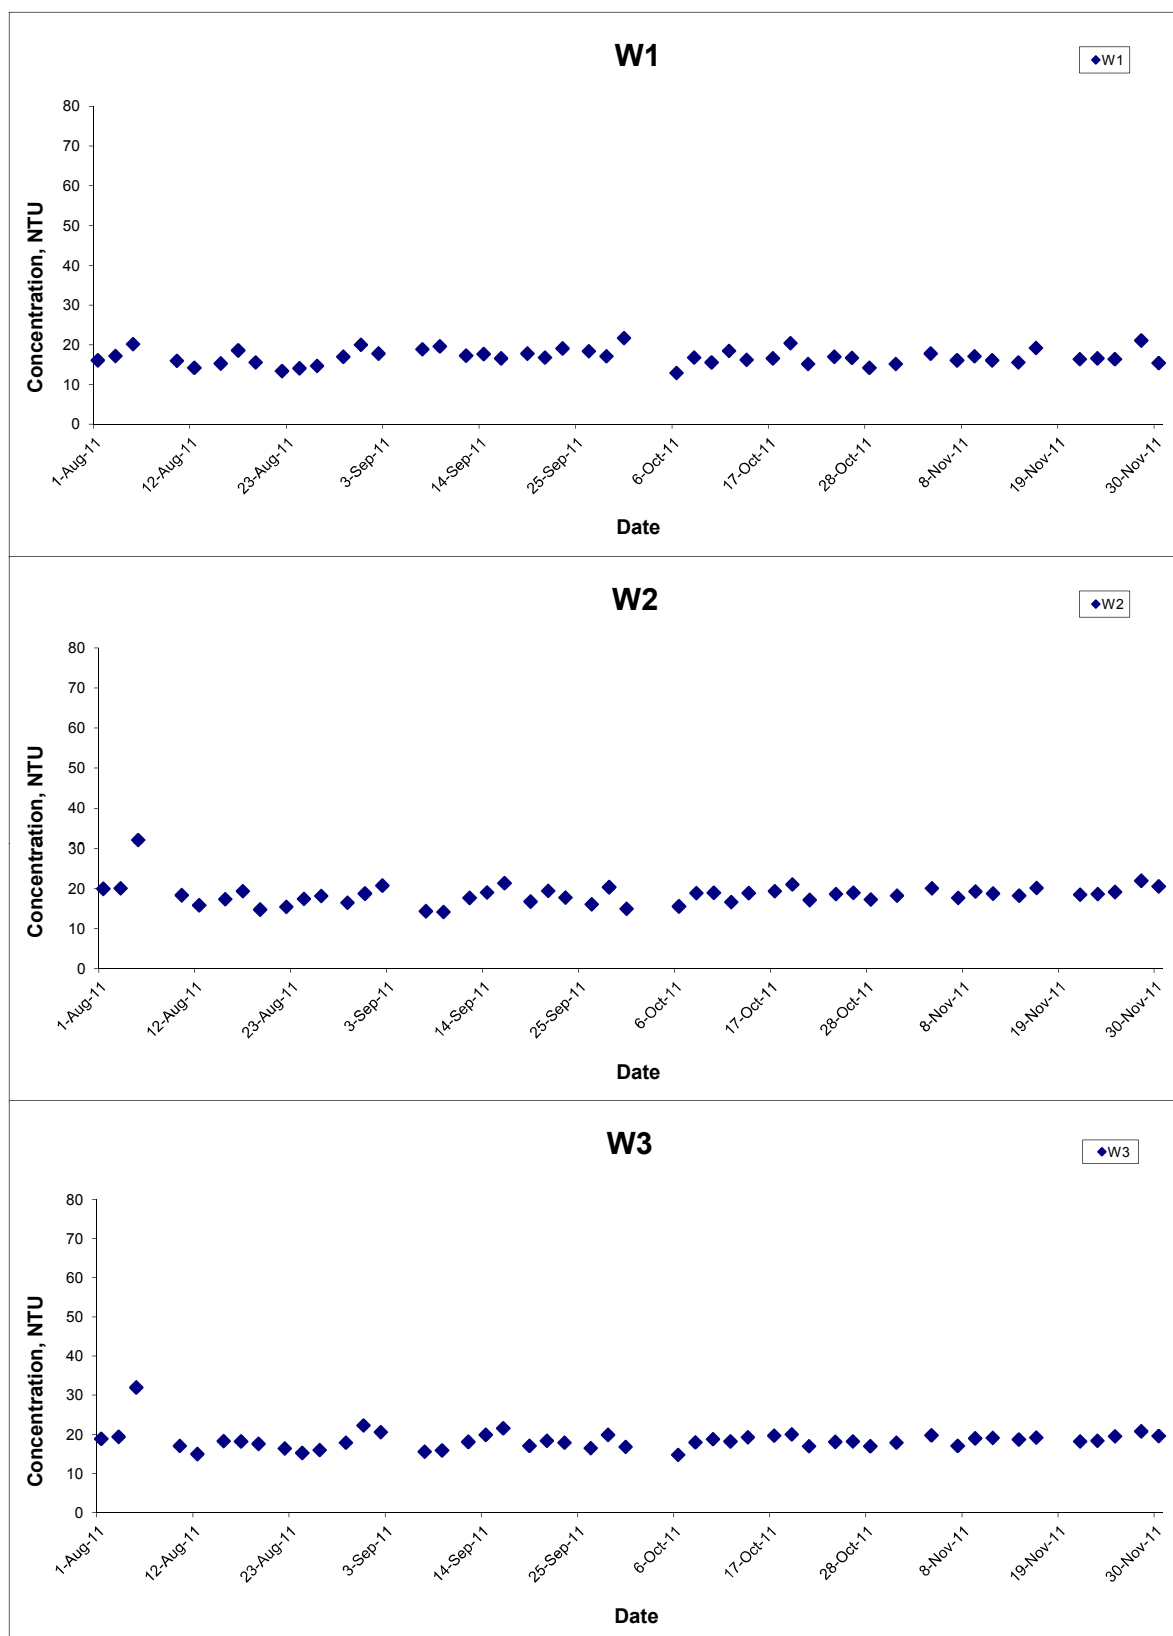
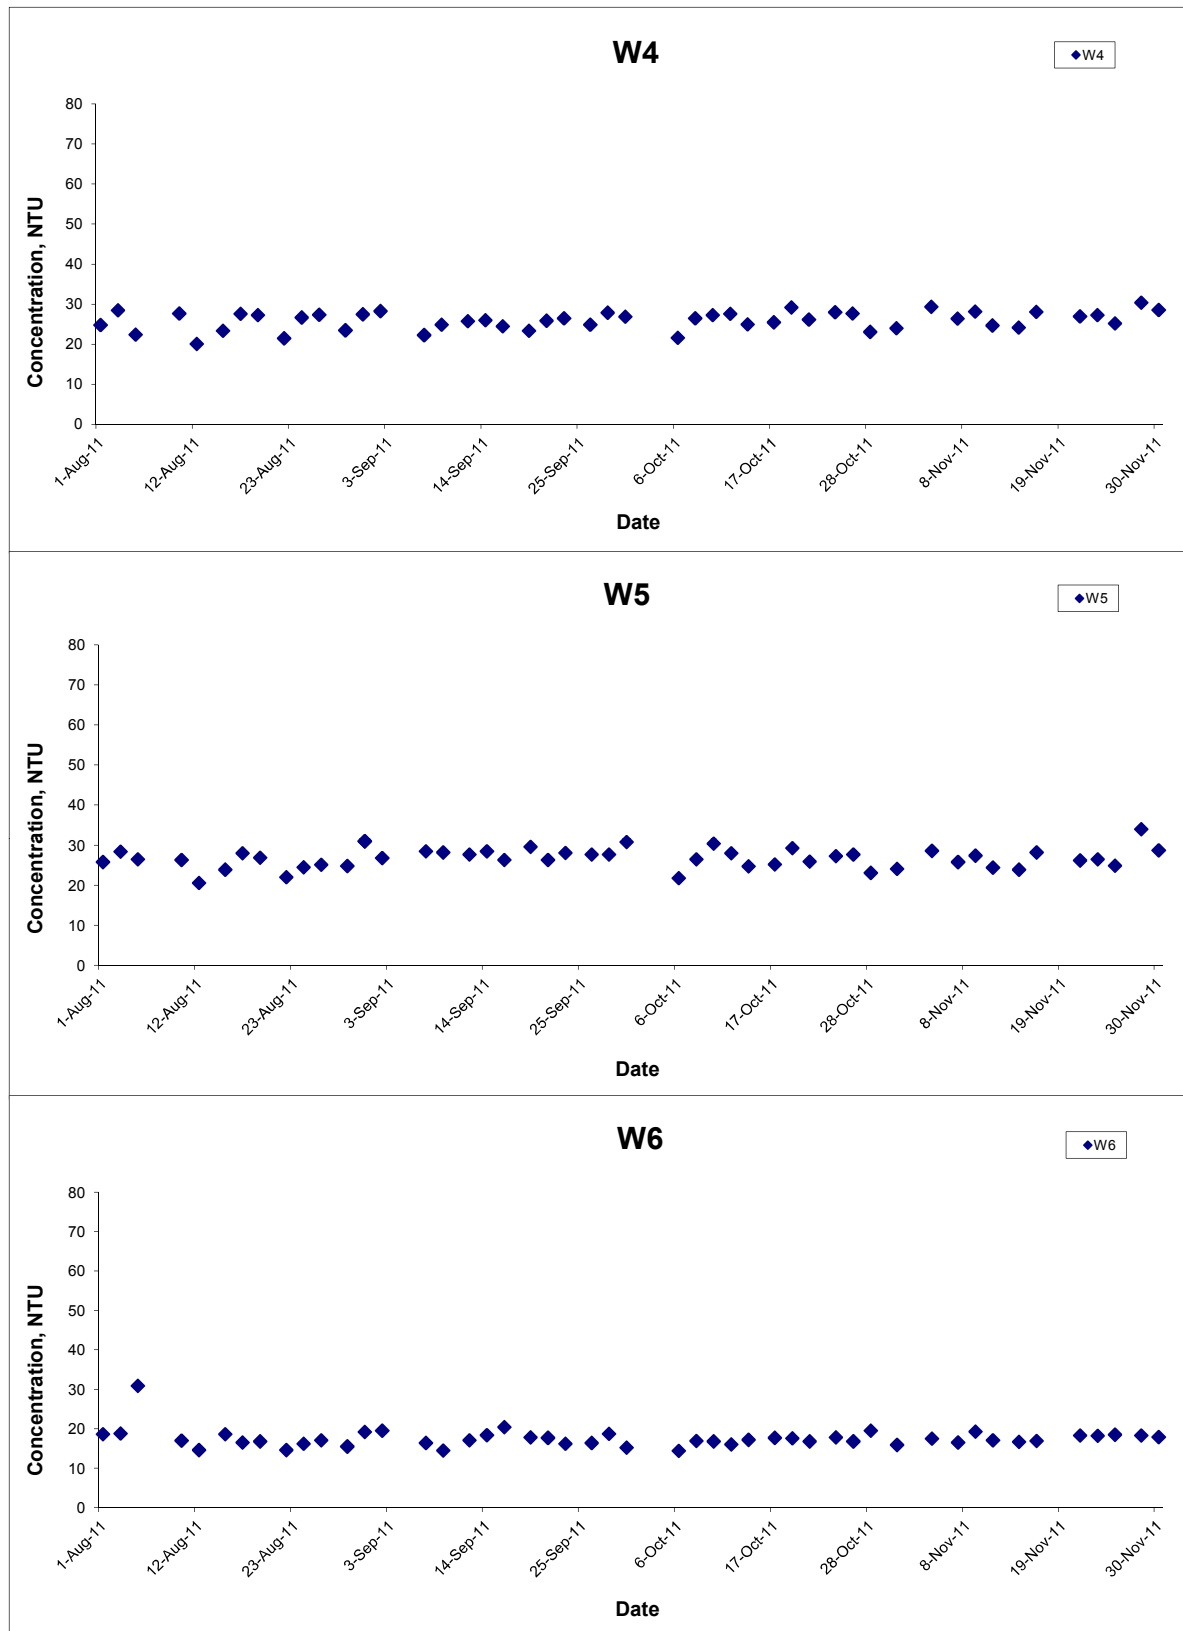
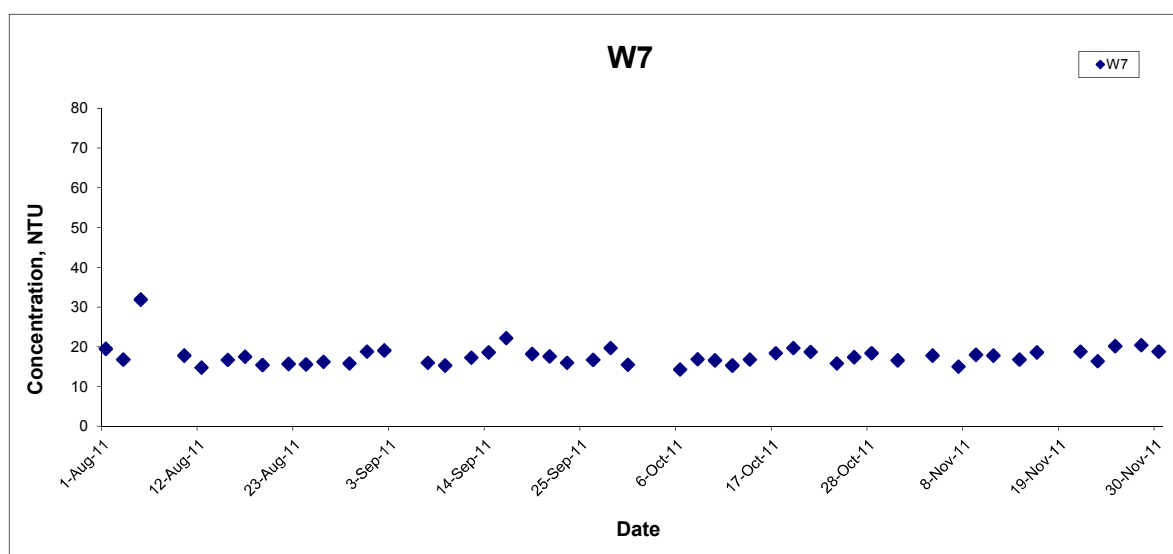
### Turbidity (Depth-averaged) at Mid-Ebb Tide

Title Contract No. YL/2009/01 Hang Hau Tsuen Channel at Lau Fau Shan Graphical Presentation of Water Quality Monitoring Results	Scale N.T.S	Project No. MA0002

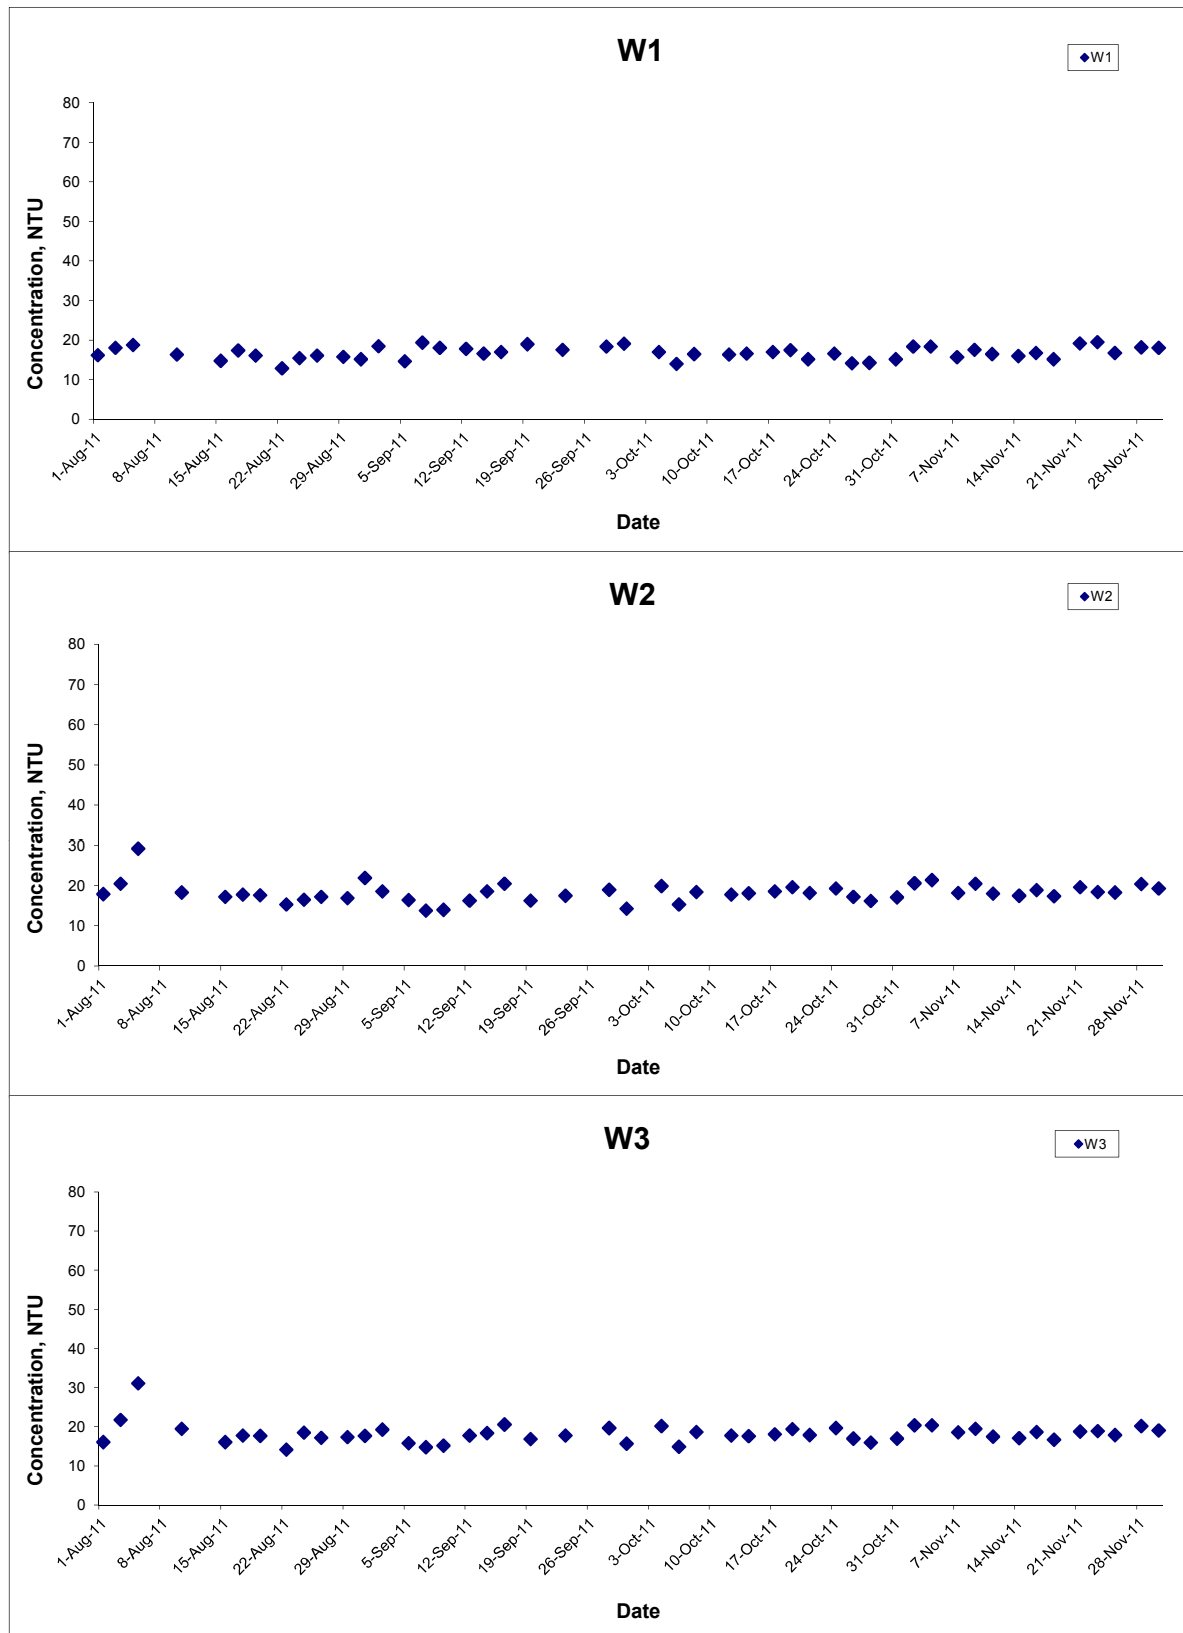
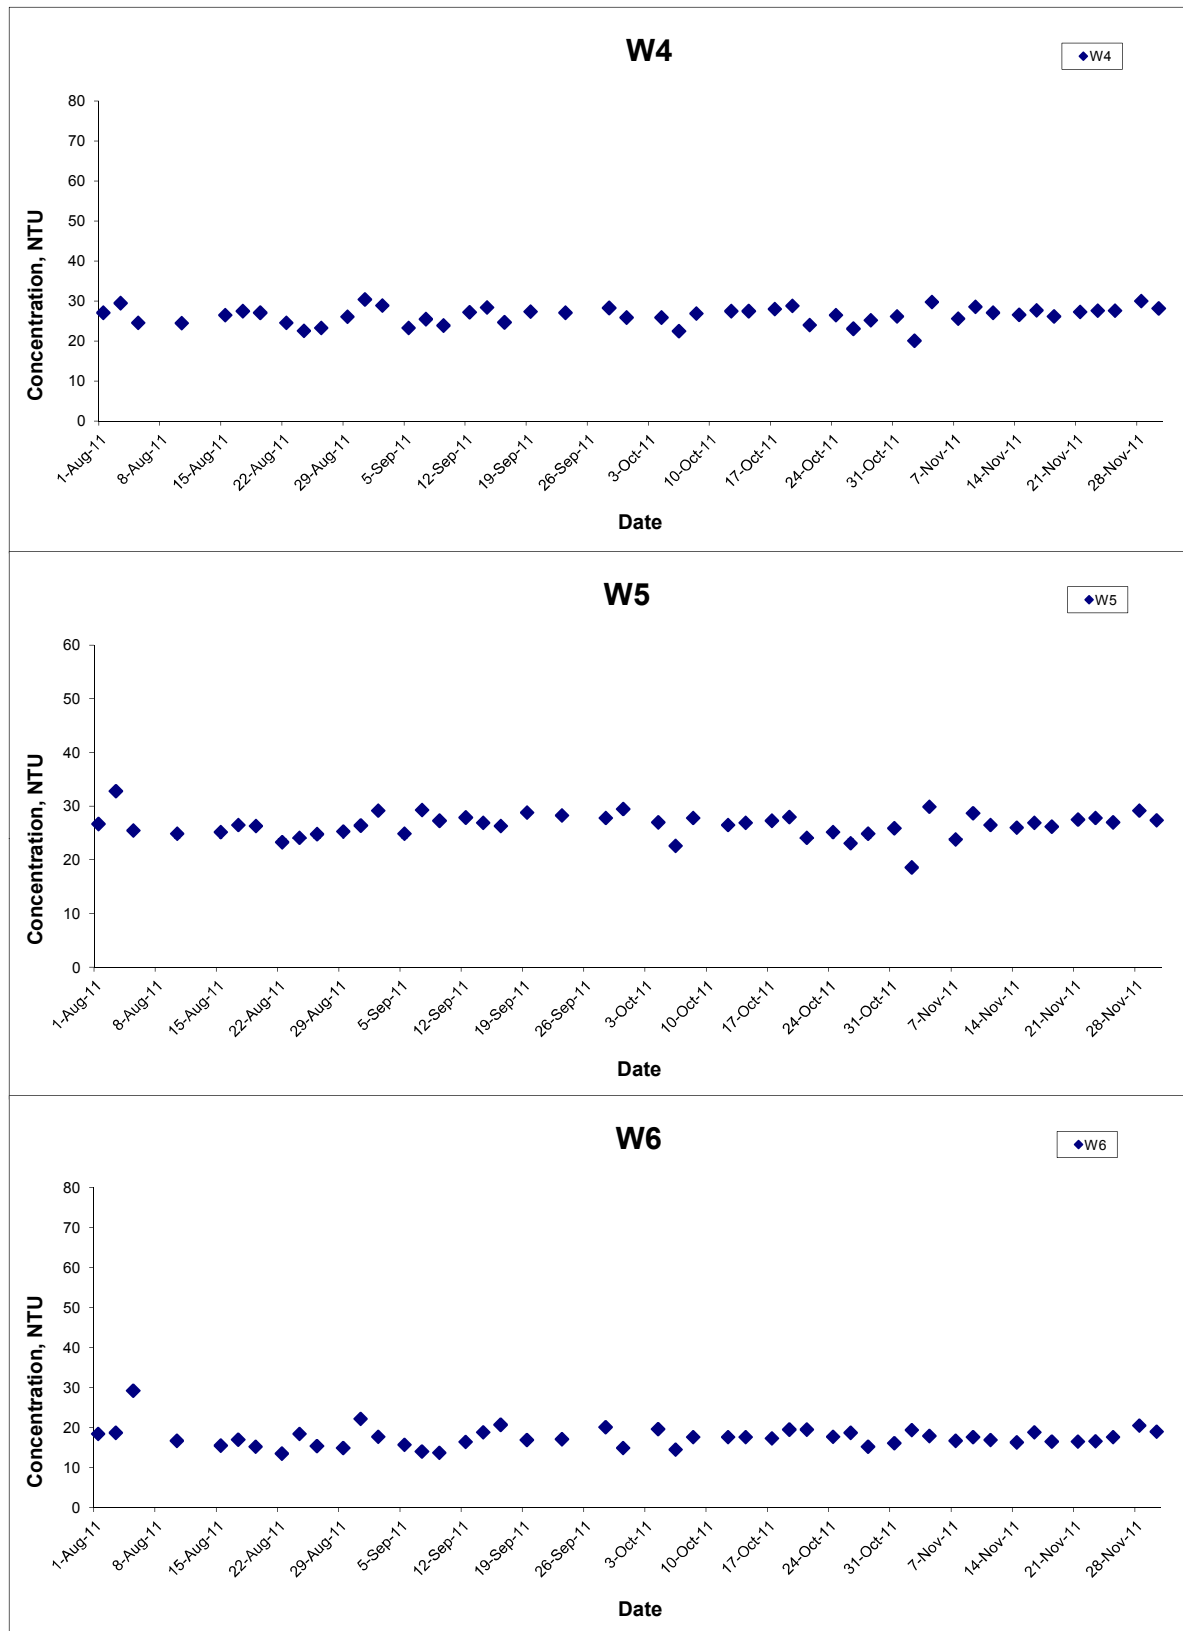
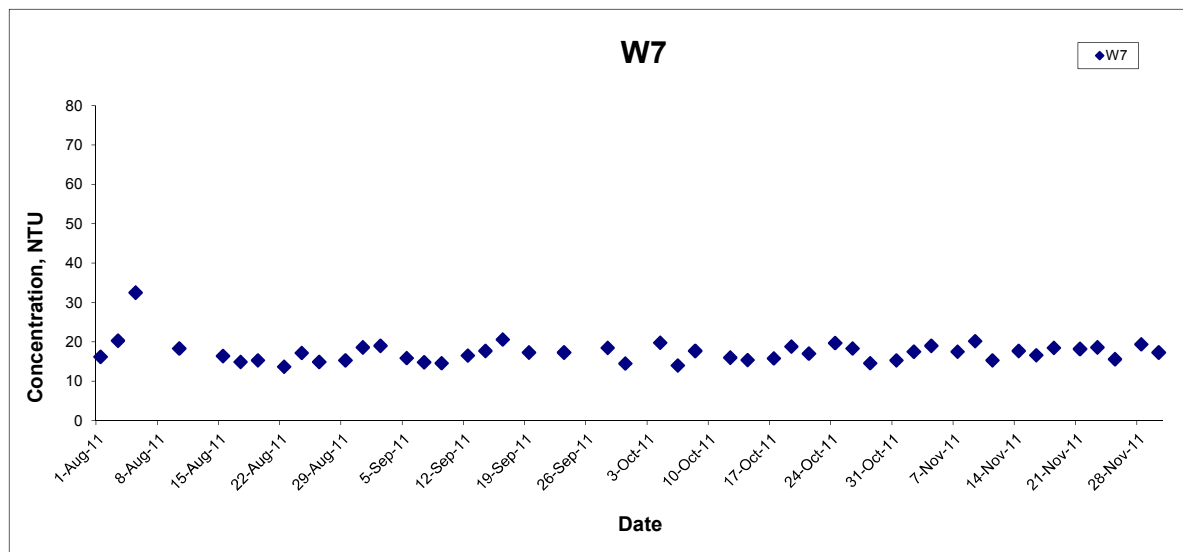
## Turbidity (Depth-averaged) at Mid-Flood Tide

Title	Contract No. YL/2009/01 Hang Hau Tsuen Channel at Lau Fau Shan Graphical Presentation of Water Quality Monitoring Results	Scale N.T.S	Project No. MA0002	CINOTECH
		Date Nov 11	Appendix H

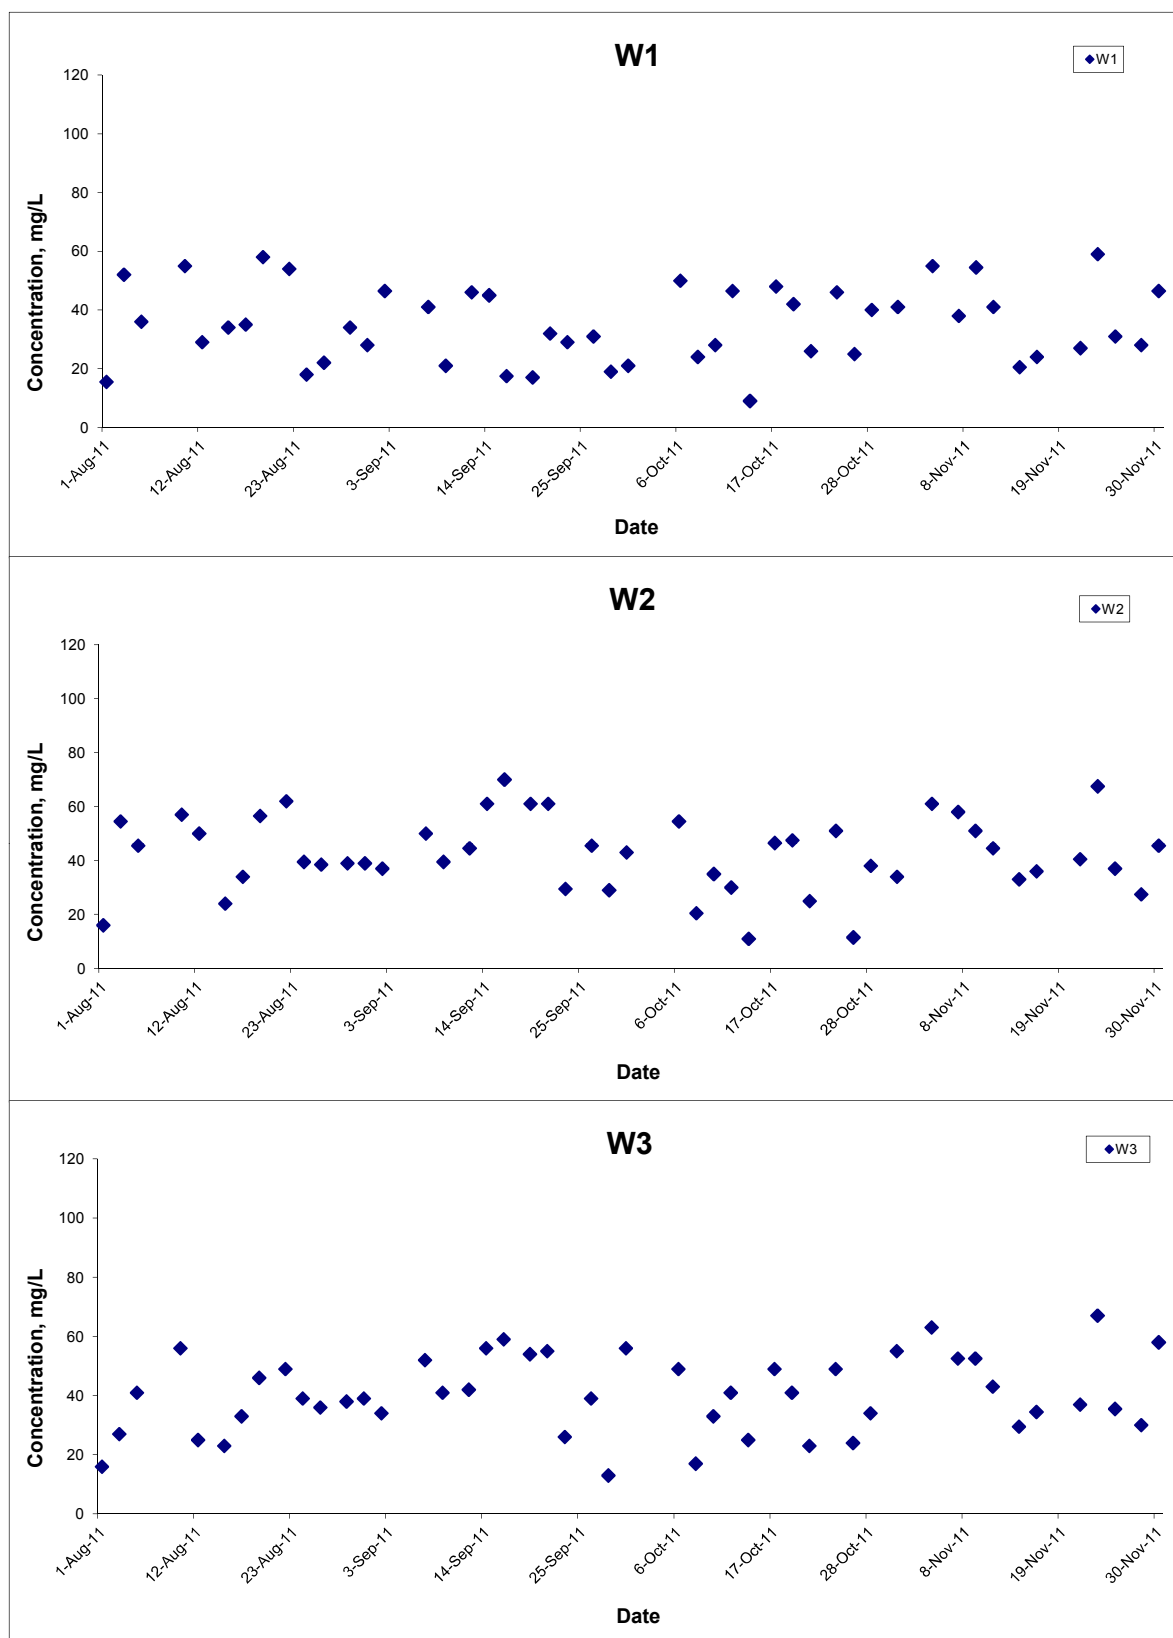
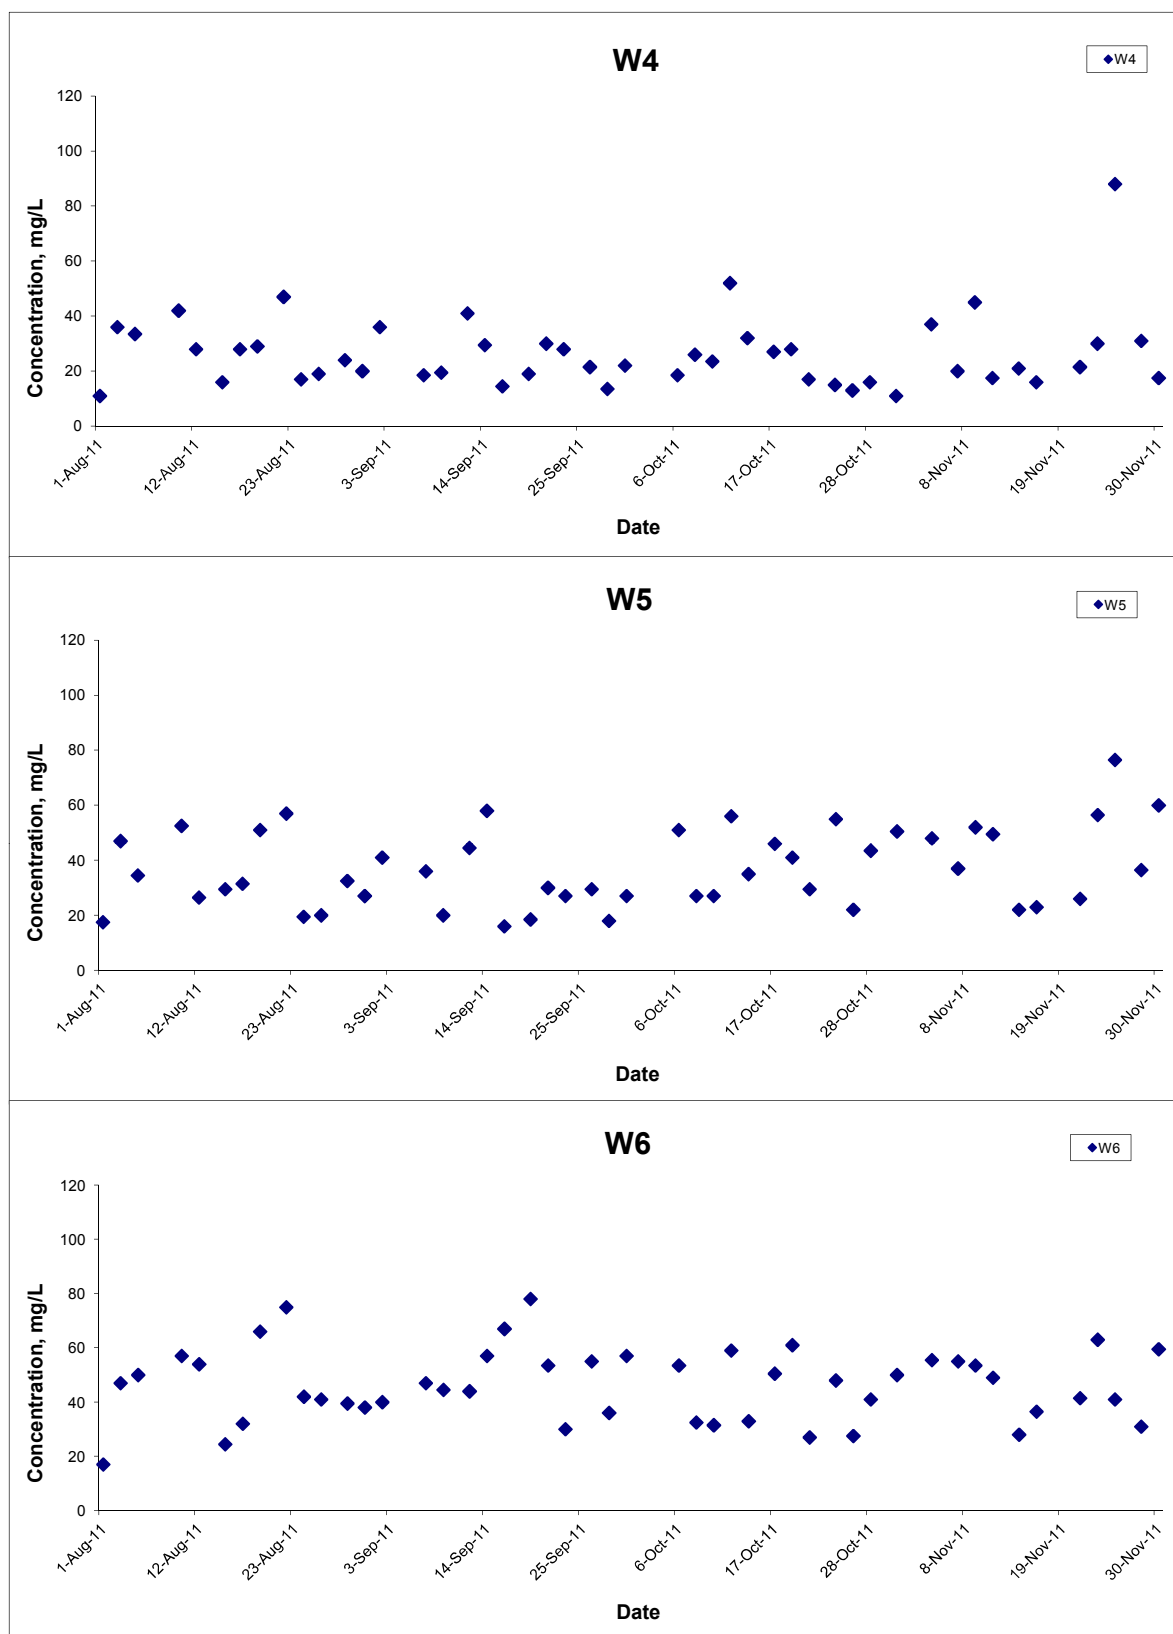
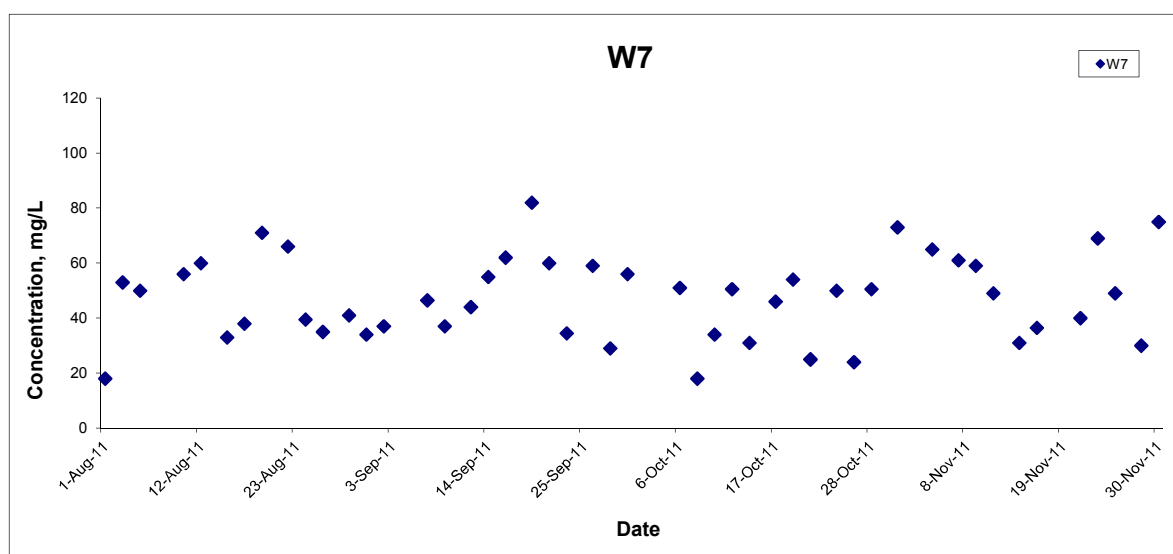
### Suspended Solids (Depth-averaged) at Mid-Ebb Tide

Title Contract No. YL/2009/01 Hang Hau Tsuen Channel at Lau Fau Shan Graphical Presentation of Water Quality Monitoring Results	Scale N.T.S	Project No. MA0002

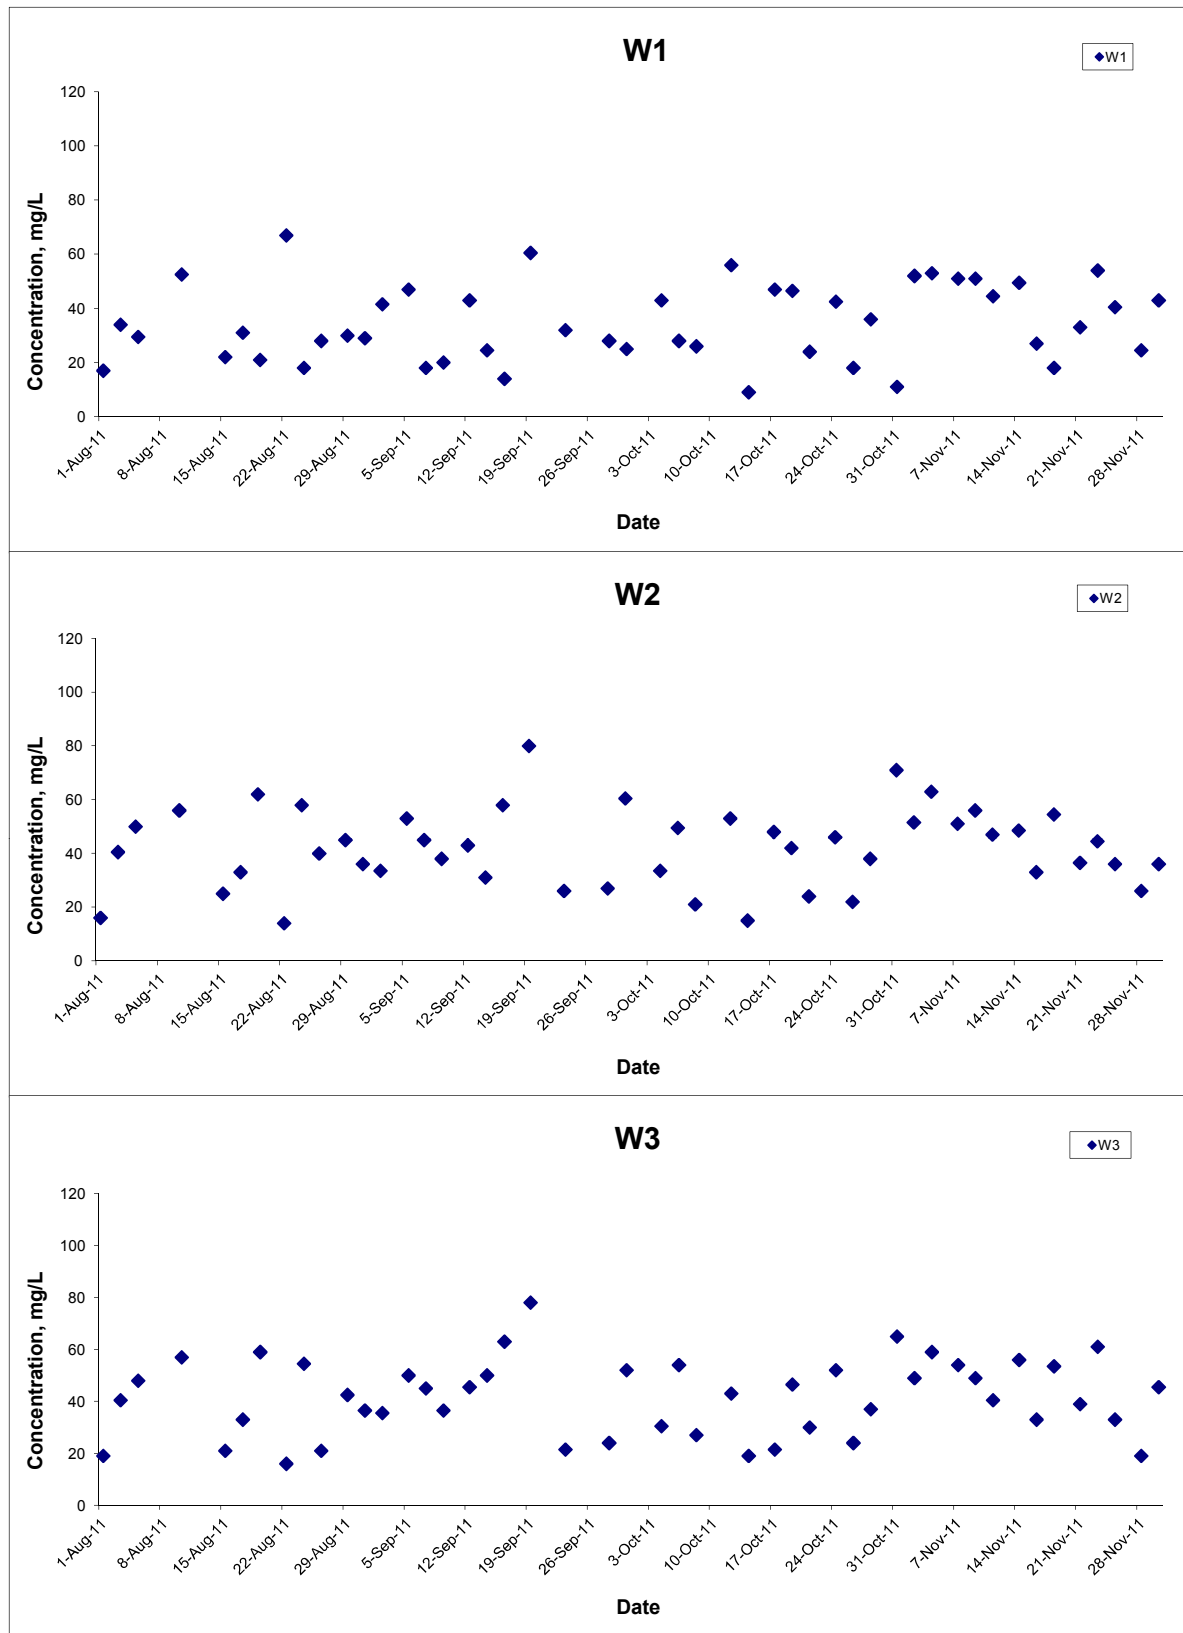
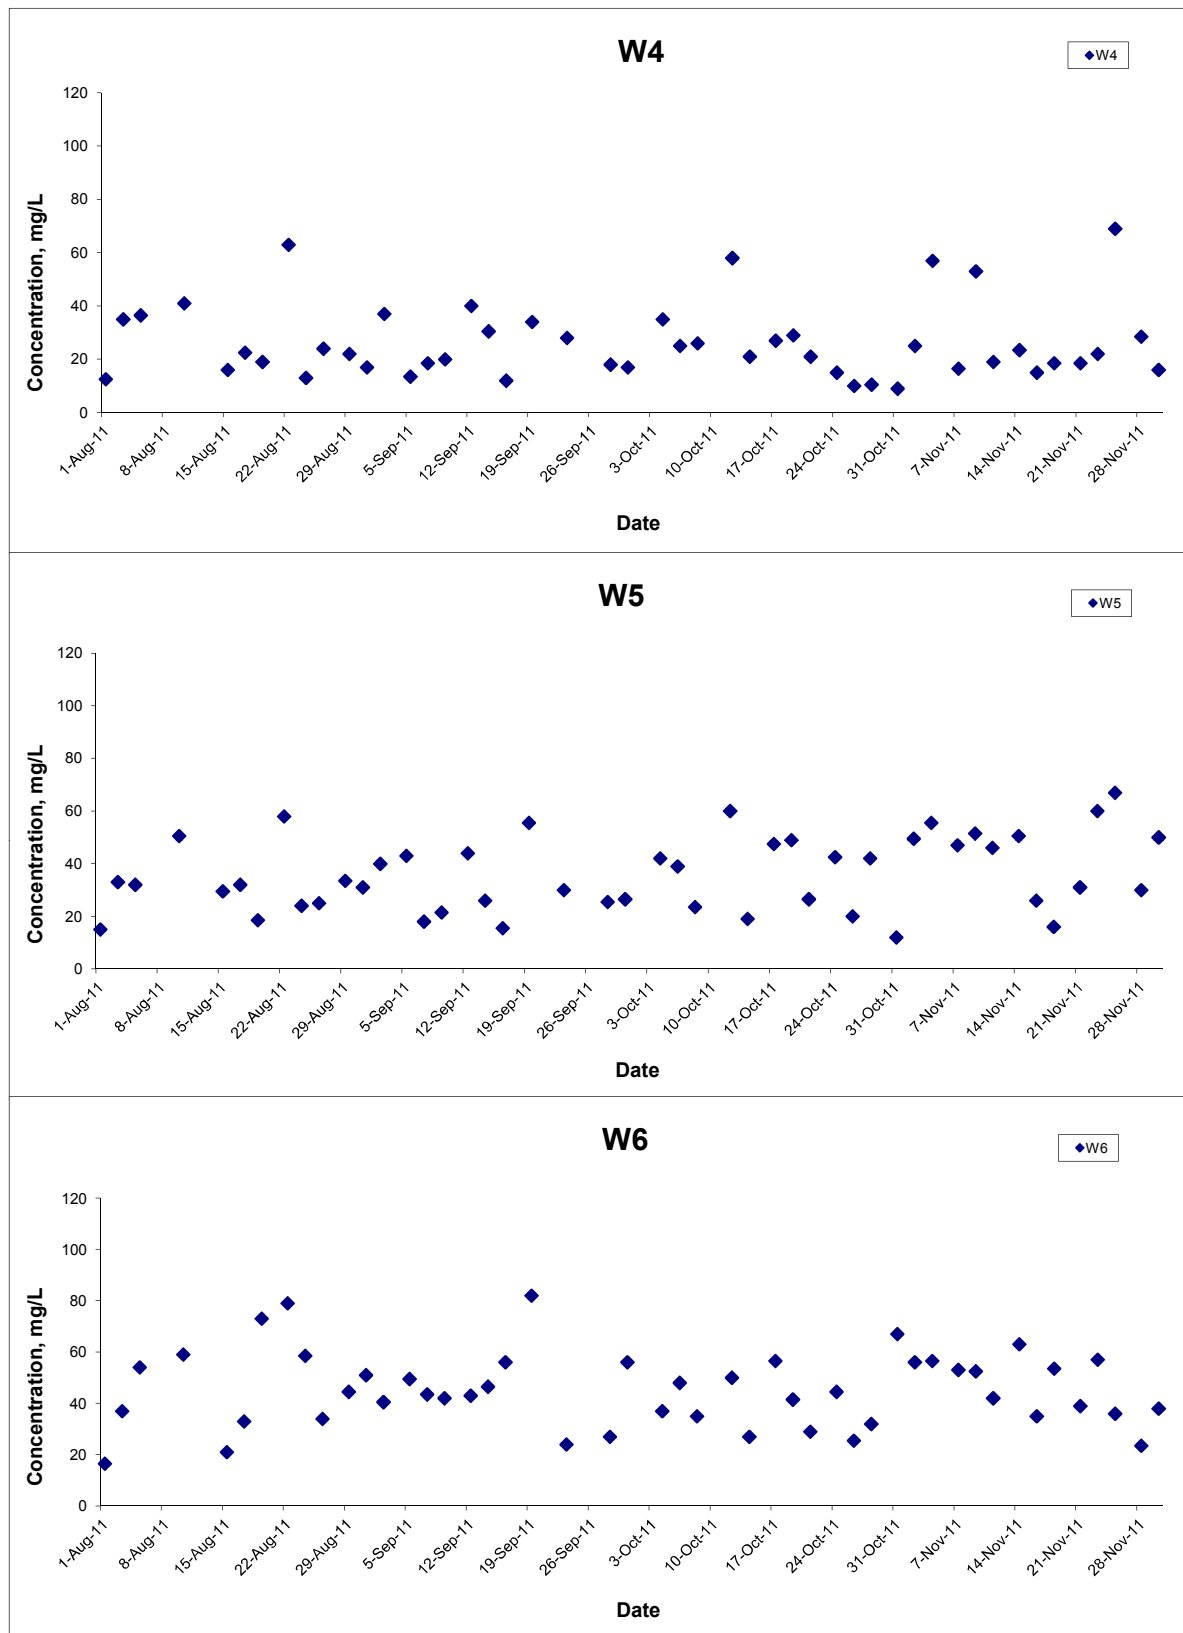
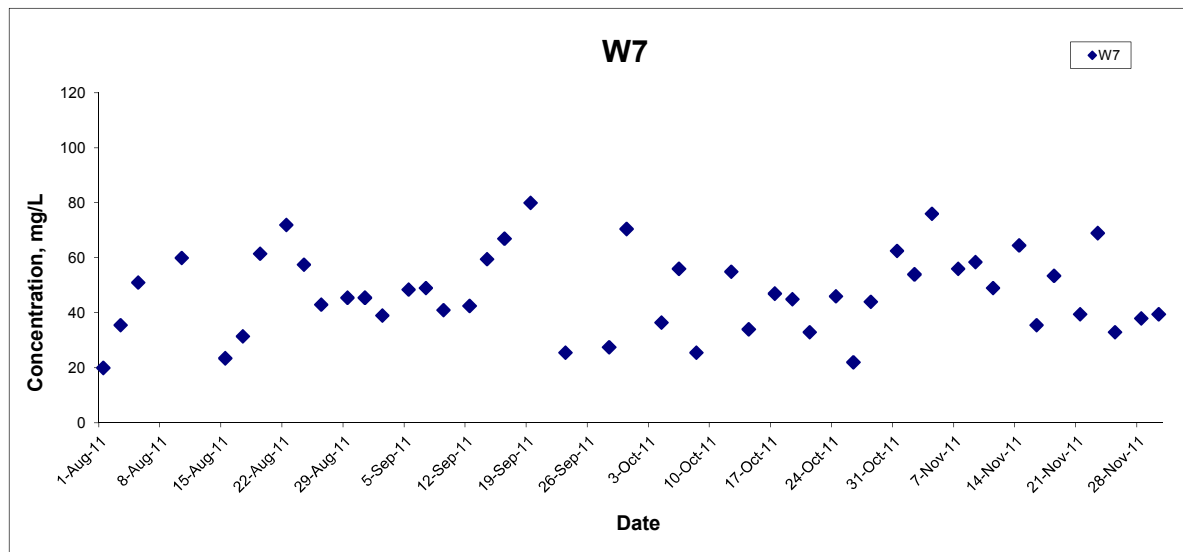
### Suspended Solids (Depth-averaged) at Mid-Flood Tide

Title Contract No. YL/2009/01 Hang Hau Tsuen Channel at Lau Fau Shan Graphical Presentation of Water Quality Monitoring Results	Scale N.T.S	Project No. MA0002
