MTR Corporation Limited

South Island Line (East)

Monthly EM&A Report No. 27

October 2013

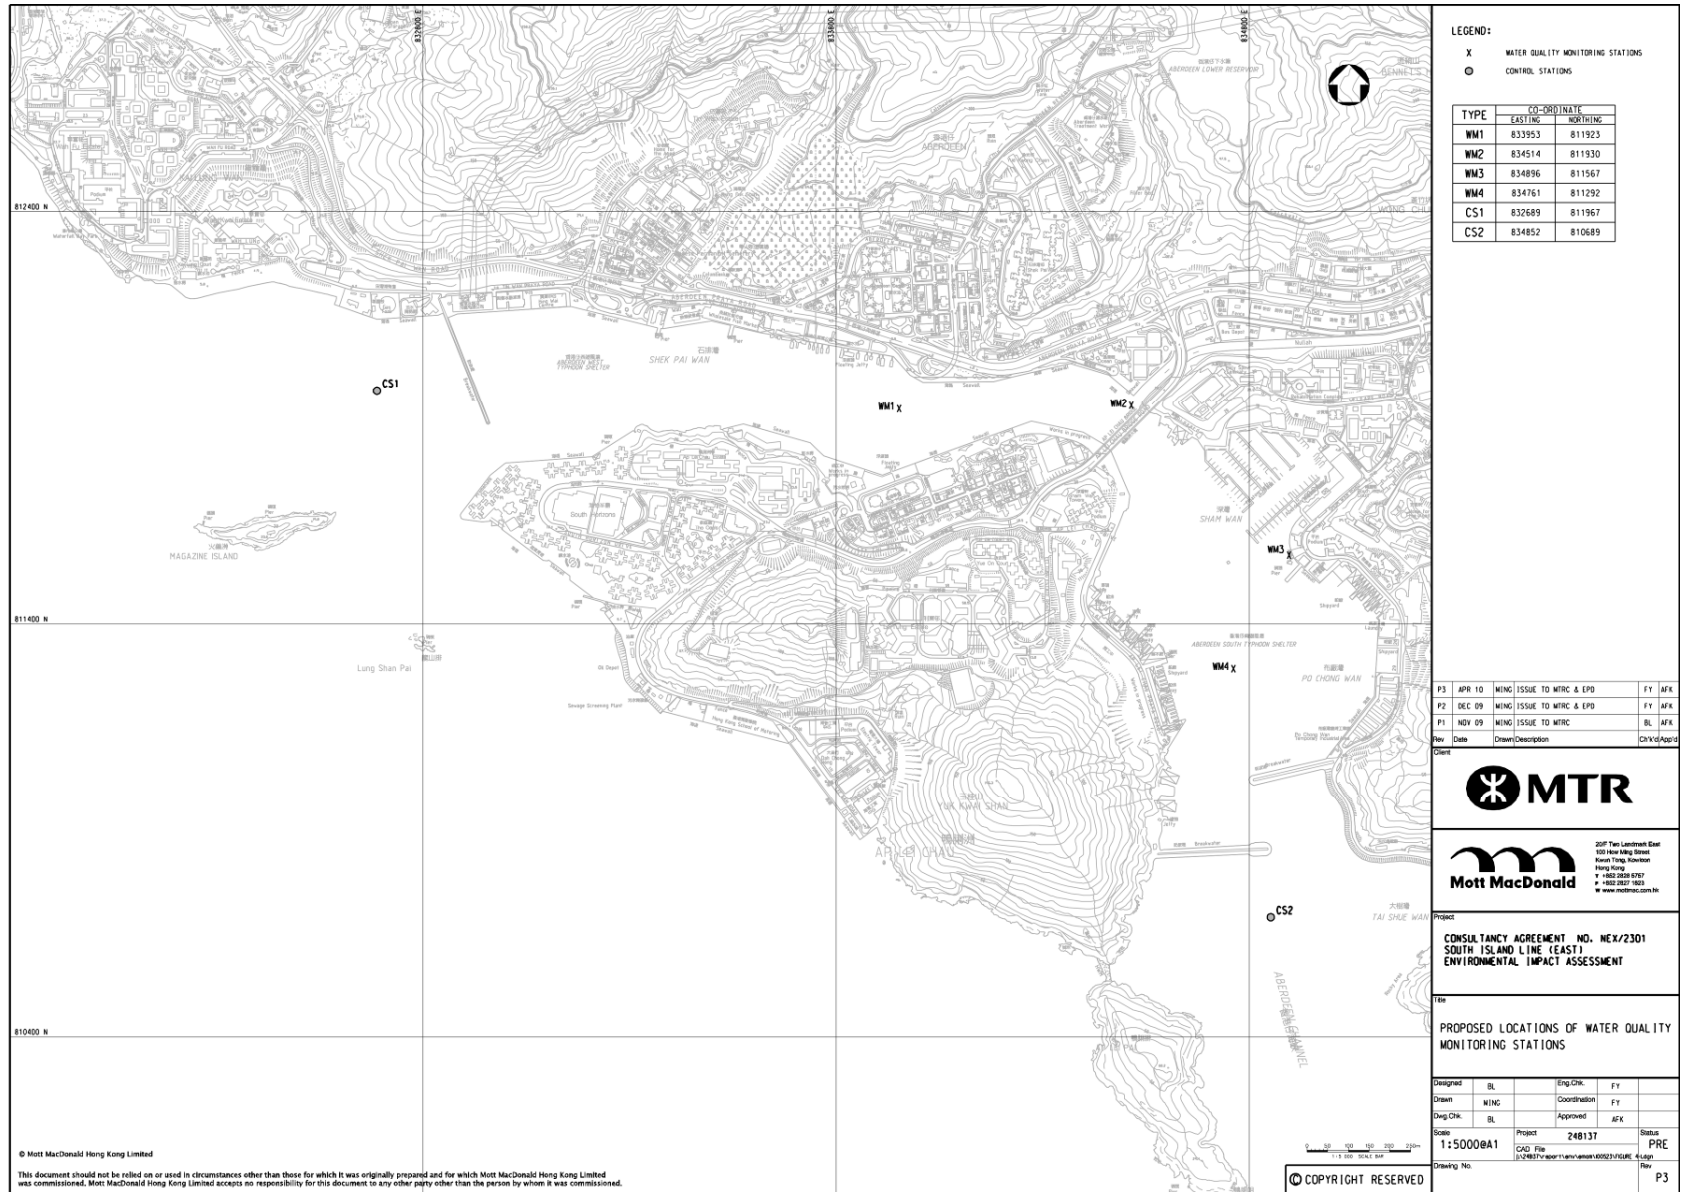
Figure 9 – Location of Water Quality Monitoring Stations

Impact water quality monitoring was undertaken in accordance with the EM&A Manual at the six designated monitoring locations at Aberdeen Channel as shown in Table 2 during the course of marine based works in the reporting period. Monitoring locations WM1-WM4 cover the Aberdeen West Typhoon Shelter, Wong Chuk Hang Nullah, WSD Brick Hill Seawater intake and Aberdeen South Typhoon Shelter while monitoring location CS1 and CS2 are the control stations. CS1 and CS2 are the upstream control stations for the Ebb and Flood tide conditions respectively.
