MTR Corporation Limited

South Island Line (East)

Monthly EM&A Report No. 43

February 2015

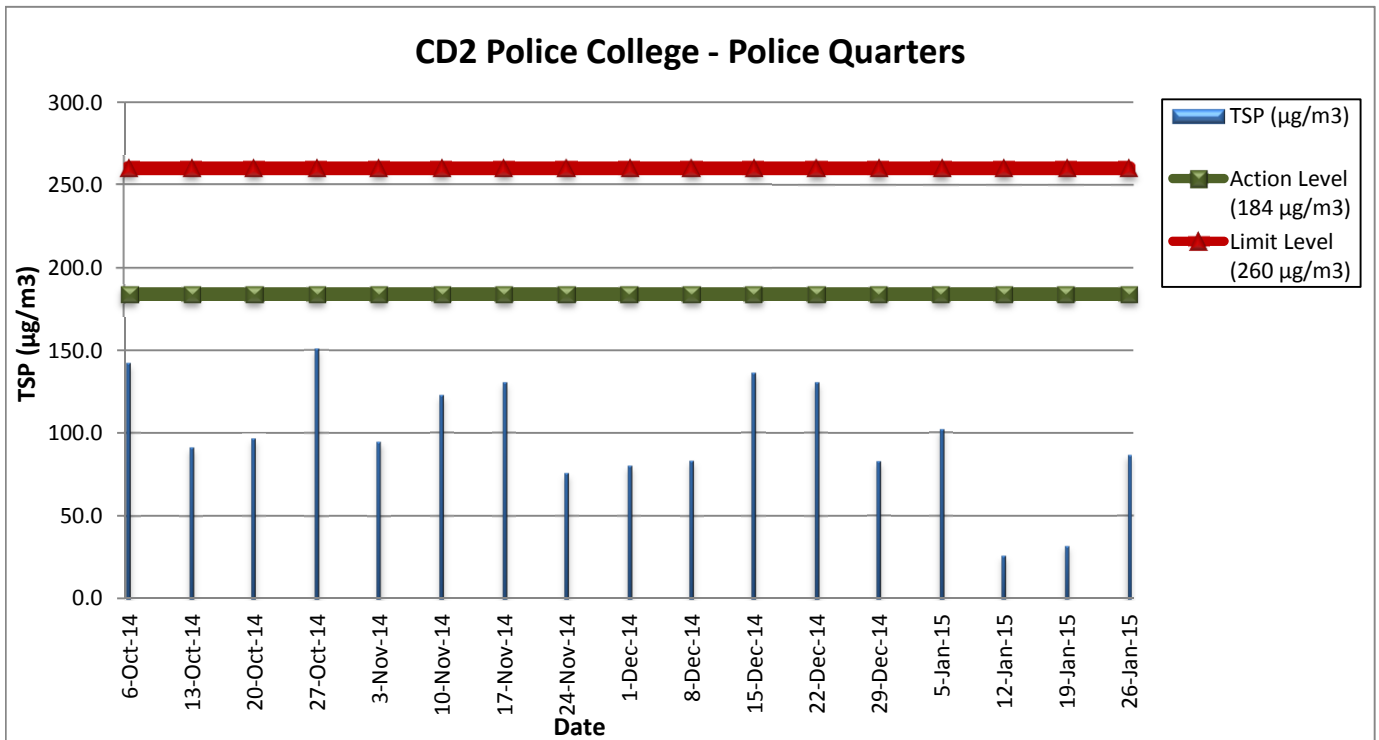
## Graphical Plots for Air Quality Monitoring Results

Monitoring results are presented in the following table (see **Appendix D** for graphical plots). The 24-hour TSP levels were within the Action Level. No exceedance was found. This indicates that the construction activities did not have a noticeable adverse effect on the general air quality of the project areas. However, excavation and reinstatement works by other Project were observed in the vicinity of monitoring station DTB1 at Telegraph Bay barging point during the reporting month, which have generated fugitive dust emitting to the local environment. The dust suppression measures, such as water spraying on the haul road and tipping hall, for the barging point operation were ongoing.
