MTR Corporation Limited

South Island Line (East)

Monthly EM&A Report No. 44

March 2015

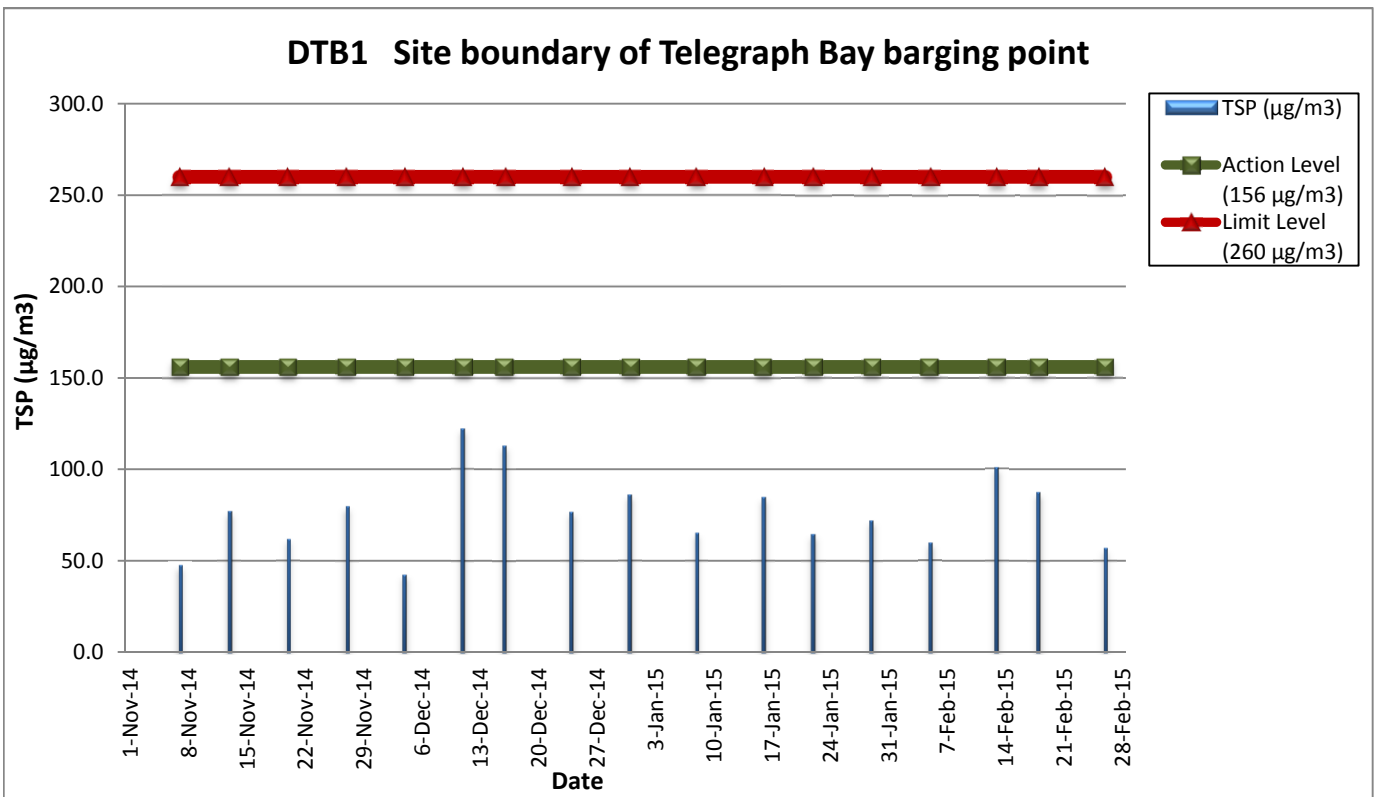
## Graphical Plots for Air Quality Monitoring Results

Monitoring results are presented in the following table (see **Appendix D** for graphical plots). The 24-hour TSP levels were within the Action Level. No exceedance was found. This indicates that the construction activities did not have a noticeable adverse effect on the general air quality of the project areas. However, excavation and reinstatement works by other Project were observed in the vicinity of monitoring station DTB1 at Telegraph Bay barging point during the reporting month, which have generated fugitive dust emitting to the local environment. The dust suppression measures, such as water spraying on the haul road and tipping hall, for the barging point operation were ongoing.
