Contract No. HY/2011/03

Hong Kong-Zhuhai-Macao Bridge Hong Kong Link Road Section between Scenic Hill and Hong Kong Boundary Crossing Facilities

Monthly EM&A Report No.157 (October 2025)

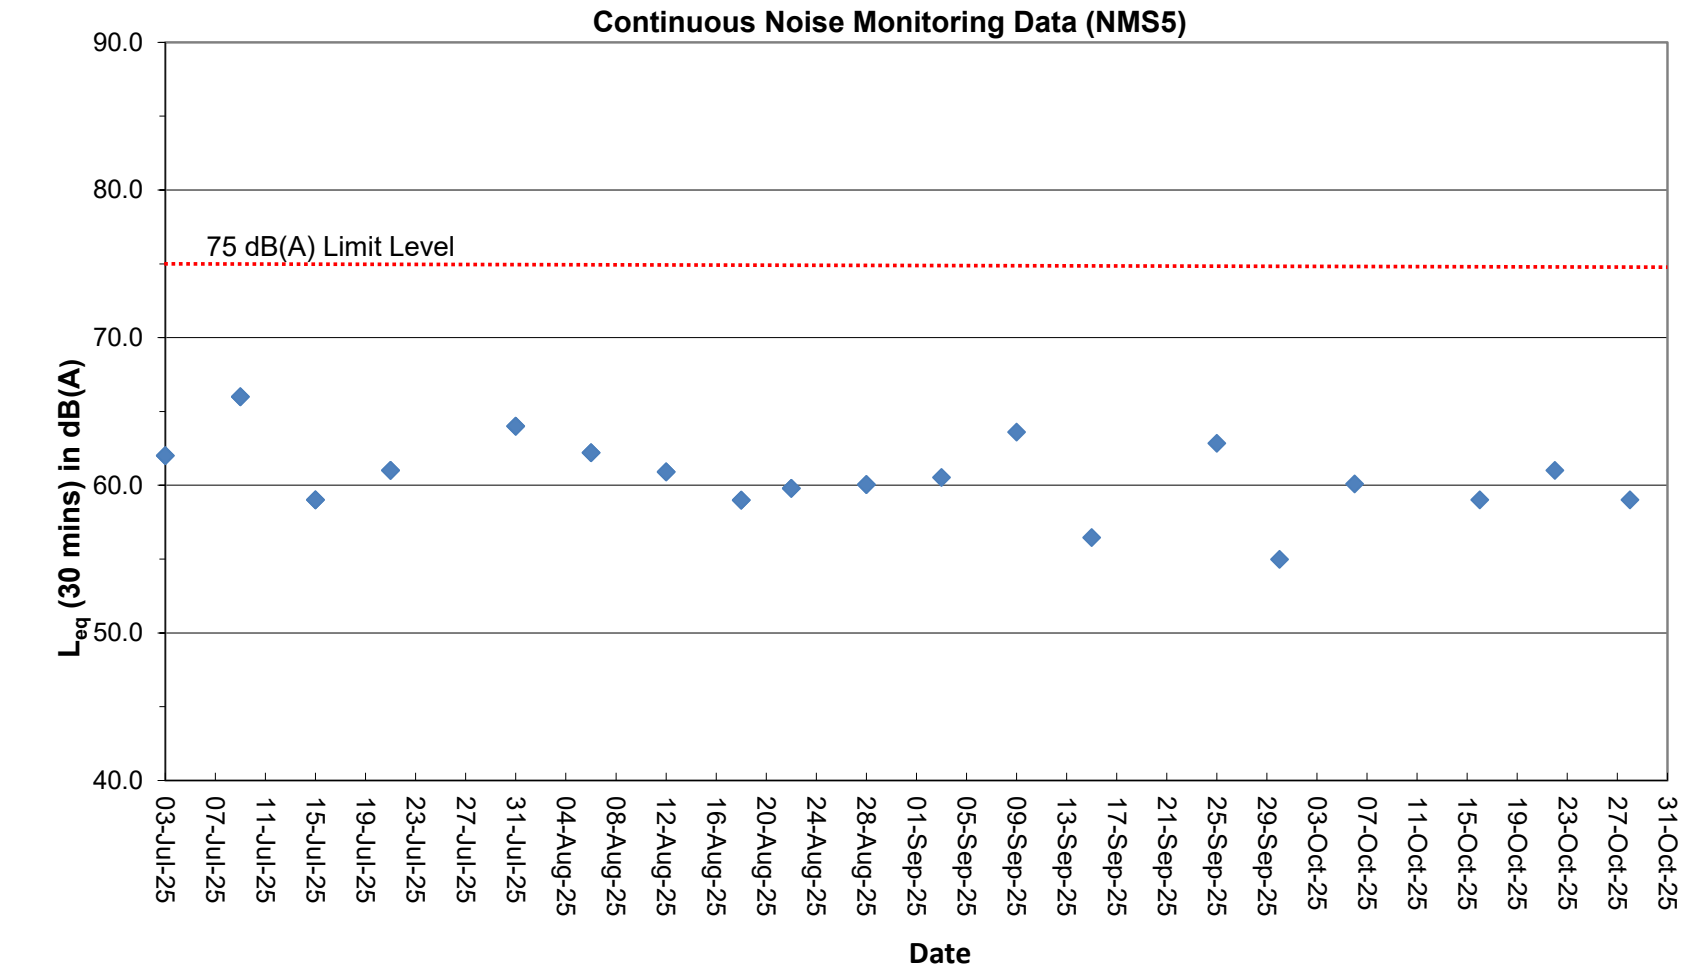
Graphical Plot of Noise Levels at NMS5

Remarks:
(1) A free field correction of +3 dB(A) was applied to the measured noise level.
