Civil Engineering and Development Department

**Agreement No. CE 59/2015 (EP)
Environmental Team for
Tseung Kwan O – Lam Tin Tunnel
Design and Construction**

**Monthly Environmental Monitoring and
Audit Report for
May 2024
(Version 1.0)**

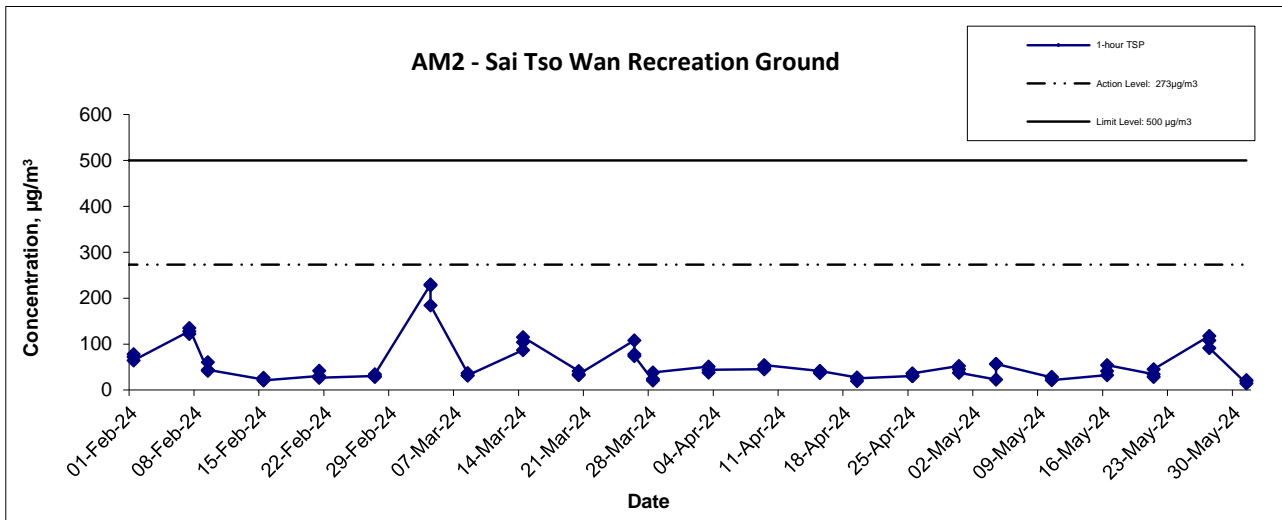
Agreement No. CE/59/2015 (EP) Environmental Team for Tseung Kwan O - Lam Tin Tunnel - Design and Construction Graphical Presentation of 1-hour TSP Monitoring Results	Scale	Project No.	
	Date	Appendix	
	N.T.S	MA16034	
	May-24	E

- 3.21 No Action/Limit Level exceedance was recorded for 1-hour TSP monitoring.
- 3.22 No Action Level and No Limit Level exceedance was recorded for 24-hour TSP monitoring.
- 3.23 The air temperature, precipitation and the relative humidity data was obtained from Hong Kong Observatory where the wind speed and wind direction were recorded by the installed Wind Anemometer at rooftop of Yau Lai Estate Bik Lai House (41/F). The location is shown in **Figure 2**. This weather information for the reporting month is summarized in **Appendix C**.
- 3.24 The monitoring data and graphical presentations of 1-hour and 24-hour TSP monitoring results are shown in **Appendix E** and **Appendix F** respectively.
- 3.25 According to our field observations, the major dust source identified at the designated air quality monitoring stations are as follows:
