# **Contract No. CM 04/2024 – Outlying Islands Sewerage Stage 2 – South Lantau Sewerage Works – Environmental Team Services (2025 - 2027)**

Monthly Environmental Monitoring and Audit  
Report for:  
October 2025  
Revision 4

**Contract No. SD 7/2020**  
**Independent Environmental Checker ("IEC") for Environmental Monitoring Work for**  
**South Lantau Sewerage Works**  
**Verification of Monthly EM&A Report (October 2025)**

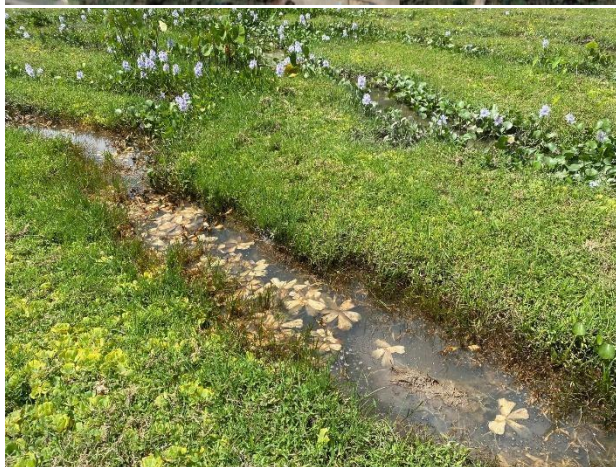
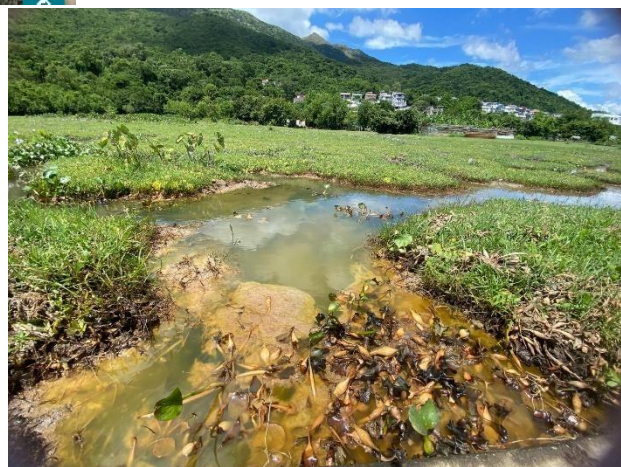
昨天收到貝澳居民投訴，指貝澳濕地（位置見圖）發現有電油，電油佈滿部份濕地的水及泥土中，導致部份浮簕及浮萍枯死。源頭不明。

今日中午時到過上址，發現在附地圖紅間位置濕地上的植物有枯萎情況，有村民表示今早仍見有油跡由西北方往東南流動。中午時，雖未見明顯油跡，但有強烈的氣油味從嶼南路方向飄來。再到嶼南路尋持氣油味的來源，似乎在羅屋村往東涌方向巴士站旁的垃圾站小徑中途發出，亦不排除與工程地盤有關。

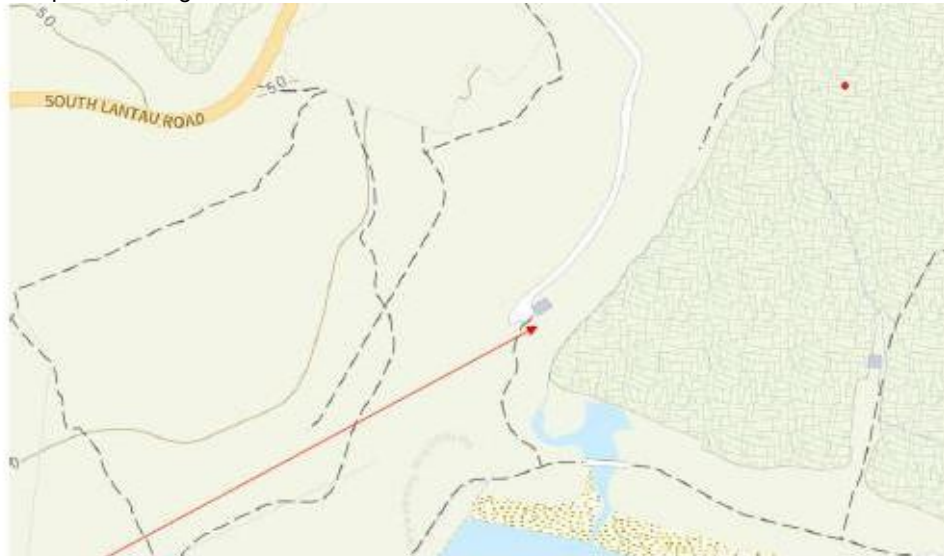
Location of oil signs

On 25 September 2025, additional information from EPD was received that oil signs spotted in the Pui O. Location map and relevant photos, are given as follows.

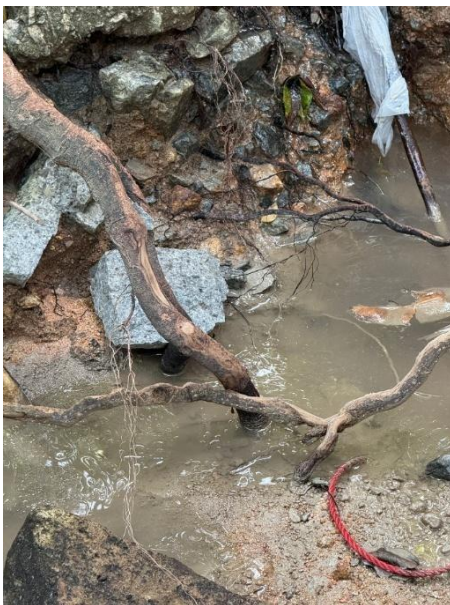
The complaint was submitted to the Environmental Protection Department (EPD) on 16 September 2025. The complaint was then referred to the Environmental Team (ET), Independent Environmental Checker (IEC), Drainage Services Department (DSD), and the Contractor on 16 September 2025. Engineer's Representative (ER) was informed on 17 September 2025. The complainants alleged that there was oil sheen found at the wetland in Pui O, leading to withering of plants.

On 25 September 2025, joint site inspection was conducted by ET, EPD, and the Contractor to inspect the location where oil signs were reported by EPD and No oil sheen was found at the location where oil signs were identified as reported by EPD (**Figure 9 to 11**). The joint inspection location was designated by EPD in **Figure 12** in Photo Records. A patch of oil stain was identified during the inspection, and the location is given in **Figure 13** in Photo Records. The location of identified oil stains was not within proximity of the project sites. No source of oil leakage was identified.

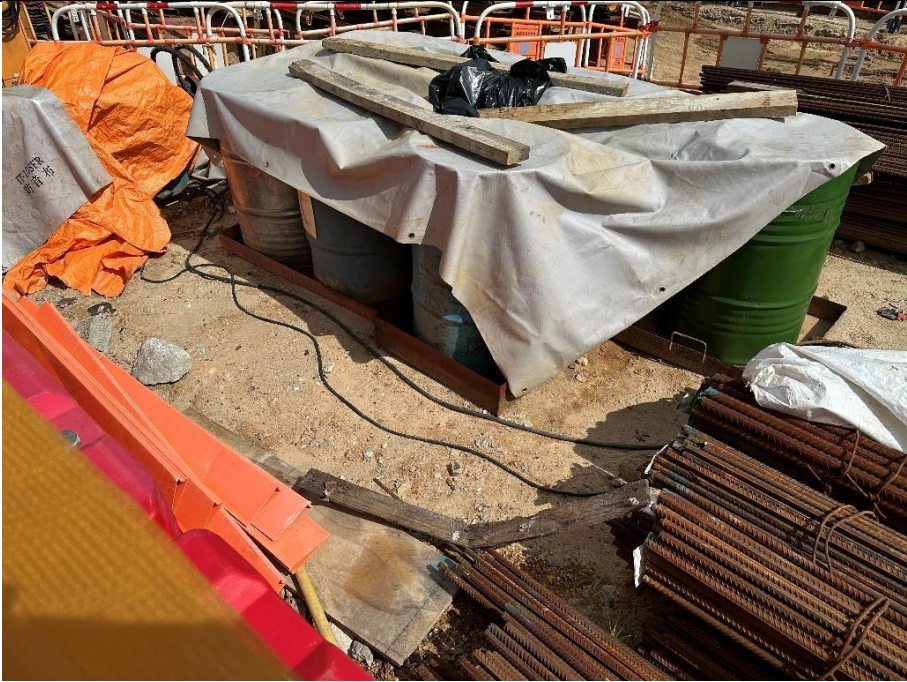
| Date | Status / Observation |
|---|---|
| 15<br>September<br>2025 | <p><b>Figure 1: Proper storage of diesel drum on 15 September 2025 (before the complaint)</b></p> |

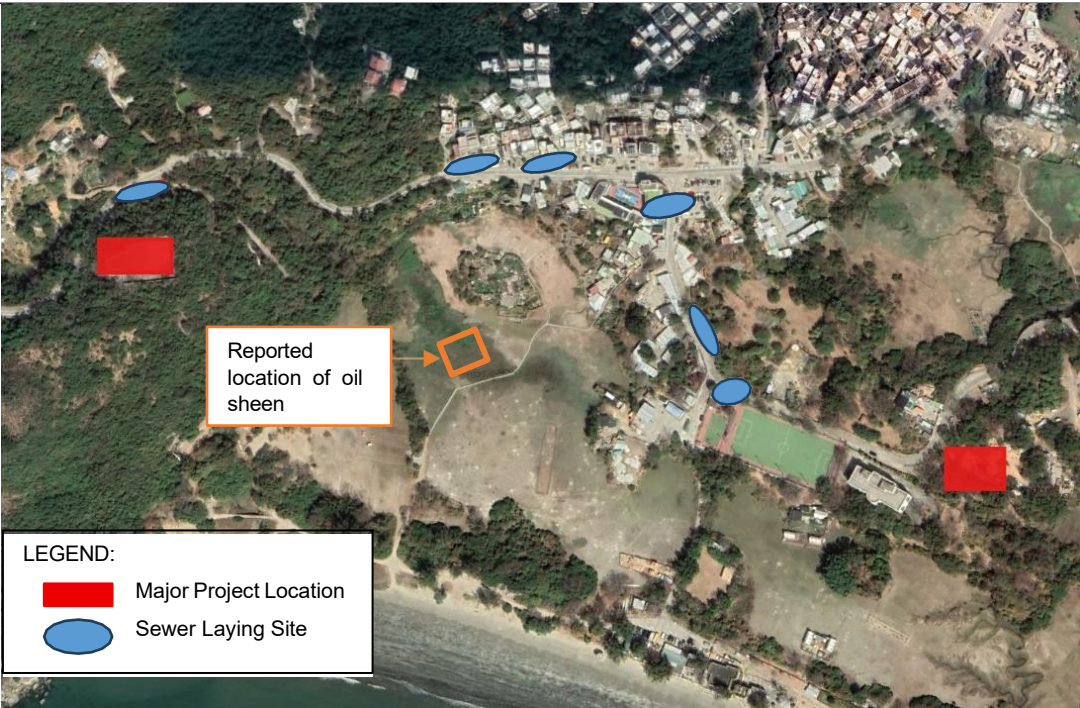
| Date | Status / Observation |
|---|---|
| -- | <p>Reported location of oil sheen</p> <p>LEGEND:<br/> Major Project Location<br/> Sewer Laying Site</p> <p><b>Figure 2: Active Site Location</b></p> |

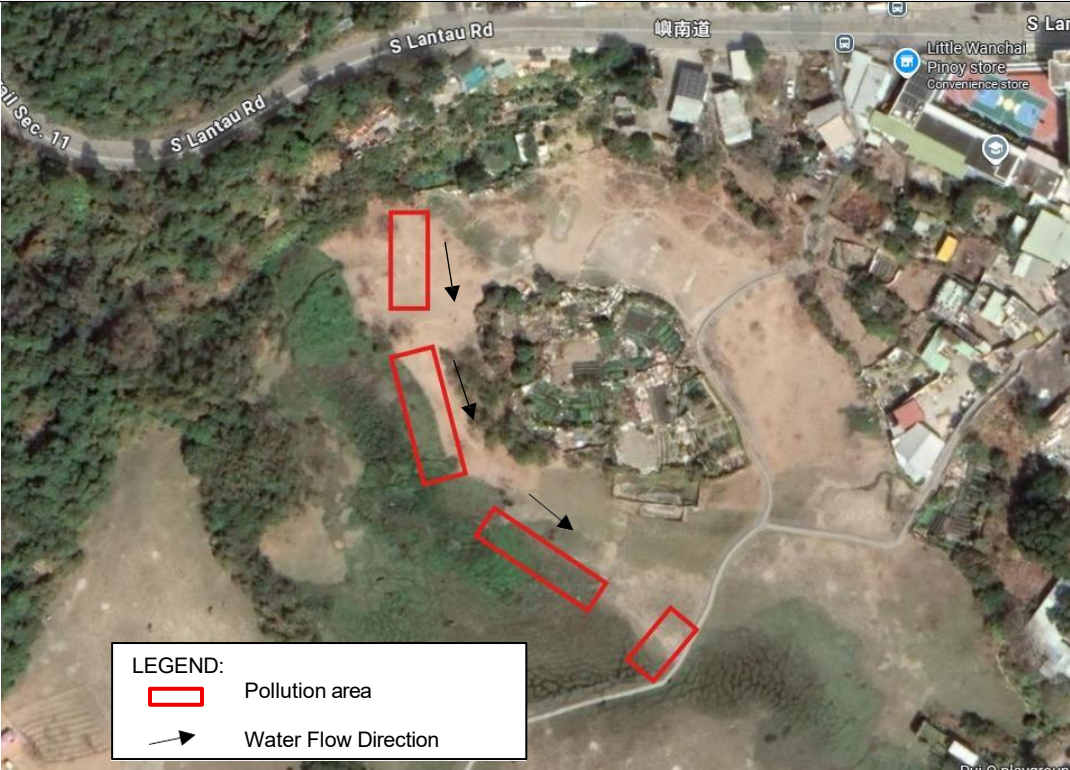
| Date | Status / Observation |
|---|---|
| 17 September 2025 | <p style="text-align: center;"><b>Figure 4: The location of the pollution found</b></p> |

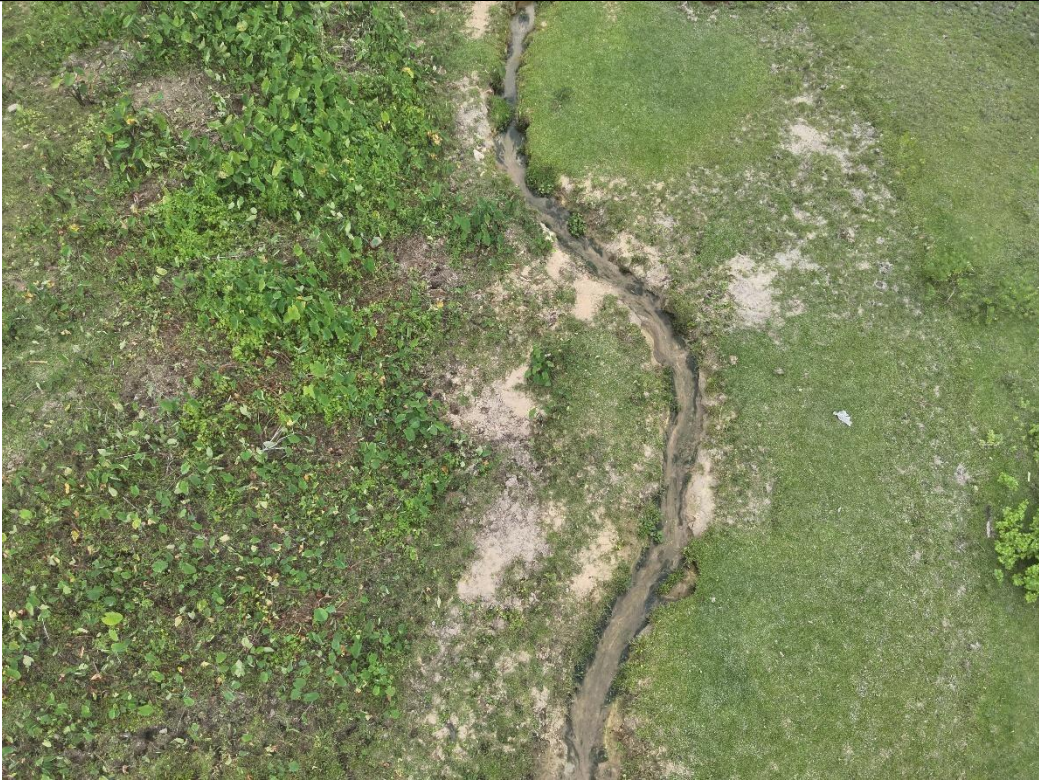
| Date | Status / Observation |
|---|---|
| 17 September 2025 | <p style="text-align: center;"><b>Figure 5: Photo on Pollution found in Pui O Wetland</b></p> |

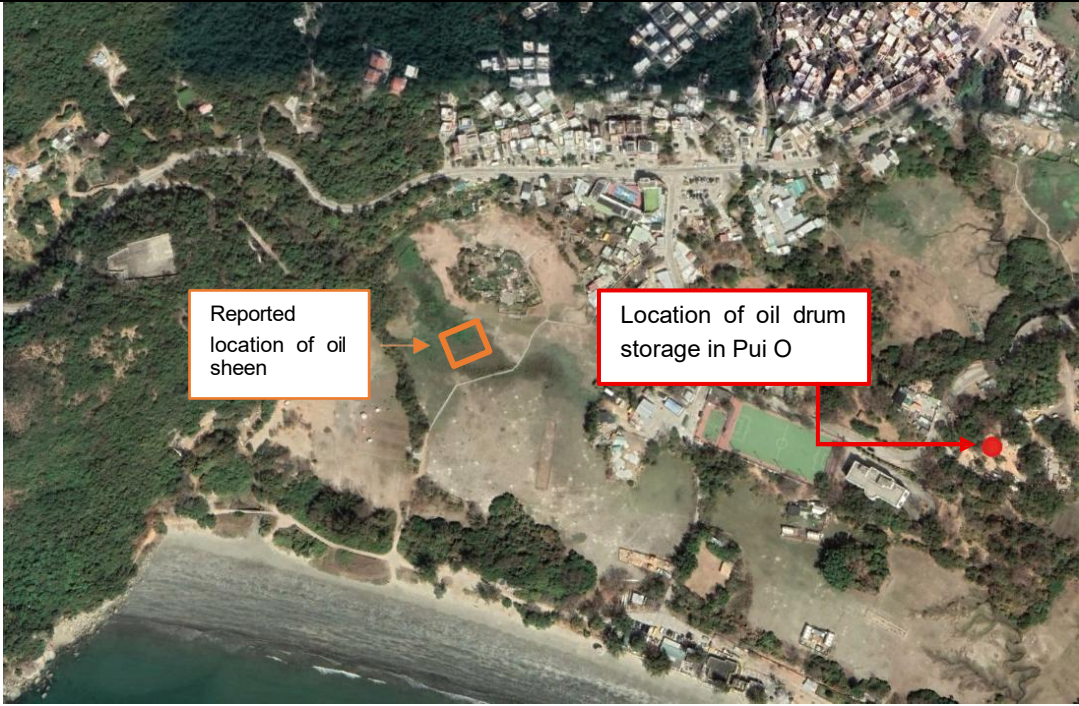
| Date | Status / Observation |
|---|---|
| 18 September 2025 | <p data-bbox="536 546 715 651">Reported location of oil sheen</p> <p data-bbox="948 546 1219 636">Location of oil drum storage in Pui O</p> <p data-bbox="627 969 1155 999"><b>Figure 6: The storage location of the oil drums</b></p> |

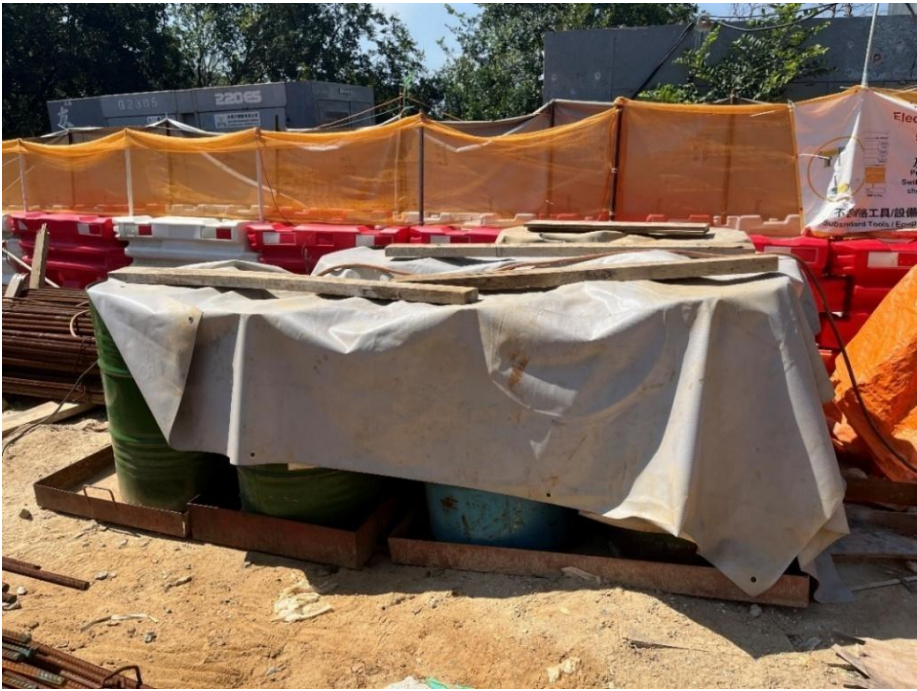
| Date | Status / Observation |
|---|---|
| 18 September 2025 | <p data-bbox="276 1039 1445 1068">Diesel fuel drums were stored in a proper manner, and no signs of leakage were detected in the generator set.</p> <p data-bbox="536 1771 1246 1800"><b>Figure 7: Proper storage of diesel drum on 18 September 2025</b></p> |

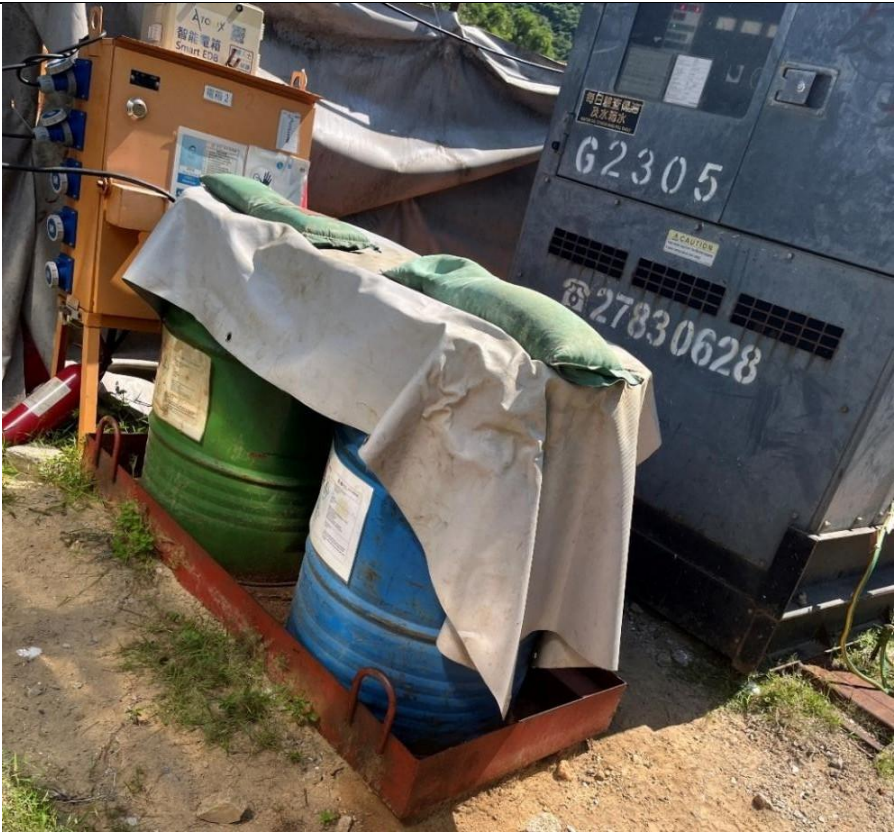
| Date | Status / Observation |
|---|---|
| 18 September 2025 | <p data-bbox="539 1099 1246 1133"><b>Figure 8: Proper storage of diesel drum on 18 September 2025</b></p> |

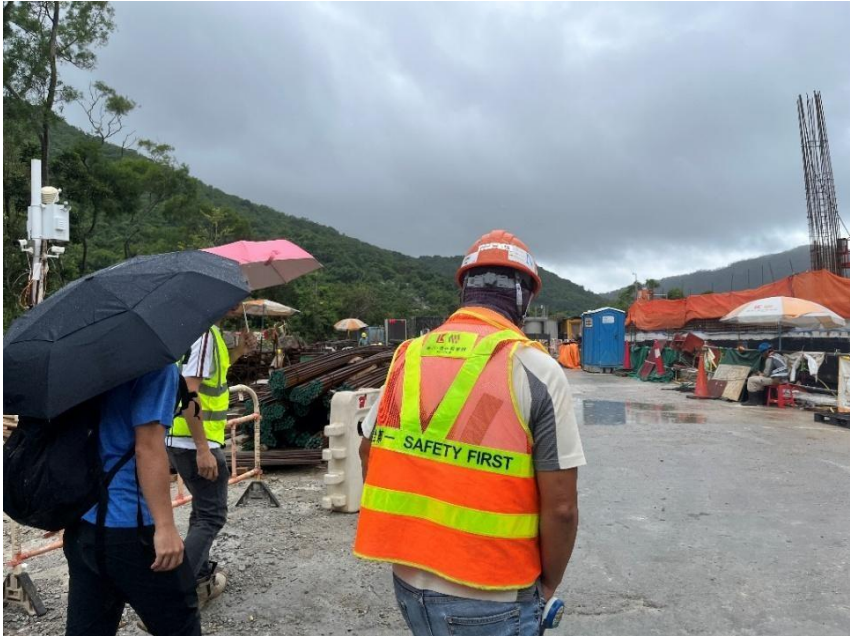
| Date | Status / Observation |
|---|---|
| 25 September 2025 | <p data-bbox="276 1182 1501 1272">On 25 September 2025, a joint inspection was conducted by ET, EPD and Contractor to inspect the location where oil signs were reported by EPD. No source of oil leakage was identified at San Shek Wan Sewerage Treatment Works.</p> <p data-bbox="381 1924 1394 1957"><b>Figure 9: Photos of the joint site investigation conducted by ET, EPD, and the Contractor</b></p> |

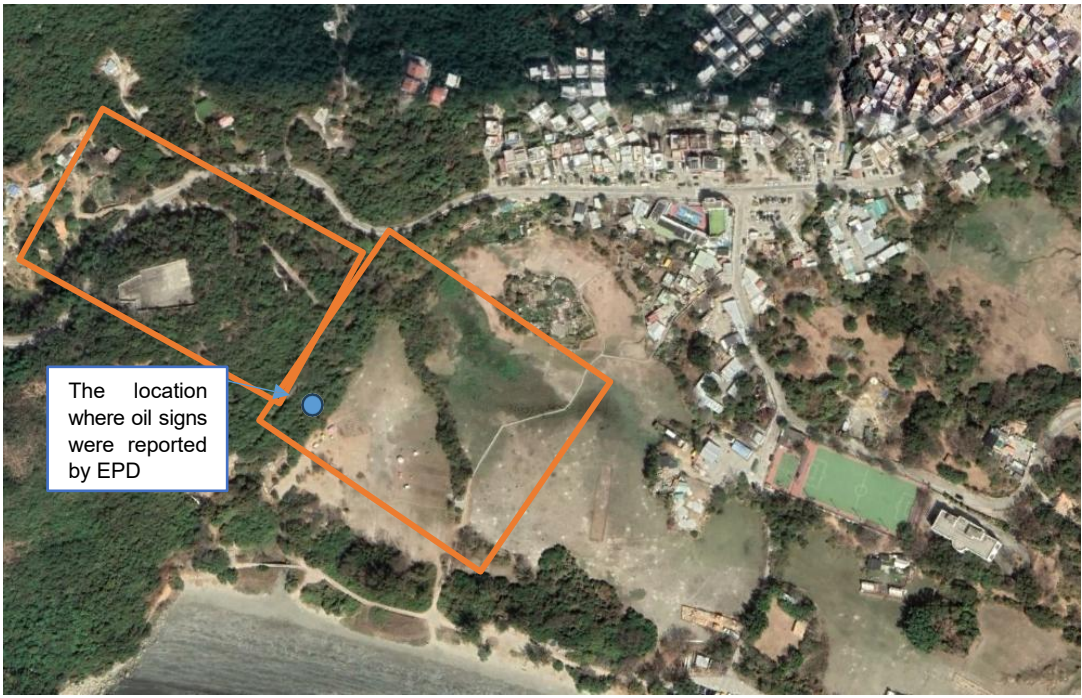
| Date | Status / Observation |
|---|---|
| 25 September 2025 | <p>The joint inspection location was designated by EPD.</p> <p style="text-align: center;"><b>Figure 10: Inspected locations</b></p> |

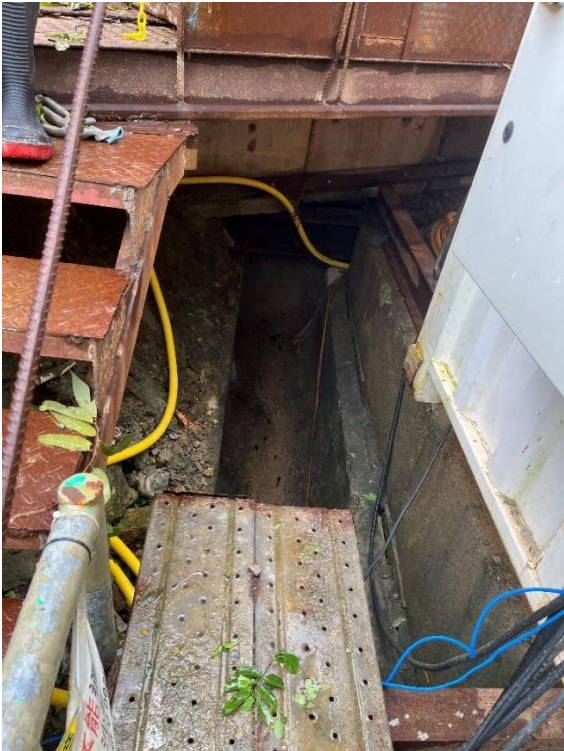
| Date | Status / Observation |
|---|---|
| 25 September 2025 | <p>No oil sheen was found at the location where oil signs were identified as reported by EPD. Its location does not fall within the project site area.</p> <p style="text-align: center;"><b>Figure 11: The location of oil sheen reported by EPD</b></p> |

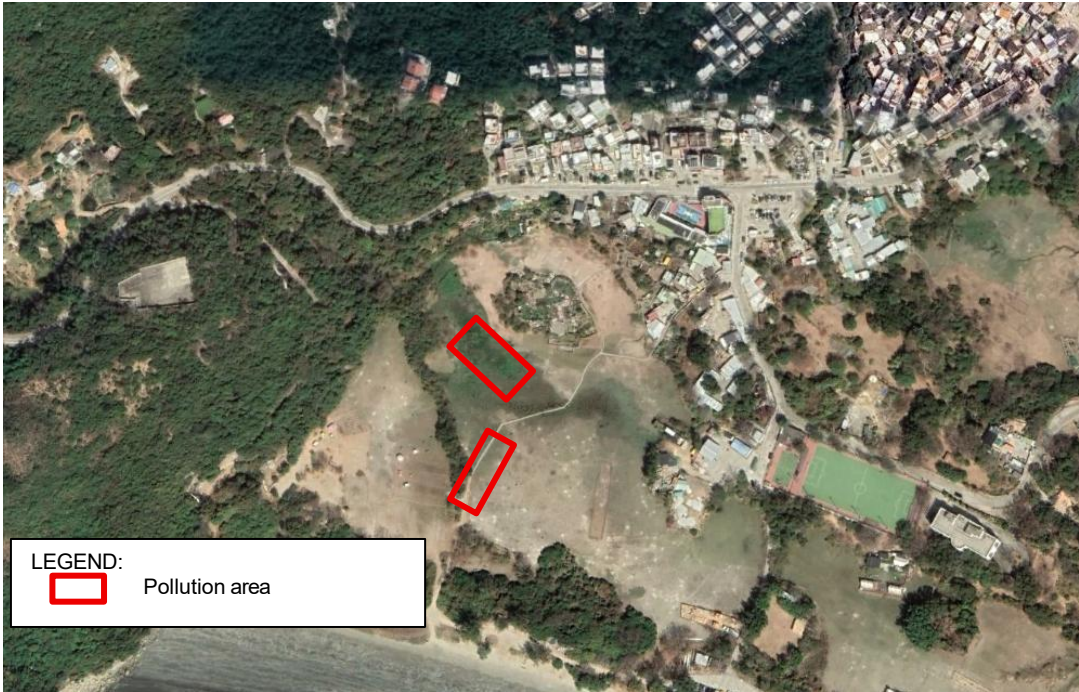
| Date | Status / Observation |
|---|---|
| 25<br>September<br>2025 | <p data-bbox="276 259 804 286">Oil signs were identified during the site inspection.</p> <p data-bbox="604 999 1176 1025">Figure 12: The location of the pollution was found</p> |

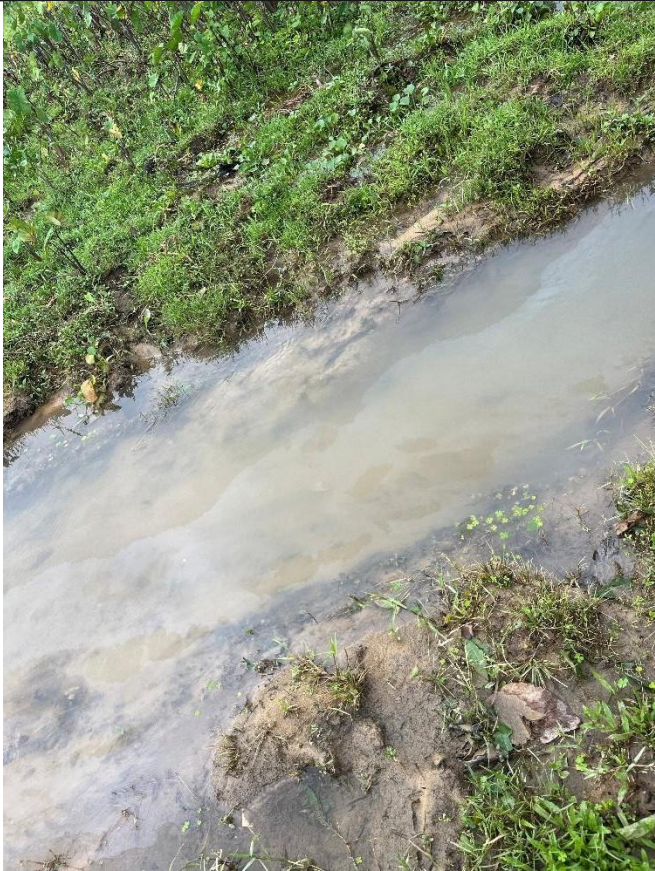
| Date | Status / Observation |
|---|---|
| 25<br>September<br>2025 | <p data-bbox="509 1951 1265 1977">Figure 13: Pollution found in Pui O Wetland on 25 September 2025</p> |

## CONCLUSION
