Existing Views and Photomontages from Nam Cheong Station Exit on Yen Chow Street West (Viewpoint 1)

Project Tile 項目名稱 REPROVISIONING OF FEHD SAI YEE STREET ENVIRONMENTAL HYGIENE OFFICES-CUM-VEHICLE DEPOT AT YEN MING ROAD, WEST KOWLOON RECLAMATION AREA 在西九龍填海區欽明路重置食物環境衞生署 涂衣街環境衞生辦事處辨車房

Drawing No. 圖則編號		Figure 8-11				
Designed Draw 設計 SYSL 繪圖	m SYSL	Check 複核	ed ICWR	Scale 此例	AS SHOWN	
Approved 批准 HTMI		Date 日期	JUN 2013	Status 現況	FINAL

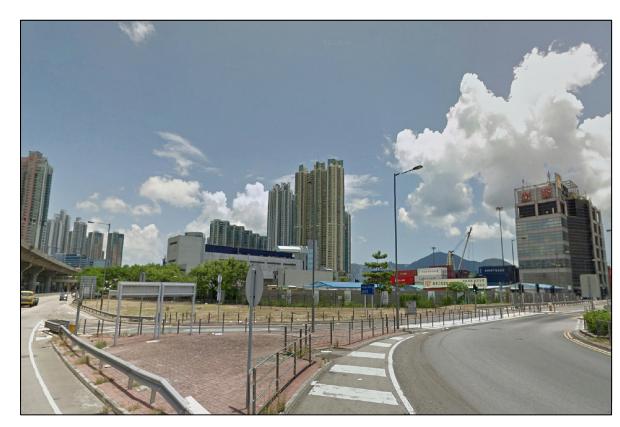
VP1 Yen Chow Street West, Existing

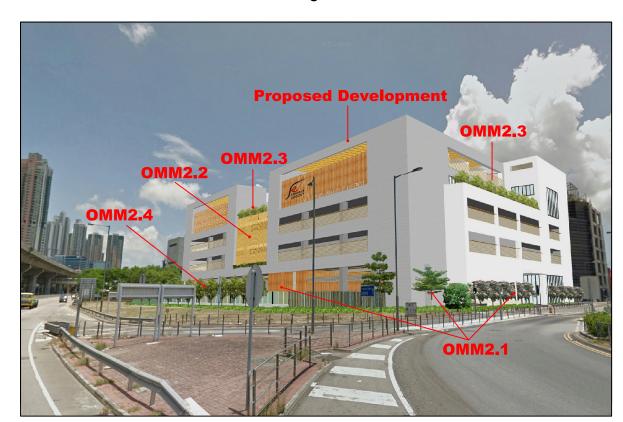
VP1 Yen Chow Street West, Day 1 with Mitigation Measures

OMM2 - LANDSCAPE DESIGN
OMM2.1:GROUND FLOOR PLANTING
OMM2.2:VERTICAL GREENING
OMM2.3:ROOF GARDEN
OMM2.4:HARD LANDSCAPE
FEATURES INCLUDING
VERTICAL GREEN FENCE
ALONG LIN CHEUNG ROAD

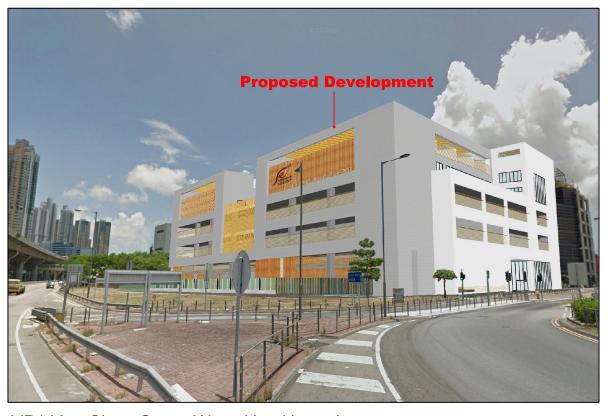
VP1 Yen Chow Street West, Unmitigated

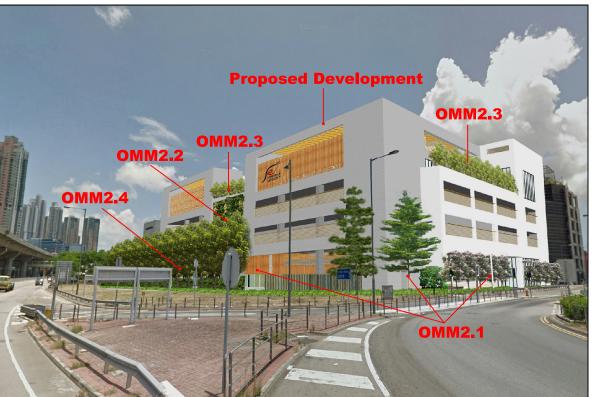
VP1 Yen Chow Street West, Year 10 with Mitigation Measures
