Expansion of Hong Kong International Airport into a Three-Runway System

Construction Phase Monthly EM&A
Report No. 103
(For July 2024)

August 2024

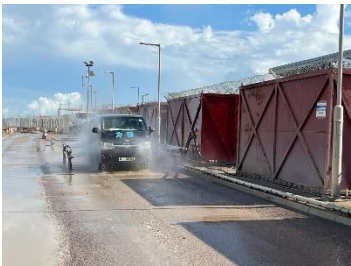
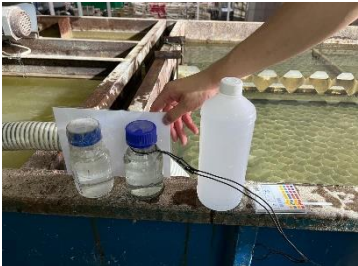
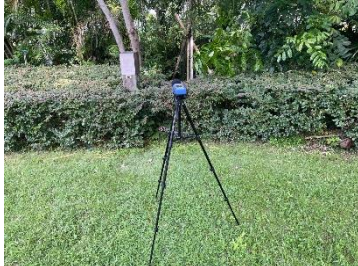
Snapshots of EM&A Activities in the Reporting Period

<p>Automatic Wheel Washing Facilities provided by Contractor</p>	<p>Contractor Conducted Visual Inspection of Treated Wastewater Quality</p>	<p>Air Quality Impact Monitoring conducted by ET at Man Tung Road Park</p>

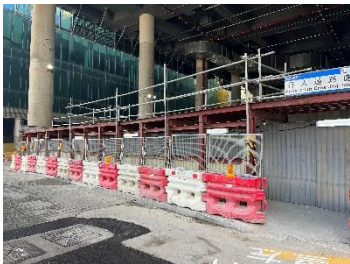
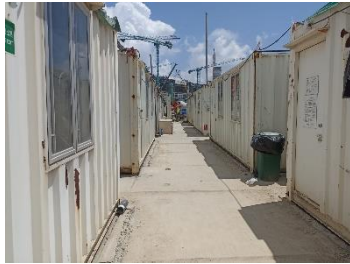
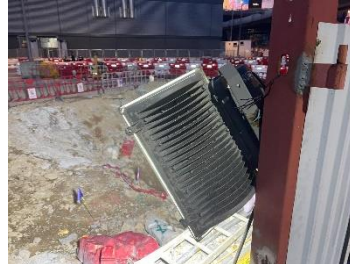
Table 7.2: Examples of Landscape and Visual Mitigation Measures in the Reporting Period

<p>Erection of site hoardings around works area in unobtrusive colours (CM5)</p>	<p>Avoidance of excessive height and bulk of site buildings (CM6)</p>	<p>Control of night-time lighting using light hooding and minimisation of night working period (CM7)</p>

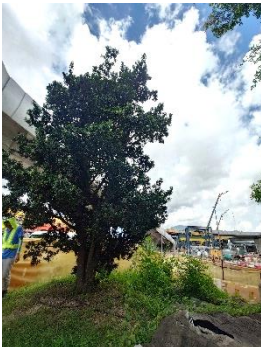
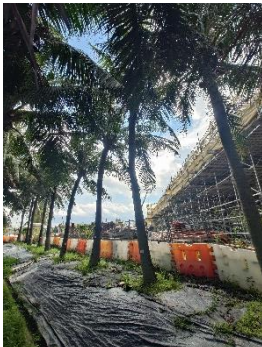
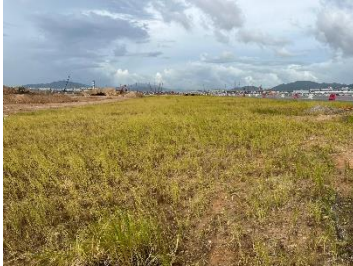
<p>General view of retained tree (CM8)</p>	<p>General view of transplanted trees (CM9)</p>	<p>General view of advanced hydroseeding works (CM10)</p>
