Expansion of Hong Kong International Airport into a Three-Runway System

Construction Phase Quarterly EM&A Report
No.40 (1 October to 31 December 2025)

February 2026

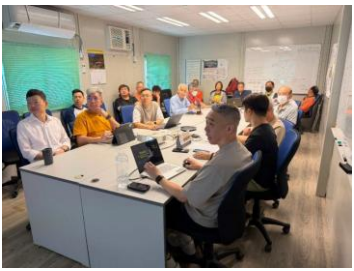
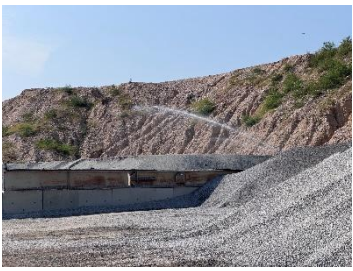
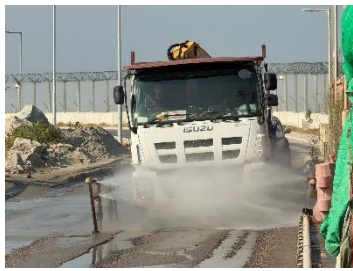
Provision of environmental training for site personnel	Provision of water spraying at the stockpiling area	Provision of wheel washing at site exit

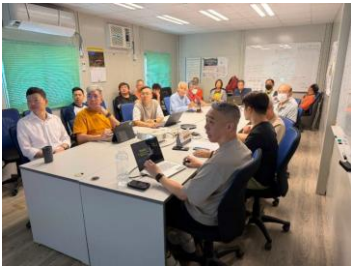
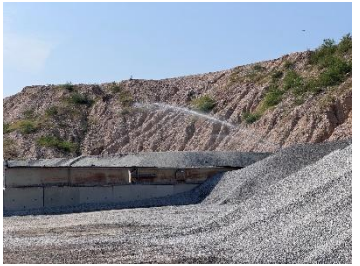
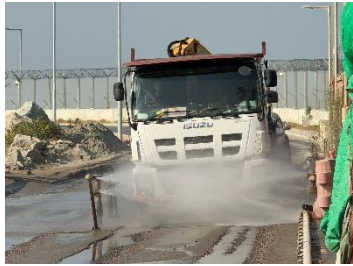
1. Provision of environmental training to site personnel on construction waste handling and disposal by contractor.
2. Provision of water spraying at stockpiling area to prevent dust nuisance.
3. Provision of wheel washing for construction vehicles leaving the site area.

<p>Provision of environmental training for site personnel</p>	<p>Provision of water spraying at the stockpiling area</p>	<p>Provision of wheel washing at site exit</p>
