Expansion of Hong Kong International Airport into a Three-Runway System

Construction Phase Quarterly EM&A Report No.3

November 2016

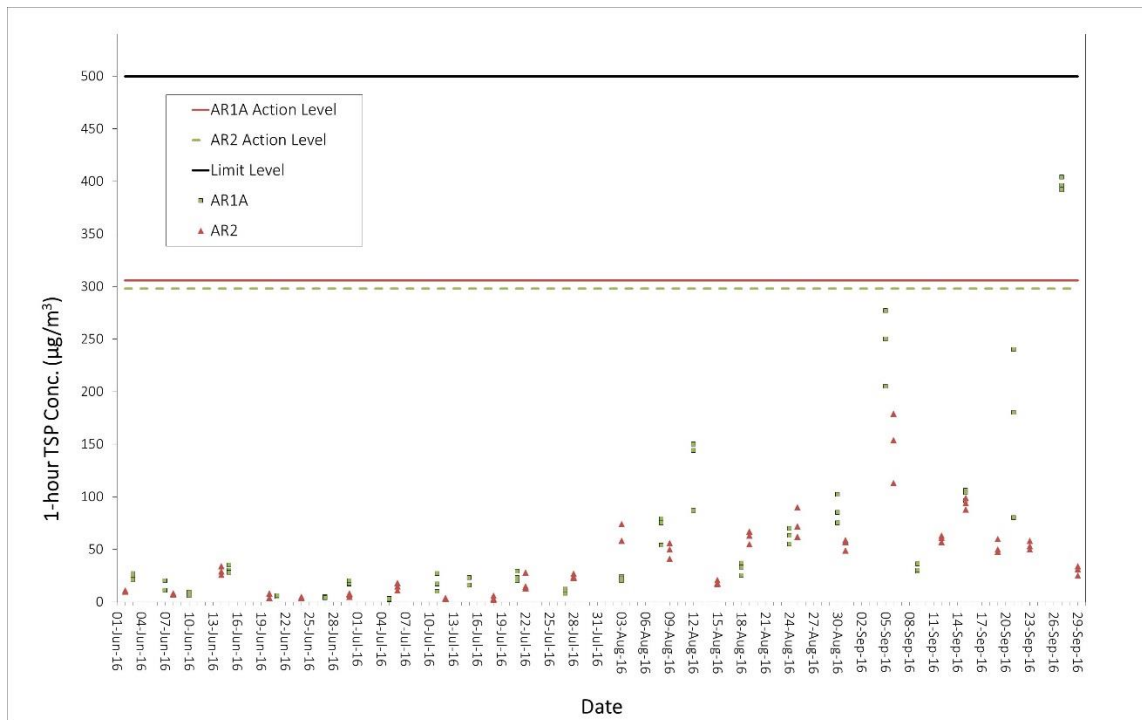
Graph 1: Graphical Plot of 1-hour TSP concentration at AR1A and AR2 during the Reporting Period

The graphical plots of impact air quality monitoring results during the reporting period are presented in **Graph 1**.

Three exceedance cases of action level of air quality monitoring were recorded at AR1A on 27 September 2016 in the 1-hour TSP monitoring that started at 08:52am, 09:52am and 10:52am. Actions were taken accordingly based on the established Event and Action Plan as presented in the Updated EM&A Manual. IEC and AAHK were informed of the exceedances.

According to on-site observation by monitoring team, haze weather was observed during monitoring. No major construction dust emission source was observed during monitoring. Based on the information from Hong Kong Observatory, tropical cyclone Megi was approaching Taiwan, its subsidence airstream create unfavourable conditions for the dispersion of pollutants and lead to low visibility to Hong Kong. According to EPD's pollutant concentration summary at Tung Chung from 08:00 to 12:00 on 27 September 2016, relatively high PM₁₀ ranging from 104 -159 µg/m³ was recorded.

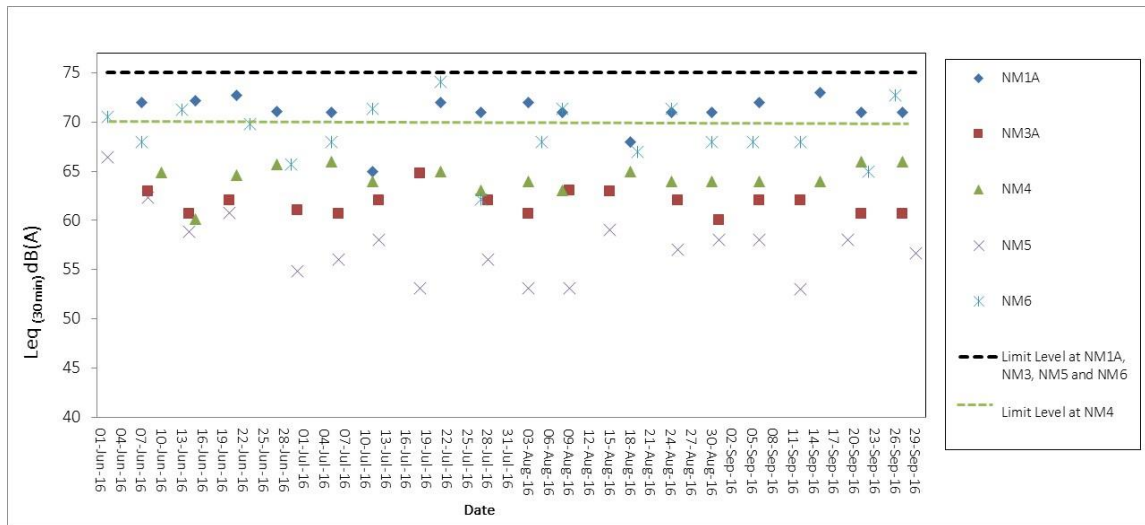
Graph 2: Graphical Plot of Leq (30min) at NM1A, NM3A, NM4, NM5 and NM6 during the Reporting Period

No exceedance of the Action and Limit Level was recorded at all monitoring stations in the reporting period.

The key activities undertaken in the reporting period were not likely to cause adverse noise impact. The active construction works of Contract P560(R) were around 3 km and 900 m away respectively from the nearest monitoring stations in Tung Chung and the villages in North Lantau. The monitoring stations were observed during the construction noise impact monitoring dominated by aircraft noise at NM3A and NM5, aircraft noise and helicopter noise at NM6, road traffic noise at NM1A and school activities at NM4 in the background. It is considered that the monitoring work in the reporting period was effective and there was no adverse impact attributable to the works of the Project.

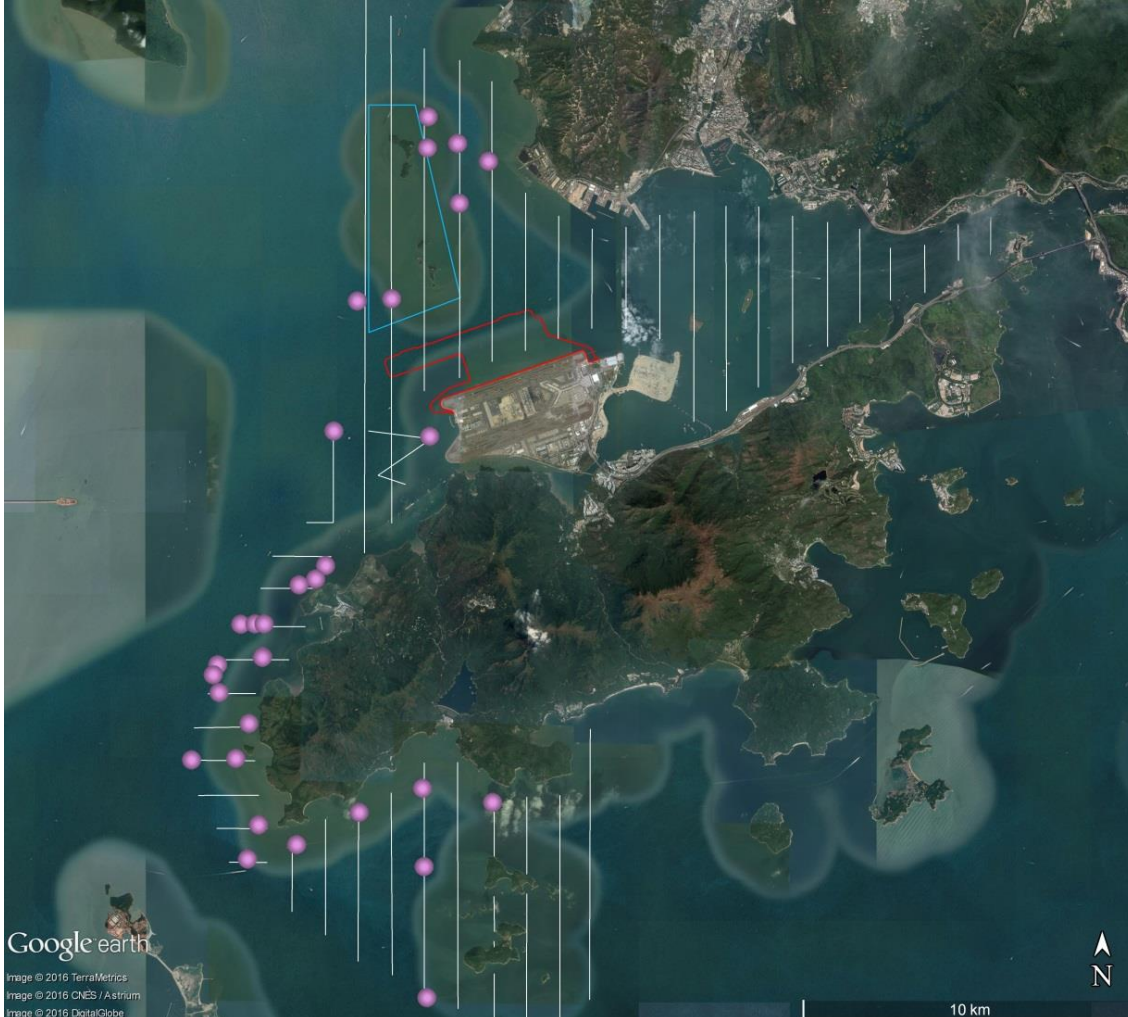
Figure 2.5: Sightings Distribution of Chinese White Dolphins

In August and September 2016, 37 groups of CWD with 142 individuals were sighted. Amongst the sightings of CWD, 31 groups with 128 individuals were made during on-effort search under favourable weather condition.

[Pink circle: Sighting locations of CWD, White line: Vessel survey transects, Blue polygon: Sha Chau and Lung Kwu Chau Marine Park (SCLKCMP), Red polygon: 3RS land-formation footprint]

Note: Only on-effort sightings under Beaufort 3 or below were presented in the figure.

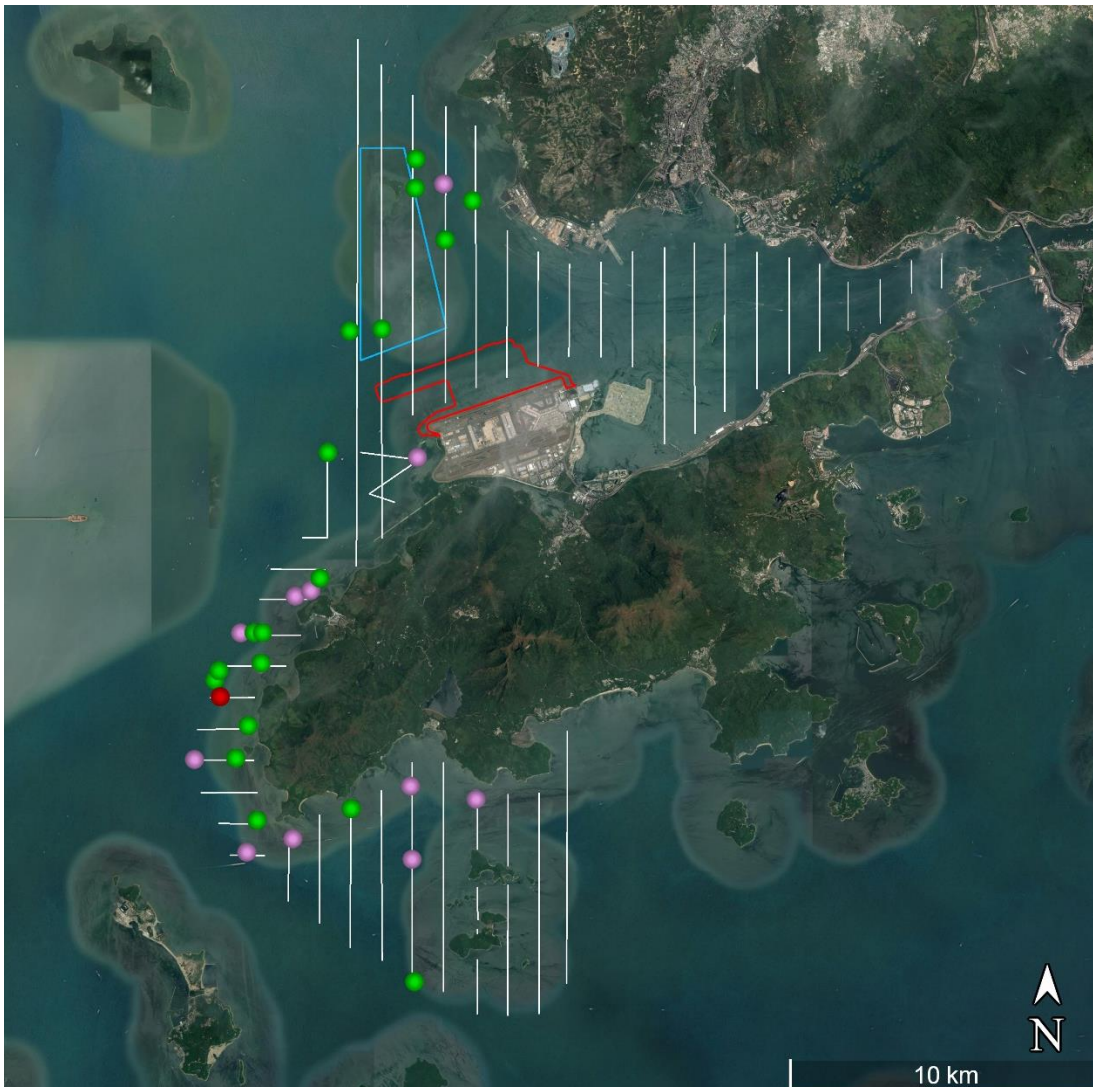
Figure 2.6: Sighting Locations of Chinese White Dolphins with Different Group Sizes

[Pink circle: Sighting locations of CWD with group size from 1 to 2 individuals, Green circle: Sighting locations of CWD with group size from 3 to 9 individuals, Red circle: Sighting locations of CWD with group size of 10 or above, White line: Vessel survey transects, Blue polygon: Sha Chau and Lung Kwu Chau Marine Park (SCLKCMP), Red polygon: 3RS land-formation footprint]

Note: Only on-effort sightings under Beaufort 3 or below were presented in the figure.

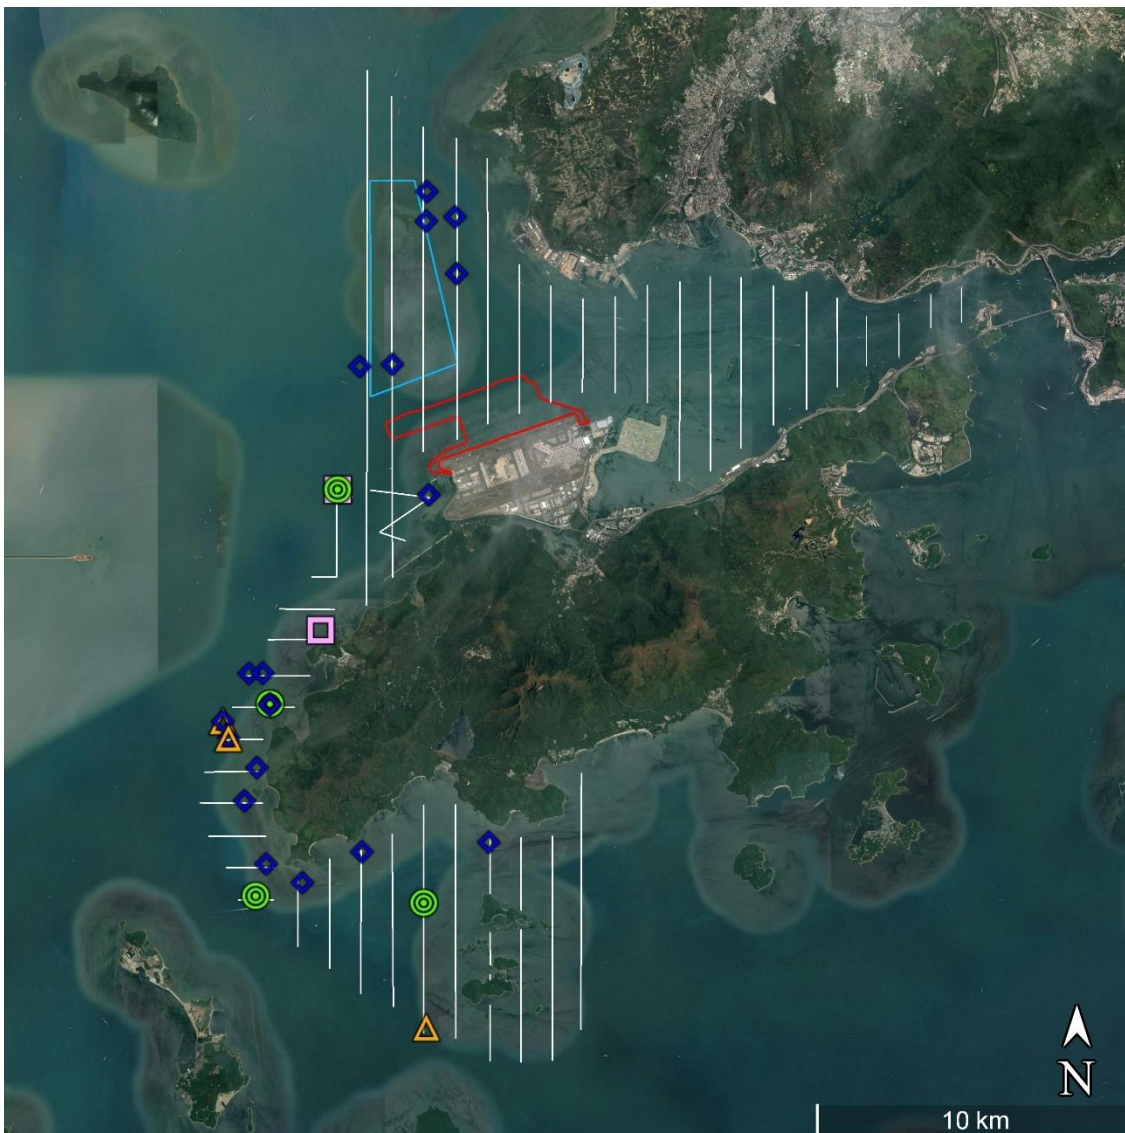
Figure 2.7: Sighting Locations of Chinese White Dolphins Engaged in Different Behaviours

During August 2016 and September 2016, 19 groups of CWDs were sighted with feeding activities. Two groups amongst 19 were observed in association with operating purse seiners, one in WL and the other in SWL. In NWL waters, the majority of the feeding activities of CWDs were observed around SCLKCMP, while CWDs mainly fed along the coast of WL and SWL during the current reporting months. The sighting locations of CWDs engaged in different behaviours during the current reporting months were illustrated in **Figure 2.7**.

[Indigo rhombus: Feeding, Green circle: Socializing, Pink square: Resting, Yellow triangle: Travelling, White line: Vessel survey transects, Blue polygon: SCLKCMP, Red polygon: 3RS land-formation footprint]

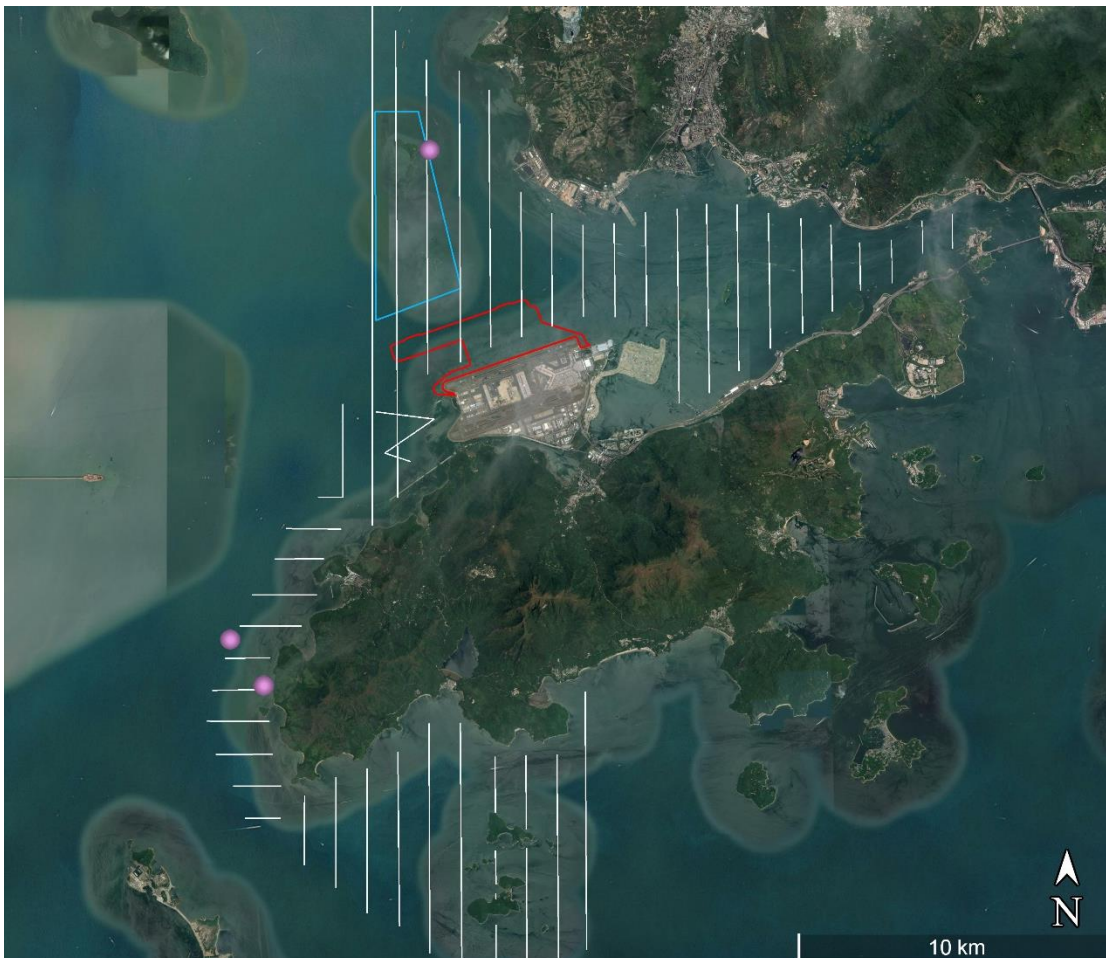
Figure 2.8: Sighting Locations of Mother-calf Pairs

In August 2016, two mother-calf pairs were sighted in WL and one mother-spotted juvenile pair was sighted in NWL near Lung Kwu Chau. No mother-calf or mother-spotted juvenile pairs were sighted in September 2016. The sighting locations of those mother-calf pairs were shown in **Figure 2.8**.

[Pink circle: Sighting locations of mother-calf pairs, White line: Vessel survey transects, Blue polygon: Sha Chau and Lung Kwu Chau Marine Park (SCLKCMP), Red polygon: 3RS land-formation footprint]
