Expansion of Hong Kong International Airport into a Three-Runway System

Construction Phase Monthly EM&A
Report No. 79
(For July 2022)

August 2022

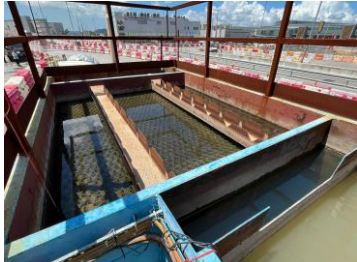
Snapshots of EM&A Activities in the Reporting Period

<p>Impact Water Quality Monitoring conducted by ET</p>	<p>Dust Suppression measure conducted by Contractor</p>	<p>Inspection of Contractor's Wastewater Treatment Facility by ET</p>

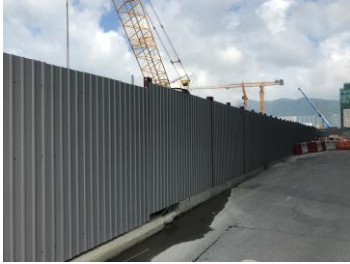
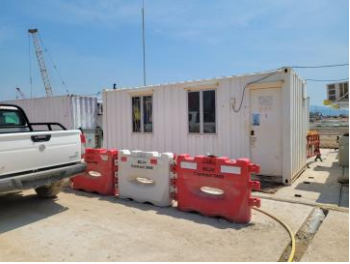
Table 7.2: Examples of Landscape and Visual Mitigation Measures in the Reporting Periods

<p>Erection of site hoardings around works area in unobtrusive colours (CM5)</p>	<p>Avoidance of excessive height and bulk of site buildings (CM6)</p>	<p>Control of night-time lighting using light hooding and minimisation of night working period (CM7)</p>
