Environmethal Team Services for Contract No. SS H504 Design and Construction of Chai Wan Government Complex and Vehicle Depot

36th Monthly EM&A Report (October 2024)

Contract No. SS H504
Design and
Construction of Chai
Wan Government
Complex and Vehicle
Depot

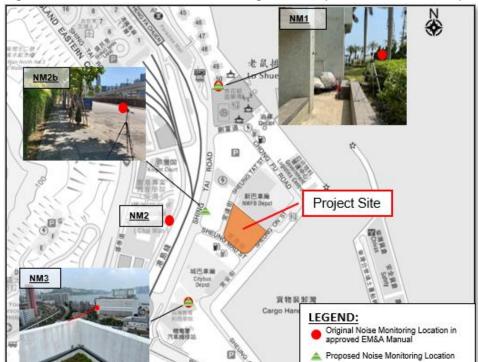
Figure 3-1 Location of Noise Monitoring Stations (NM1, NM2b and NM3)

Due to the adjustment of the location of NM2a to NM2b, the measured noise level at NM2b would represent the noise levels at NM2.

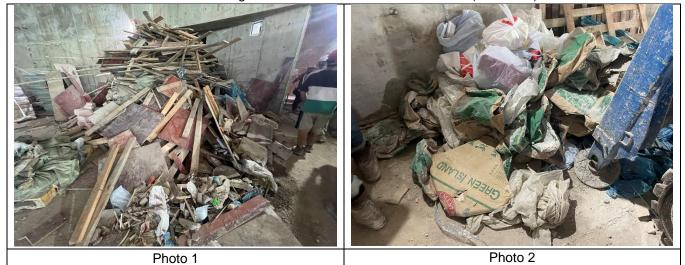
1. The accumulated of C&D waste with general waste is observed on the floor. (Photo 1-2)

1. The contractor has been advised to increase the frequency of waste disposal to prevent waste accumulation and to provide enclosed bins or a segregation area for general waste to ensure proper segregation.
