# Environmental Team Services for Contract No. SS H504 Design and Construction of Chai Wan Government Complex and Vehicle Depot

## 38<sup>th</sup> Monthly EM&A Report (December 2024)

**Contract No. SS H504  
Design and  
Construction of Chai  
Wan Government  
Complex and Vehicle  
Depot**

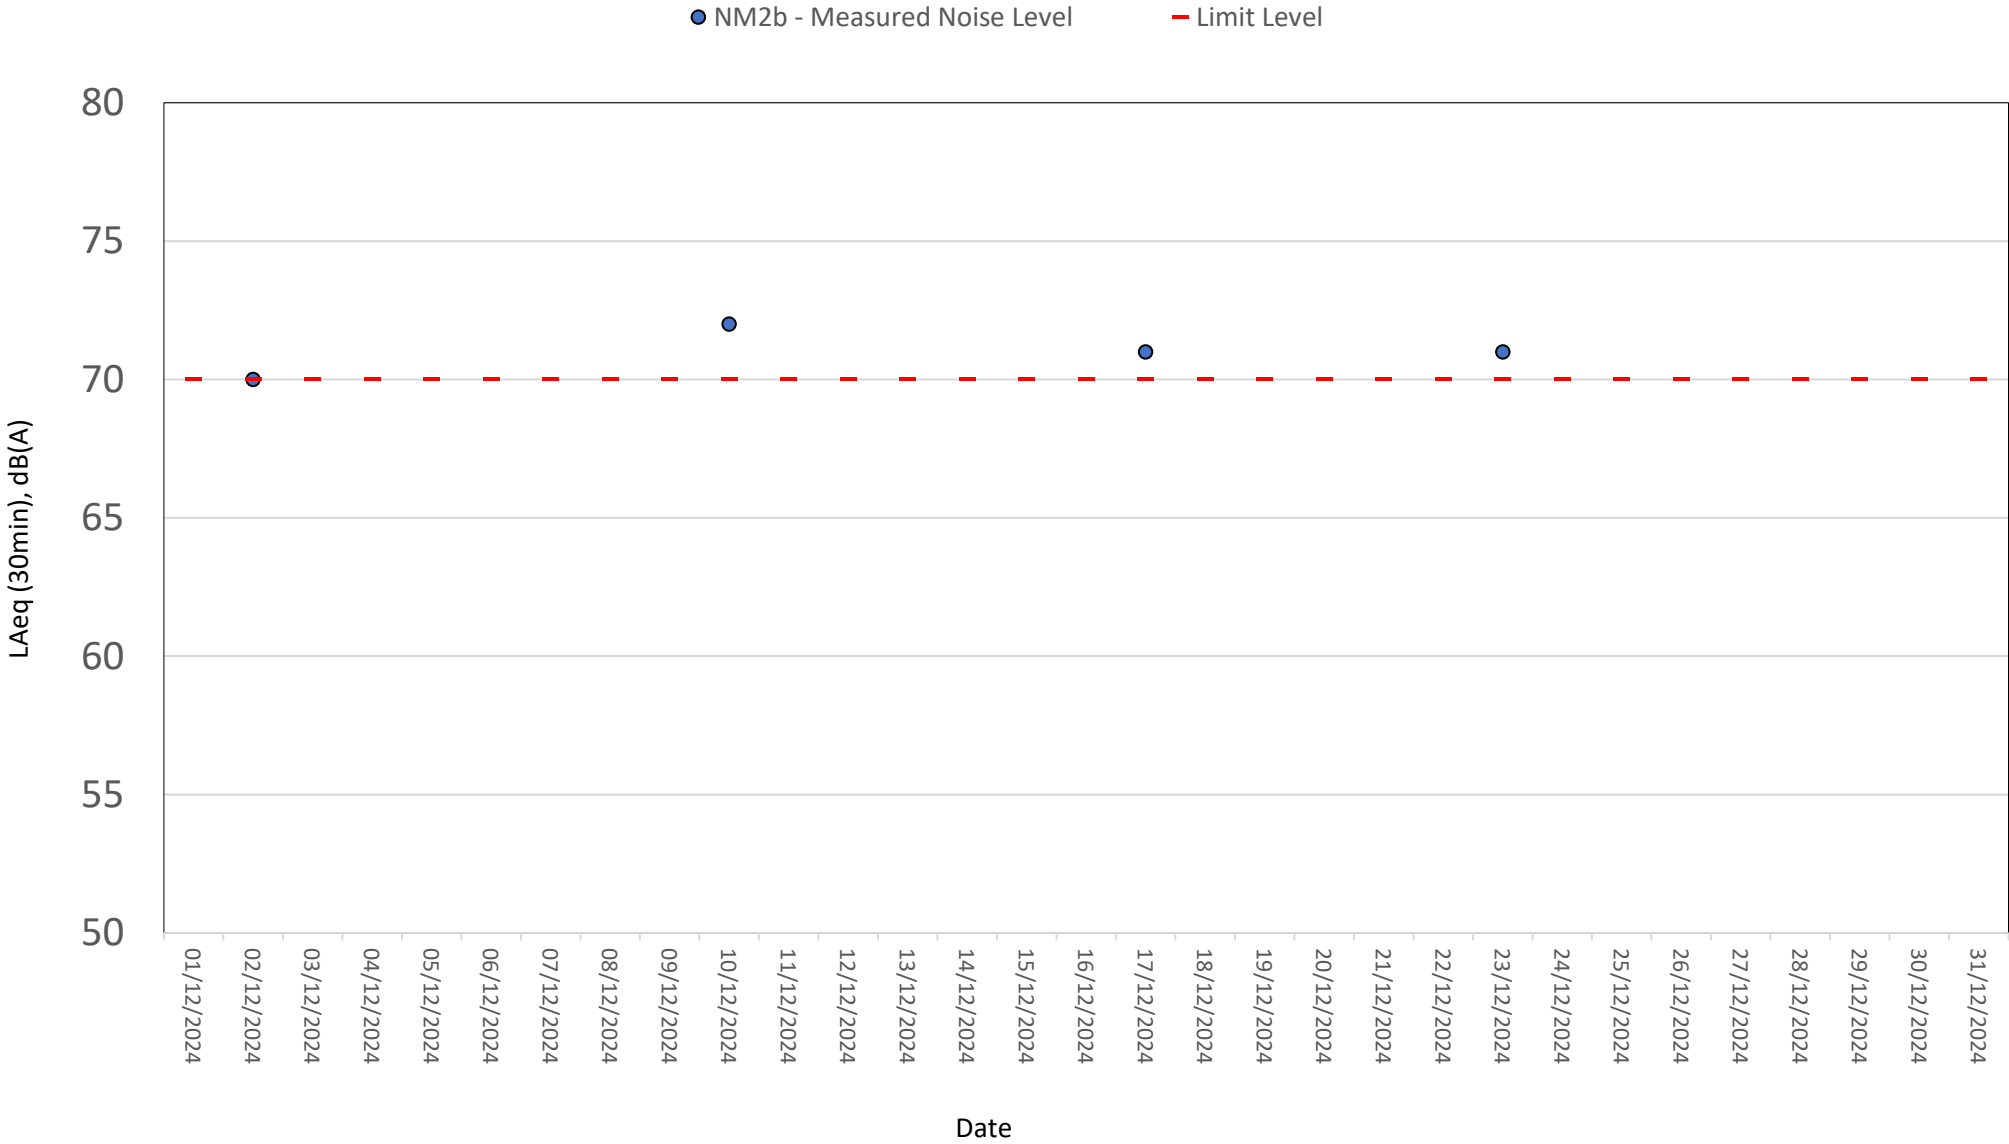
Normal Weekdays Noise Monitoring Results at NM2b(Leq, 30min)

Remark(s):  
On 10, 17 and 23 December 2024, the measured noise levels of NM2b exceeded the limit level of 70dB(A). However, they were lower than the baseline level of 73.4 dB(A). Therefore, they are not considered as an limit level exceedance.

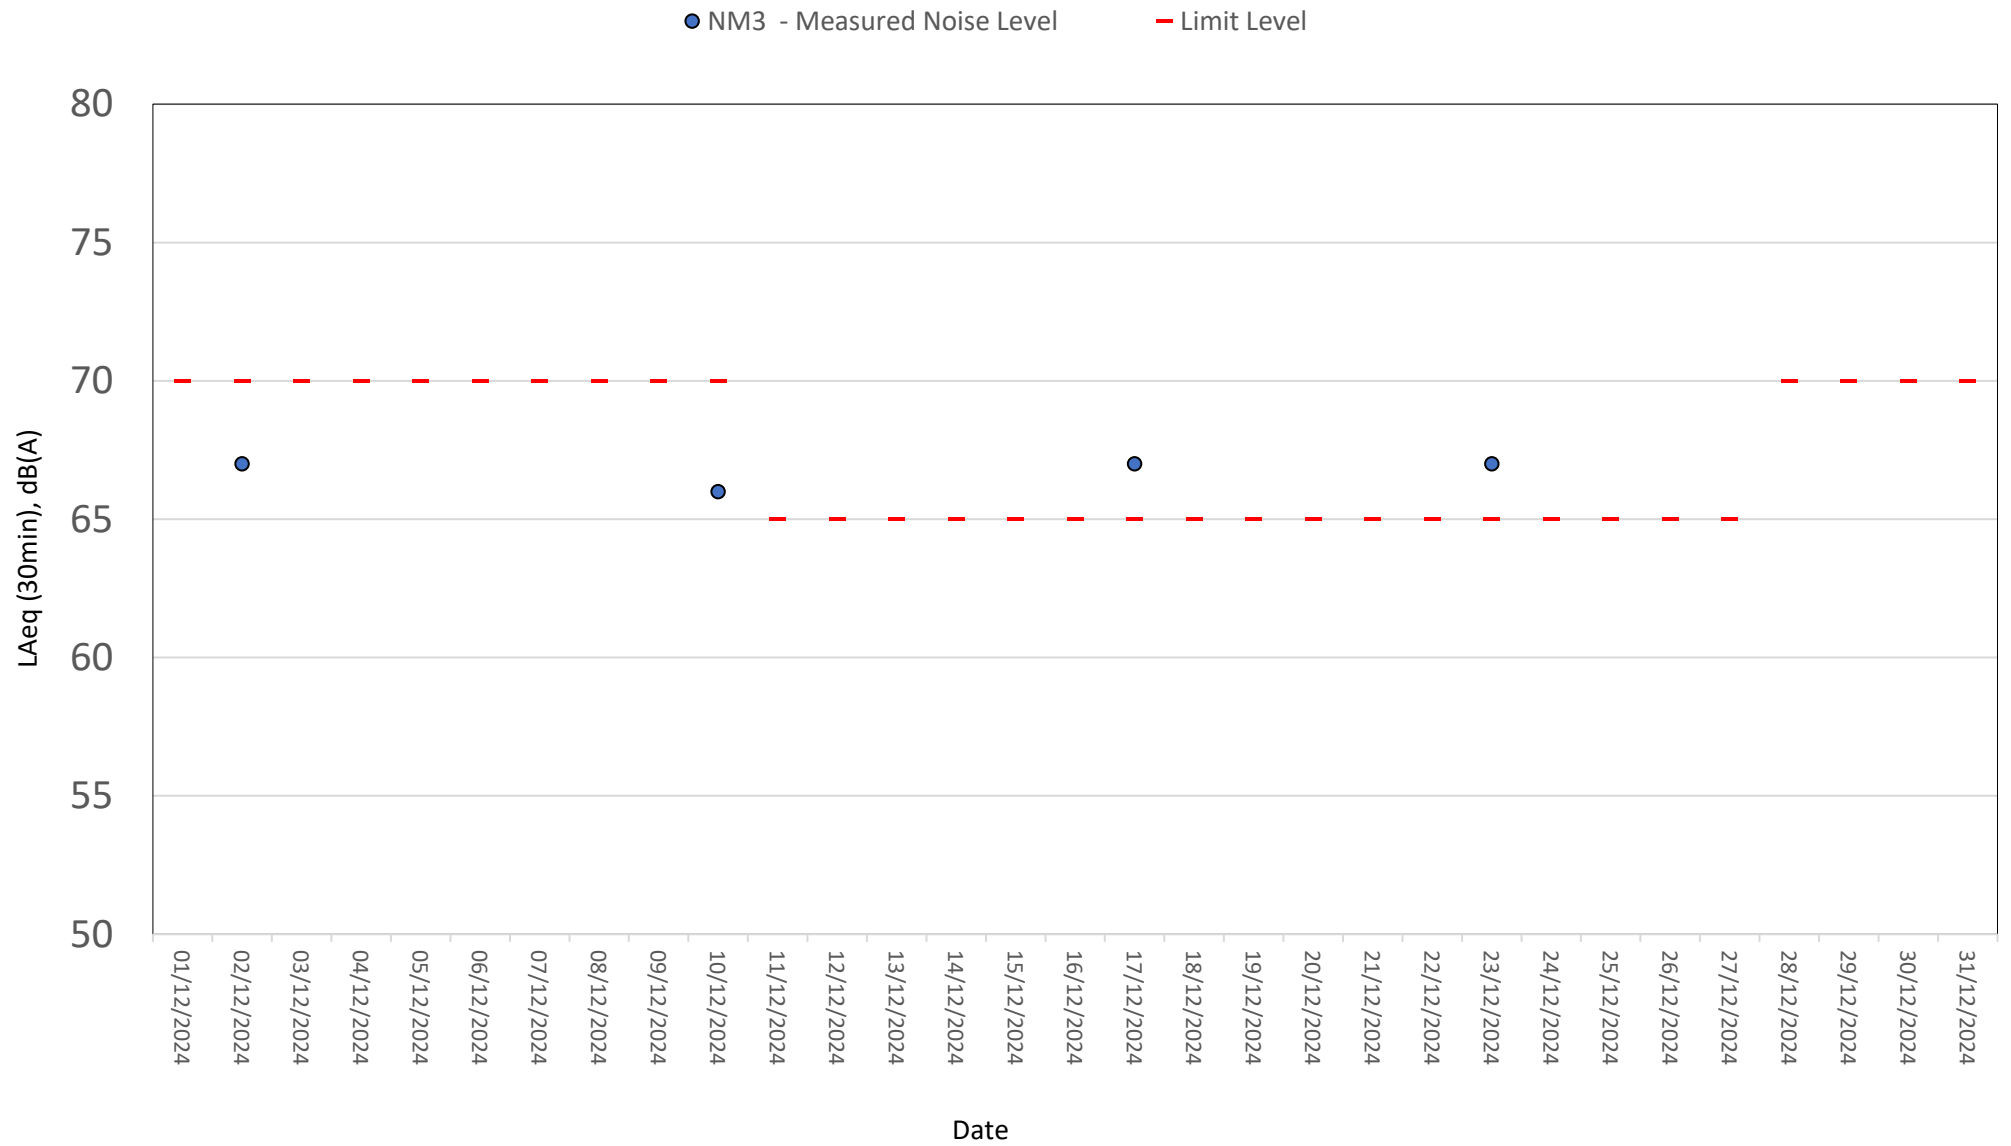
### Normal Weekdays Noise Monitoring Results at NM3(Leq, 30min)

On 17 and 23 December 2024, the measured noise levels of NM3 exceeded the limit level of 65 dB(A) as they were within exam period. However, they were lower than the baseline level of 69.8 dB(A). Therefore, they are not considered as an limit level exceedance

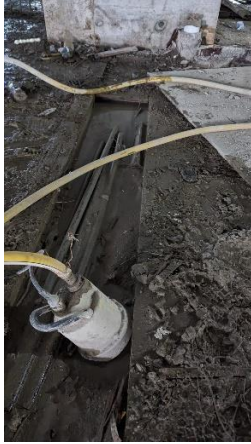
Photo R1

1. The accumulated of construction waste and soil in the L3 drainage channel was cleaned. (Photo R1)
2. The accumulated of C&D waste was cleaned. (Photo R2)
3. Chemical wastes and dry PFA packaging waste in L3 were removed. (Photo R3)

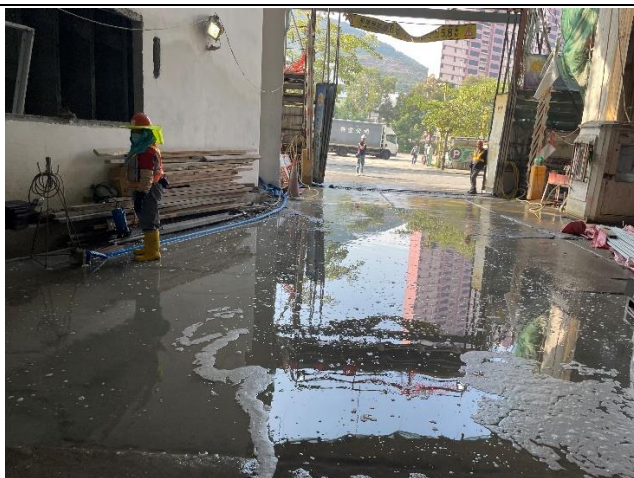
Photo 1

1. Dry PFA material should be stored properly on L3. (Photo 3)
2. The efficiency of wheel washing area should be properly maintained on the G/F site entry. (Photo 1)
3. The general wastes were found on L5 ground. (Photo 2)

1. The Contractor has been advised that dry PFA material should be stored properly to prevent it from becoming wet.
2. The Contractor has been reminded that the wheel washing area should be maintained regularly to ensure its efficiency in delivering wastewater to prevent surface runoff from the site.
3. The Contractor has been recommended to provide an enclosed bin for general waste collection and to arrange for site cleaning to ensure that the site remains clean and tidy on L5.

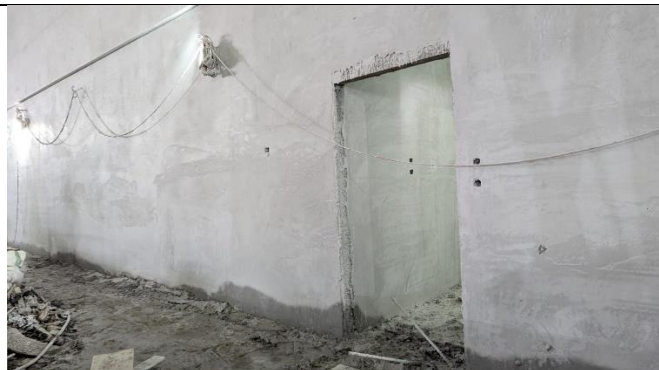
Photo R1

1. Dry PFA material on L3 was removed. (Photo R1)
2. The wheel washing area was maintained. (Photo R2)
3. General wastes on L5 ground were removed. (Photo R3)

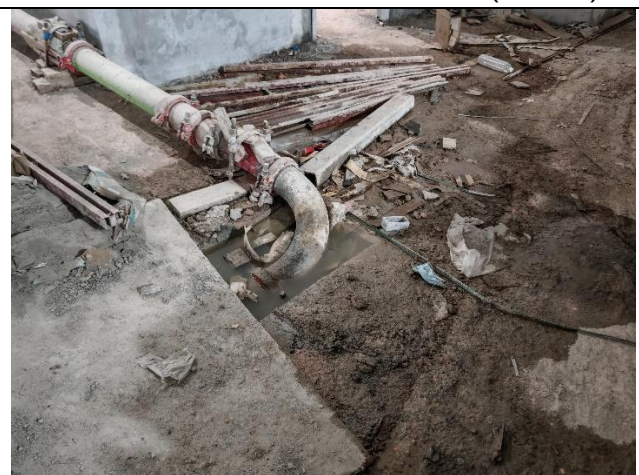
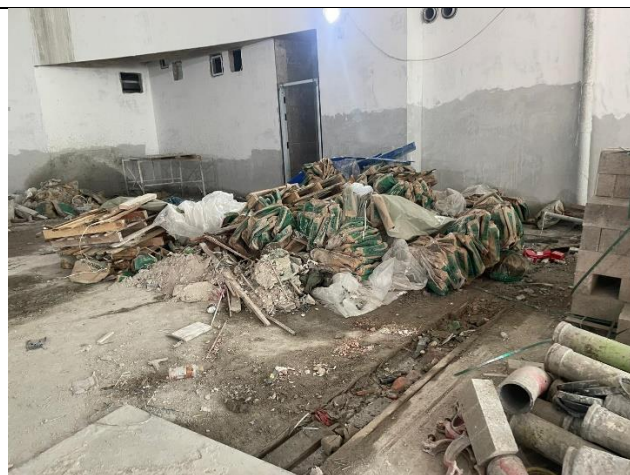
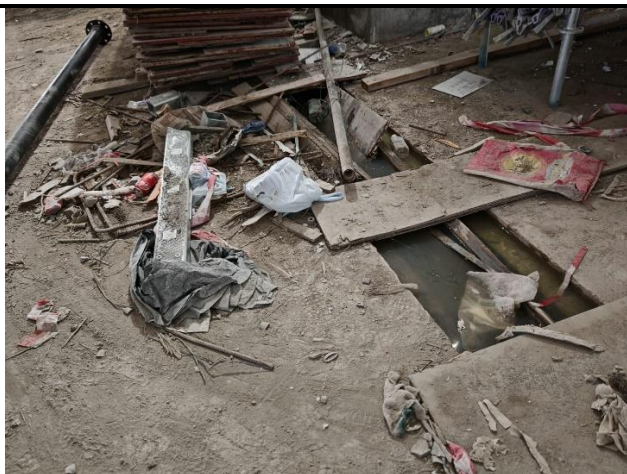
1. The general waste & C&D materials are found in and close to the drainage channel at L2 to L4. (Photos 1-3)
2. Silt and wastewater are observed on L3 ground. (Photo 4)
3. The accumulated waste is found on L4. (Photo 5)

1. The Contractor has been recommended that the general waste and C&D materials in and close to the drainage channels should be removed to prevent blocking the drainage channels and contamination of runoff at drainage channels. The waste storage area with clearly labelling, which far from the drainage system, should be setup.
2. The Contractor has been advised that silt and water should be removed immediately after construction works to avoid the risk of casing muddy water.
3. The Contractor has been advised that the C&D waste storage area with clearly labelling should be established and the collection frequency of C&D waste should be increased to avoid the high amount of C&D waste accumulated in the project site.

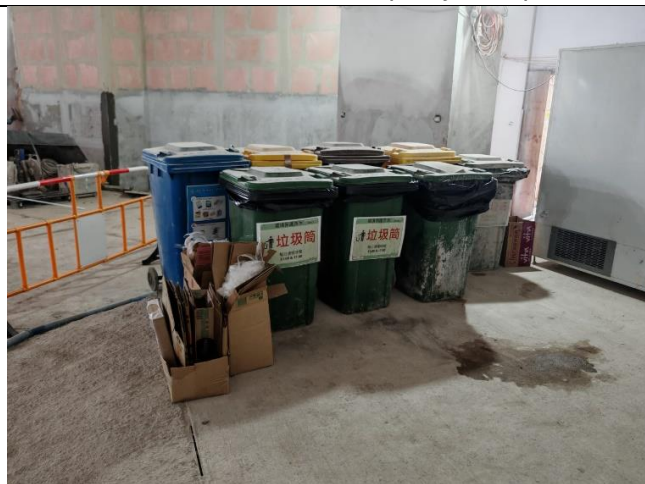
Photo 1

1. The accumulated of waste is found on the floor.
2. Chemical containers without drip tray or impervious sheet are observed on L4.

1. The Contractor has been recommended to dispose of general waste more frequently to prevent waste accumulation and to collect recyclable materials properly in recycling bins.
2. The Contractor has been advised to provide drip tray or impervious sheet during using chemical to avoid leakage or spillages.

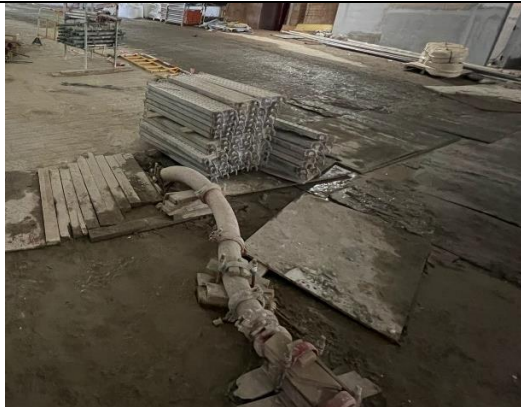
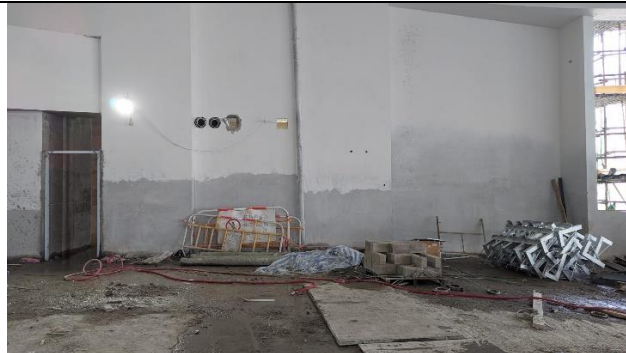
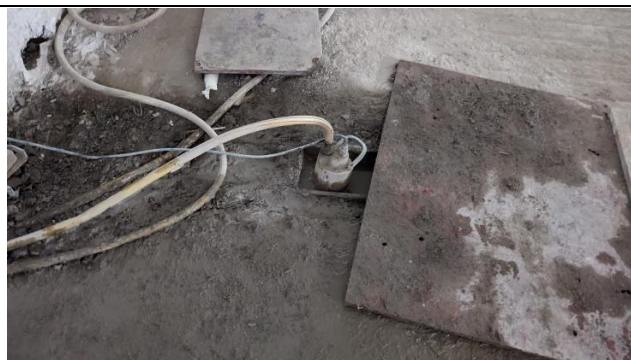
1. General waste and C&D waste in and close to the drainage channel on L2 to L4 were removed. (Photo R1 to R3)
2. Silt and wastewater on L3 ground was cleared. (Photo R4)
3. Waiting for Contractor' input.

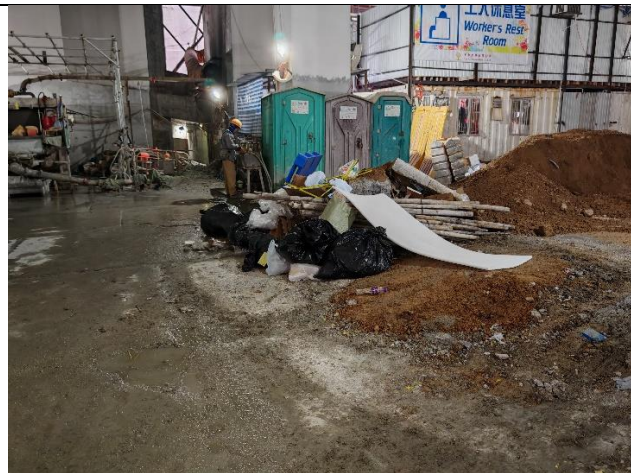
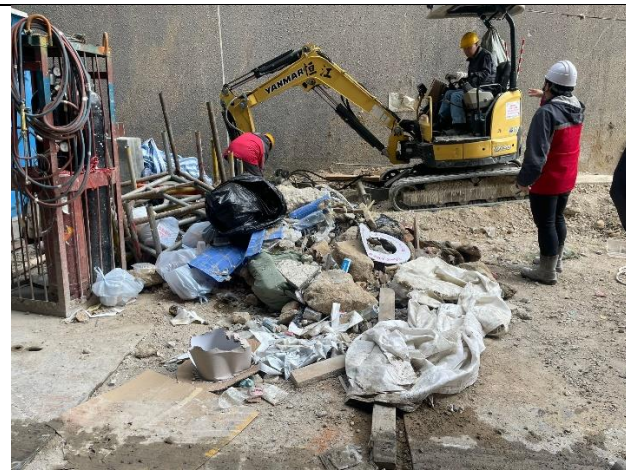
1. The accumulated general waste and C&D waste is observed on G/F. (Photo 1 & 2)
2. Chemical containers on L1 are placed near the drainage channel without drip tray and the chemical cabinet on G/F should be locked. (Photo 3 & 4)
