# Environmental Team Services for Contract No. SS H504 Design and Construction of Chai Wan Government Complex and Vehicle Depot

## 43<sup>rd</sup> Monthly EM&A Report (May 2025)

**Contract No. SS H504  
Design and  
Construction of Chai  
Wan Government  
Complex and Vehicle  
Depot**

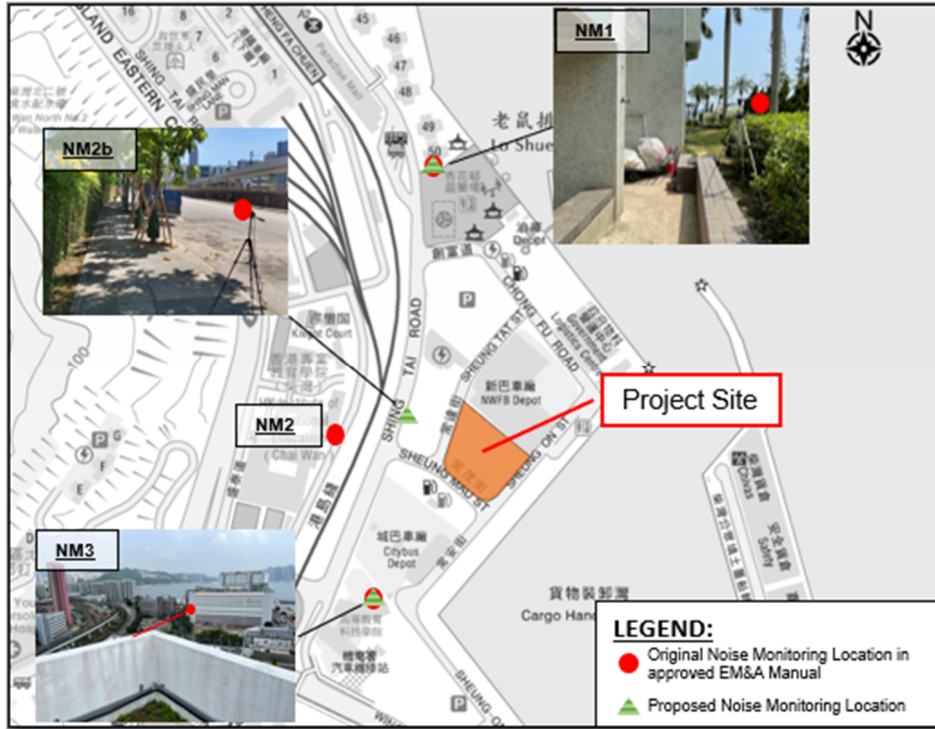
**Figure 3-1 Location of Noise Monitoring Stations (NM1, NM2b and NM3)**

Lamp Post no. 47447 at Sheung Mau Street (NM2a), which is located between project site and original noise monitoring location, Hong Kong Institute of Vocational Education (Chai Wan) - Academic Block (NM2), is found suitable and available to be an alternative noise monitoring location for NM2. Also, NM2a, which has a direct line of sight towards project site (where construction works will be carried out and likely to have noise impacts), is located closer to project site than NM2 and thus considered as a representative noise monitoring location. Monitoring position at NM2a is proposed at 2m above ground due to security concerns and minimize the road traffic noise contribution. Noise measurement at NM2a will be considered as free-field and a correction of +3dB(A) would be made to the noise monitoring results. The alternative location of NM2a, were therefore proposed and agreed by the Independent Environmental Checker (IEC).

Due to the adjustment of the location of NM2a to NM2b, the measured noise level at NM2b would represent the noise levels at NM2.

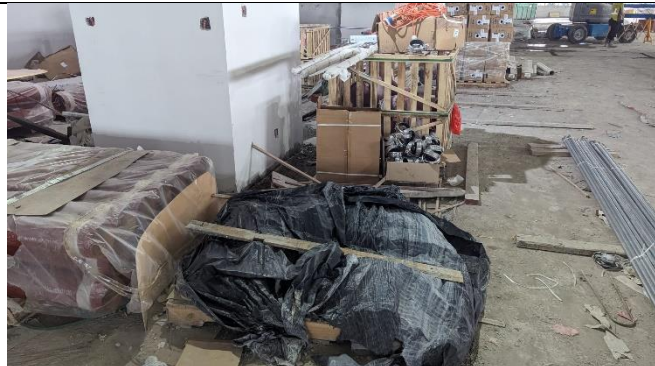
Photo R1

1. Chemical containers on L6 were covered by impervious sheet. (Photo R1)
2. The accumulated general waste on L4 & L5 were removed. (Photo R2 & R3)
3. Chemicals on L2 ground and in the drainage were cleaned. (Photo R4)

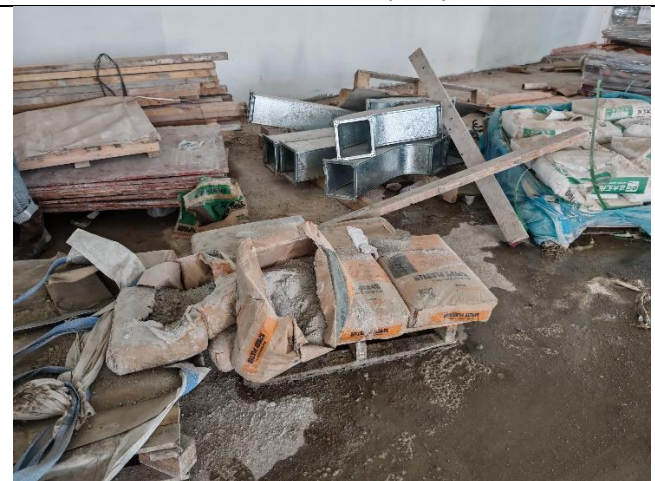
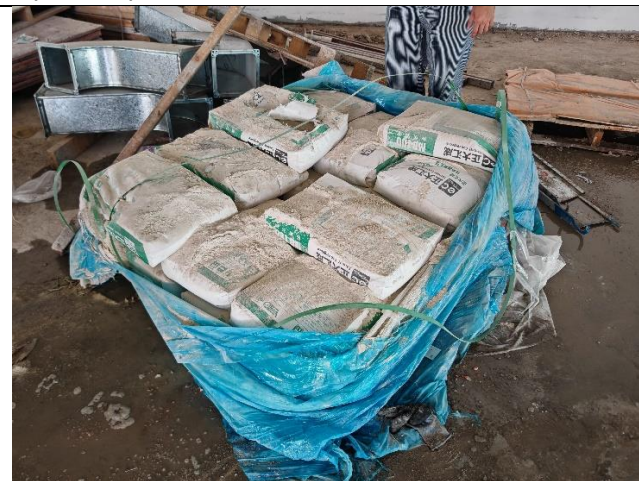
1. Dry PFA materials without cover are observed on L6. (Photo 1 & 2)
2. Chemical containers without drip tray are observed on L8. (Photo 3)

- Dry PFA materials without cover were observed on L6. The Contractor has been recommended that dry PFA material should be stored properly and covered by impervious sheet to avoid dust dispersion.
- Chemical containers without drip tray were observed on L8. The Contractor has been recommended to provide drip tray for chemical containers and to covered with impervious sheet when not in use to avoid pollution.

1. The Contractor has been recommended that dry PFA material should be stored properly and covered by impervious sheet to avoid dust dispersion.
2. The Contractor has been recommended to provide drip tray for chemical containers and to covered with impervious sheet when not in use to avoid pollution.

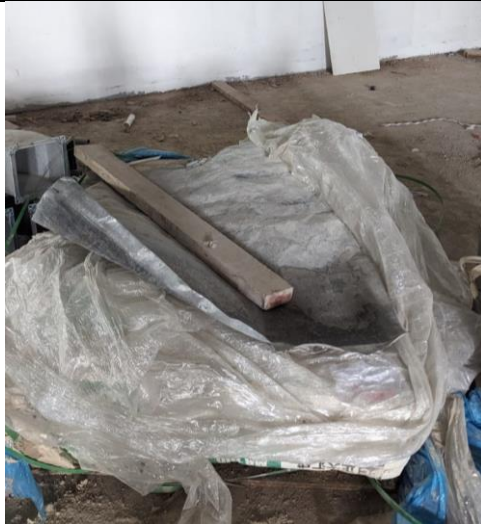
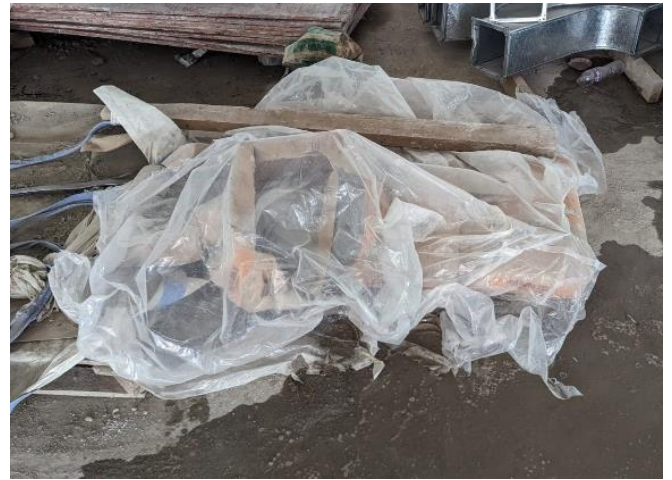
1. Dry PFA materials on L6 were covered by impervious sheet (Photo R1 & R2)
2. Chemical containers without drip tray on L8 were removed. (Photo R3)

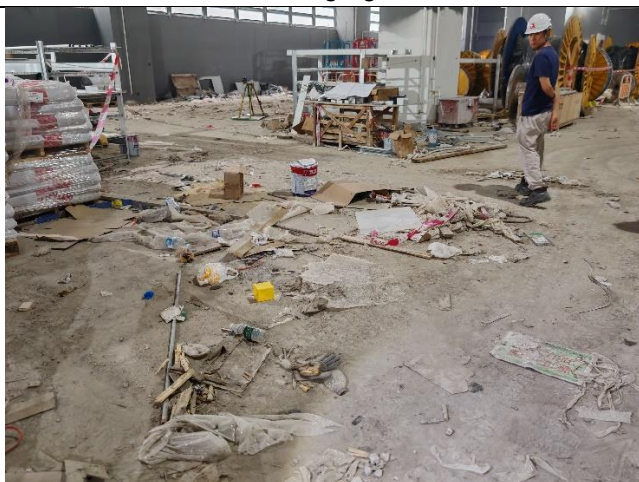
Photo 1

1. The general waste is observed on L3 ground. (Photo 1)
2. The accumulated wastes are observed on L3 – L5. (Photo 2 - 4)
3. The C&D waste without segregation is observed on L2. (Photo 2)

- The general waste was observed on L3 ground. The Contractor has been recommended to provide enough enclosed bin for general waste collection and to arrange for site cleaning to ensure the site remains clean and tidy.
- The accumulated wastes were observed on L3 – L5. The Contractor has been recommended to disposed of waste more frequently to prevent waste accumulation.
- The C&D waste without segregation was observed on L2. The Contractor has been recommended to segregate general waste from C&D waste and provide waste skip for general waste.

1. The Contractor has been recommended to provide enough enclosed bin for general waste collection and to arrange for site cleaning to ensure the site remains clean and tidy.
2. The Contractor has been recommended to disposed of waste more frequently to prevent waste accumulation.
3. The Contractor has been recommended to segregate general waste from C&D waste and provide waste skip for general waste.

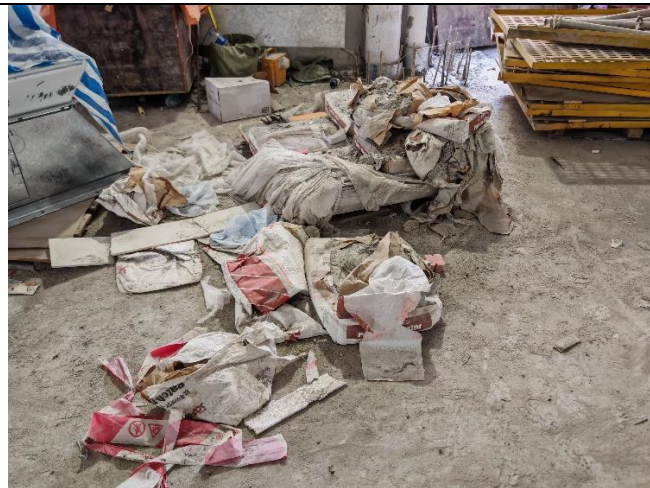
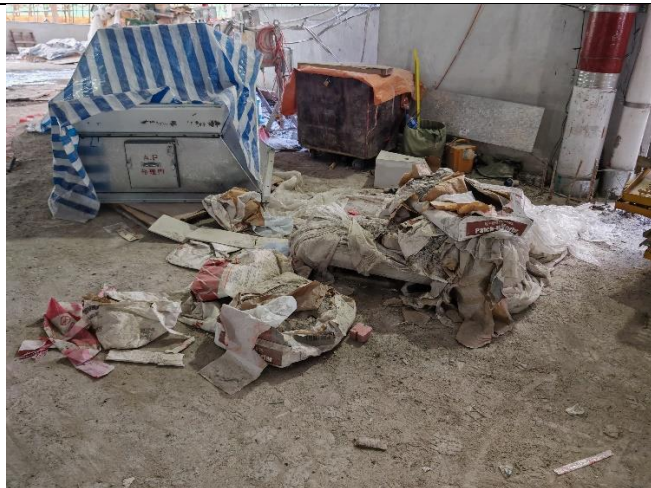
1. Dry PFA materials without proper storage are observed on L6. (Photo 1 & 2)
2. The accumulated wastewater is observed on G/F. (Photo 3)

- Dry PFA materials without proper storage were observed on L6. The Contractor has been recommended to store dry PFA material properly in designated area to prevent it from becoming wet.
- The accumulated wastewater was observed on G/F. The Contractor has been recommended to provide sandbag barriers and direct wastewater to the silt removal facilities to avoid surface runoff.

1. The Contractor has been recommended to store dry PFA material properly in designated area to prevent it from becoming wet.
2. The Contractor has been recommended to provide sandbag barriers and direct wastewater to the silt removal facilities to avoid surface runoff.

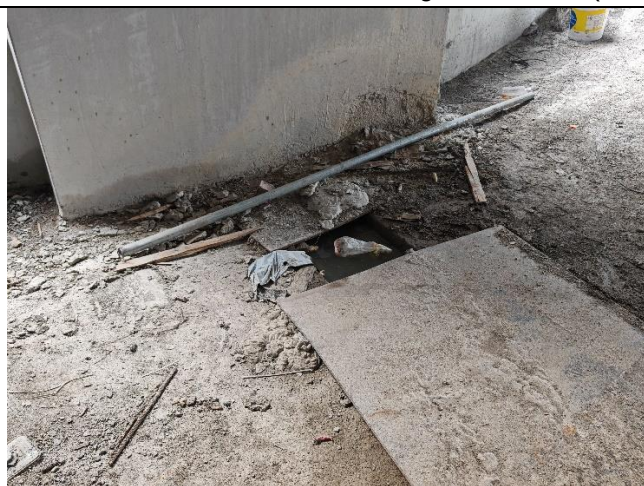
Photo 1

1. The efficiency of drainage channel should be properly maintained on L8. (Photo 1)
2. General waste is observed on the ground of L4. (Photo 2 & 3)

- The efficiency of drainage channel should be properly maintained on L8. The Contractor has been recommended to maintain and clean the drainage channel regularly to ensure its efficiency in delivering wastewater to the slit removal facility.
- General waste was observed on the ground of L4. The Contractor has been recommended to provide enough waste skip for general waste and increase the frequency of site cleaning to ensure the site is clean and tidy.
