**Service Contract No. NDO 07/2019
Environmental Team for Site Formation
and Infrastructure Works for Police
Facilities in Kong Nga Po**

**Monthly Environmental Monitoring and
Audit Report for July 2020
(Version 1.0)**

**Site Formation and Infrastructure Works for Police Facilities in Kong Nga Po
Monthly Environmental Monitoring and Audit Report for July 2020**

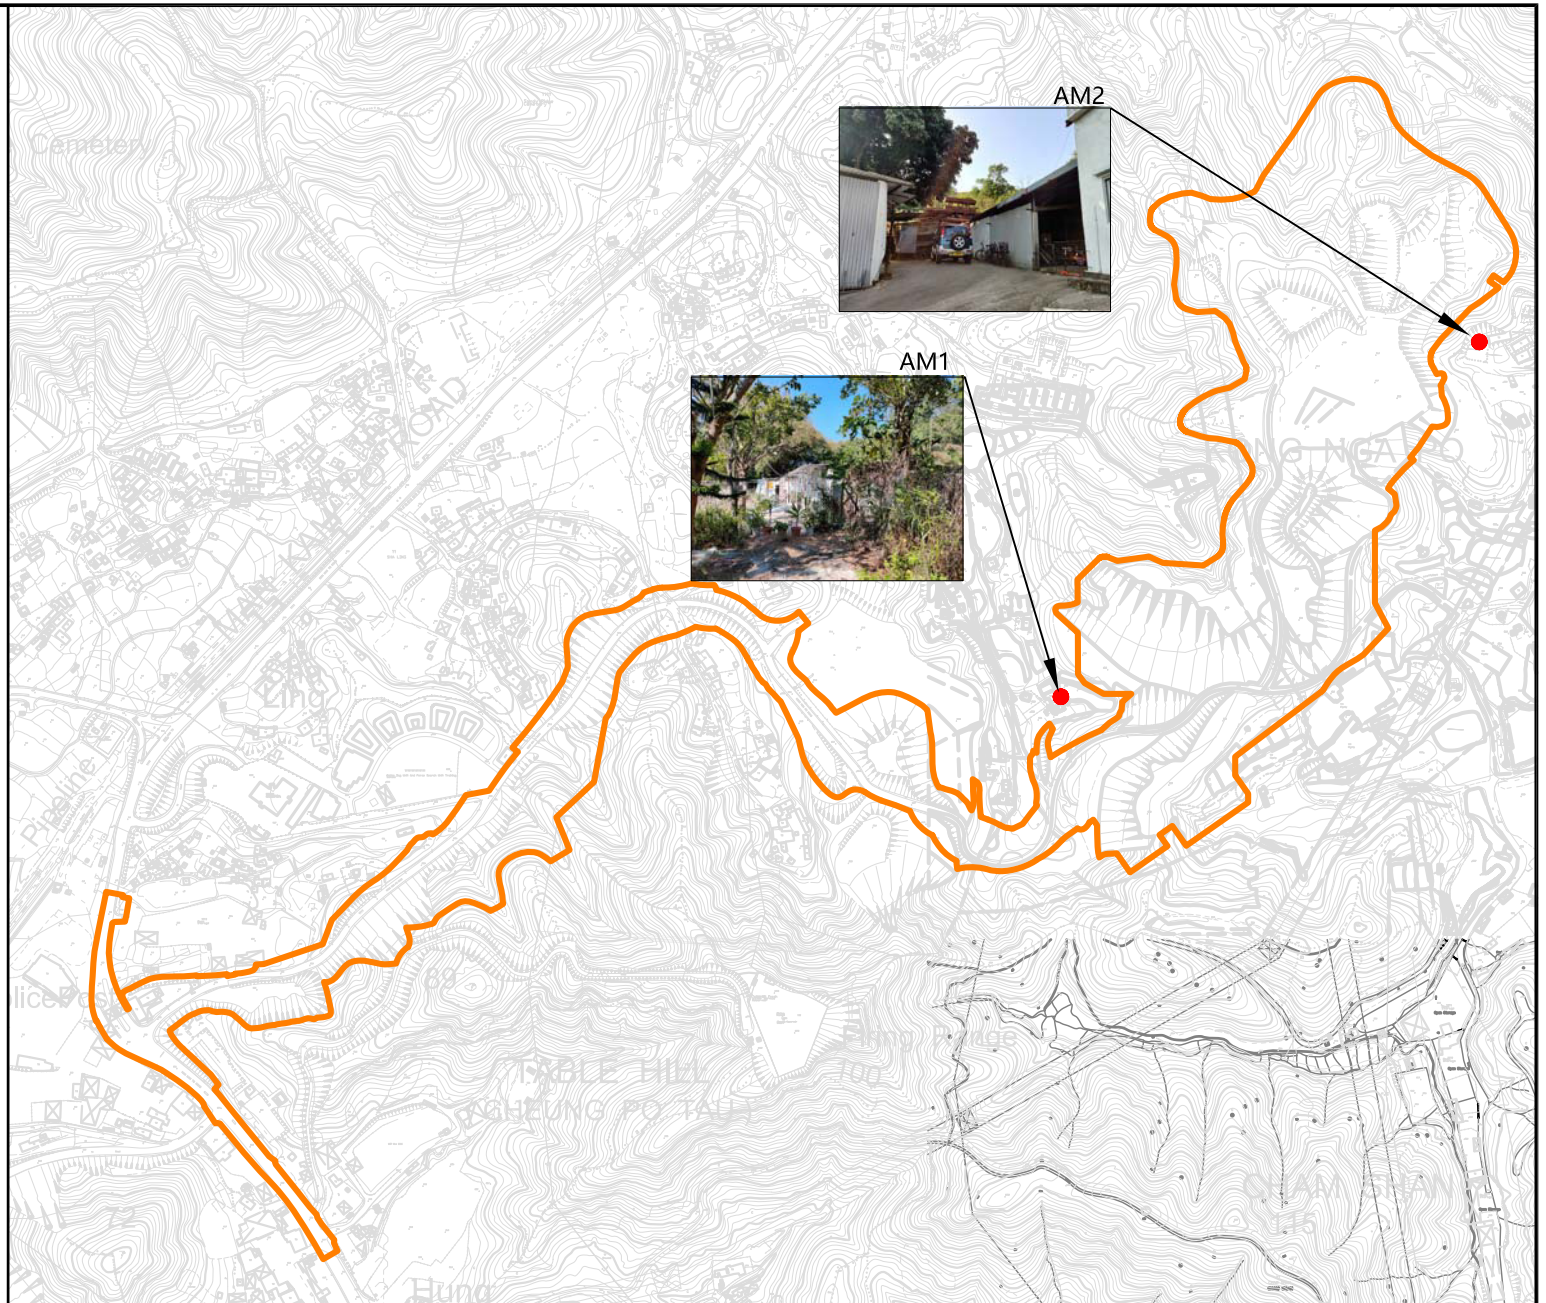
Air Quality Monitoring Stations

AIR QUALITY MONITORING STATIONS	
I.D	Description
AM1	Village House, Kong Nga Po
AM2	Village House, Kong Nga Po

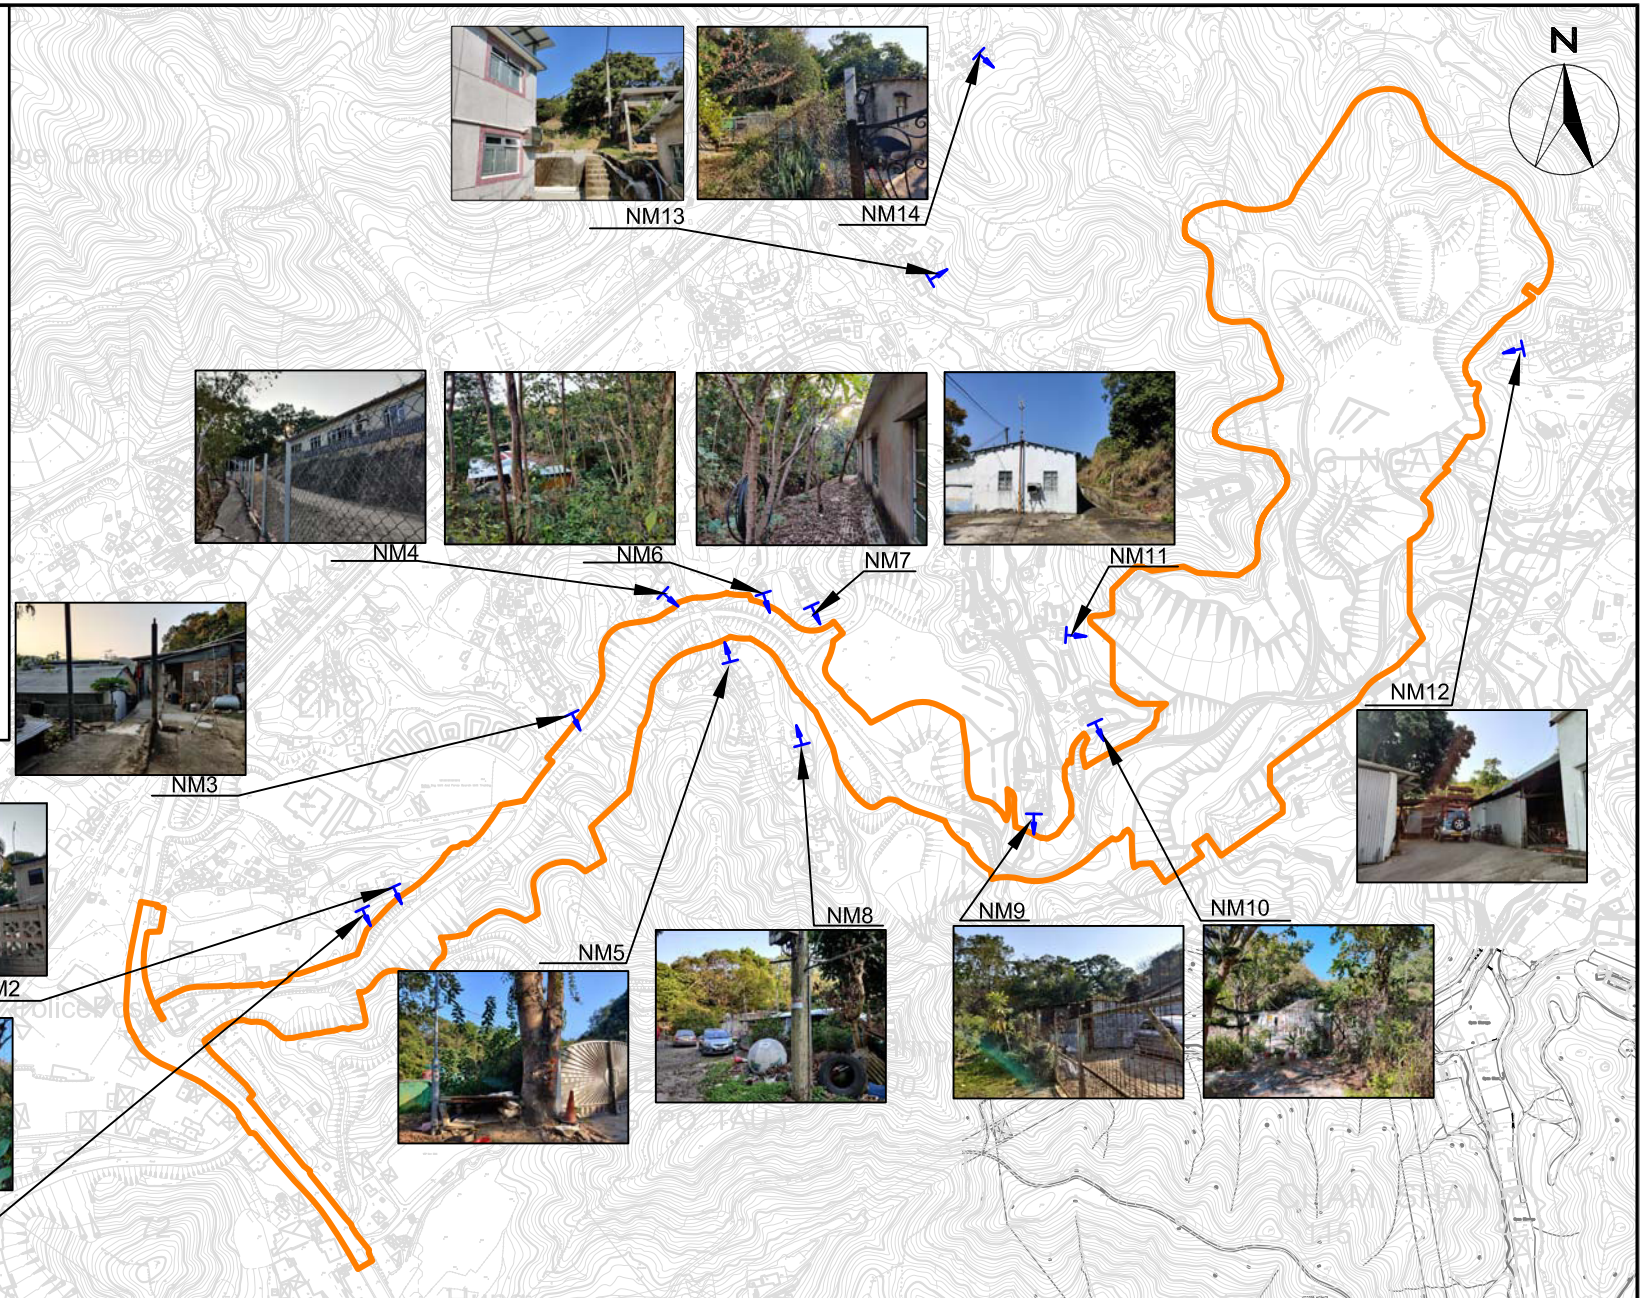
Service Contract No. NDO 07/2019
 Environmental Team for Site Formation and Infrastructure Works for Police Facilities in Kong Nga Po
Noise Monitoring Stations

NOISE MONITORING STATIONS	
I.D	Description
NM1	Village House, Sha Ling
NM2	Village House, Sha Ling
NM3	Village House No. 248, Sha Ling
NM4	Village House, Sha Ling
NM5	Village House No. 270, Sha Ling
NM6	Village House, Sha Ling
NM7	Village House, Sha Ling
NM8	Village House, Sha Ling
NM9	Village House, Kong Nga Po
NM10	Village House, Kong Nga Po
NM11	Village House, Kong Nga Po
NM12	Village House, Kong Nga Po
NM13	Village House, Kong Nga Po
NM14	Village House, near Man Kam To Road

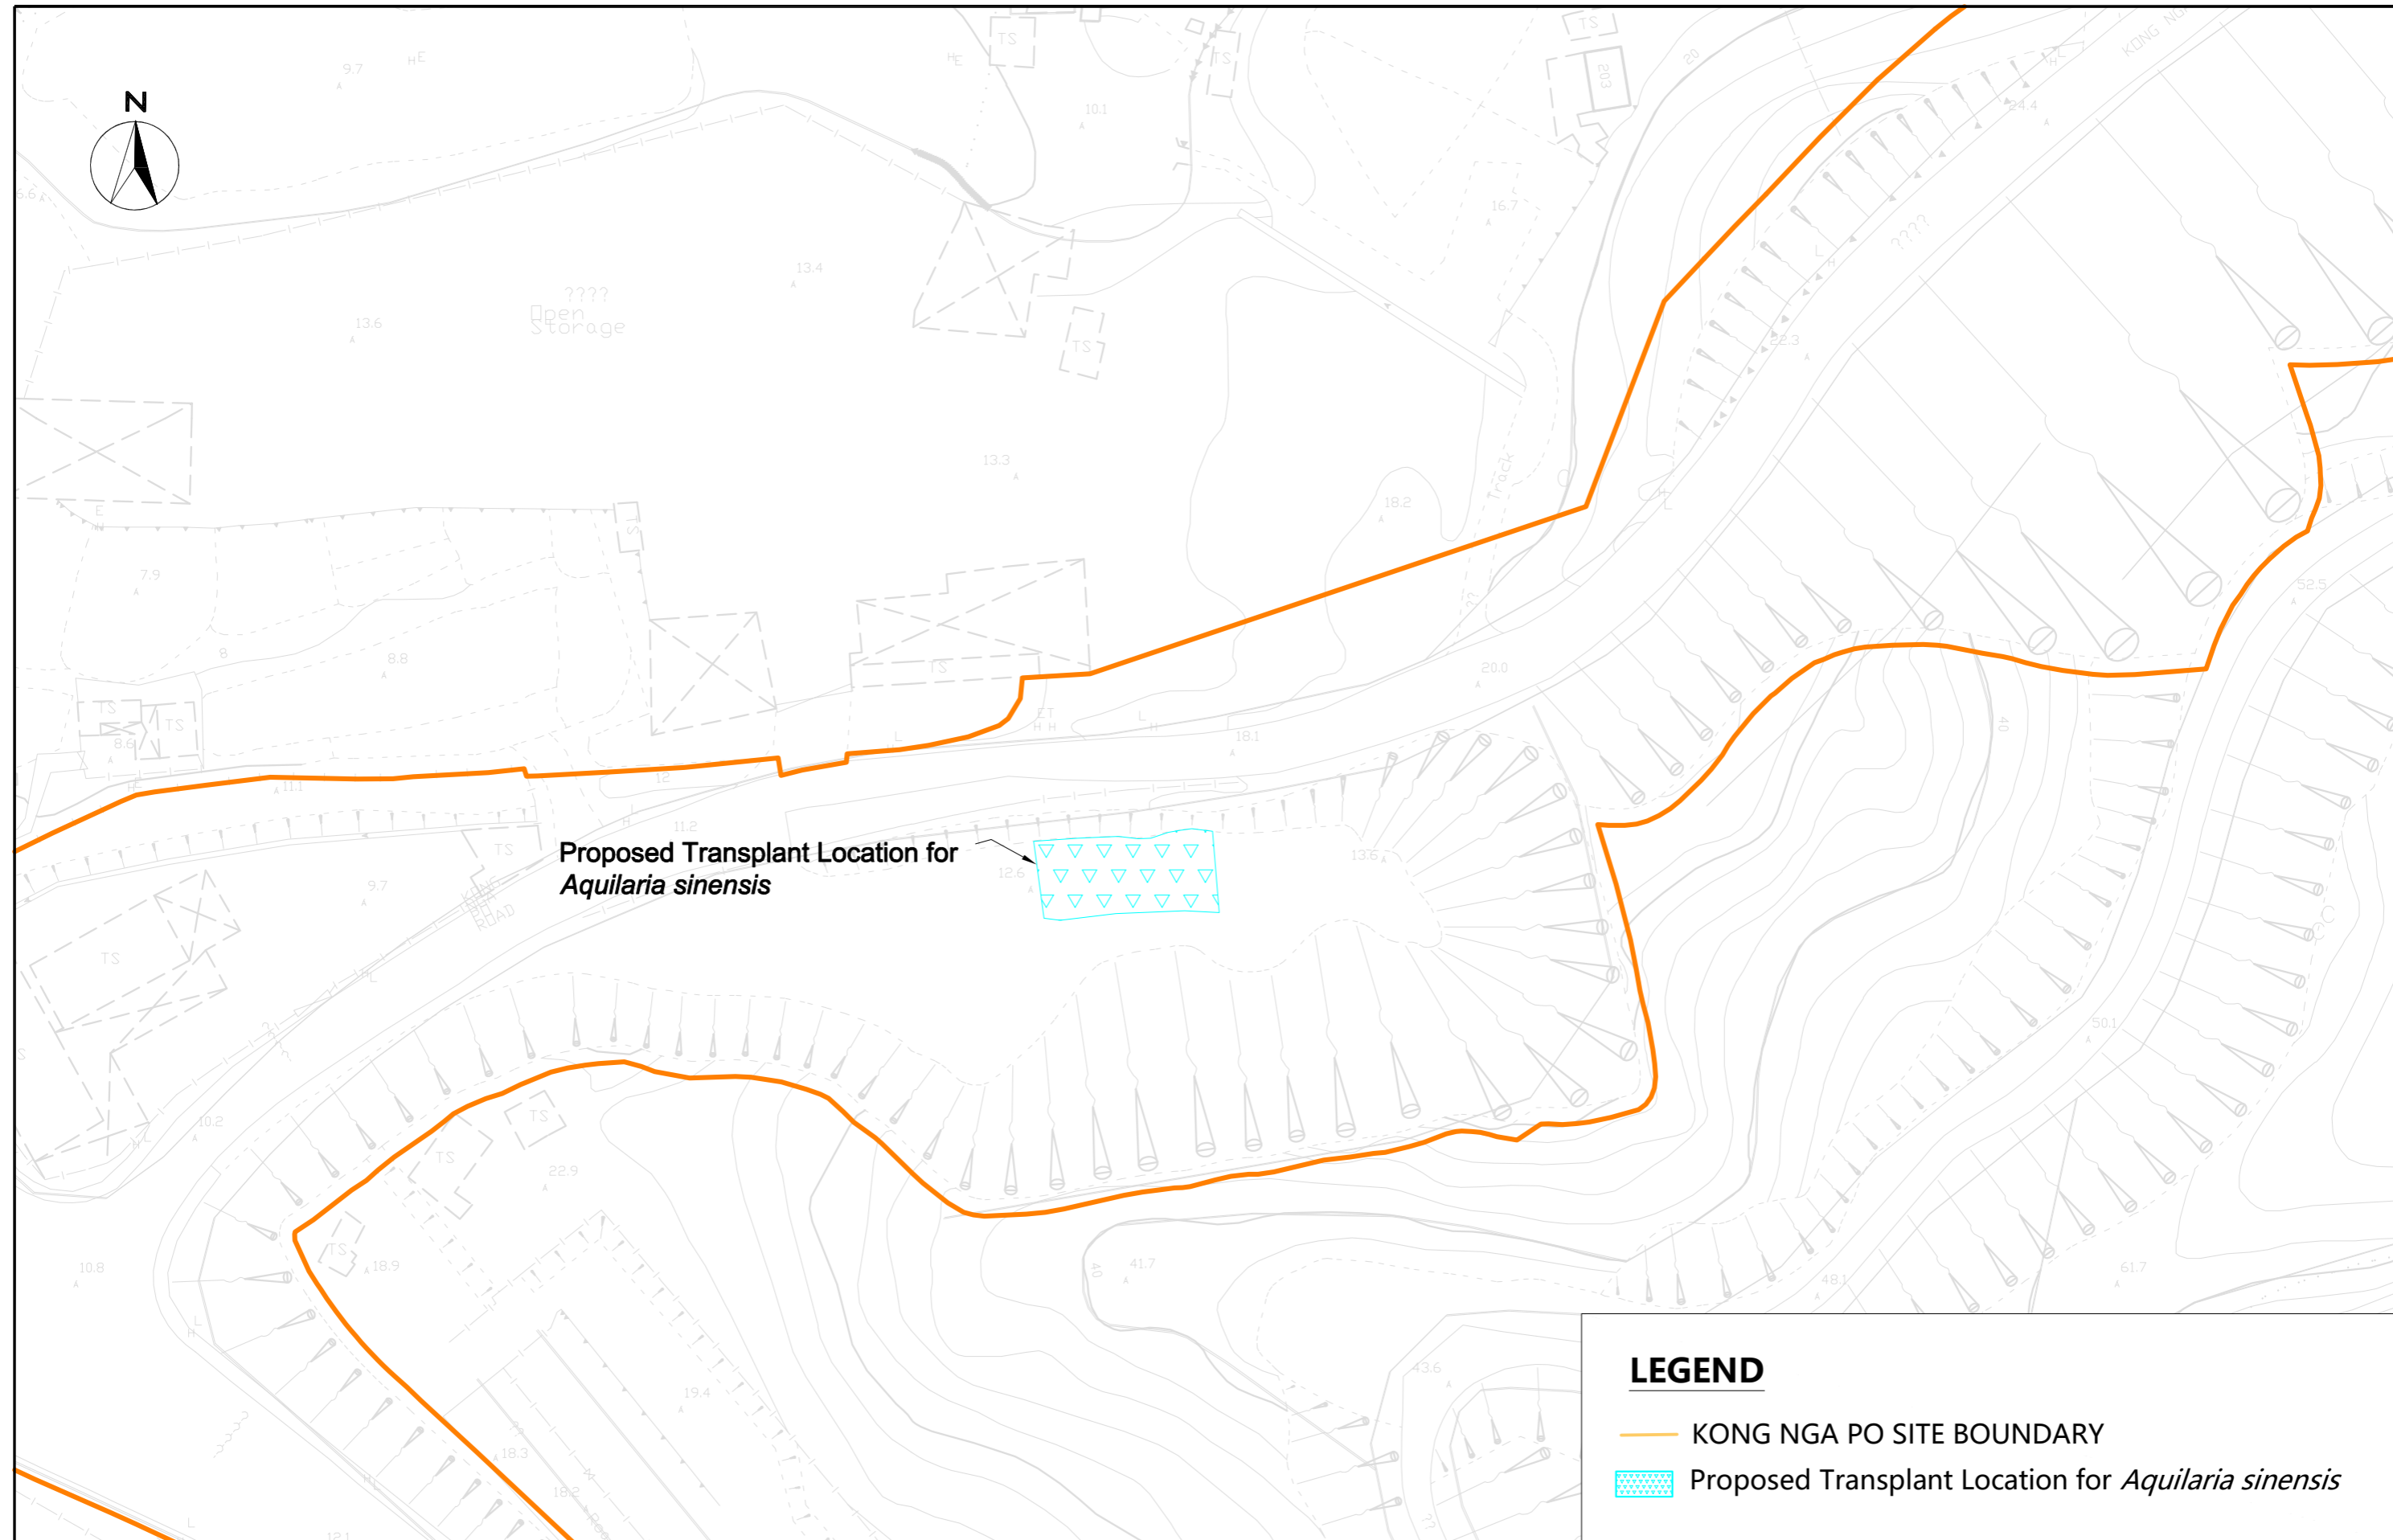
SCALE	A3 @1:5000	DATE	JUL 2020
CHECK	IT	DRAWN	NL
JOB No.	WMA20001	DRAWING No.	4B
		REV	—

Proposed Transplant Location for *Aquilaria sinensis*

- KONG NGA PO SITE BOUNDARY
- ▨ Proposed Transplant Location for *Aquilaria sinensis*

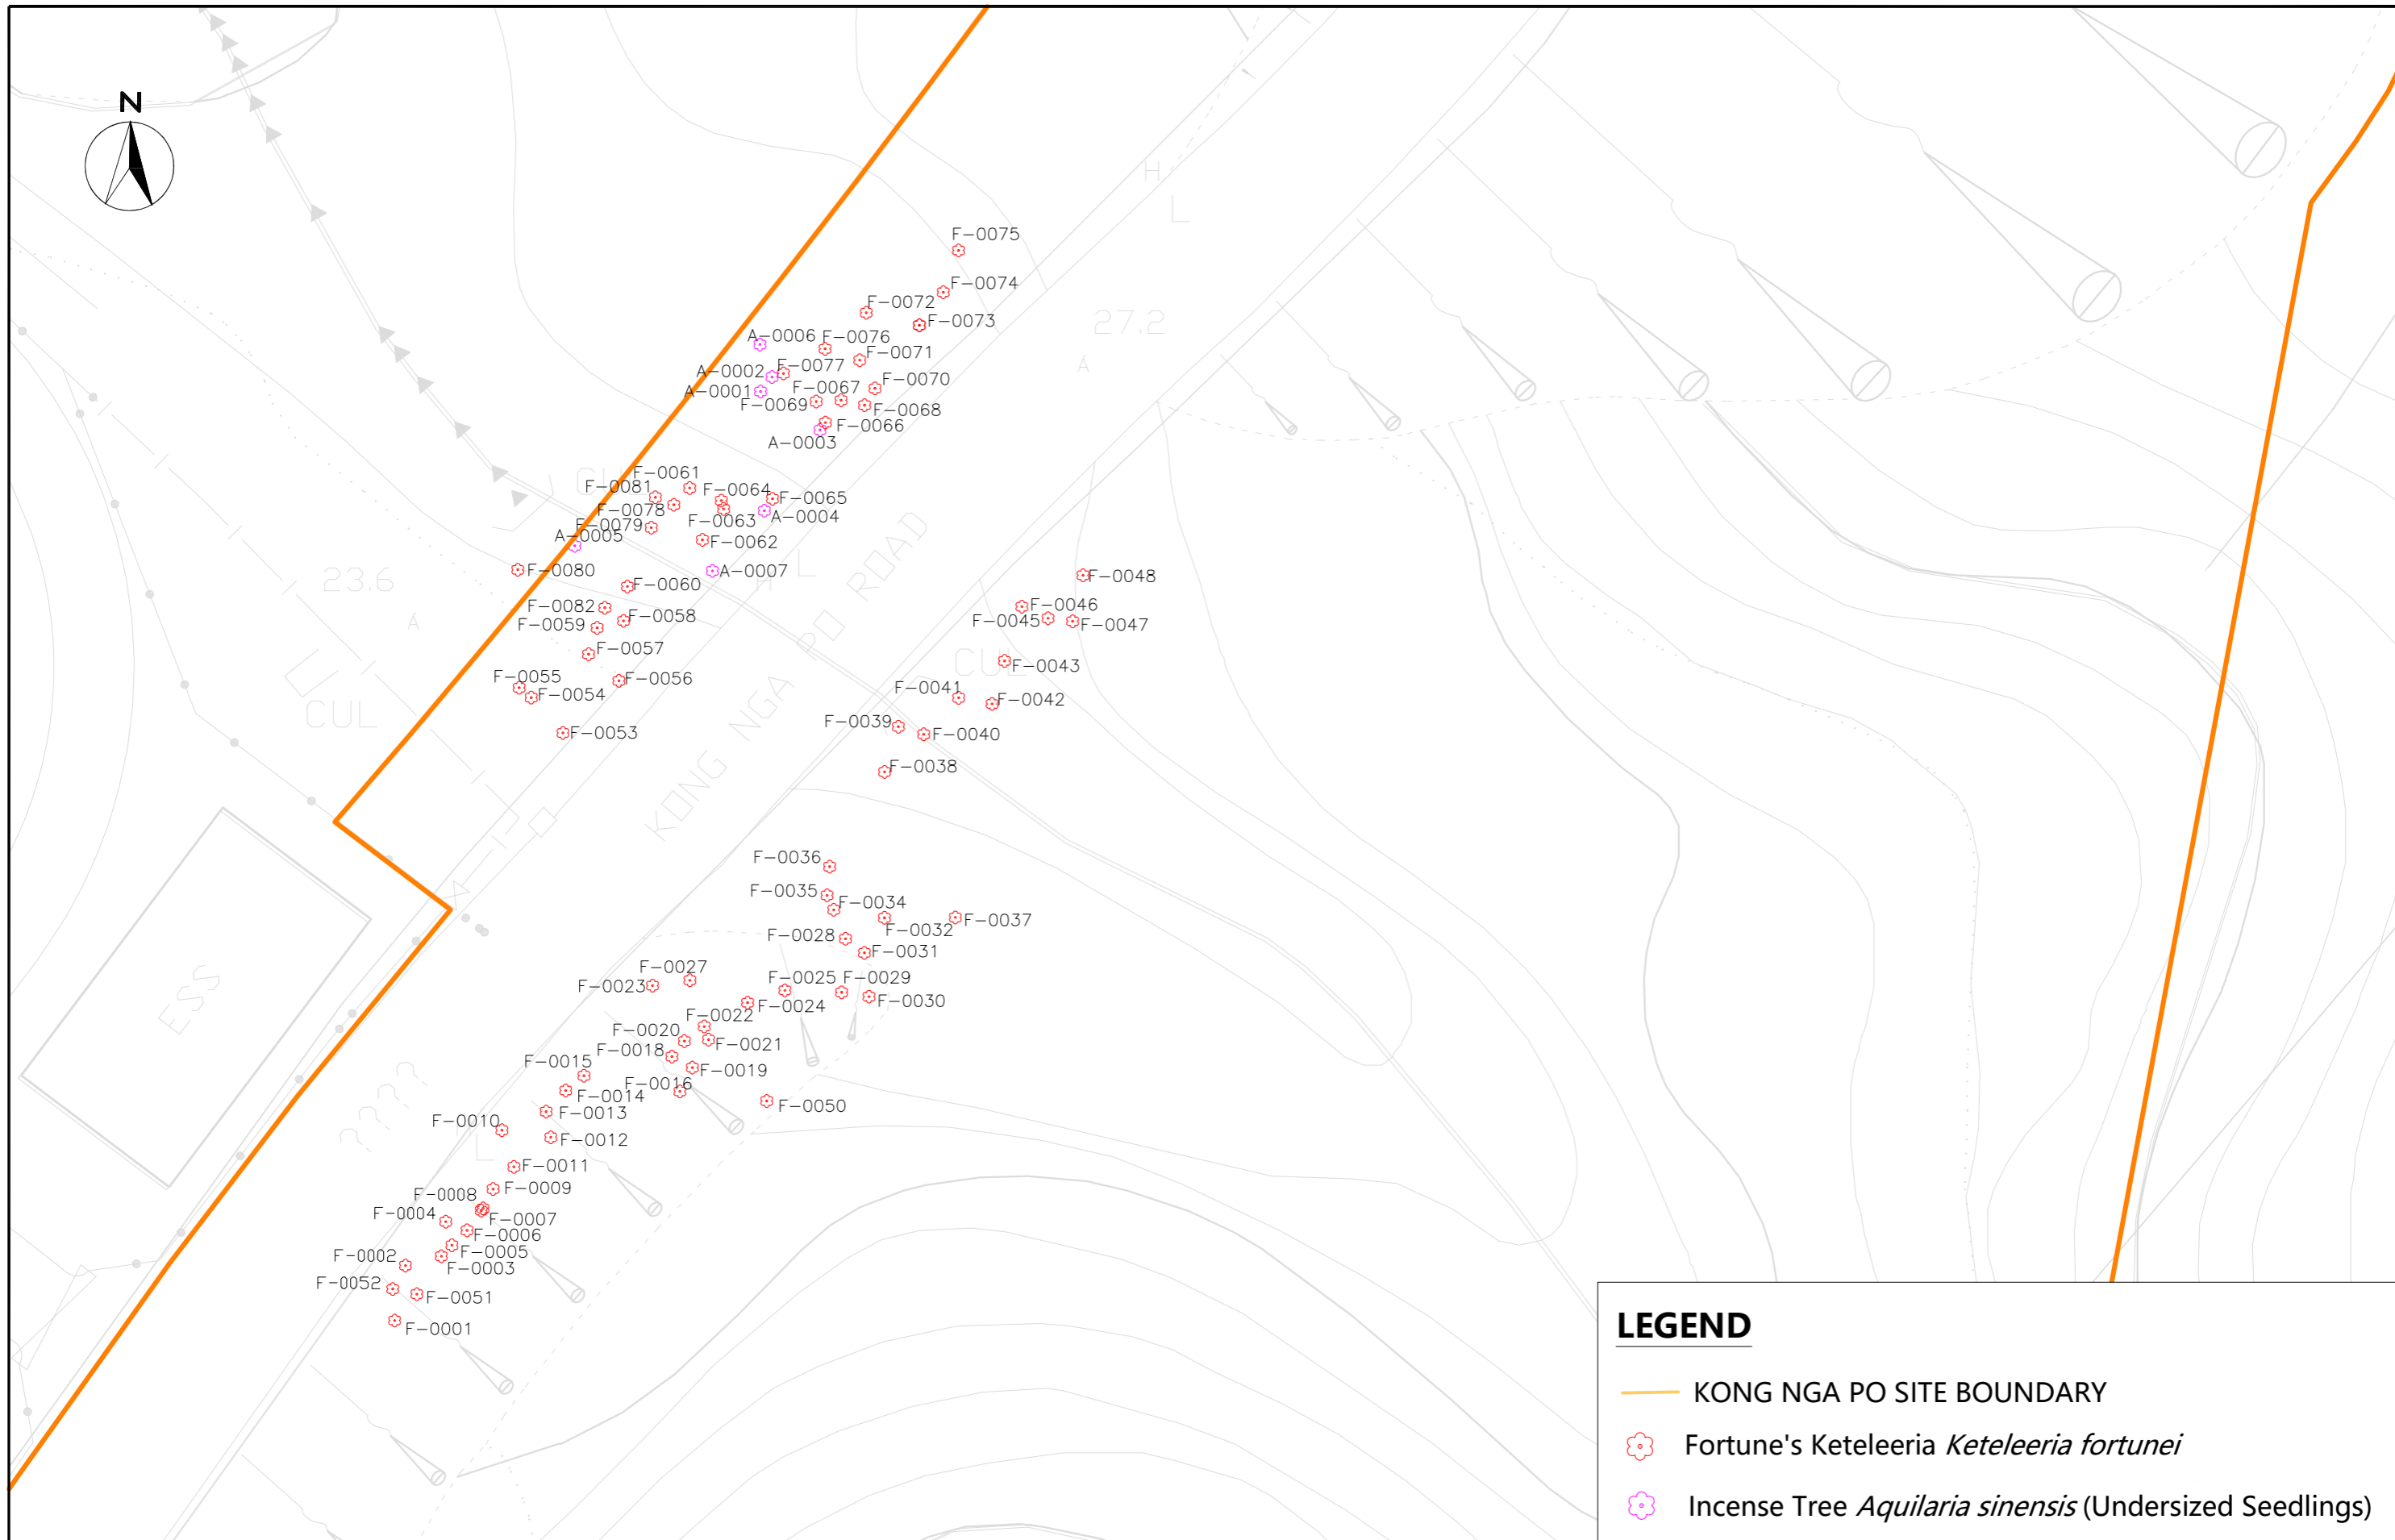
SCALE	A3 @1:2000	DATE	JUL 2020
CHECK	IT	DRAWN	NL
JOB No.	WMA20001	DRAWING No.	4C
		REV	—

Service Contract No. NDO 07/2019 Environmental Team for Site
 Formation and Infrastructure Works for Police Facilities in Kong Nga Po
 Location of Fortune's Keteleeria *Keteleeria fortunei* & Incense Tree *Aquilaria sinensis* (Undersized Seedlings)

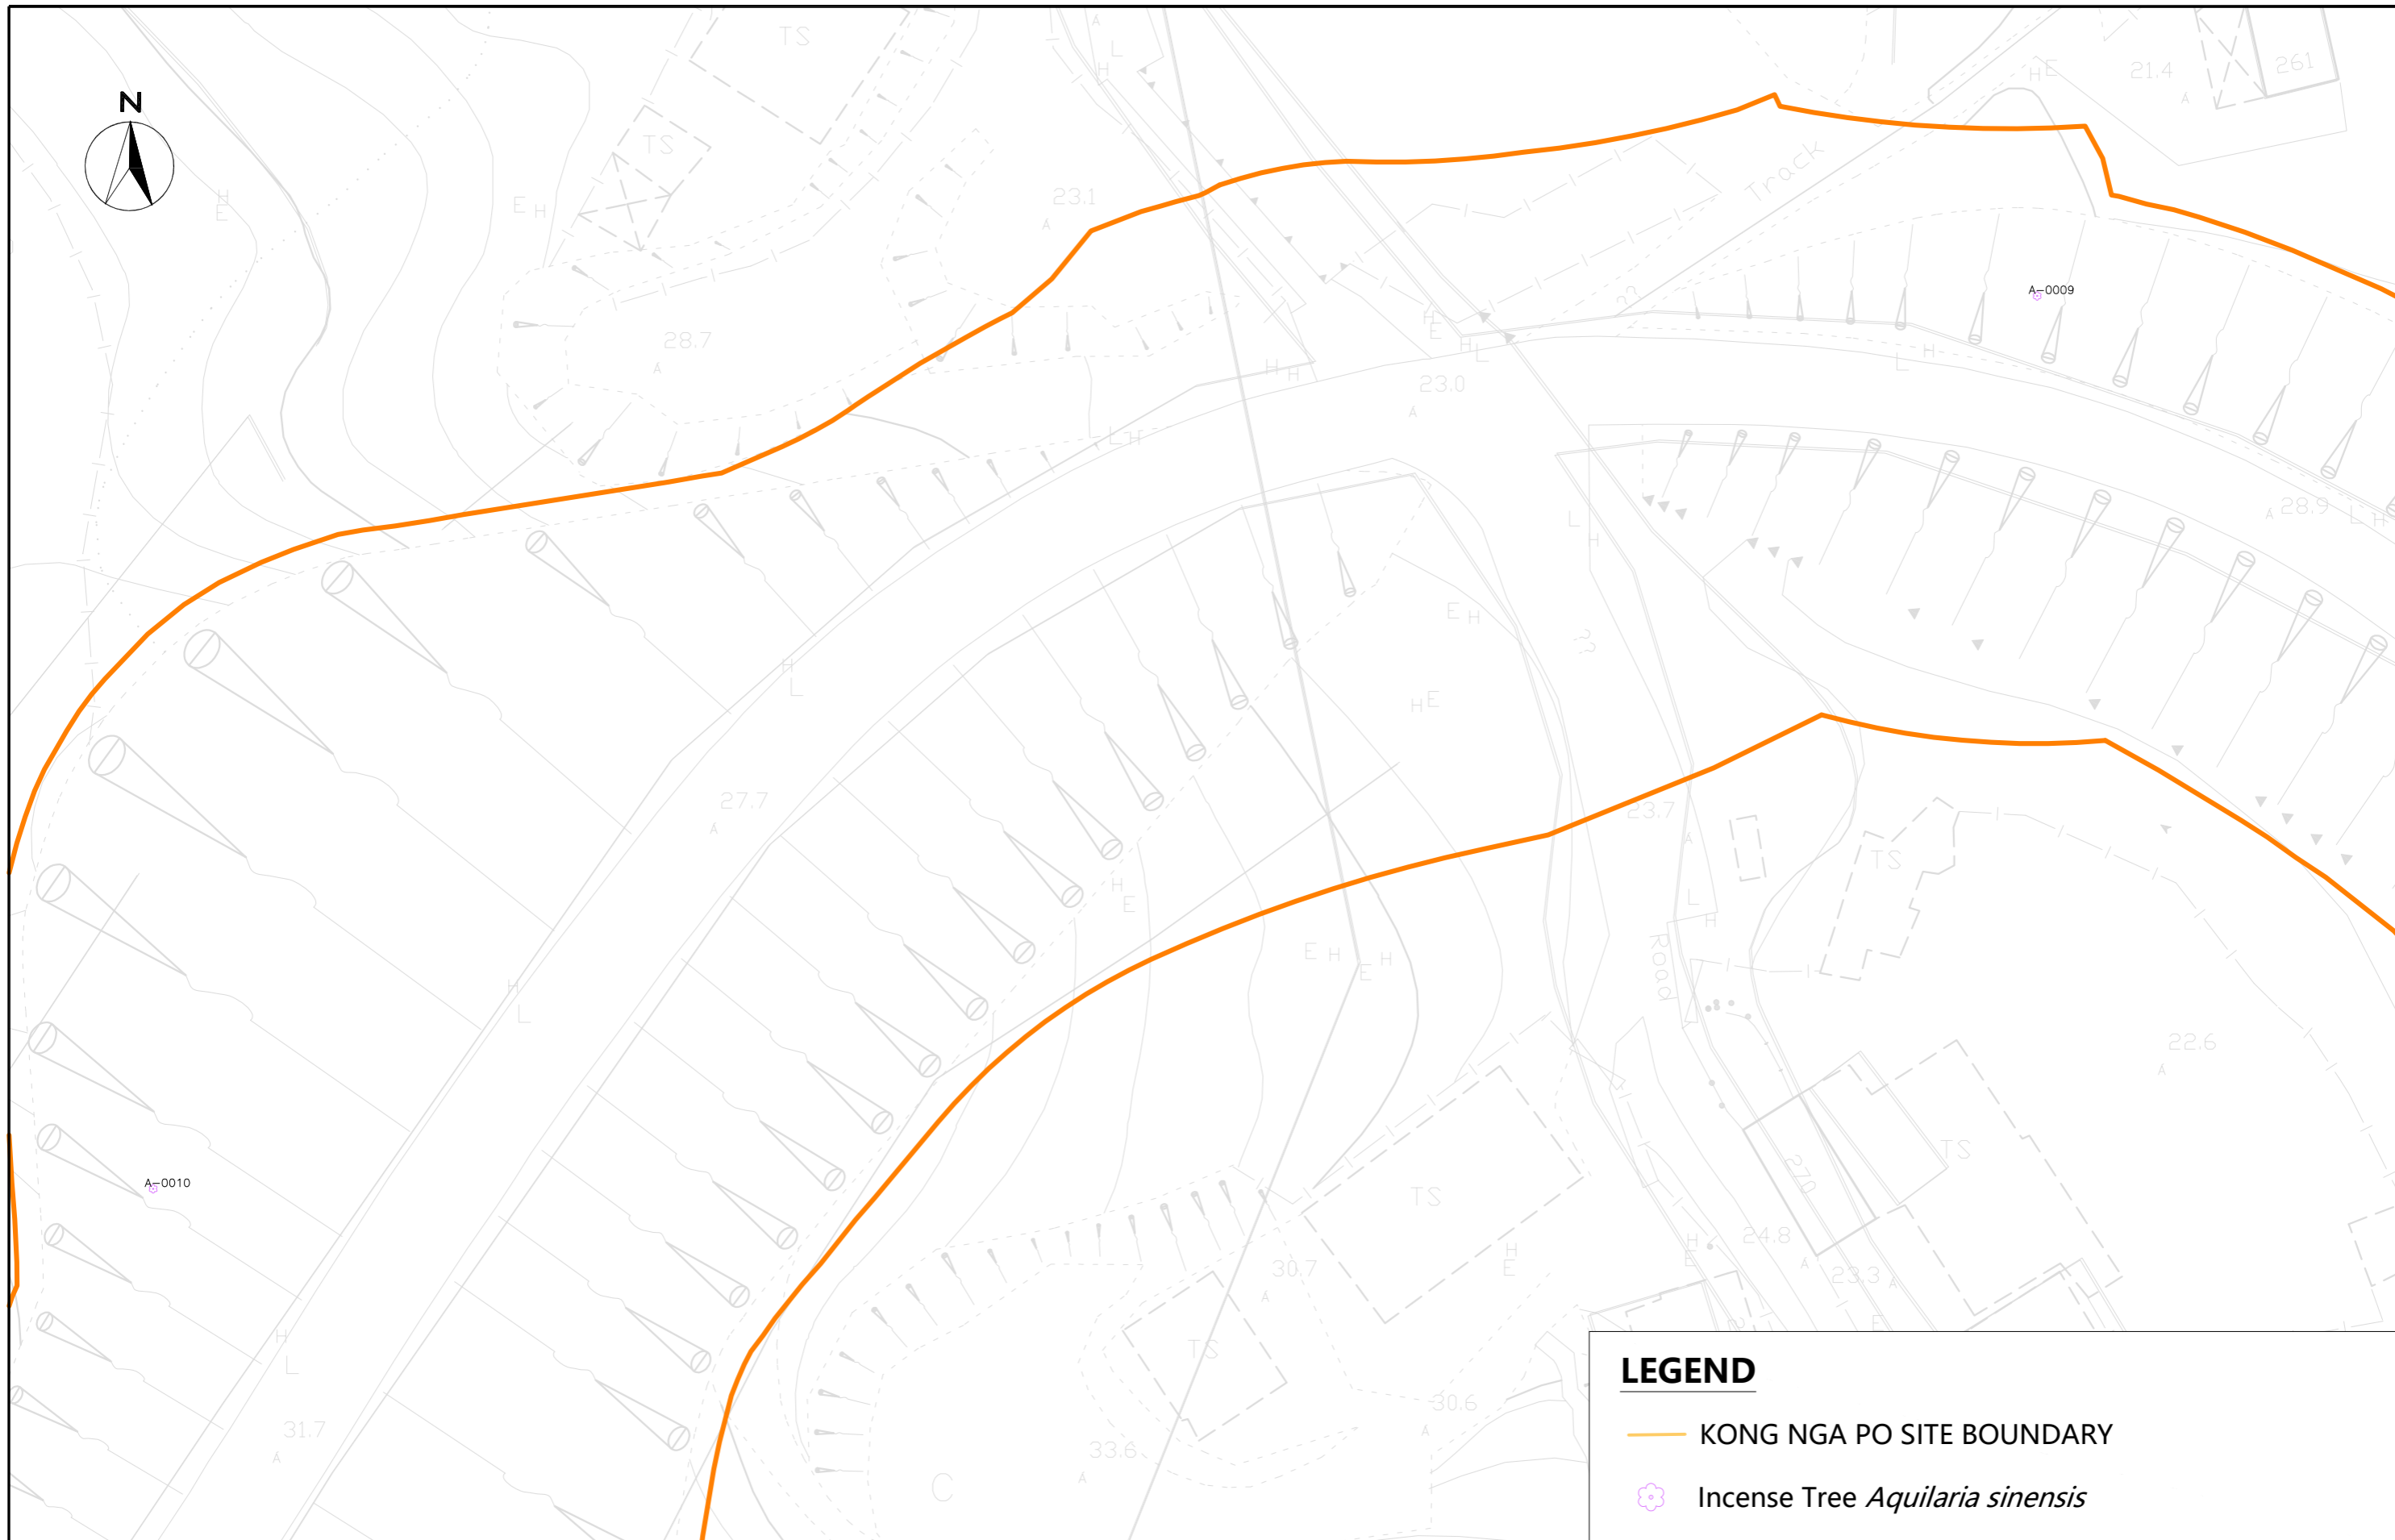
SCALE	A3 @1:3000	DATE	JUL 2020
CHECK	IT	DRAWN	NL
JOB No.	WMA20001	DRAWING No.	4D
		REV	—

Service Contract No. NDO 07/2019 Environmental Team for Site
 Formation and Infrastructure Works for Police Facilities in Kong Nga Po
 Location of Incense Tree *Aquilaria sinensis*

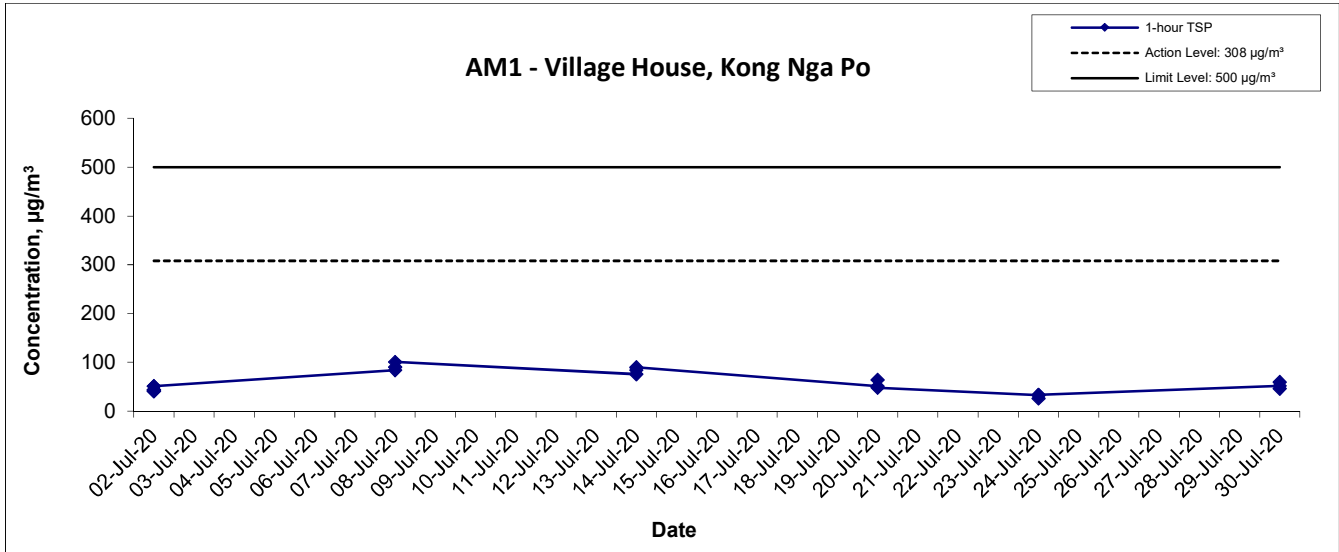
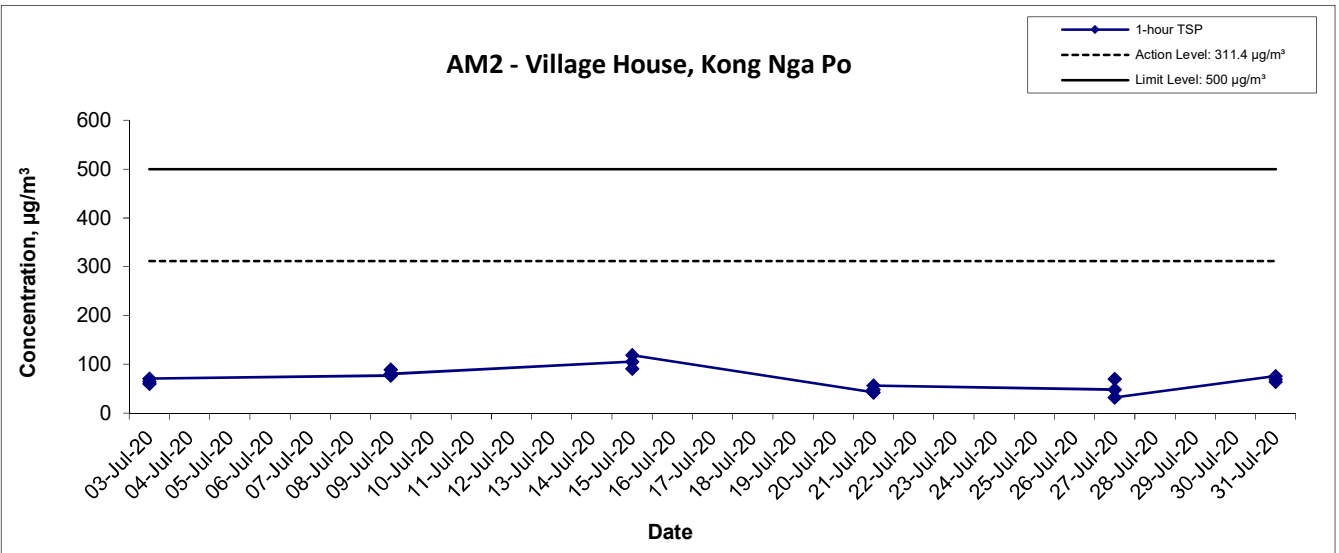
1-hr TSP Concentration Levels

Location AM2 - Village House, Kong Nga Po			
Date	Time	Weather	Particulate Concentration ($\mu\text{g}/\text{m}^3$)
3-Jul-20	8:45	Cloudy	60.3
3-Jul-20	9:45	Cloudy	65.2
3-Jul-20	10:45	Cloudy	70.9
9-Jul-20	13:00	Cloudy	77.2
9-Jul-20	14:00	Cloudy	89.5
9-Jul-20	15:00	Cloudy	80.1
15-Jul-20	9:00	Sunny	105.5
15-Jul-20	10:00	Sunny	91.4
15-Jul-20	11:00	Sunny	118.8
21-Jul-20	8:35	Fine	42.2
21-Jul-20	9:35	Fine	48.2
21-Jul-20	10:35	Fine	56.7
27-Jul-20	13:00	Cloudy	48.5
27-Jul-20	14:00	Cloudy	70.2
27-Jul-20	15:00	Cloudy	32.2
31-Jul-20	9:00	Cloudy	75.6
31-Jul-20	10:00	Cloudy	64.5
31-Jul-20	11:00	Cloudy	69.6
		Minimum	32.2
		Maximum	118.8
		Average	70.4

Title Service Contract No. NDO 07/2019 Environmental Team for Site Formation and Infrastructure Works for Police Facilities in Kong Nga Po Graphical Presentation of 1-hour TSP Monitoring Results	Scale N.T.S	Project No. WMA20001

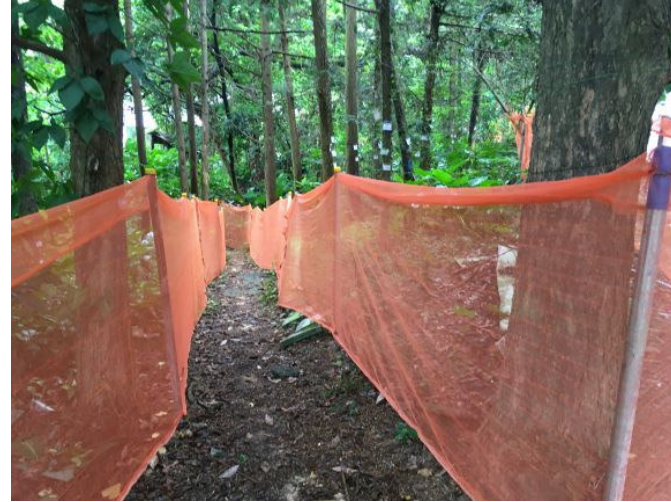
Photo 16

Description: Protective fence for undersized seedling of *Aquilaria sinensis* are properly erected.
