**EP-510/2016 – Police Facilities in Kong Nga Po**

**Service Contract No. NDO 07/2019  
Environmental Team for Site Formation and  
Infrastructure Works for Police Facilities in  
Kong Nga Po**

**Quarterly Environmental Monitoring and  
Audit Report for July to September 2020  
(Version 1.0)**

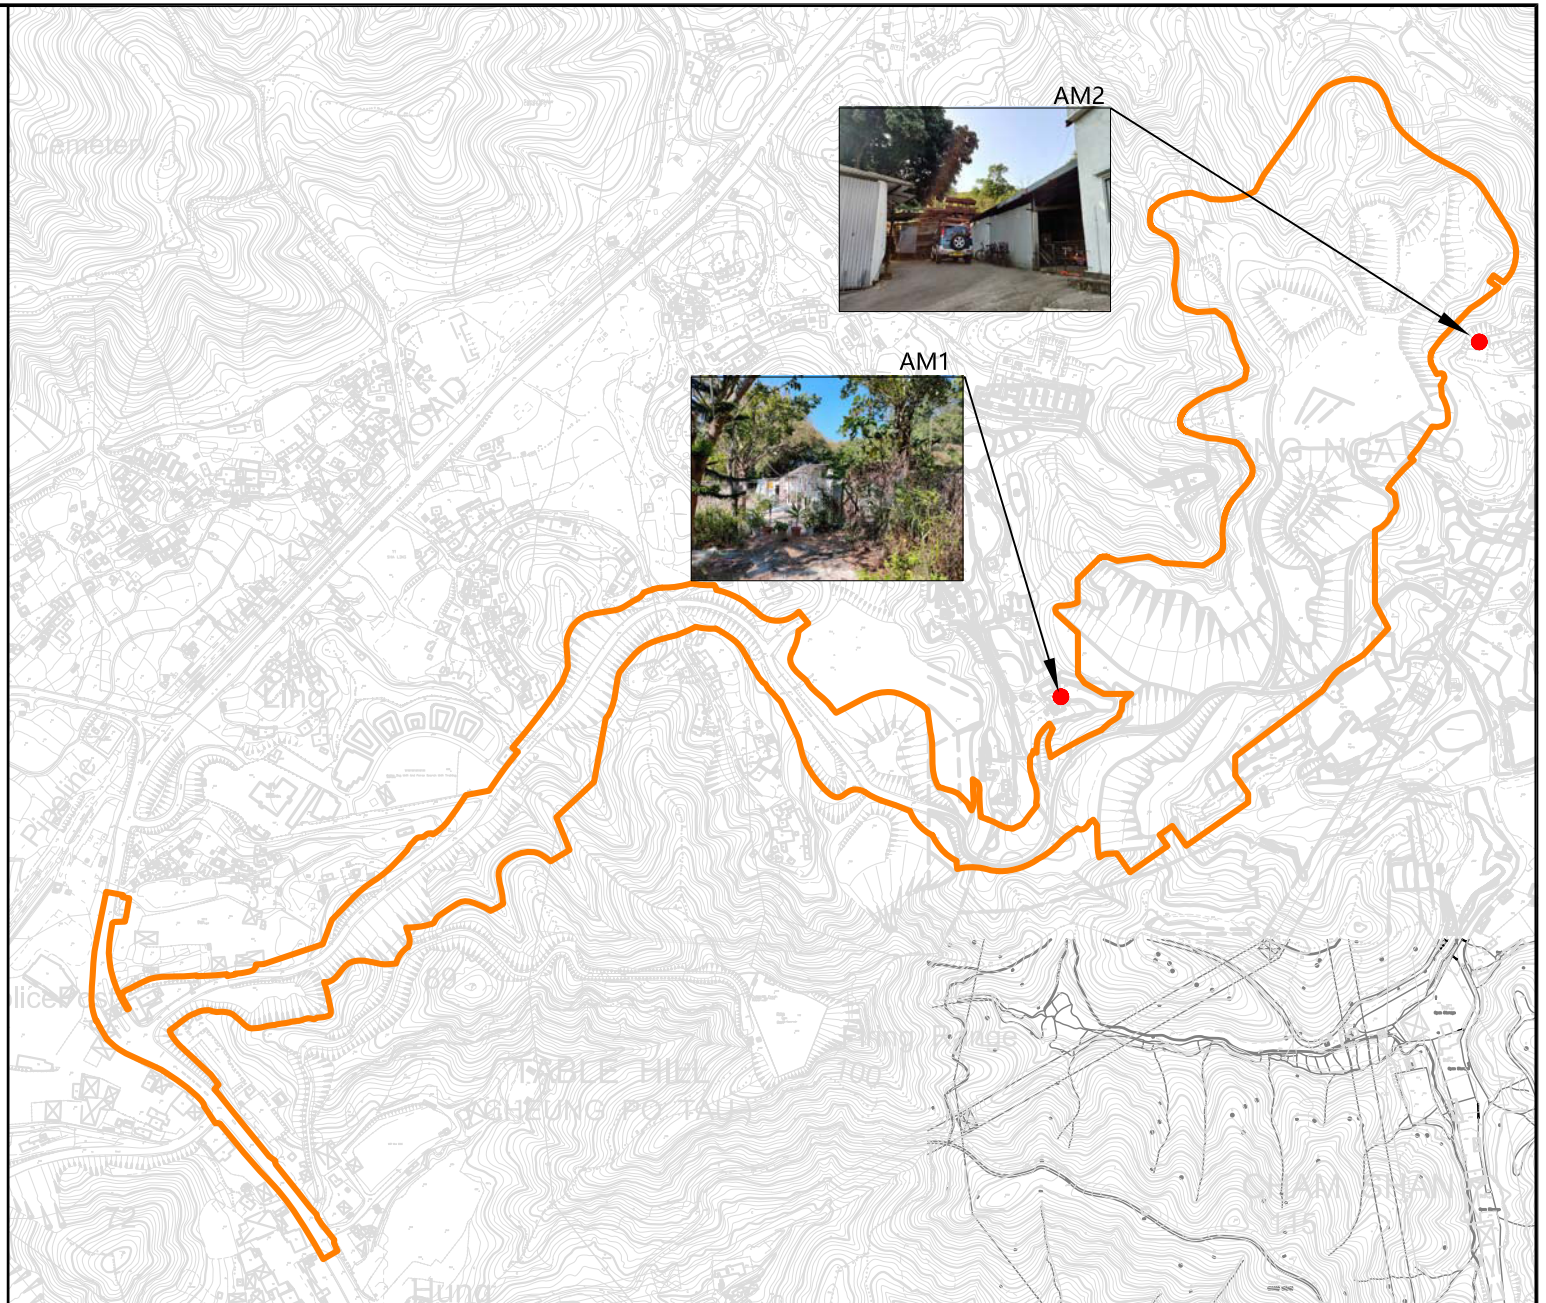
**Air Quality Monitoring Stations**

AIR QUALITY MONITORING STATIONS	
I.D	Description
AM1	Village House, Kong Nga Po
AM2	Village House, Kong Nga Po

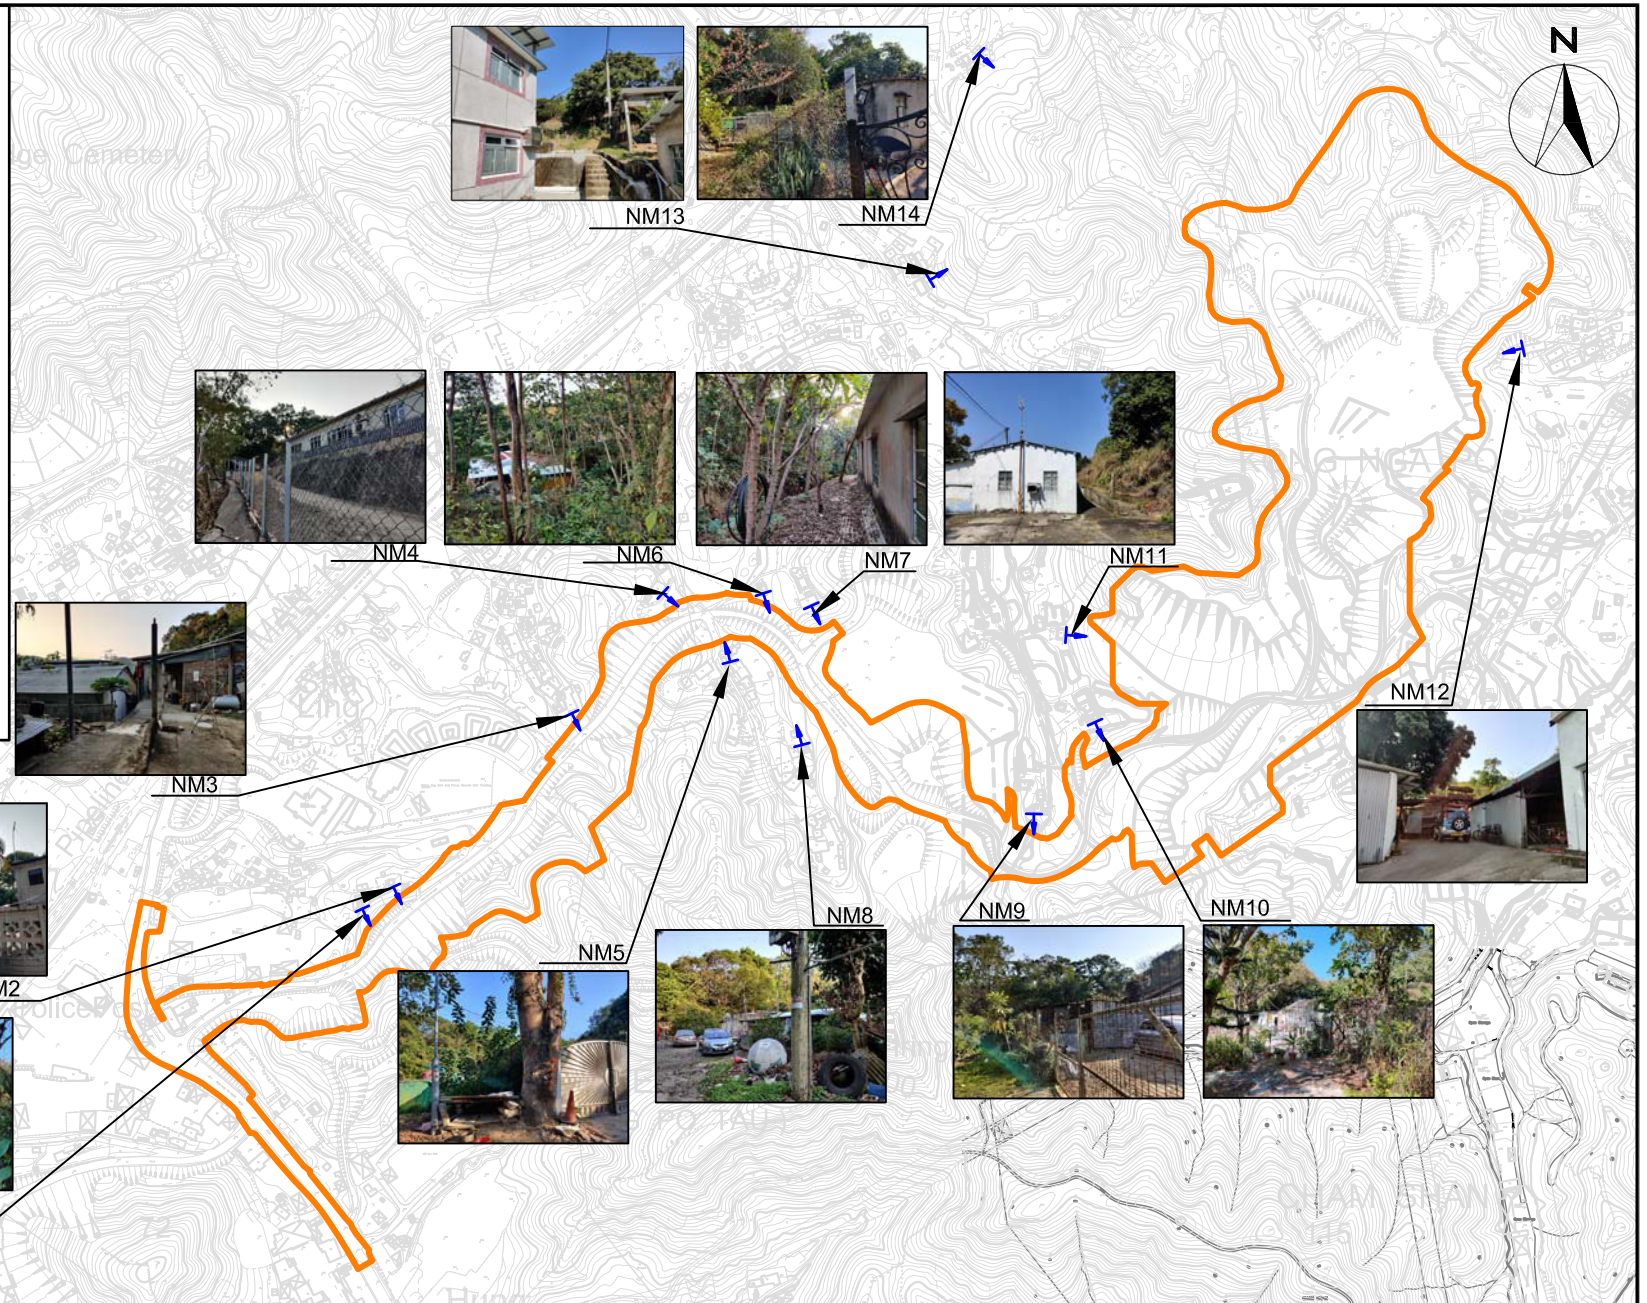
Service Contract No. NDO 07/2019  
 Environmental Team for Site Formation and Infrastructure Works for Police Facilities in Kong Nga Po  
**Noise Monitoring Stations**

NOISE MONITORING STATIONS	
I.D	Description
NM1	Village House, Sha Ling
NM2	Village House, Sha Ling
NM3	Village House No. 248, Sha Ling
NM4	Village House, Sha Ling
NM5	Village House No. 270, Sha Ling
NM6	Village House, Sha Ling
NM7	Village House, Sha Ling
NM8	Village House, Sha Ling
NM9	Village House, Kong Nga Po
NM10	Village House, Kong Nga Po
NM11	Village House, Kong Nga Po
NM12	Village House, Kong Nga Po
NM13	Village House, Kong Nga Po
NM14	Village House, near Man Kam To Road
