EP-510/2016 – Police Facilities in Kong Nga Po

**Service Contract No. NDO 07/2019
Environmental Team for Site Formation and
Infrastructure Works for Police Facilities in
Kong Nga Po**

**Quarterly Environmental Monitoring and
Audit Report for October to December 2020
(Version 1.0)**

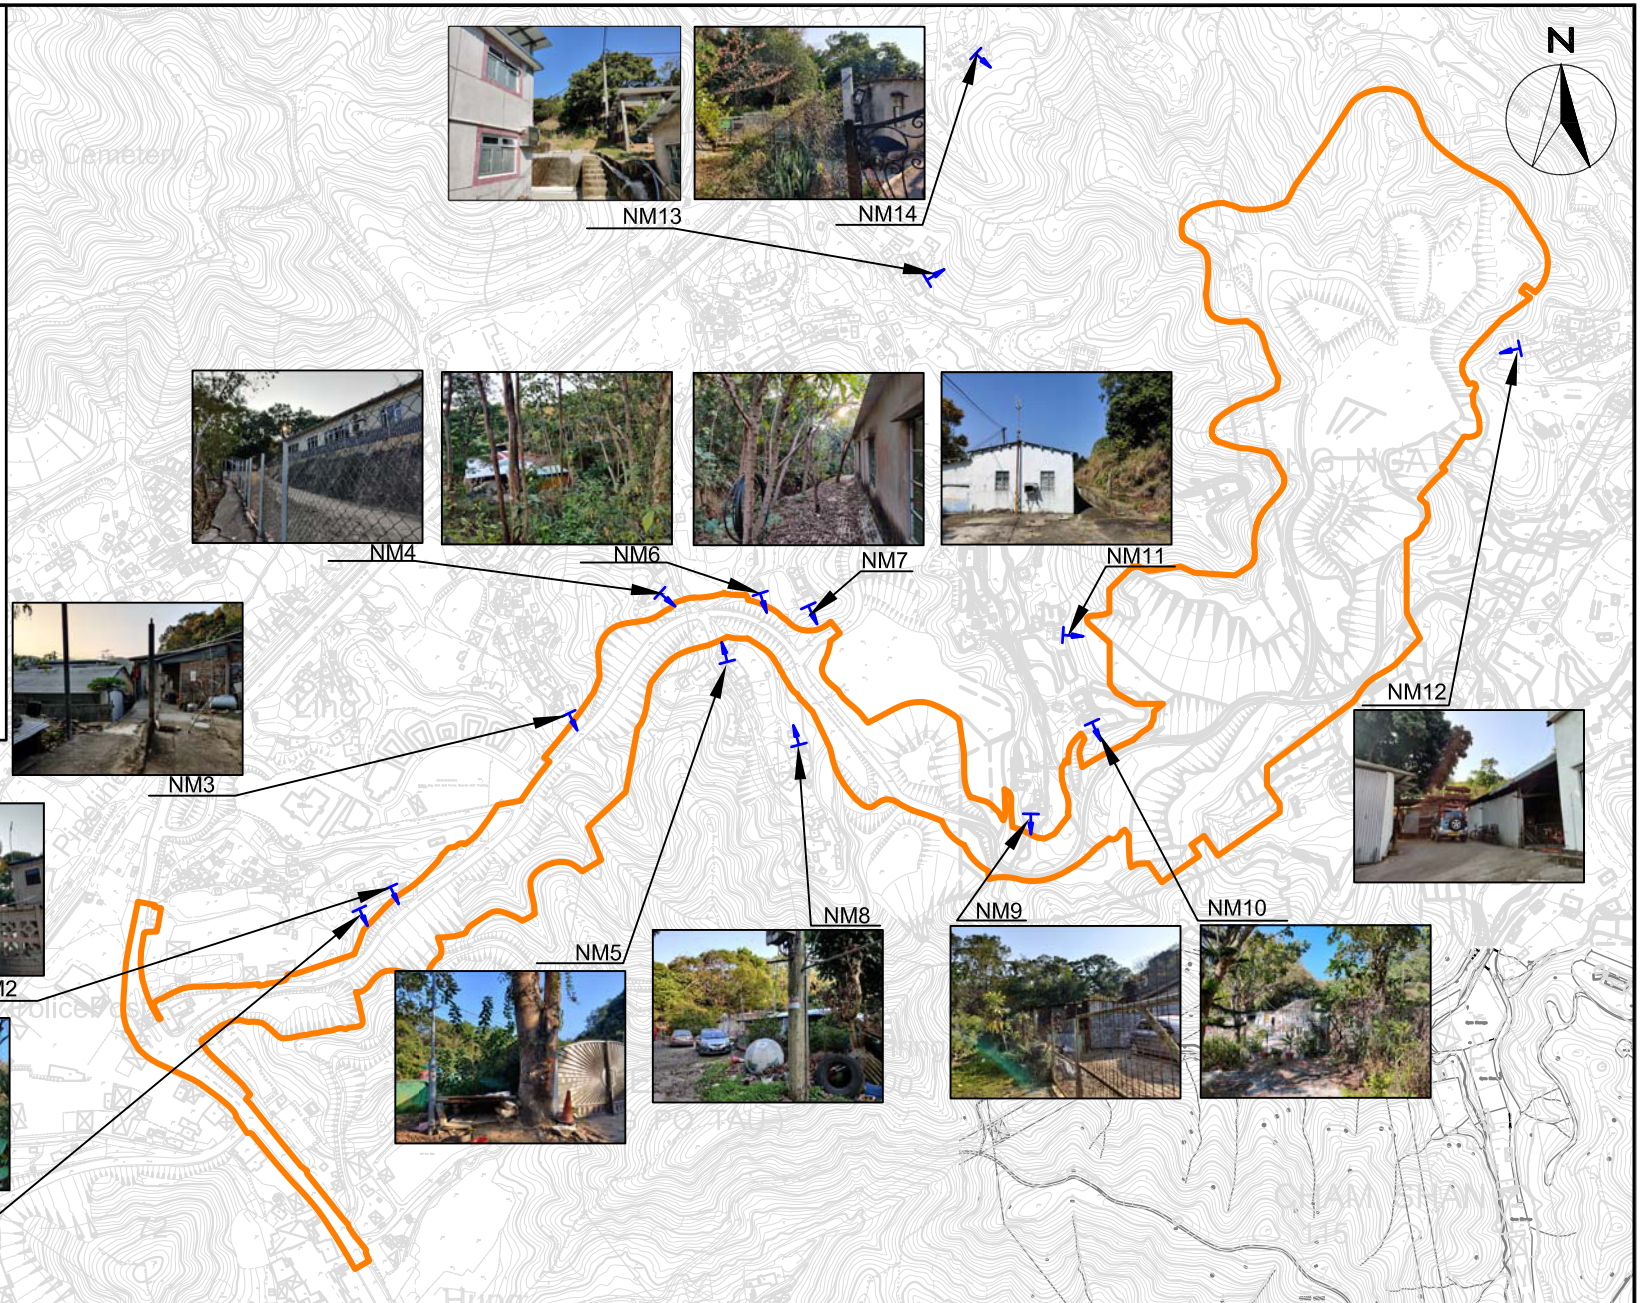
Noise Monitoring Stations

NOISE MONITORING STATIONS	
I.D	Description
NM1	Village House, Sha Ling
NM2	Village House, Sha Ling
NM3	Village House No. 248, Sha Ling
NM4	Village House, Sha Ling
NM5	Village House No. 270, Sha Ling
NM6	Village House, Sha Ling
NM7	Village House, Sha Ling
NM8	Village House, Sha Ling
NM9	Village House, Kong Nga Po
NM10	Village House, Kong Nga Po
NM11	Village House, Kong Nga Po
NM12	Village House, Kong Nga Po
NM13	Village House, Kong Nga Po
NM14	Village House, near Man Kam To Road

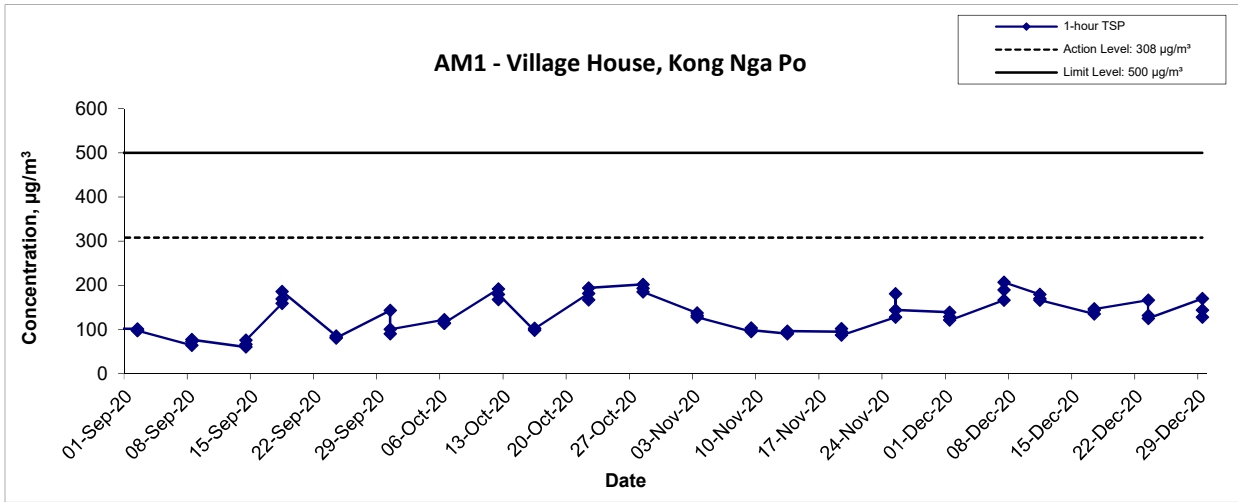
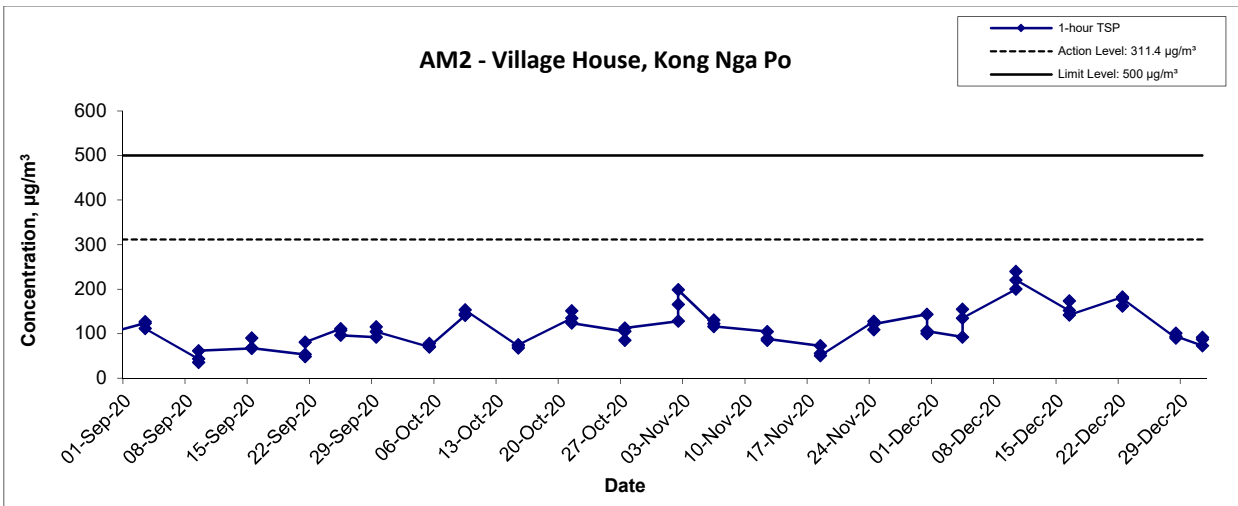
1-hr TSP Concentration Levels

Title Service Contract No. NDO 07/2019
 Environmental Team for Site Formation and Infrastructure Works for
 Police Facilities in Kong Nga Po
 Graphical Presentation of 1-hour TSP Monitoring Results
