EP-510/2016 – Police Facilities in Kong Nga Po

**Service Contract No. NDO 07/2019
Environmental Team for Site Formation and
Infrastructure Works for Police Facilities in
Kong Nga Po**

**Quarterly Environmental Monitoring and
Audit Report for January to March 2021
(Version 1.0)**

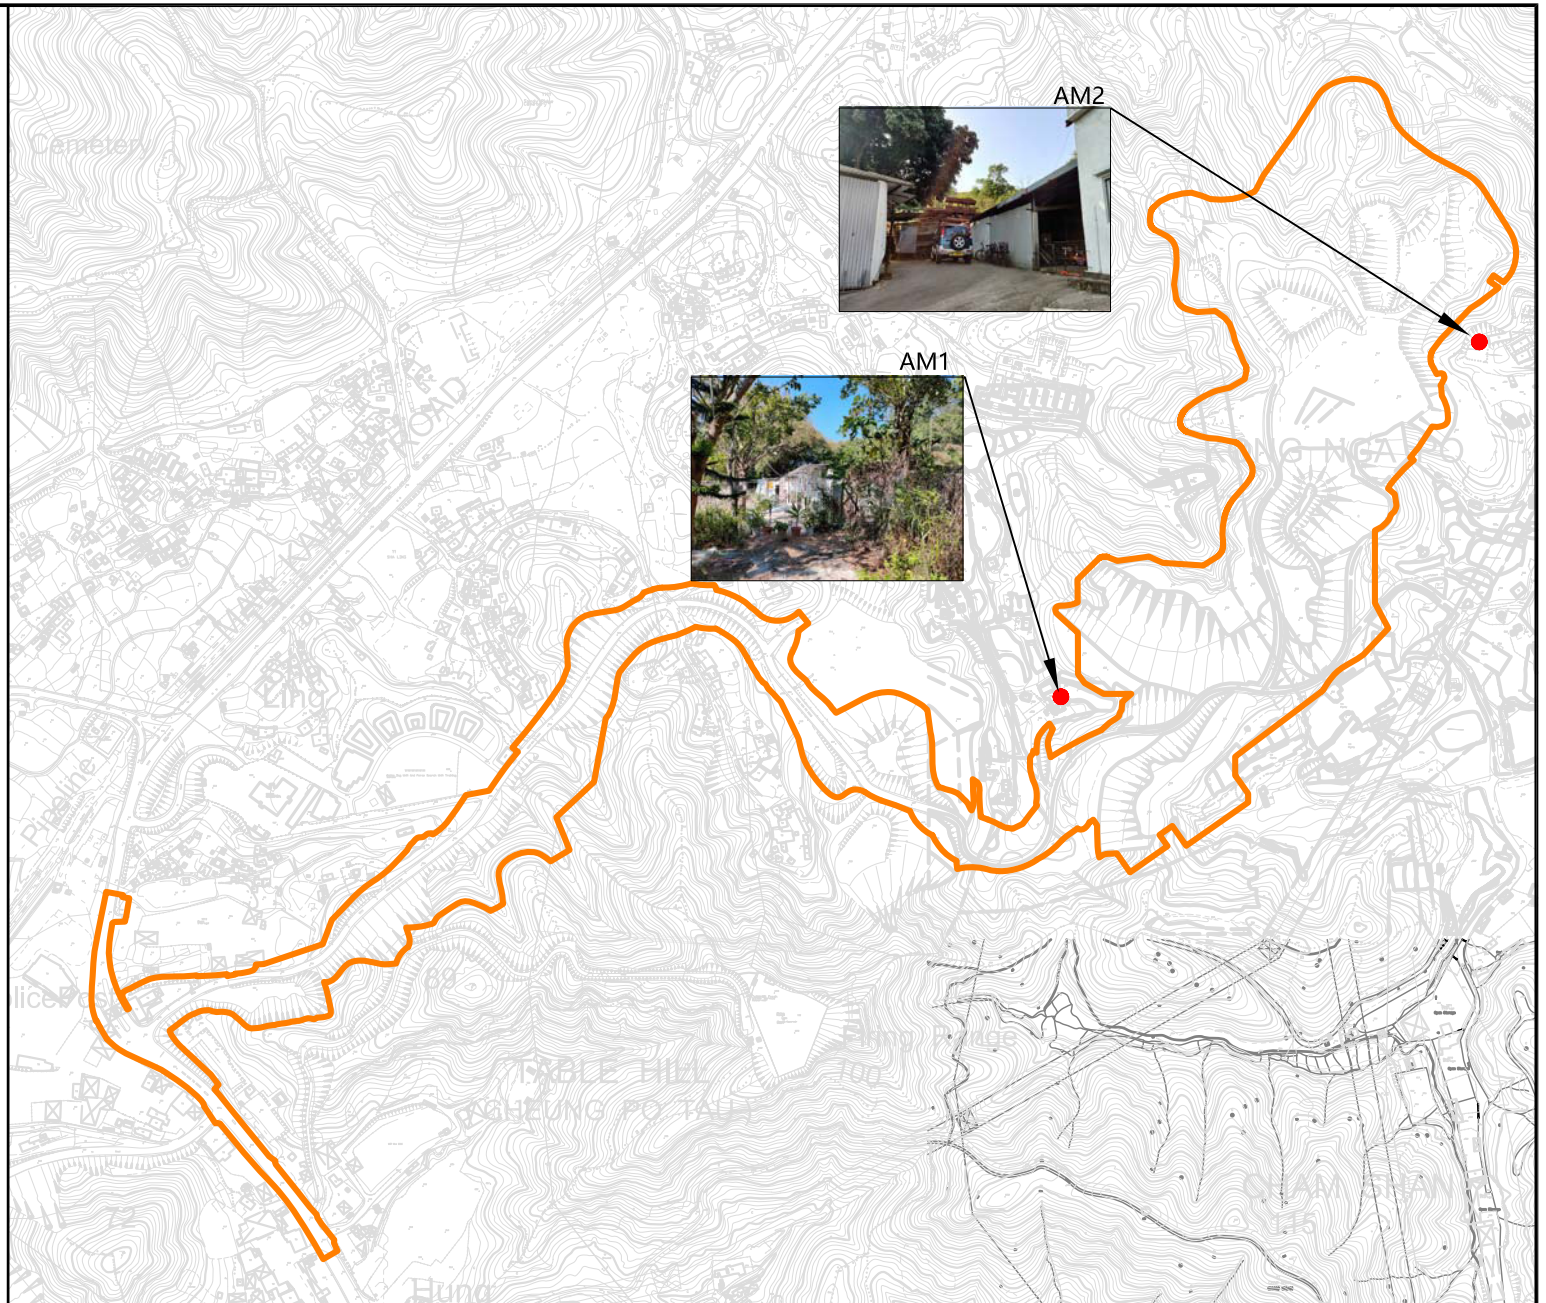
Air Quality Monitoring Stations

AIR QUALITY MONITORING STATIONS	
I.D	Description
AM1	Village House, Kong Nga Po
AM2	Village House, Kong Nga Po

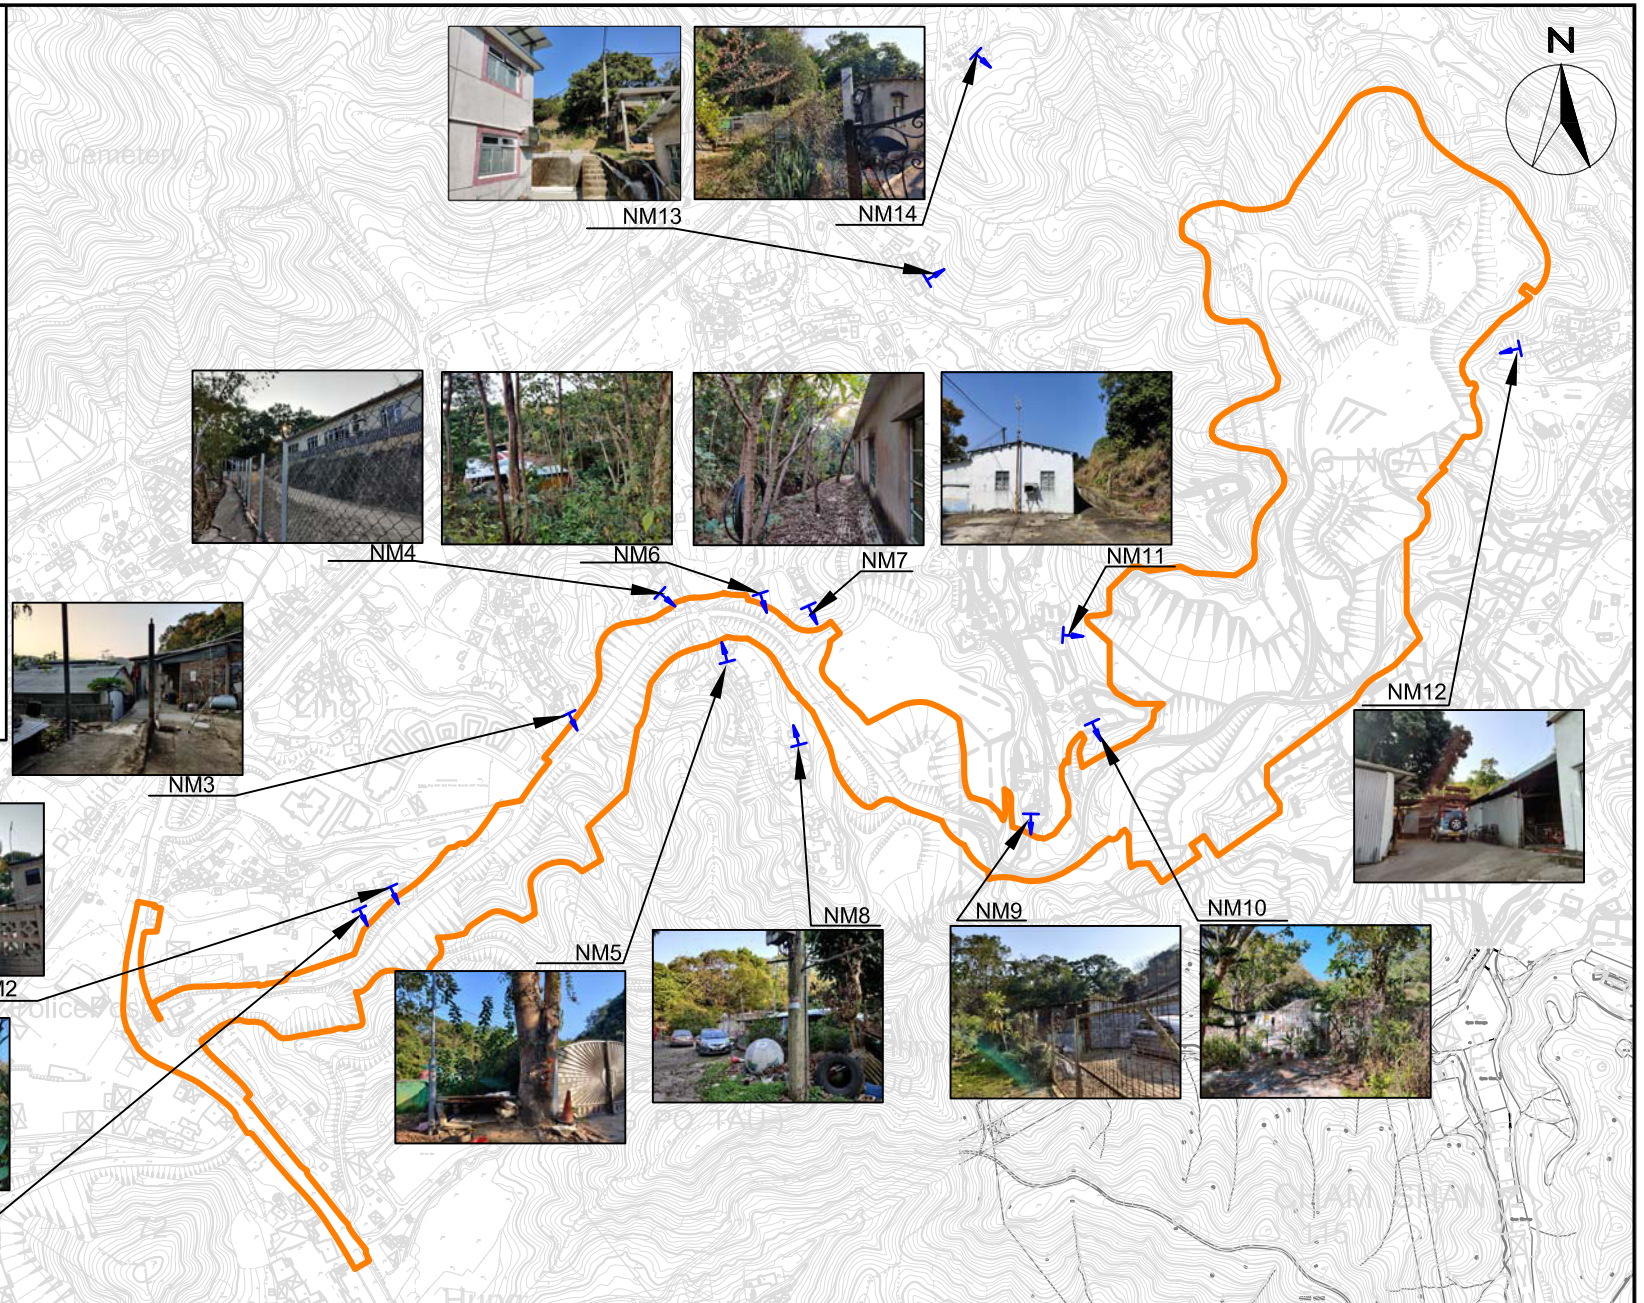
SCALE	A4 @ 1:50000	DATE	JUL 2020	
CHECK	IT	DRAWN	NL	
JOB No.	WMA20001	FIGURE NO.	3	REV —

NOISE MONITORING STATIONS	
I.D	Description
NM1	Village House, Sha Ling
NM2	Village House, Sha Ling
NM3	Village House No. 248, Sha Ling
NM4	Village House, Sha Ling
NM5	Village House No. 270, Sha Ling
NM6	Village House, Sha Ling
NM7	Village House, Sha Ling
NM8	Village House, Sha Ling
NM9	Village House, Kong Nga Po
NM10	Village House, Kong Nga Po
NM11	Village House, Kong Nga Po
NM12	Village House, Kong Nga Po
NM13	Village House, Kong Nga Po
NM14	Village House, near Man Kam To Road

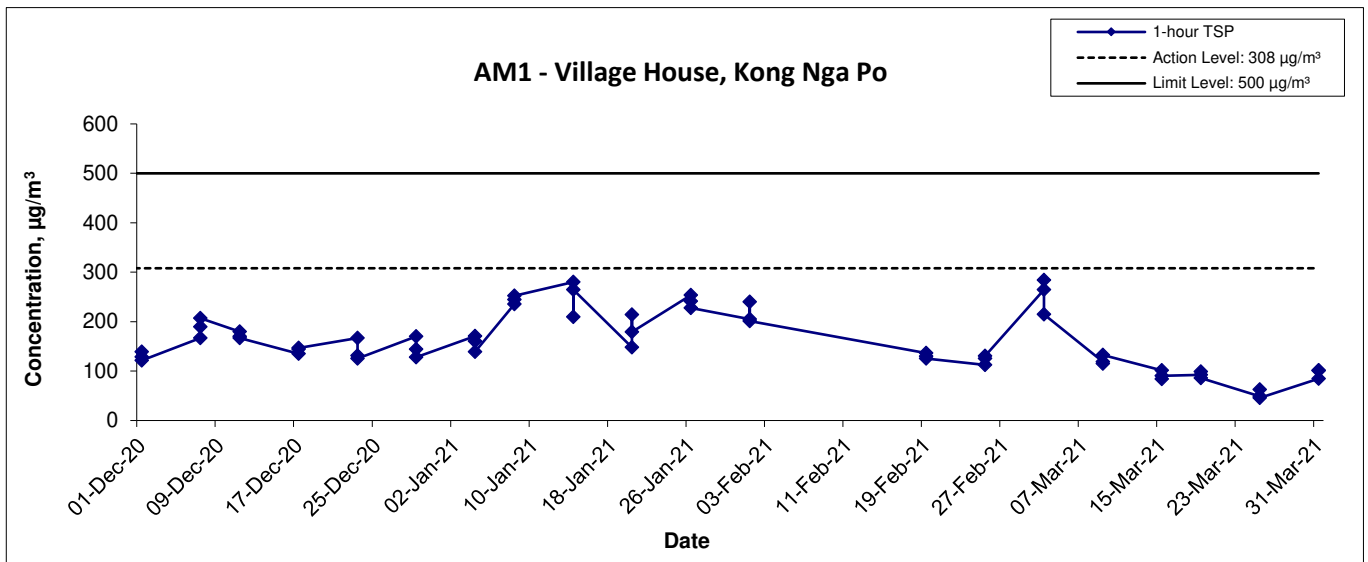
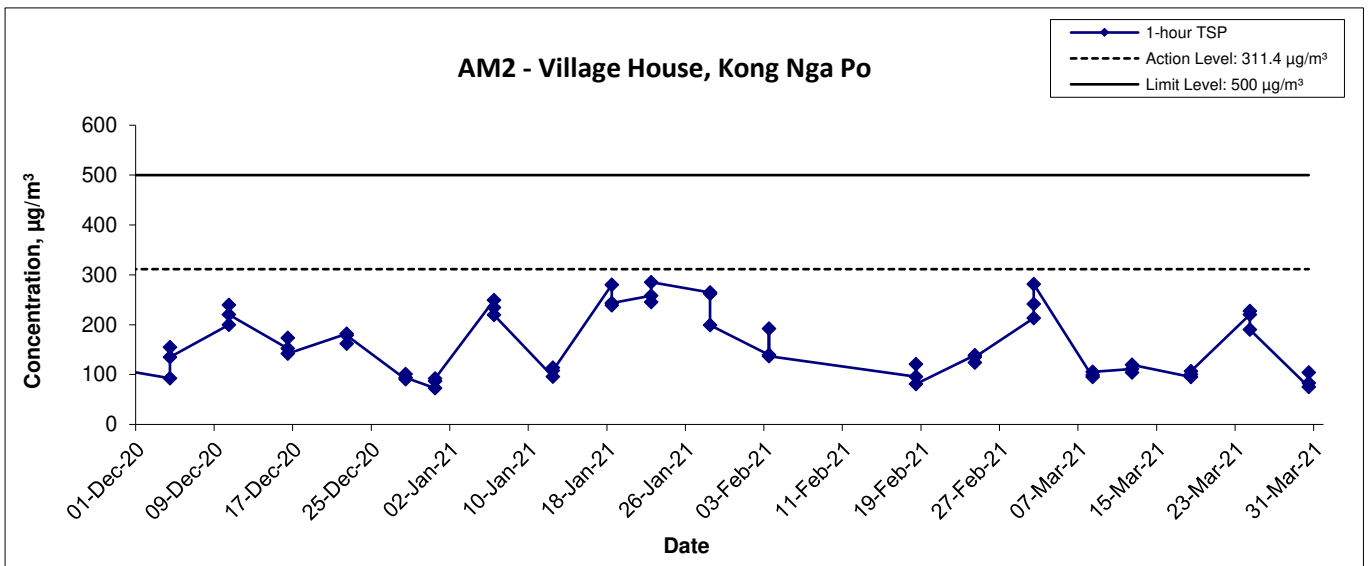
1-hr TSP Concentration Levels

Title Service Contract No. NDO 07/2019 Environmental Team for Site Formation and Infrastructure Works for Police Facilities in Kong Nga Po Graphical Presentation of 1-hour TSP Monitoring Results	Scale N.T.S	Project No. WMA20001

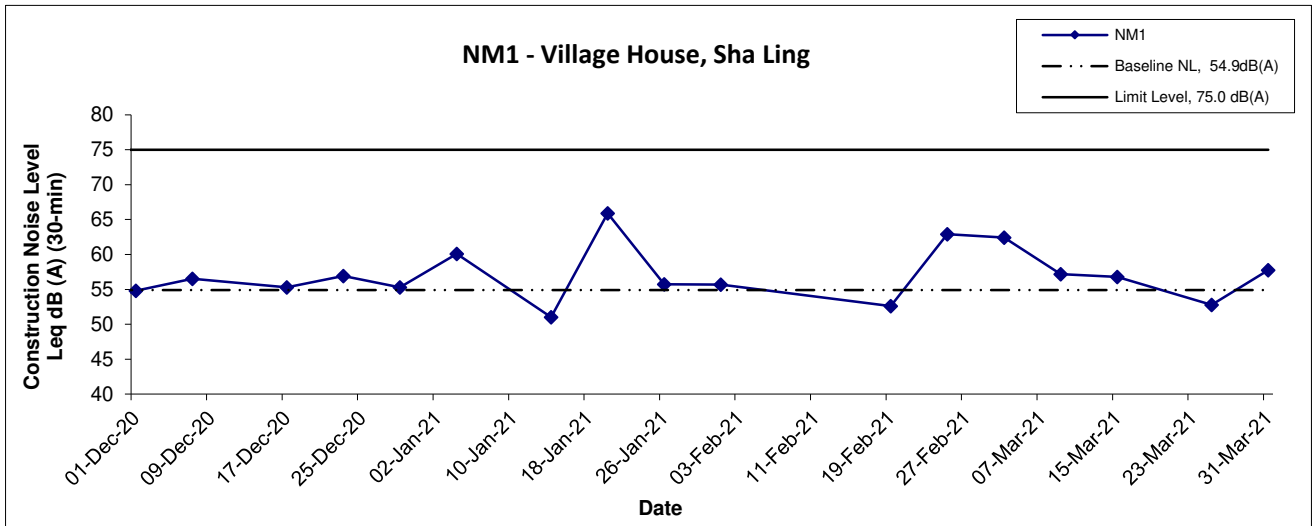
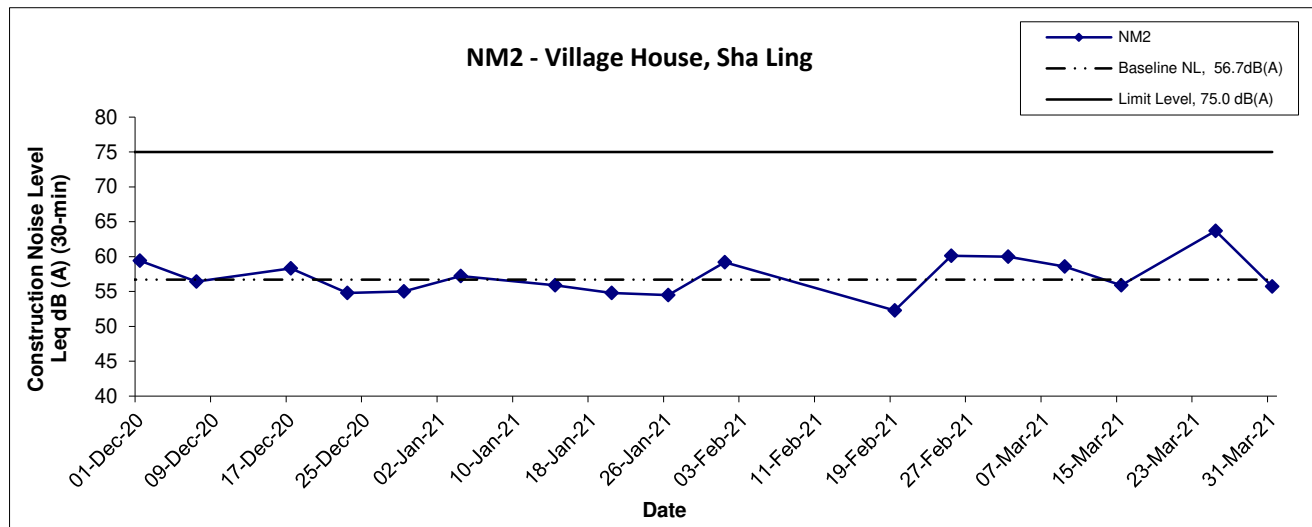
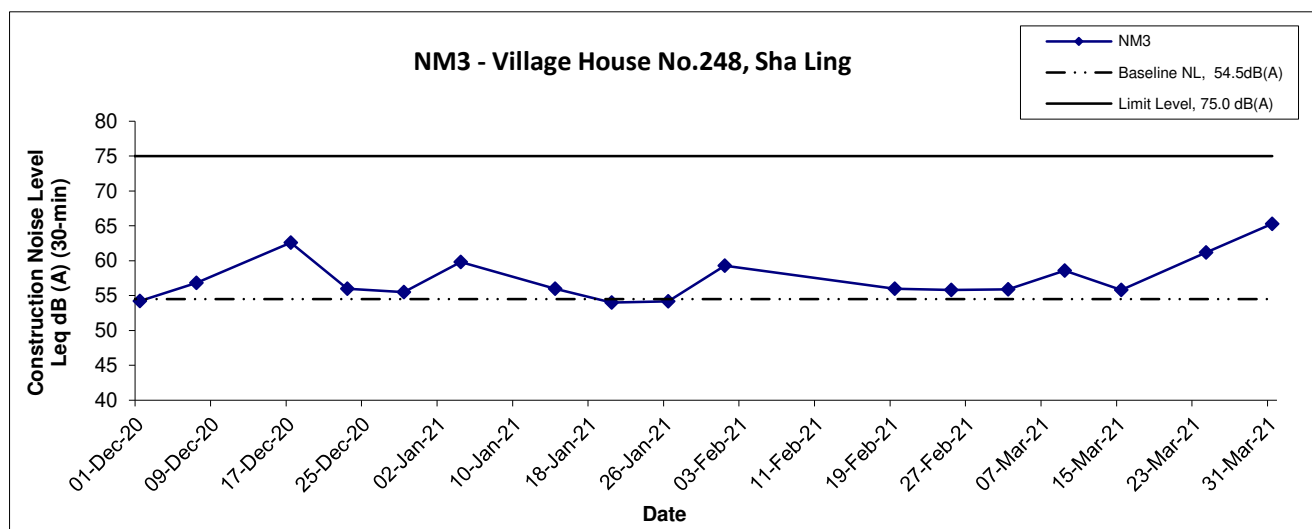
Noise Levels

Title Service Contract No. NDO 07/2019 Environmental Team for Site Formation and Infrastructure Works for Police Facilities in Kong Nga Po Graphical Presentation of Construction Noise Monitoring Results	Scale N.T.S	Project No. WMA20001	匯力 consulting · testing · research
	Date Mar 21	Appendix C

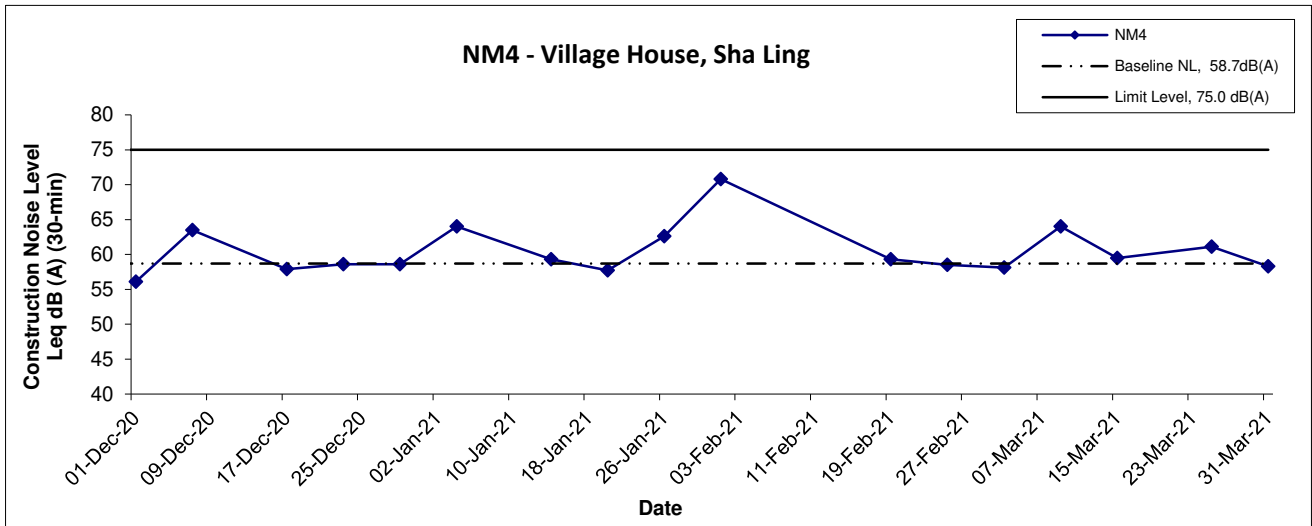
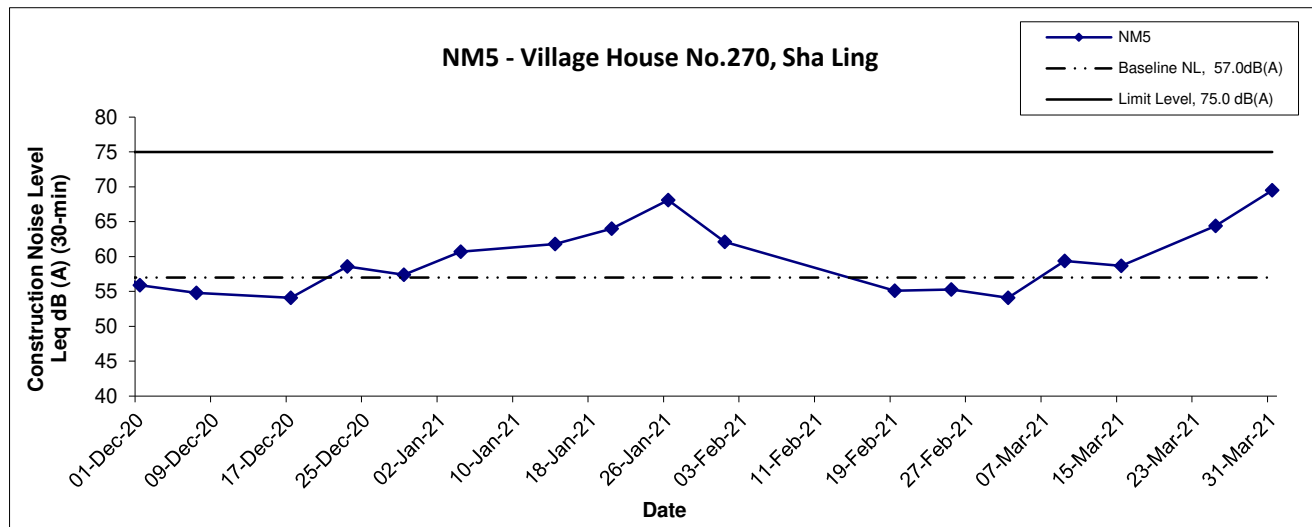
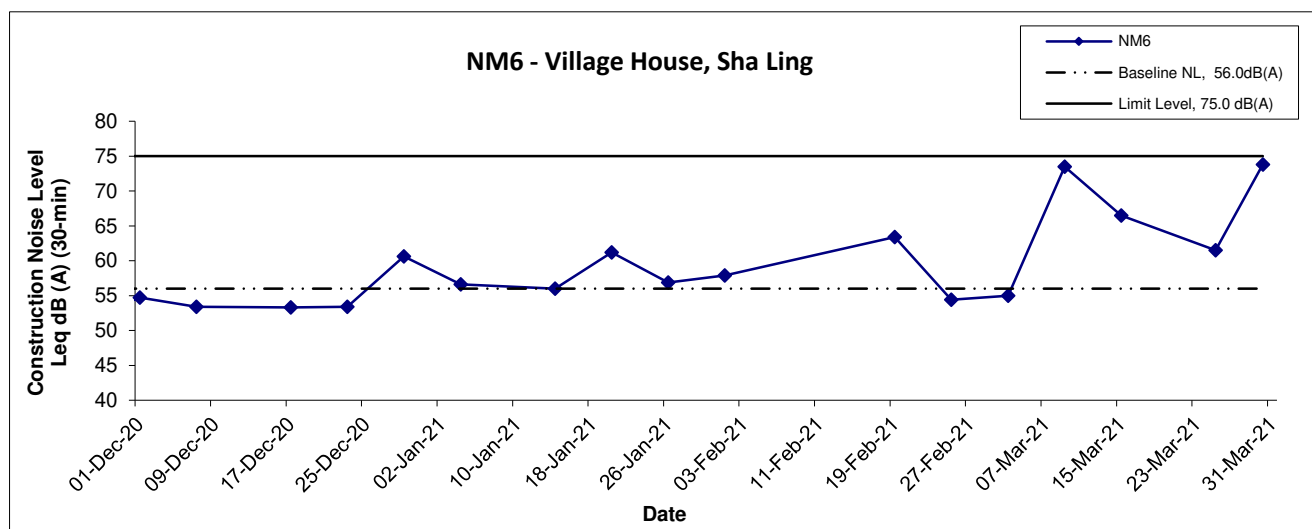
Noise Levels

Title Service Contract No. NDO 07/2019 Environmental Team for Site Formation and Infrastructure Works for Police Facilities in Kong Nga Po Graphical Presentation of Construction Noise Monitoring Results	Scale N.T.S	Project No. WMA20001	consulting · testing · research
	Date Mar 21	Appendix C

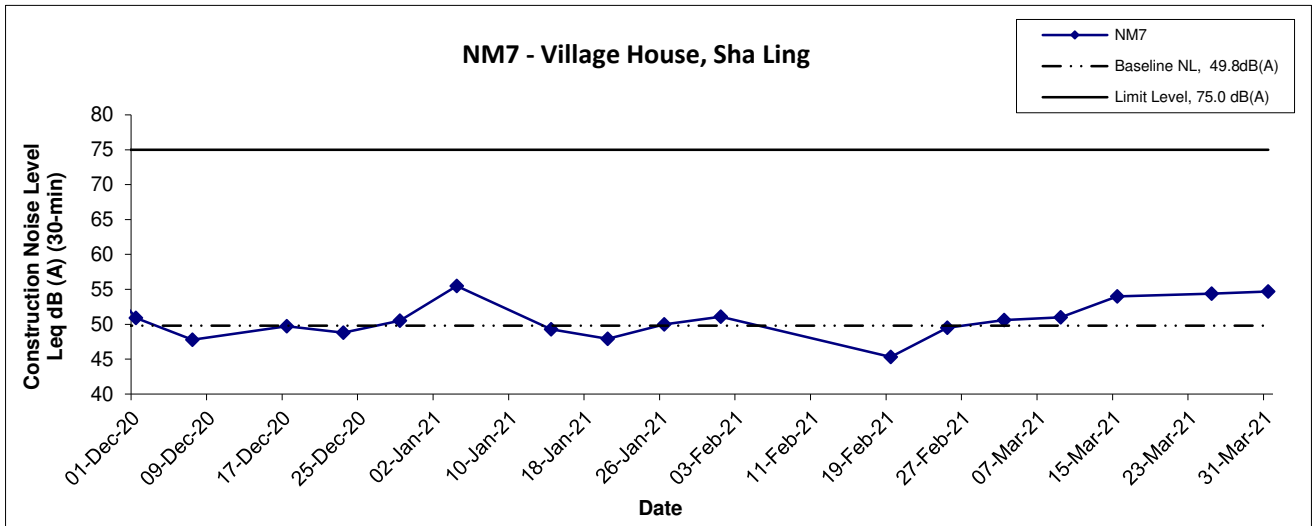
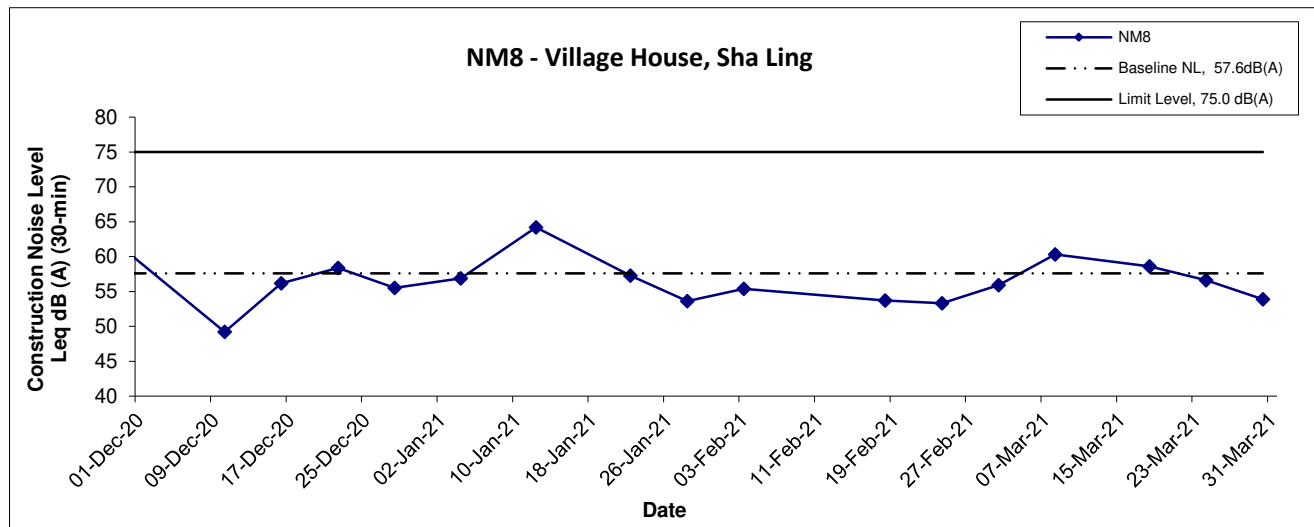
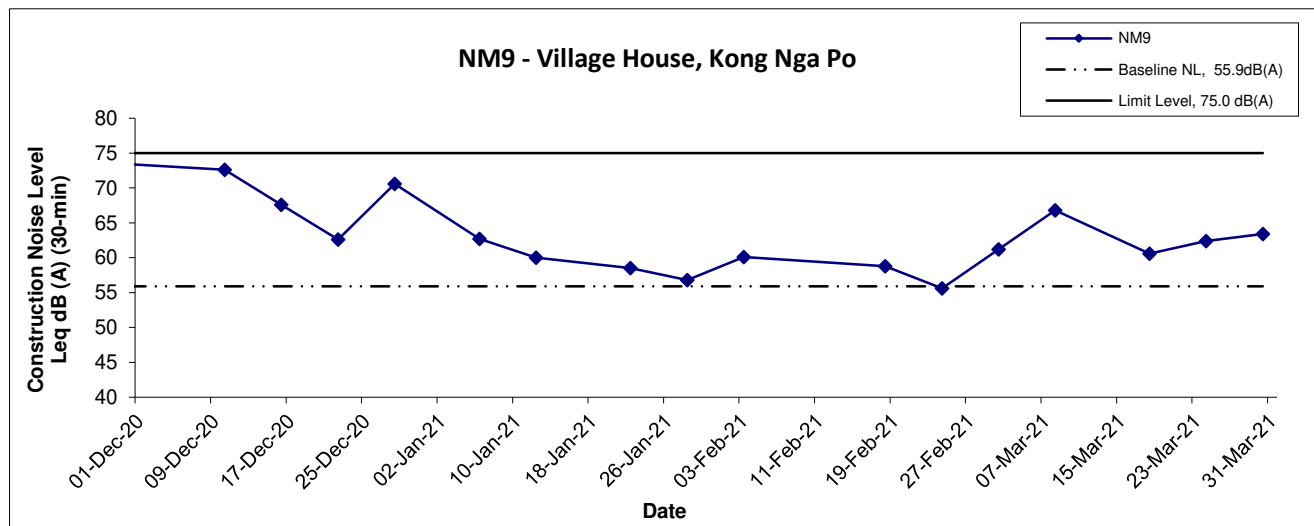
Noise Levels

Title Service Contract No. NDO 07/2019 Environmental Team for Site Formation and Infrastructure Works for Police Facilities in Kong Nga Po Graphical Presentation of Construction Noise Monitoring Results	Scale N.T.S	Project No. WMA20001	匯力 consulting · testing · research
	Date Mar 21	Appendix C

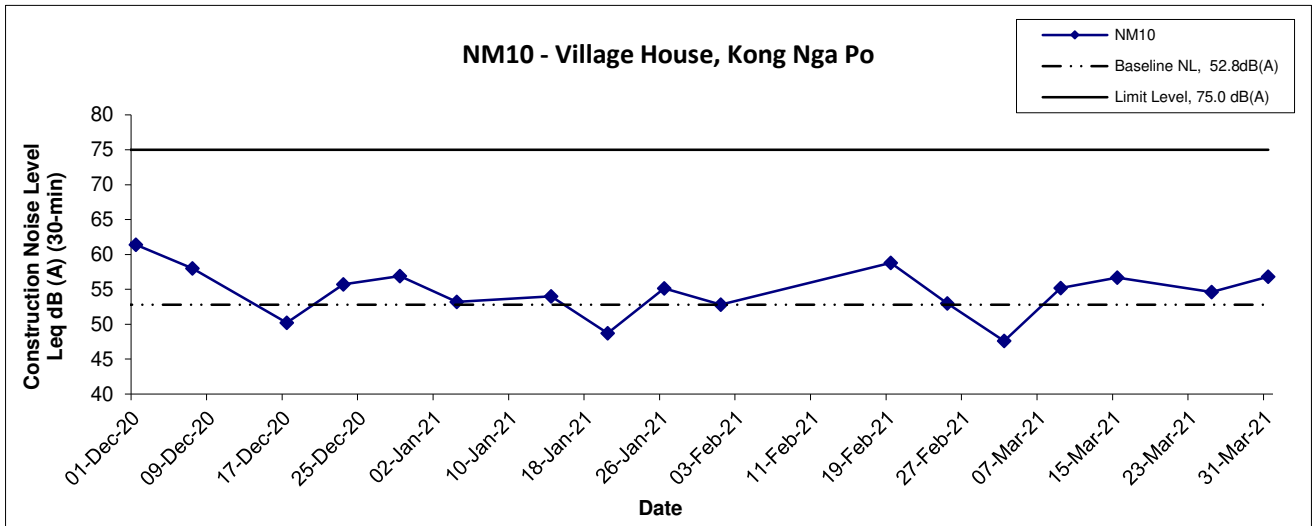
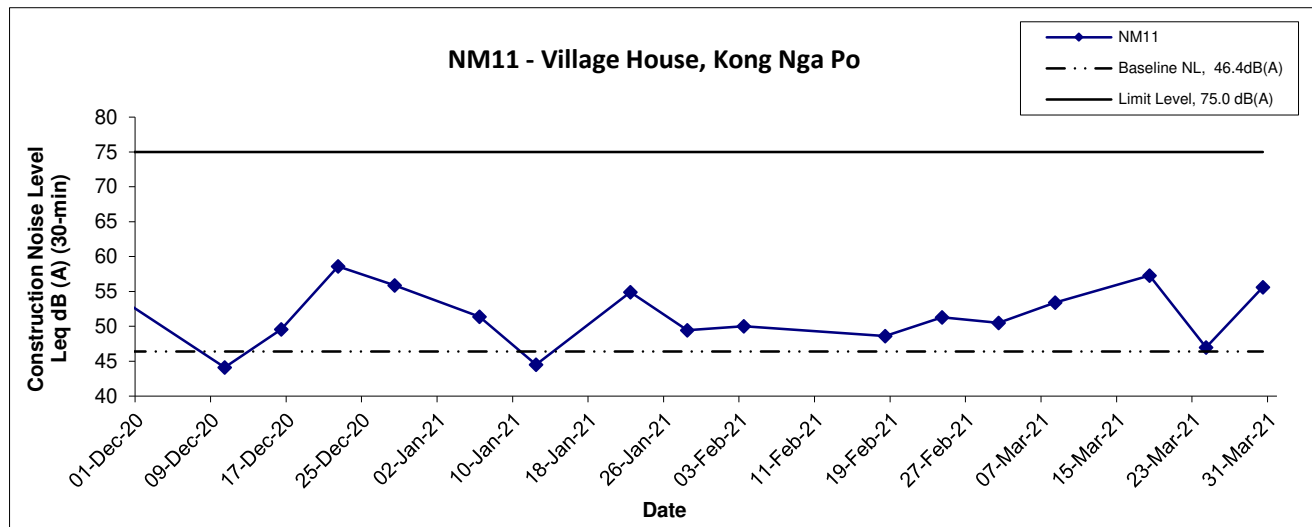
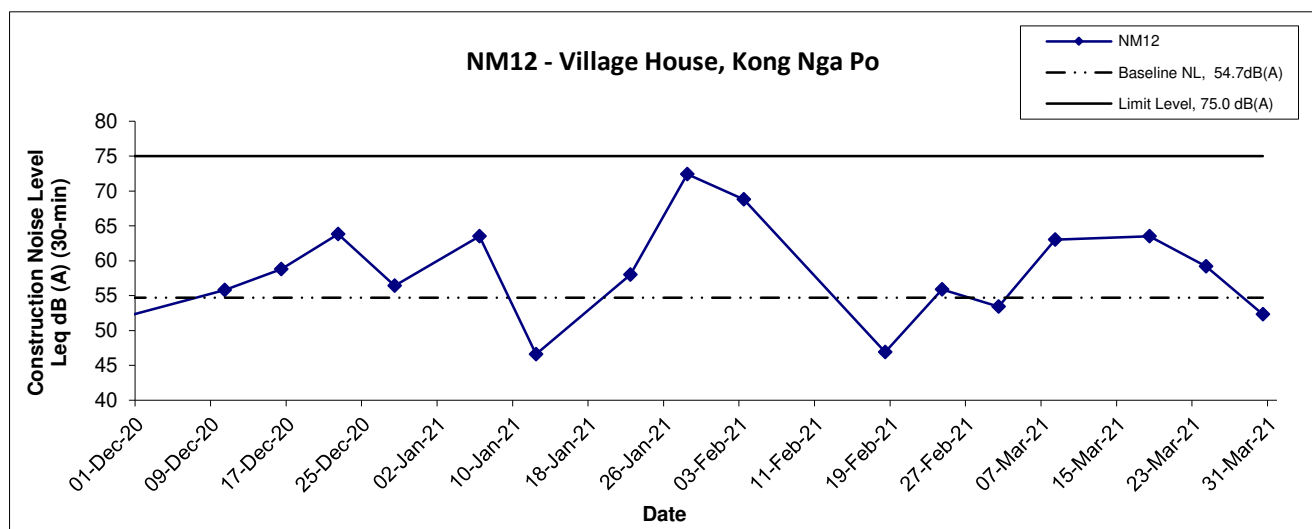
Noise Levels

Title Service Contract No. NDO 07/2019 Environmental Team for Site Formation and Infrastructure Works for Police Facilities in Kong Nga Po Graphical Presentation of Construction Noise Monitoring Results	Scale N.T.S	Project No. WMA20001	consulting · testing · research
	Date Mar 21	Appendix C

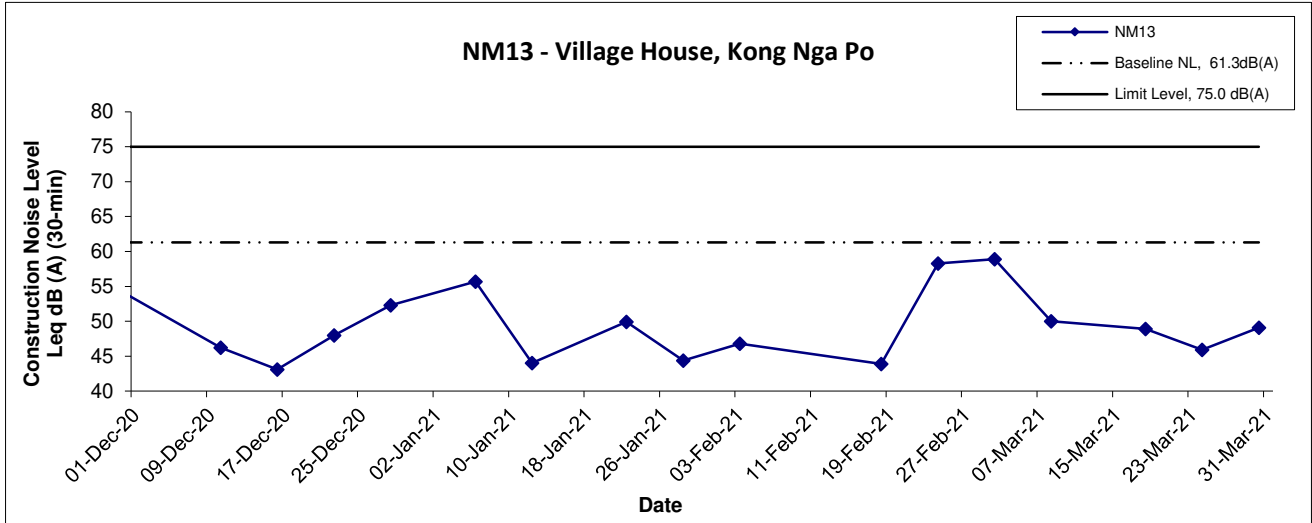
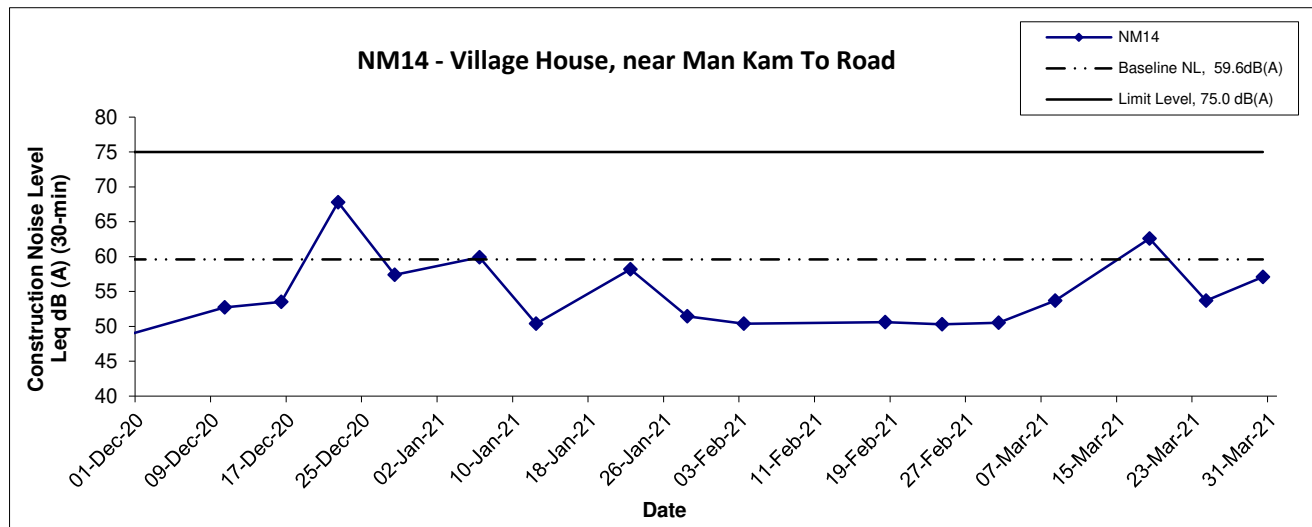
Noise Levels

Title Service Contract No. NDO 07/2019 Environmental Team for Site Formation and Infrastructure Works for Police Facilities in Kong Nga Po Graphical Presentation of Construction Noise Monitoring Results	Scale	N.T.S	Project No.	WMA20001
	Date	Mar 21	Appendix	C
