**Provision of Independent Environmental Checker Consultancy for Design  
and Construction of Kong Nga Po Police Training Facilities  
Verification of Monthly EM&A Report (October 2024)**

**Provision of Environmental Team consultancy  
for Design and Construction of Kong Nga Po Police  
Training Facilities (Programme No. 279LP)**

**Monthly Environmental Monitoring and  
Audit Report for October 2024  
(Version 2)**

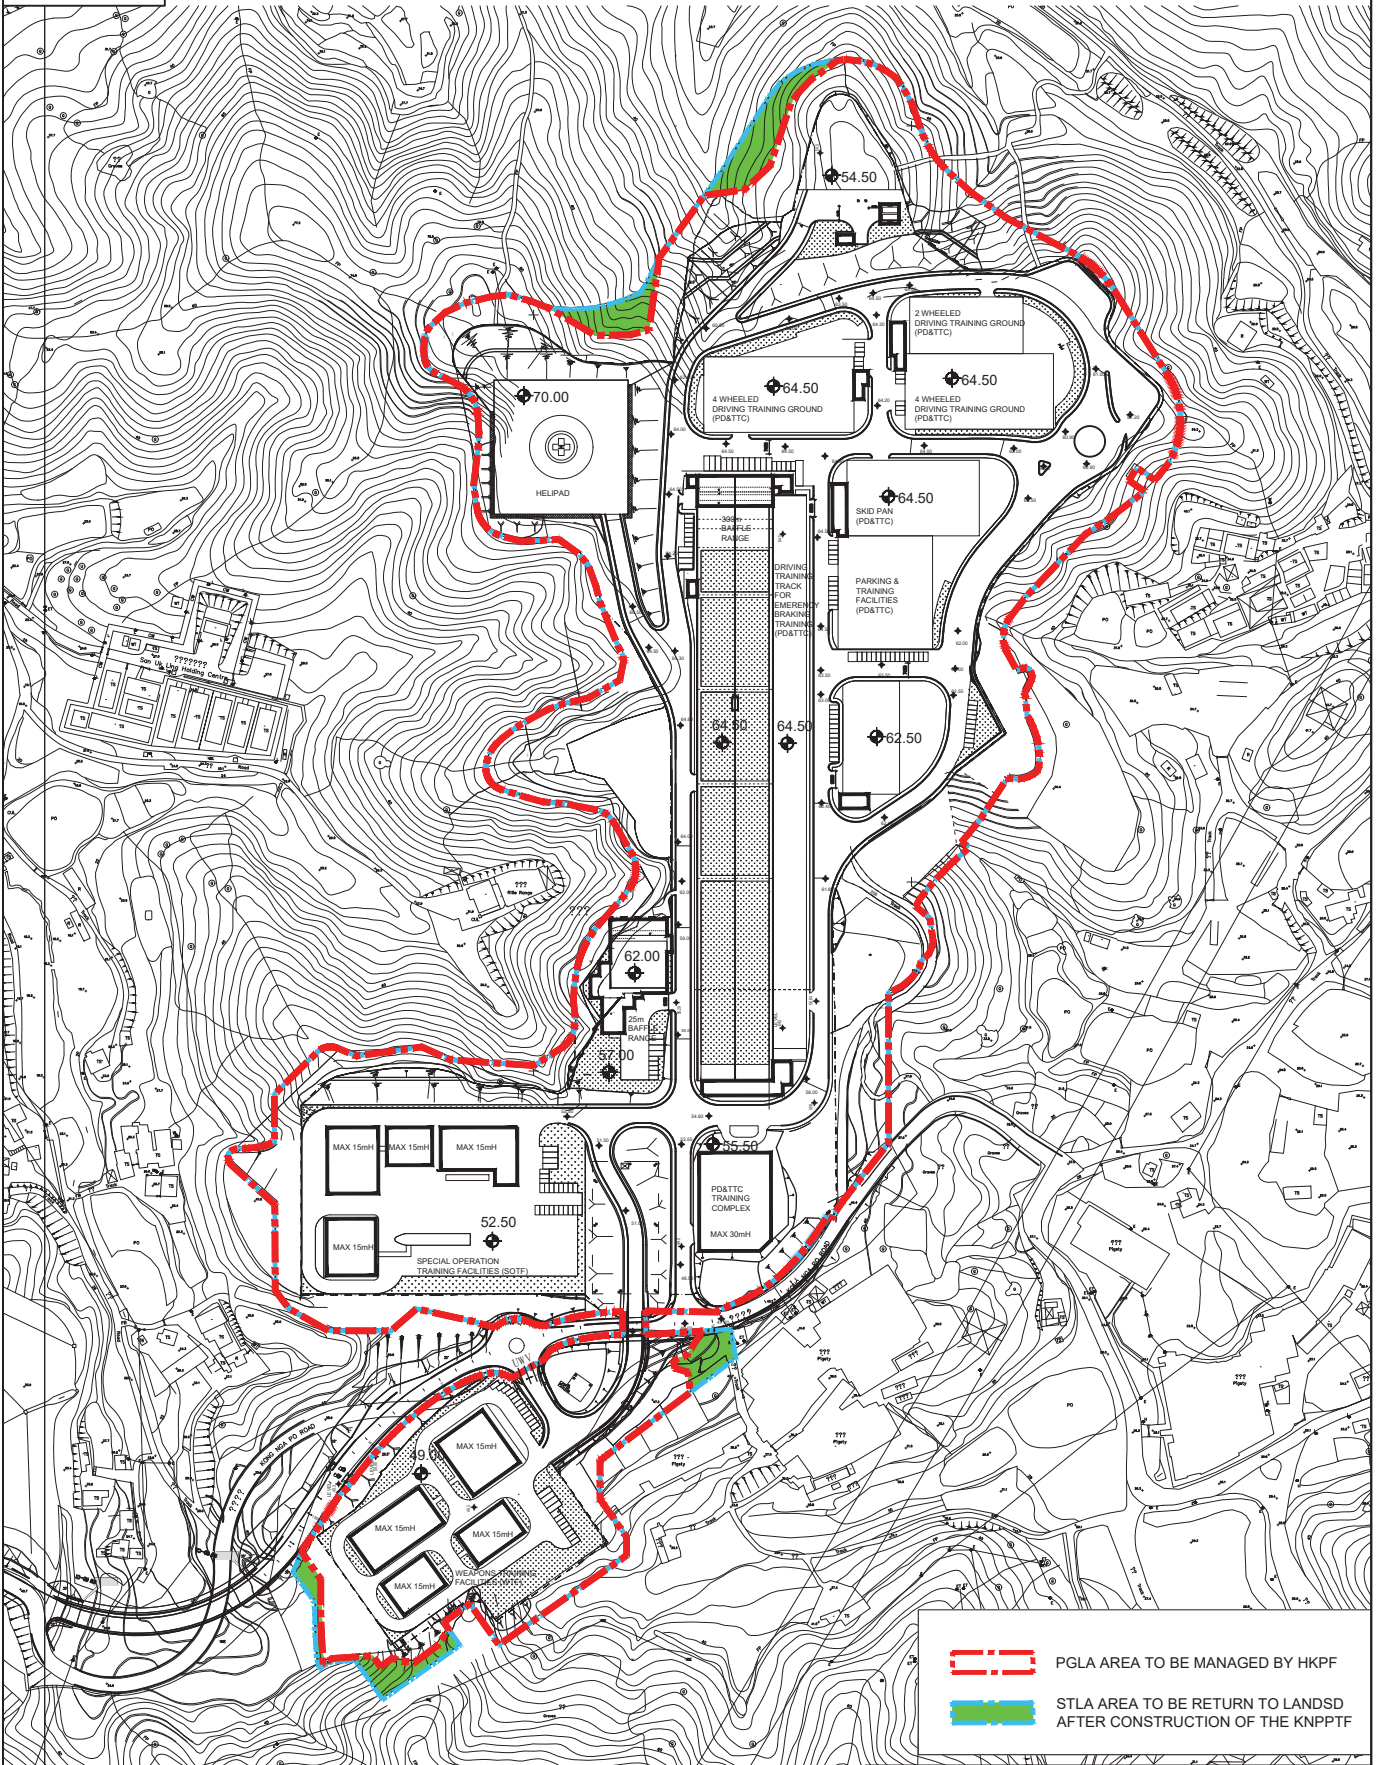
PGLA AREA TO BE MANAGED BY HKPF

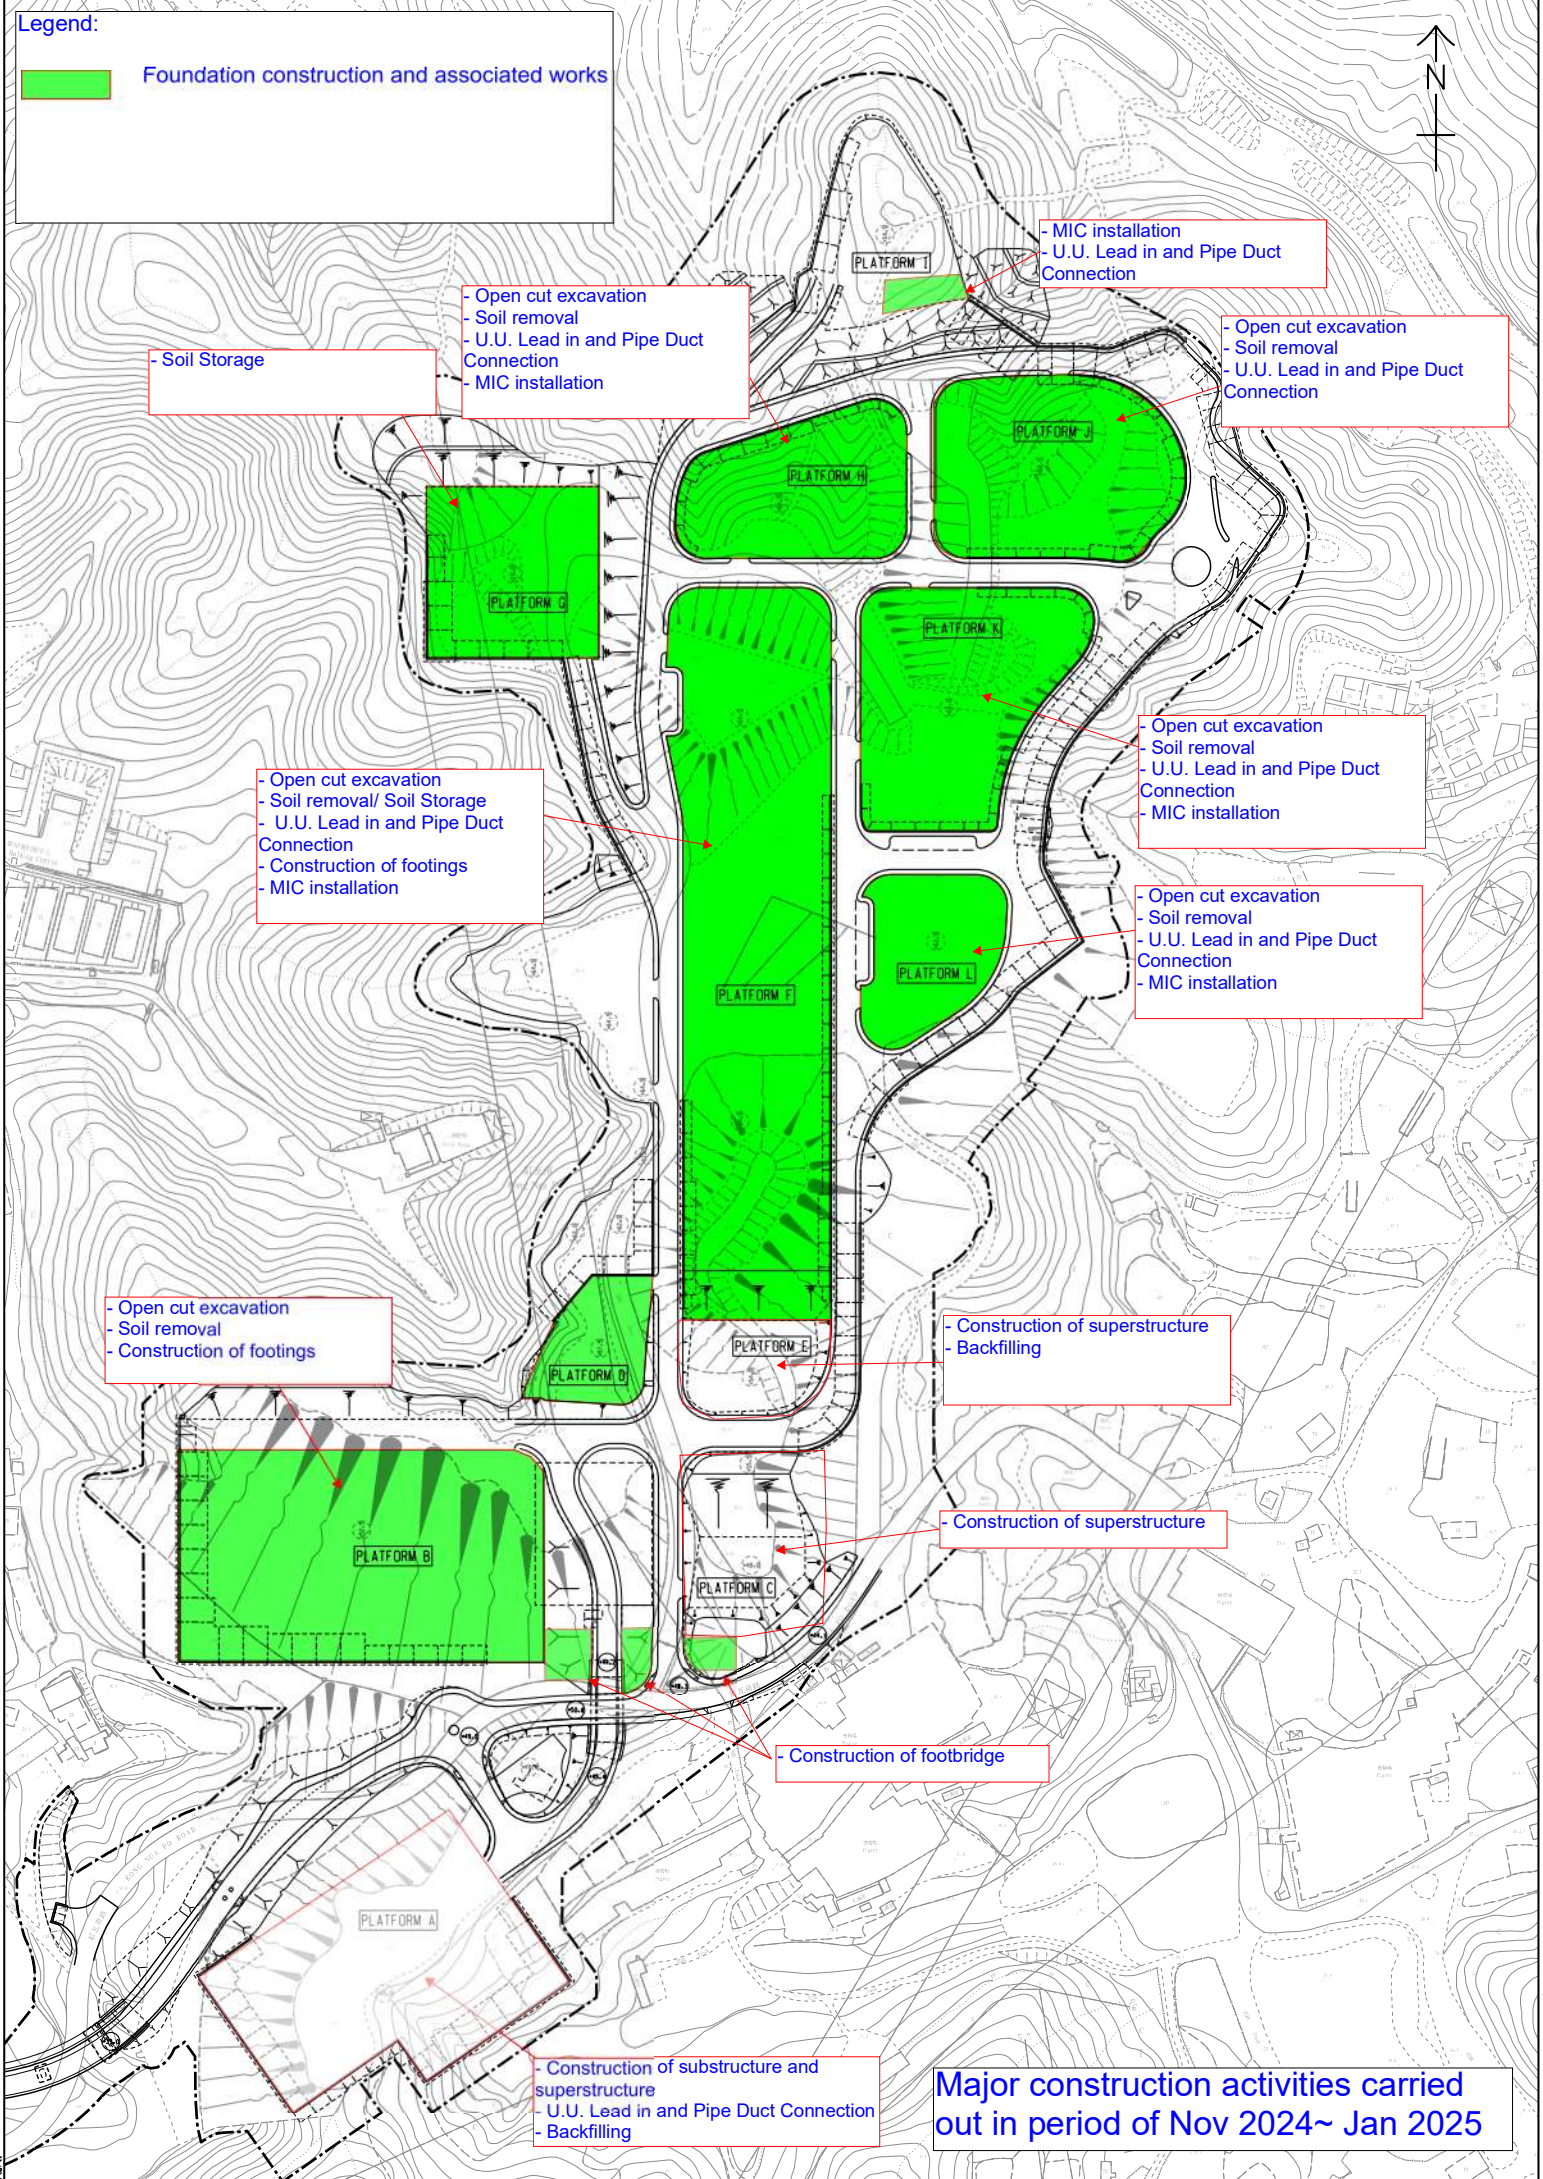
# Layout Plan with major construction activities

- Construction of substructure and superstructure  
- U.U. Lead in and Pipe Duct Connection  
- Backfilling

**Major construction activities carried out in period of Nov 2024~ Jan 2025**

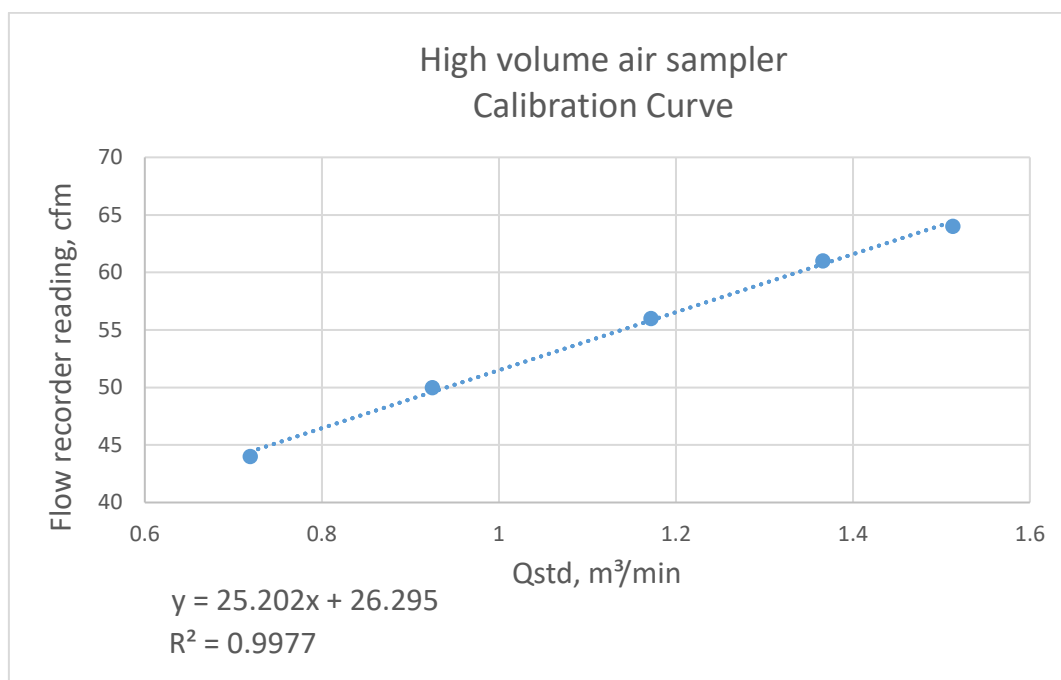
Qstd, Actual flow rate, m <sup>3</sup> /min	1.513	1.366	1.172	0.925	0.719
Flow recorder reading, cfm	64	61	56	50	44
Pressure, mm Hg	757				
Temperature, K	303

**Note** : The coefficient of determination ( $R^2$ ) of the calibration curve greater than 0.99 after a 5-point calibration, the high volume air sampler complies with the specified requirements and deemed acceptable for use.

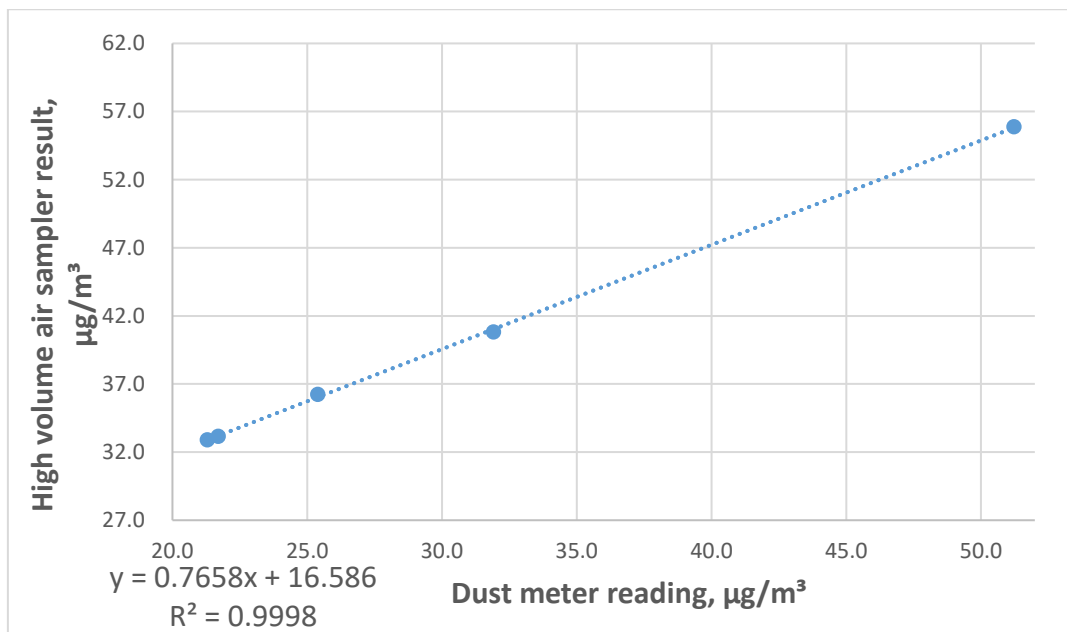
Test Result : 1 hour Total suspended particulate (TSP)

Calibration Point	Average Dust Meter reading, $\mu\text{g}/\text{m}^3$	High volume air sampler results, $\mu\text{g}/\text{m}^3$
1	51.2	55.9
2	25.4	36.2
3	31.9	40.8
4	21.7	33.2
5	21.3	32.9

- Note : 1. "Instrument Readings" presents the figures shown on item under calibration / checking regardless of equipment precision or significant figures.  
2. The coefficient of determination ( $R^2$ ) of the calibration curve greater than 0.99 after a 5-point calibration, the dust meter complies with the specified requirements and deemed acceptable for use.

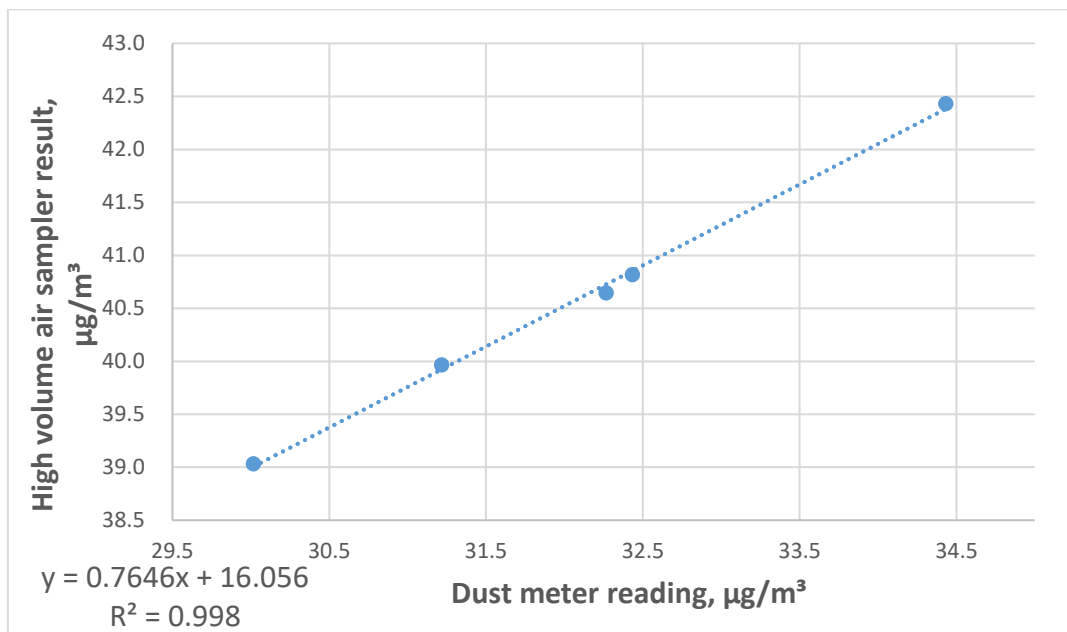
Test Result : 1 hour Total suspended particulate (TSP)

Calibration Point	Average Dust Meter reading, $\mu\text{g}/\text{m}^3$	High volume air sampler results, $\mu\text{g}/\text{m}^3$
1	31.2	40.0
2	30.0	39.0
3	32.4	40.8
4	34.4	42.4
5	32.3	40.6

- Note : 1. "Instrument Readings" presents the figures shown on item under calibration / checking regardless of equipment precision or significant figures.  
2. The coefficient of determination ( $R^2$ ) of the calibration curve greater than 0.99 after a 5-point calibration, the dust meter complies with the specified requirements and deemed acceptable for use.

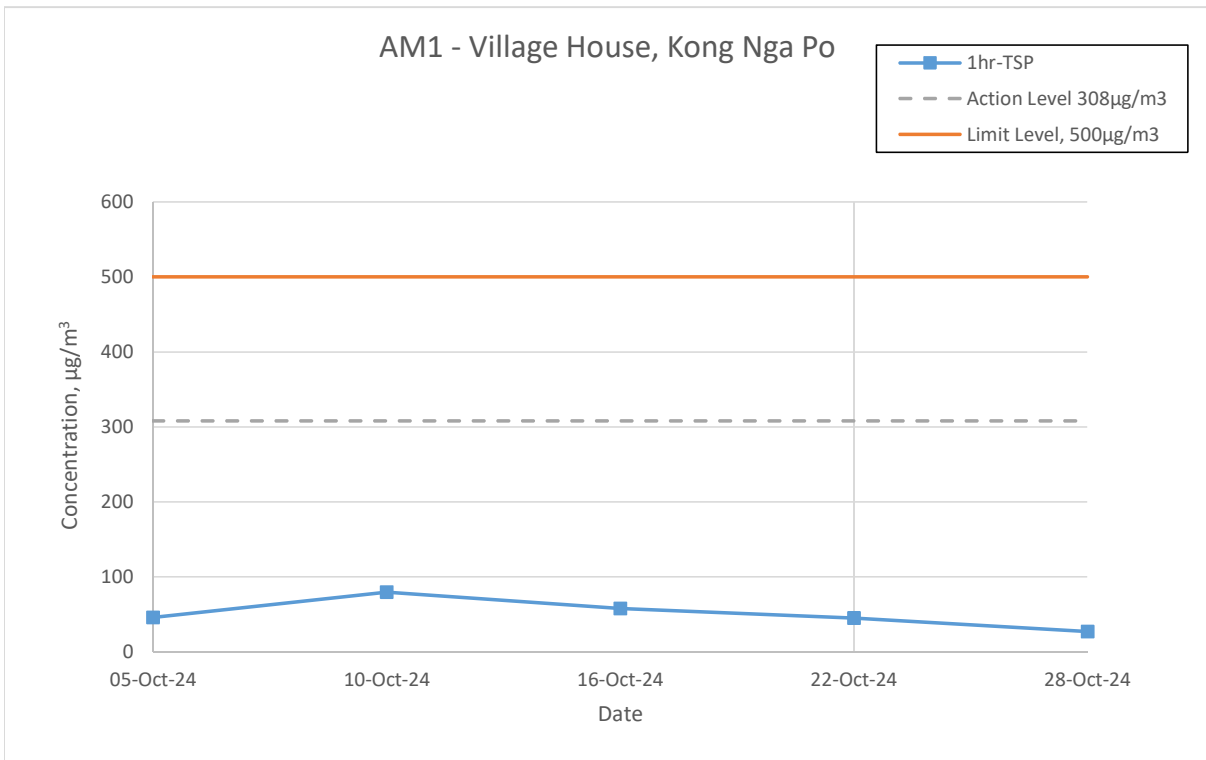
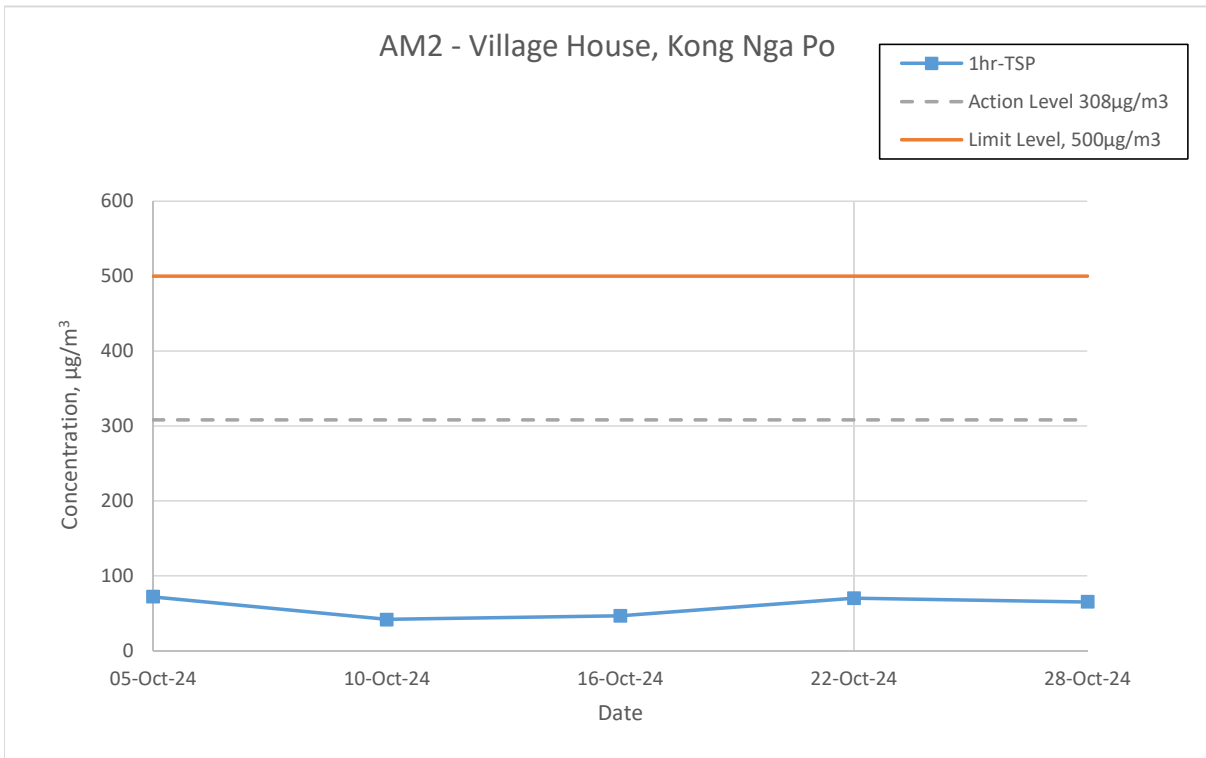
### 1-hr TSP Concentration Levels

Location AM2 - Village House, Kong Nga Po			
Date	Time	Weather	Particulate Concentration ( $\mu\text{g}/\text{m}^3$ )
05-Oct-24	13:02	Sunny	72
	14:02		53
	15:02		20
10-Oct-24	13:14	Sunny	42
	14:14		76
	15:14		44
16-Oct-24	13:23	Sunny	47
	14:23		27
	15:23		21
22-Oct-24	8:56	Sunny	70
	9:56		78
	10:56		69
28-Oct-24	13:00	Sunny	65
	14:00		67
	15:00		65
		Minimum	20
		Maximum	78
		Average	54

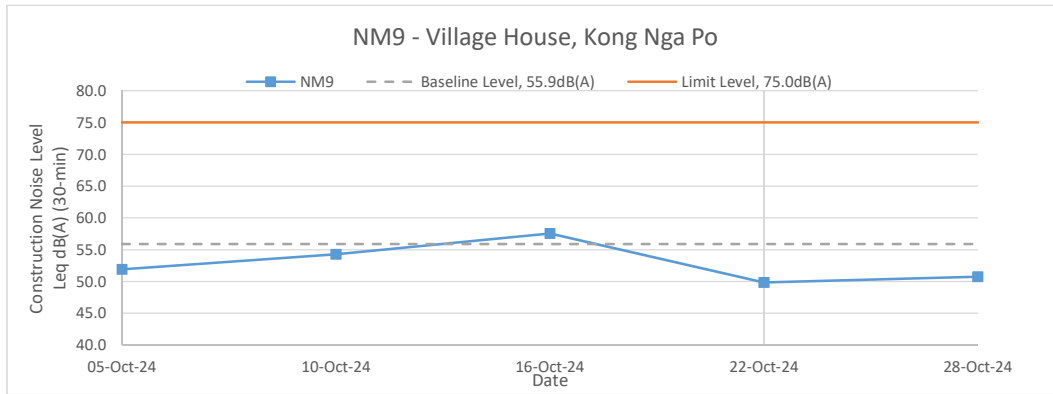
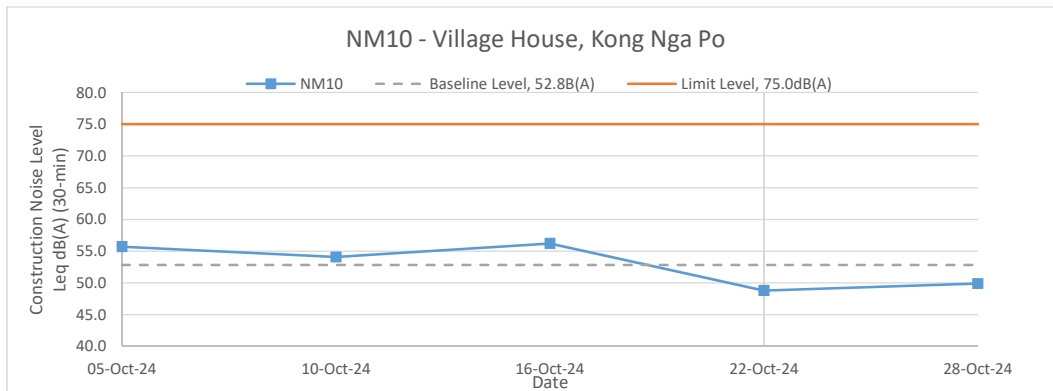
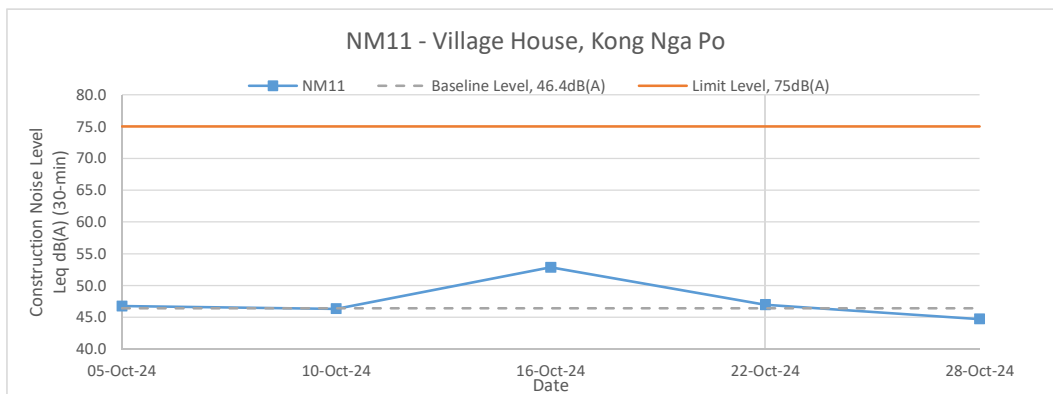
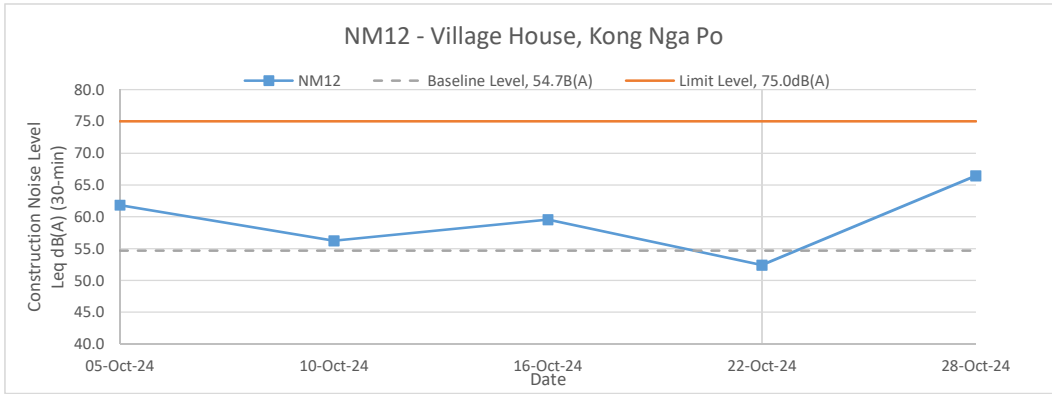
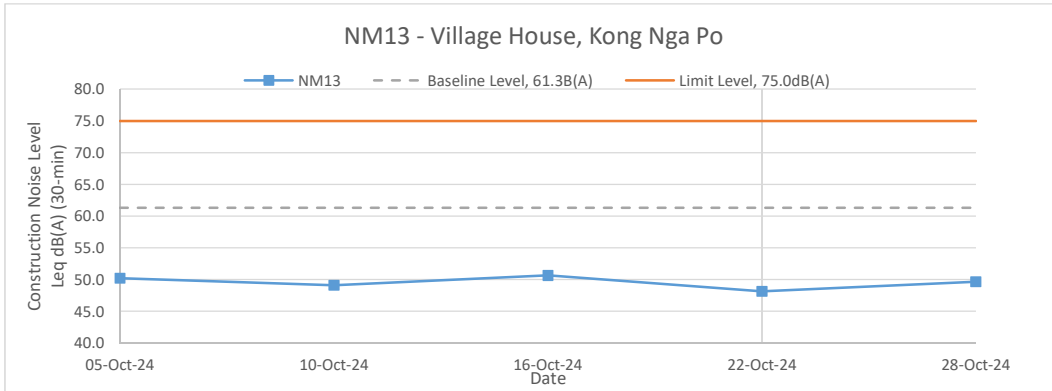
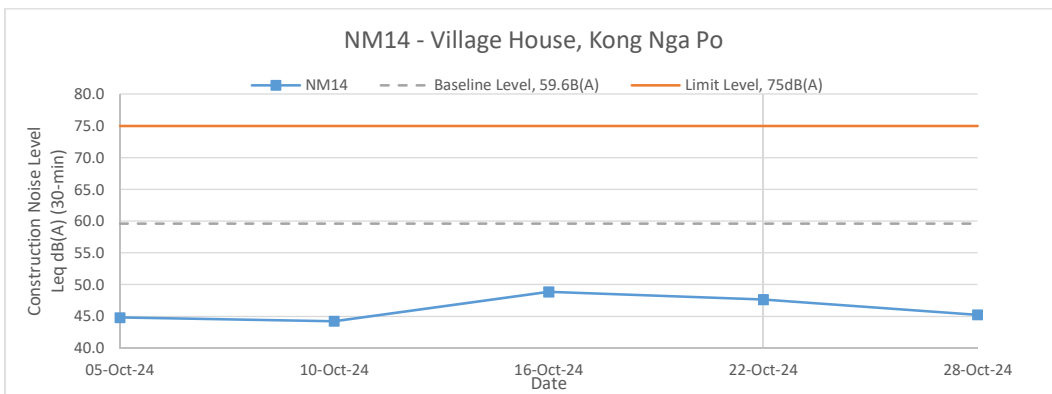
**Noise Levels**

46.1	48.7	42.3			
				45.3	47.4	39.9			
				45.5	49.0	40.2			
				45.2	48.3	40.2			
				43.4	46.1	39.1

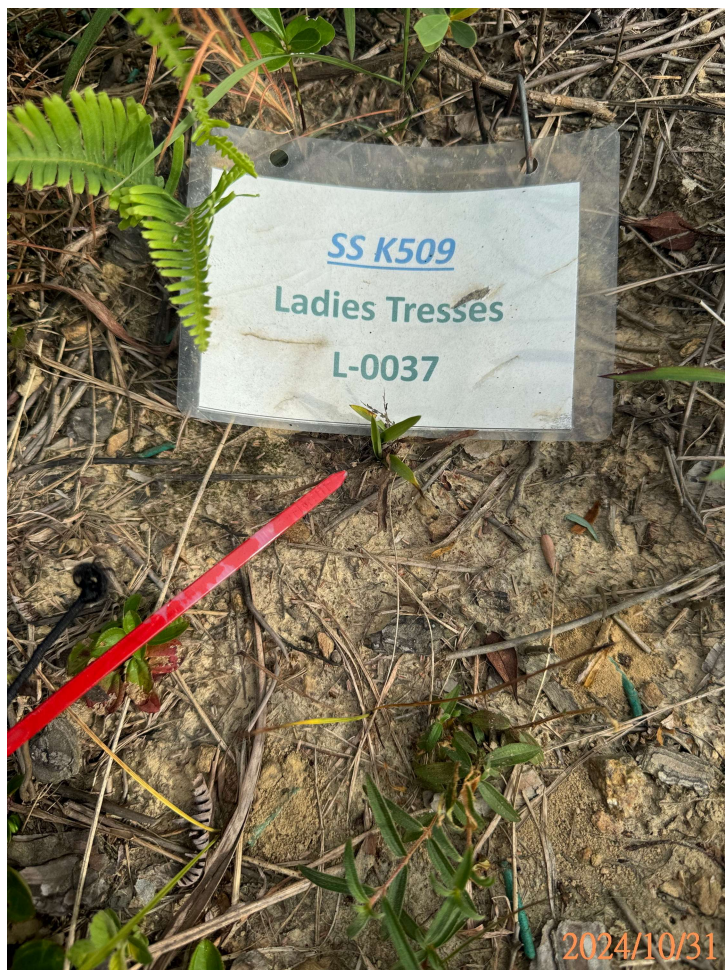
L-0037	<i>Spiranthes sinensis</i>	F	F	Leaf observed
L-0038	<i>Spiranthes sinensis</i>	P	P	Leaf observed
L-0039	<i>Spiranthes sinensis</i>	-	-	Not observed
L-0040	<i>Spiranthes sinensis</i>	-	-	Not observed
L-0041	<i>Spiranthes sinensis</i>	-	-	Not observed
L-0042	<i>Spiranthes sinensis</i>	-	-	Not observed

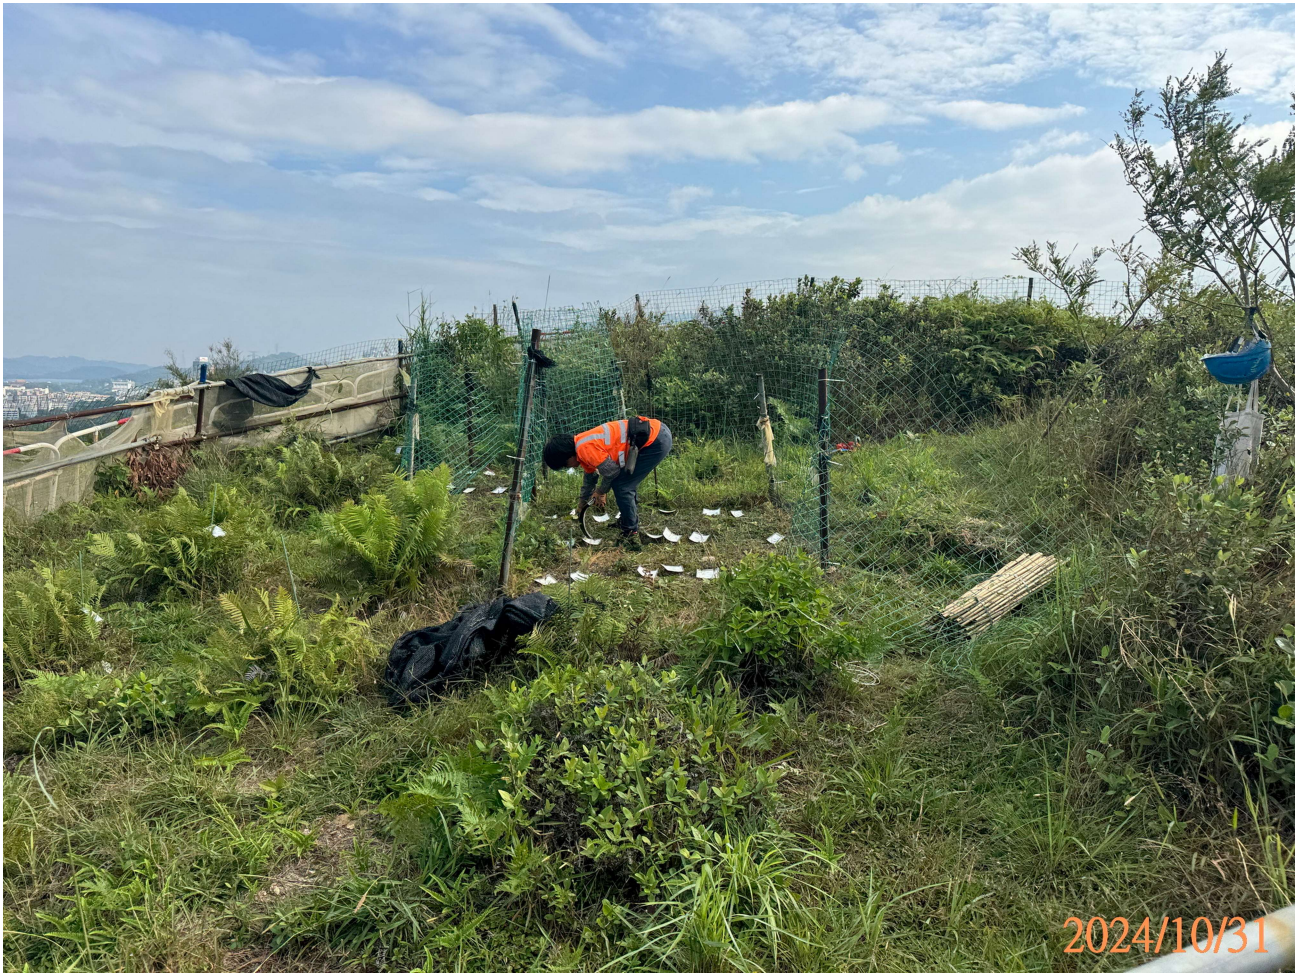
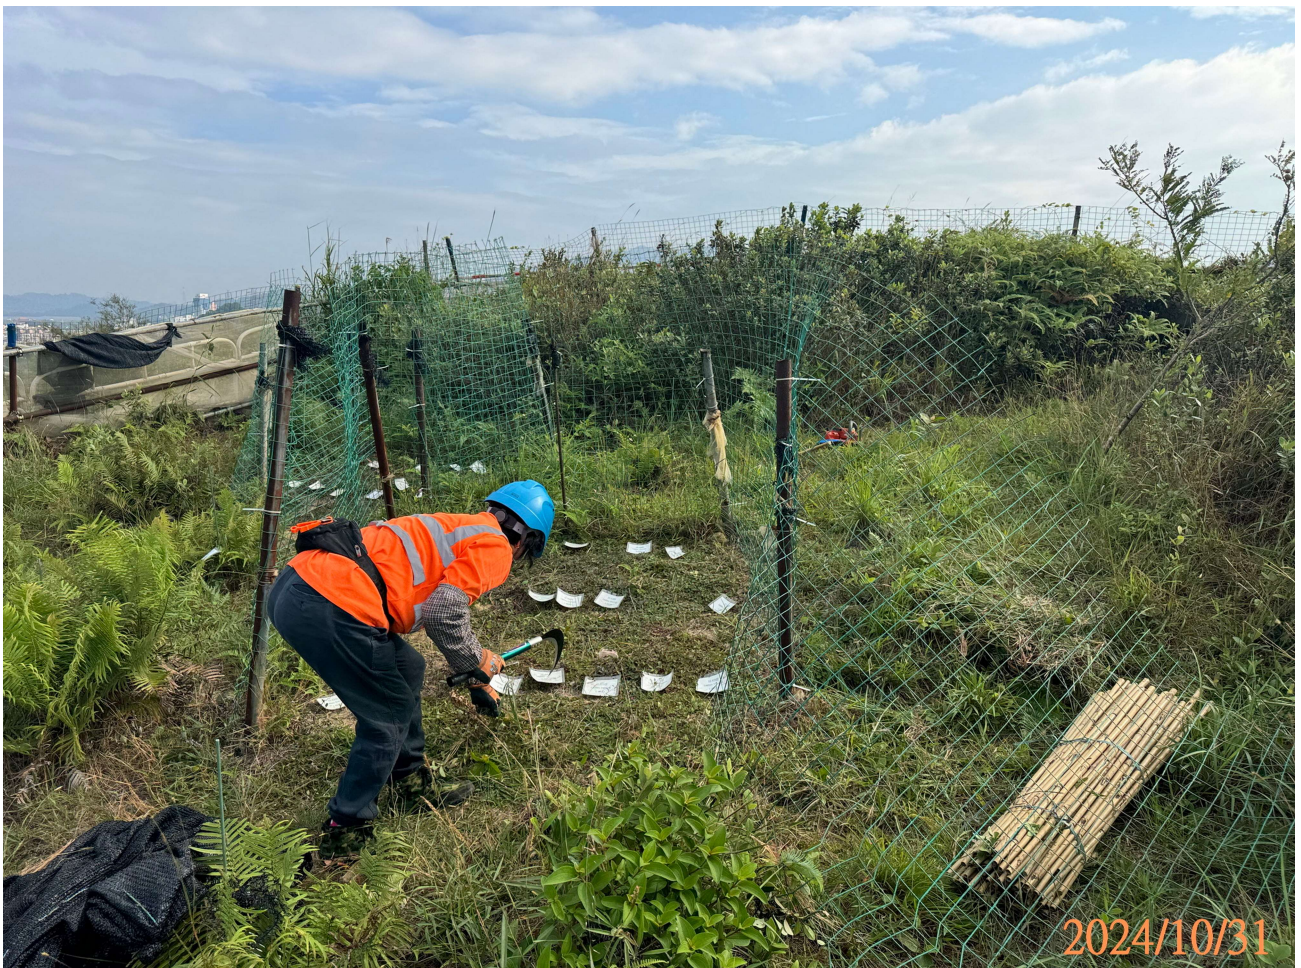
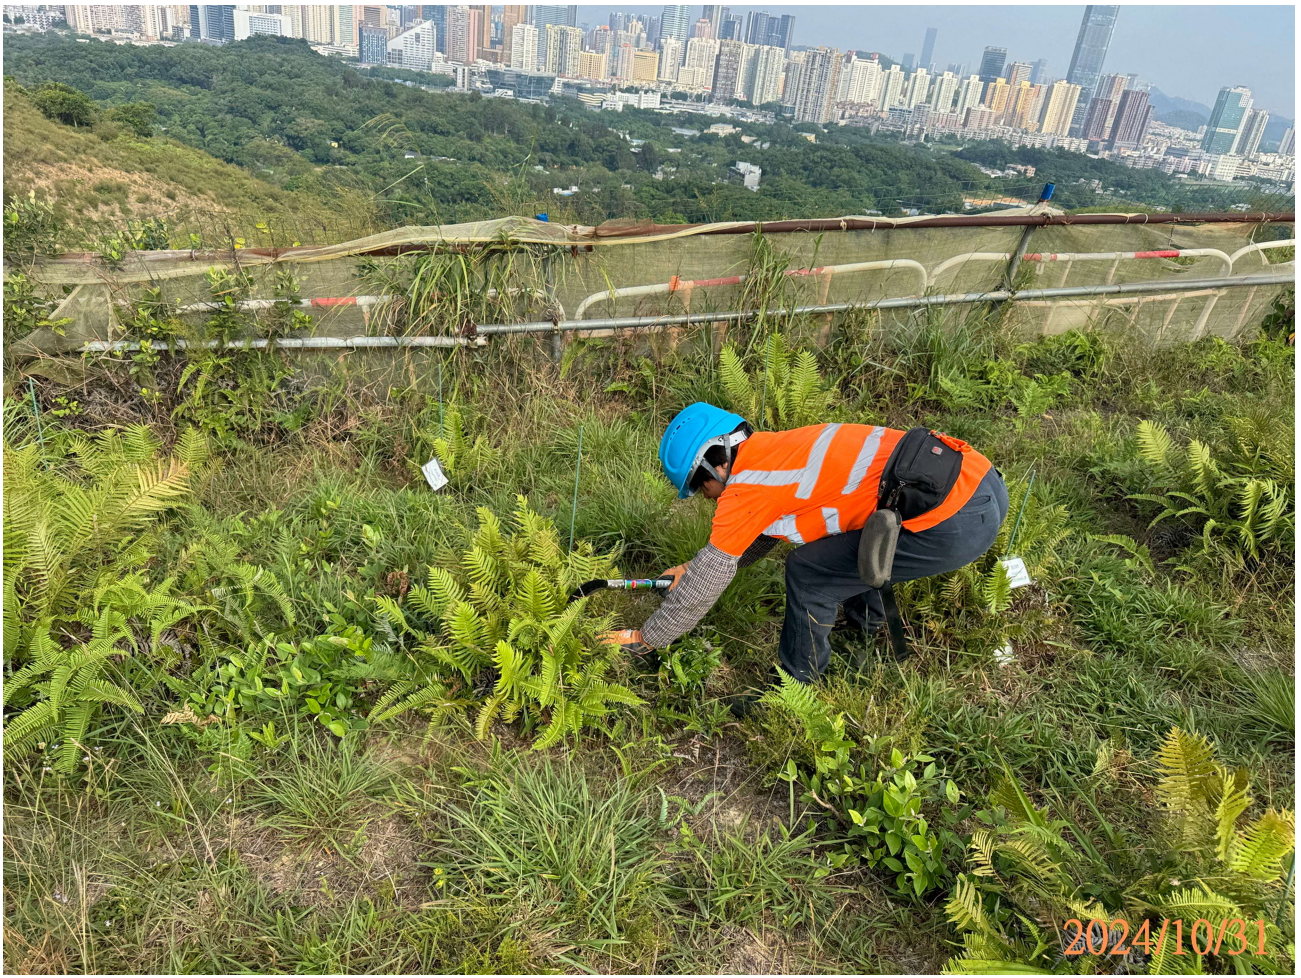
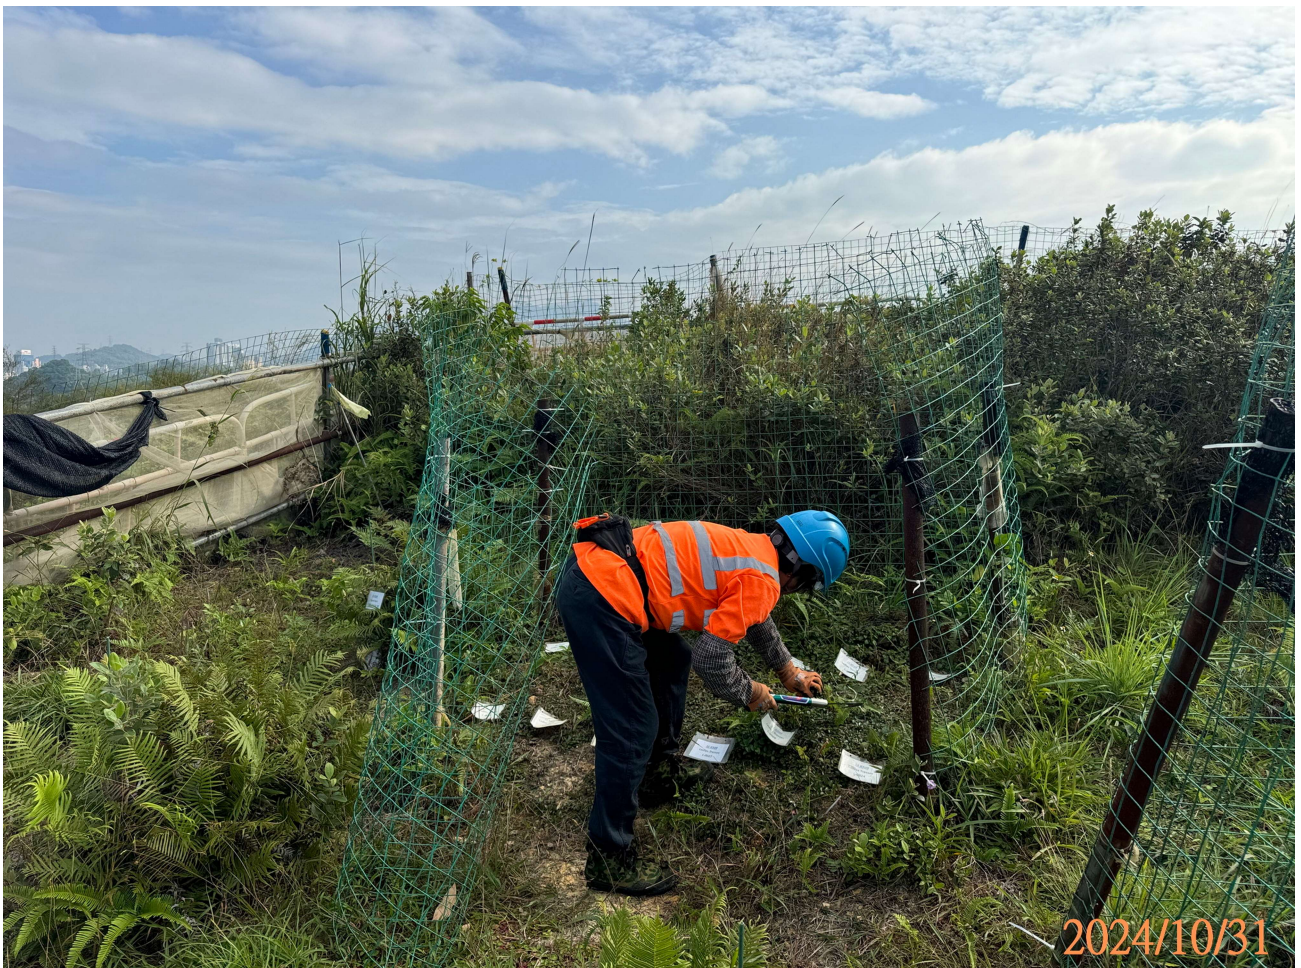
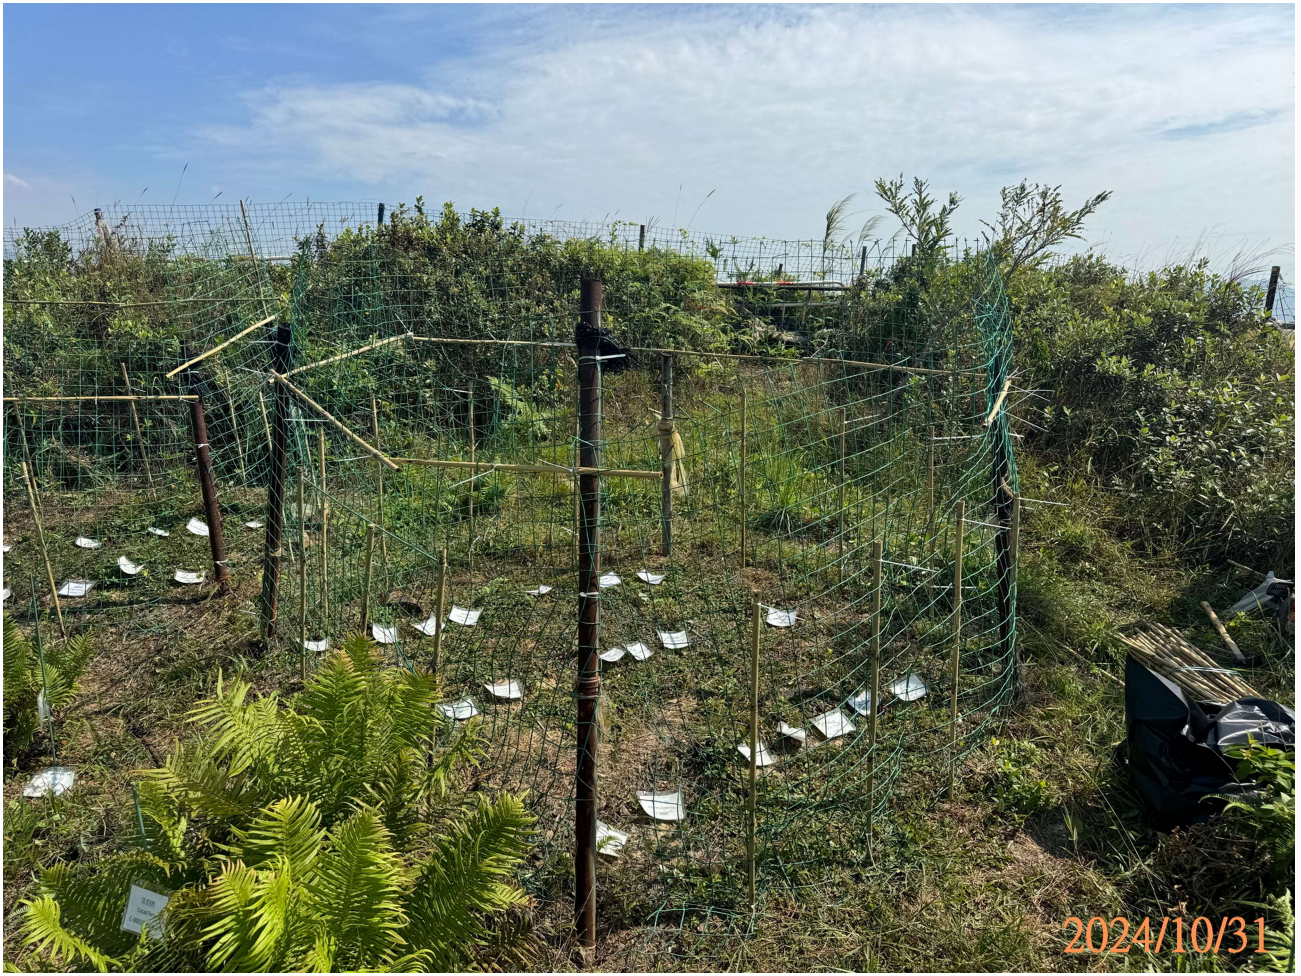
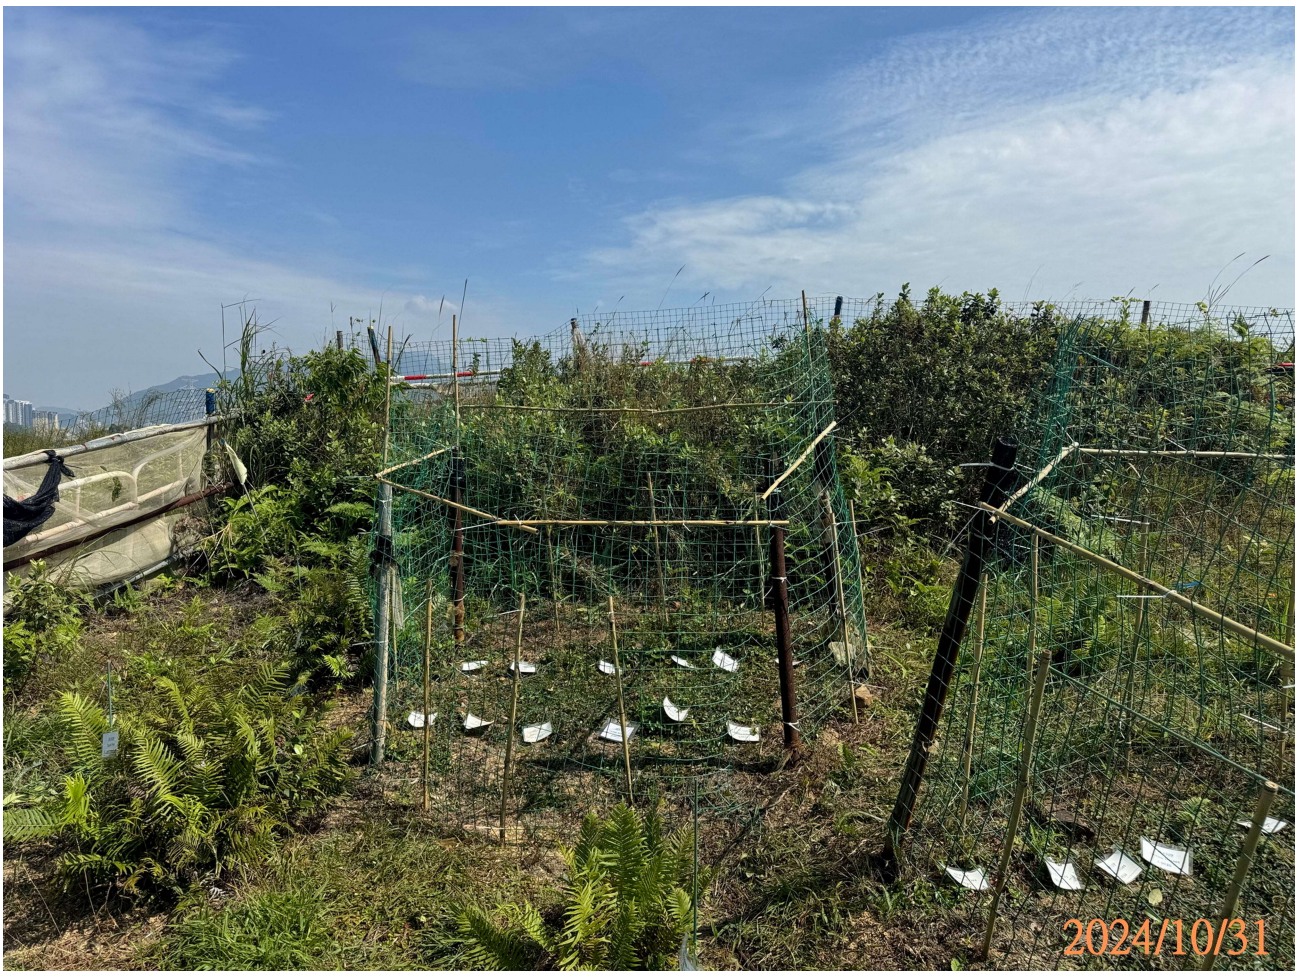
Description of Work	Date																														
	1	2	3	4	5	6	7	8	9	10	11	12	13	14	15	16	17	18	19	20	21	22	23	24	25	26	27	28	29	30	31
Watering		Y						Y				Y			Y				Y				Y		Y			Y			Y
Weeding																															Y
Fertilization																															
Pest/Disease Control																															
Firming up of fence																															Y
Installation of shaded net																															Y
Mulching																															
Inspection																															Y
Checking of Protection Zone																															Y
Remarks	MH,H, W	MH	MH	MH	MH	RH,H	MH,H	MH	MH,R	MH,R	RH,R	MH	RH	RH	RH	RH,R	RH,R	RH,R	MH,H	RH,R, W	RH,R	MH,H	MH	MH,W	MH	RH,R	MH	MH	MH	MH	MH

Maintenance works & inspection\_1

Maintenance works & inspection\_2

Maintenance works & inspection\_3

Maintenance works & inspection\_4

Maintenance works & inspection\_5

Maintenance works & inspection\_6
