**Provision of Independent Environmental Checker Consultancy for Design  
and Construction of Kong Nga Po Police Training Facilities  
Verification of Monthly EM&A Report (October 2024)**

**Provision of Environmental Team consultancy  
for Design and Construction of Kong Nga Po Police  
Training Facilities (Programme No. 279LP)**

**Monthly Environmental Monitoring and  
Audit Report for October 2024  
(Version 2)**

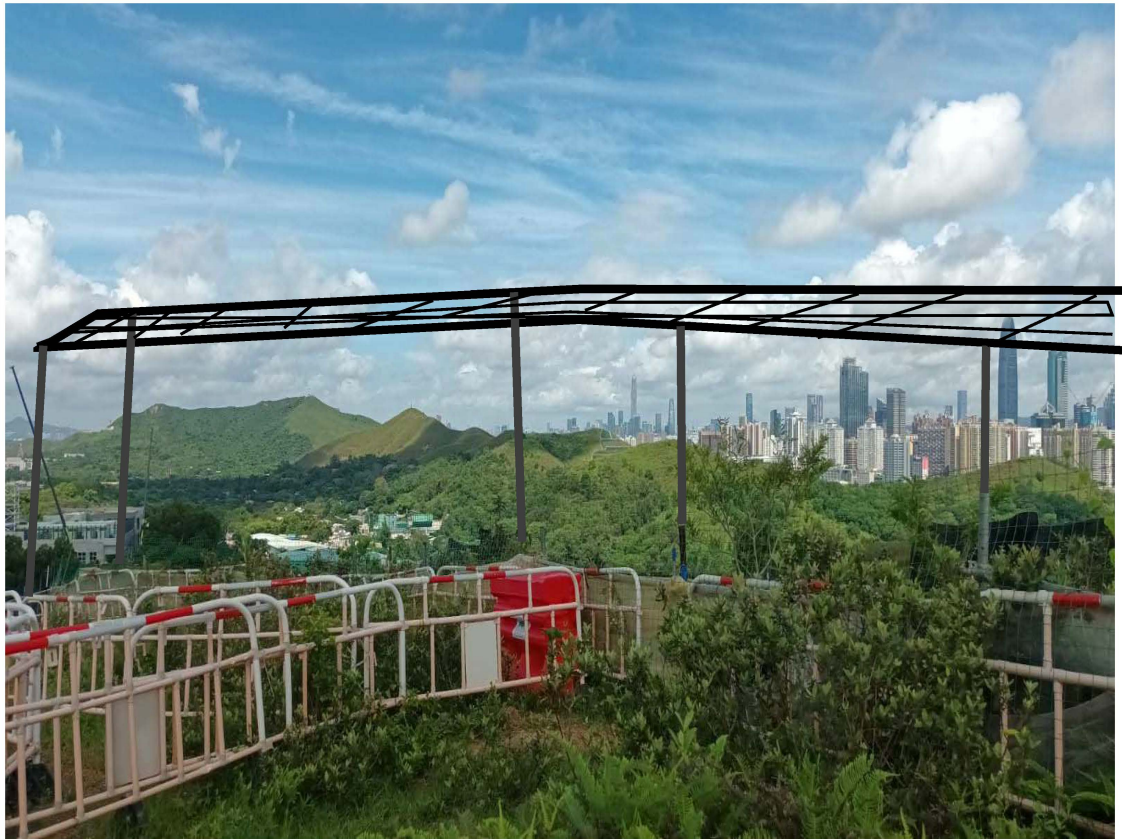
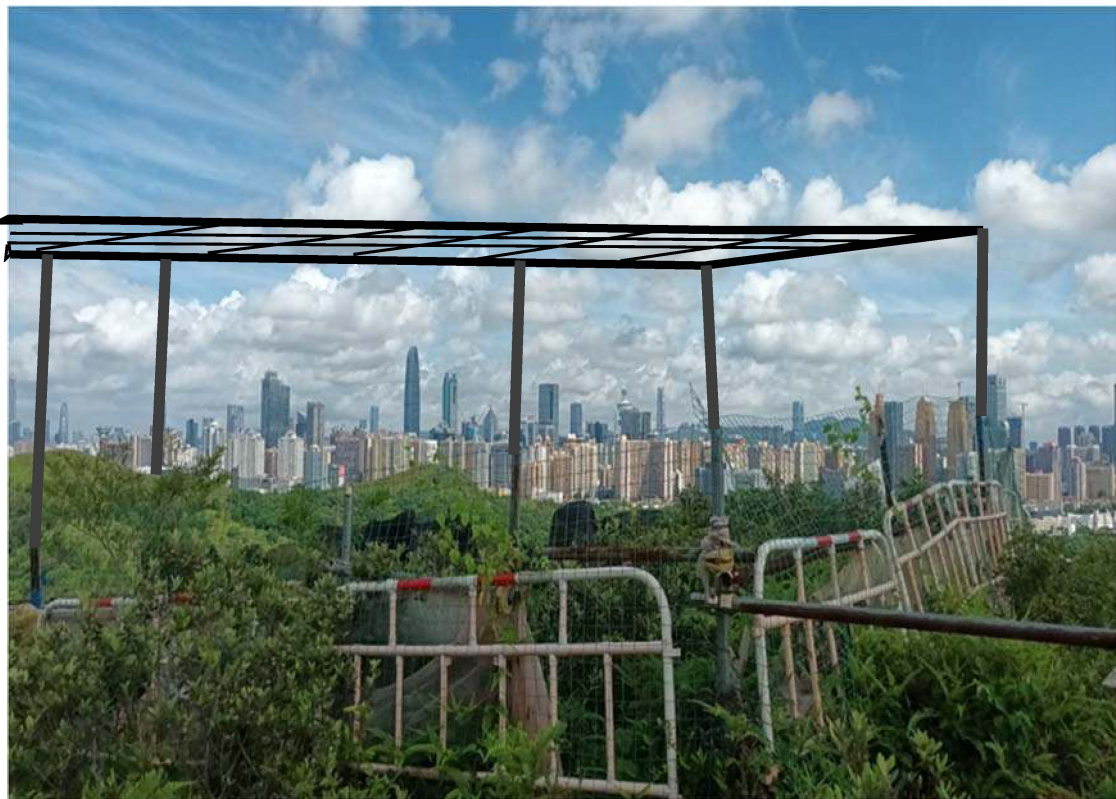
## The installation of a shaded net

Remark: Non scale & Conceptual drawing

- 1) Please refer to the guidelines on soil improvement issued by the Greening, Landscape and Tree Management Section (GLTMS) of the development bureau (2022) to apply to monitoring and maintenance of transplanted flora species.
- 2) Daily watering frequency is needed to keep the soil moist.
- 3) Installation of a shaded net is provided below.
- 4) The wild plants that are growing in undesirable areas should be removed.
- 5) The damaged Black Shade Net should be repaired or replaced with a new one.
