**Agreement No. CE 64/2020 (EP)
Environmental Team for
Tung Chung New Town
Extension (West) –
Design and Construction**

Monthly Environmental Monitoring & Audit Report
for February 2024

Environmental Permit No. EP-519/2016

Tung Chung New Town Extension (West)

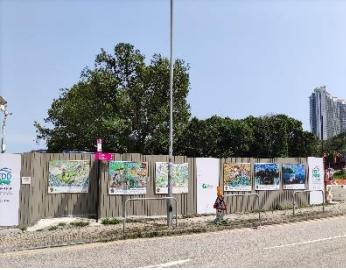
Erection of site hoardings around works area in unobtrusive colours	General view of tree protection zone for retained tree	Transplanting of existing trees to temporary nursery site

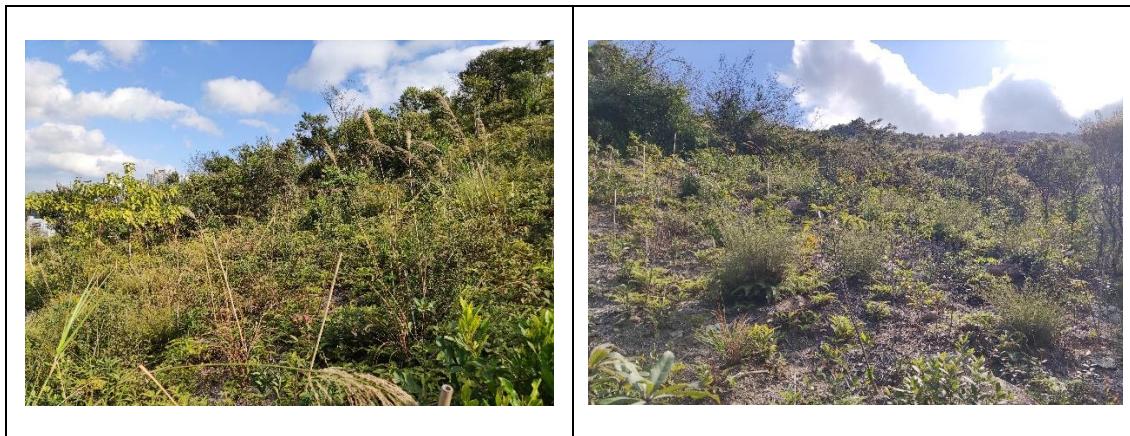
Table 7.6: Photos of the Compensation Woodland Planting

commenced in November 2022. Photos of the Compensation Woodland planting are shown in **Table 7.6**.

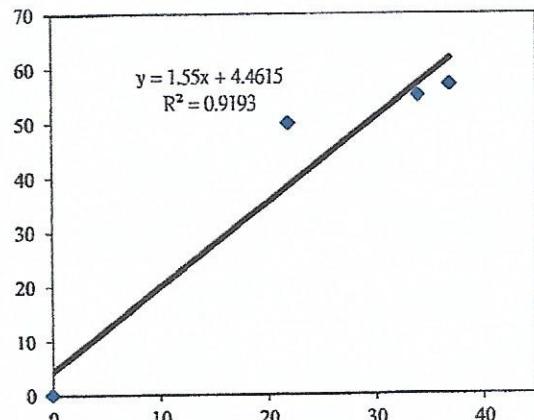
Slope (K-factor): 1.5500($\mu\text{g}/\text{m}^3$)/CPM
 Correlation Coefficient (R): 0.9588
 Date of Issue: 1-Jun-2023

1. Strong Correlation (>0.8)
2. Factor 1.5500 ($\mu\text{g}/\text{m}^3$)/CPM should be applied for TSP monitoring

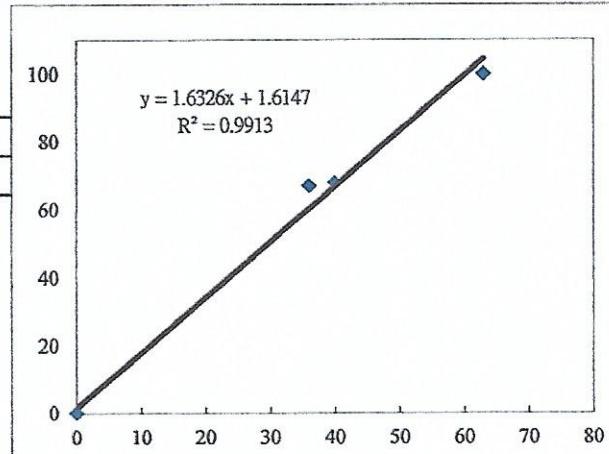
Slope (K-factor): 1.6326($\mu\text{g}/\text{m}^3$)/CPM
 Correlation Coefficient (R): 0.9956
 Date of Issue: 29-Mar-2023

1. Strong Correlation (>0.8)
2. Factor 1.6326 ($\mu\text{g}/\text{m}^3$)/CPM should be applied for TSP monitoring

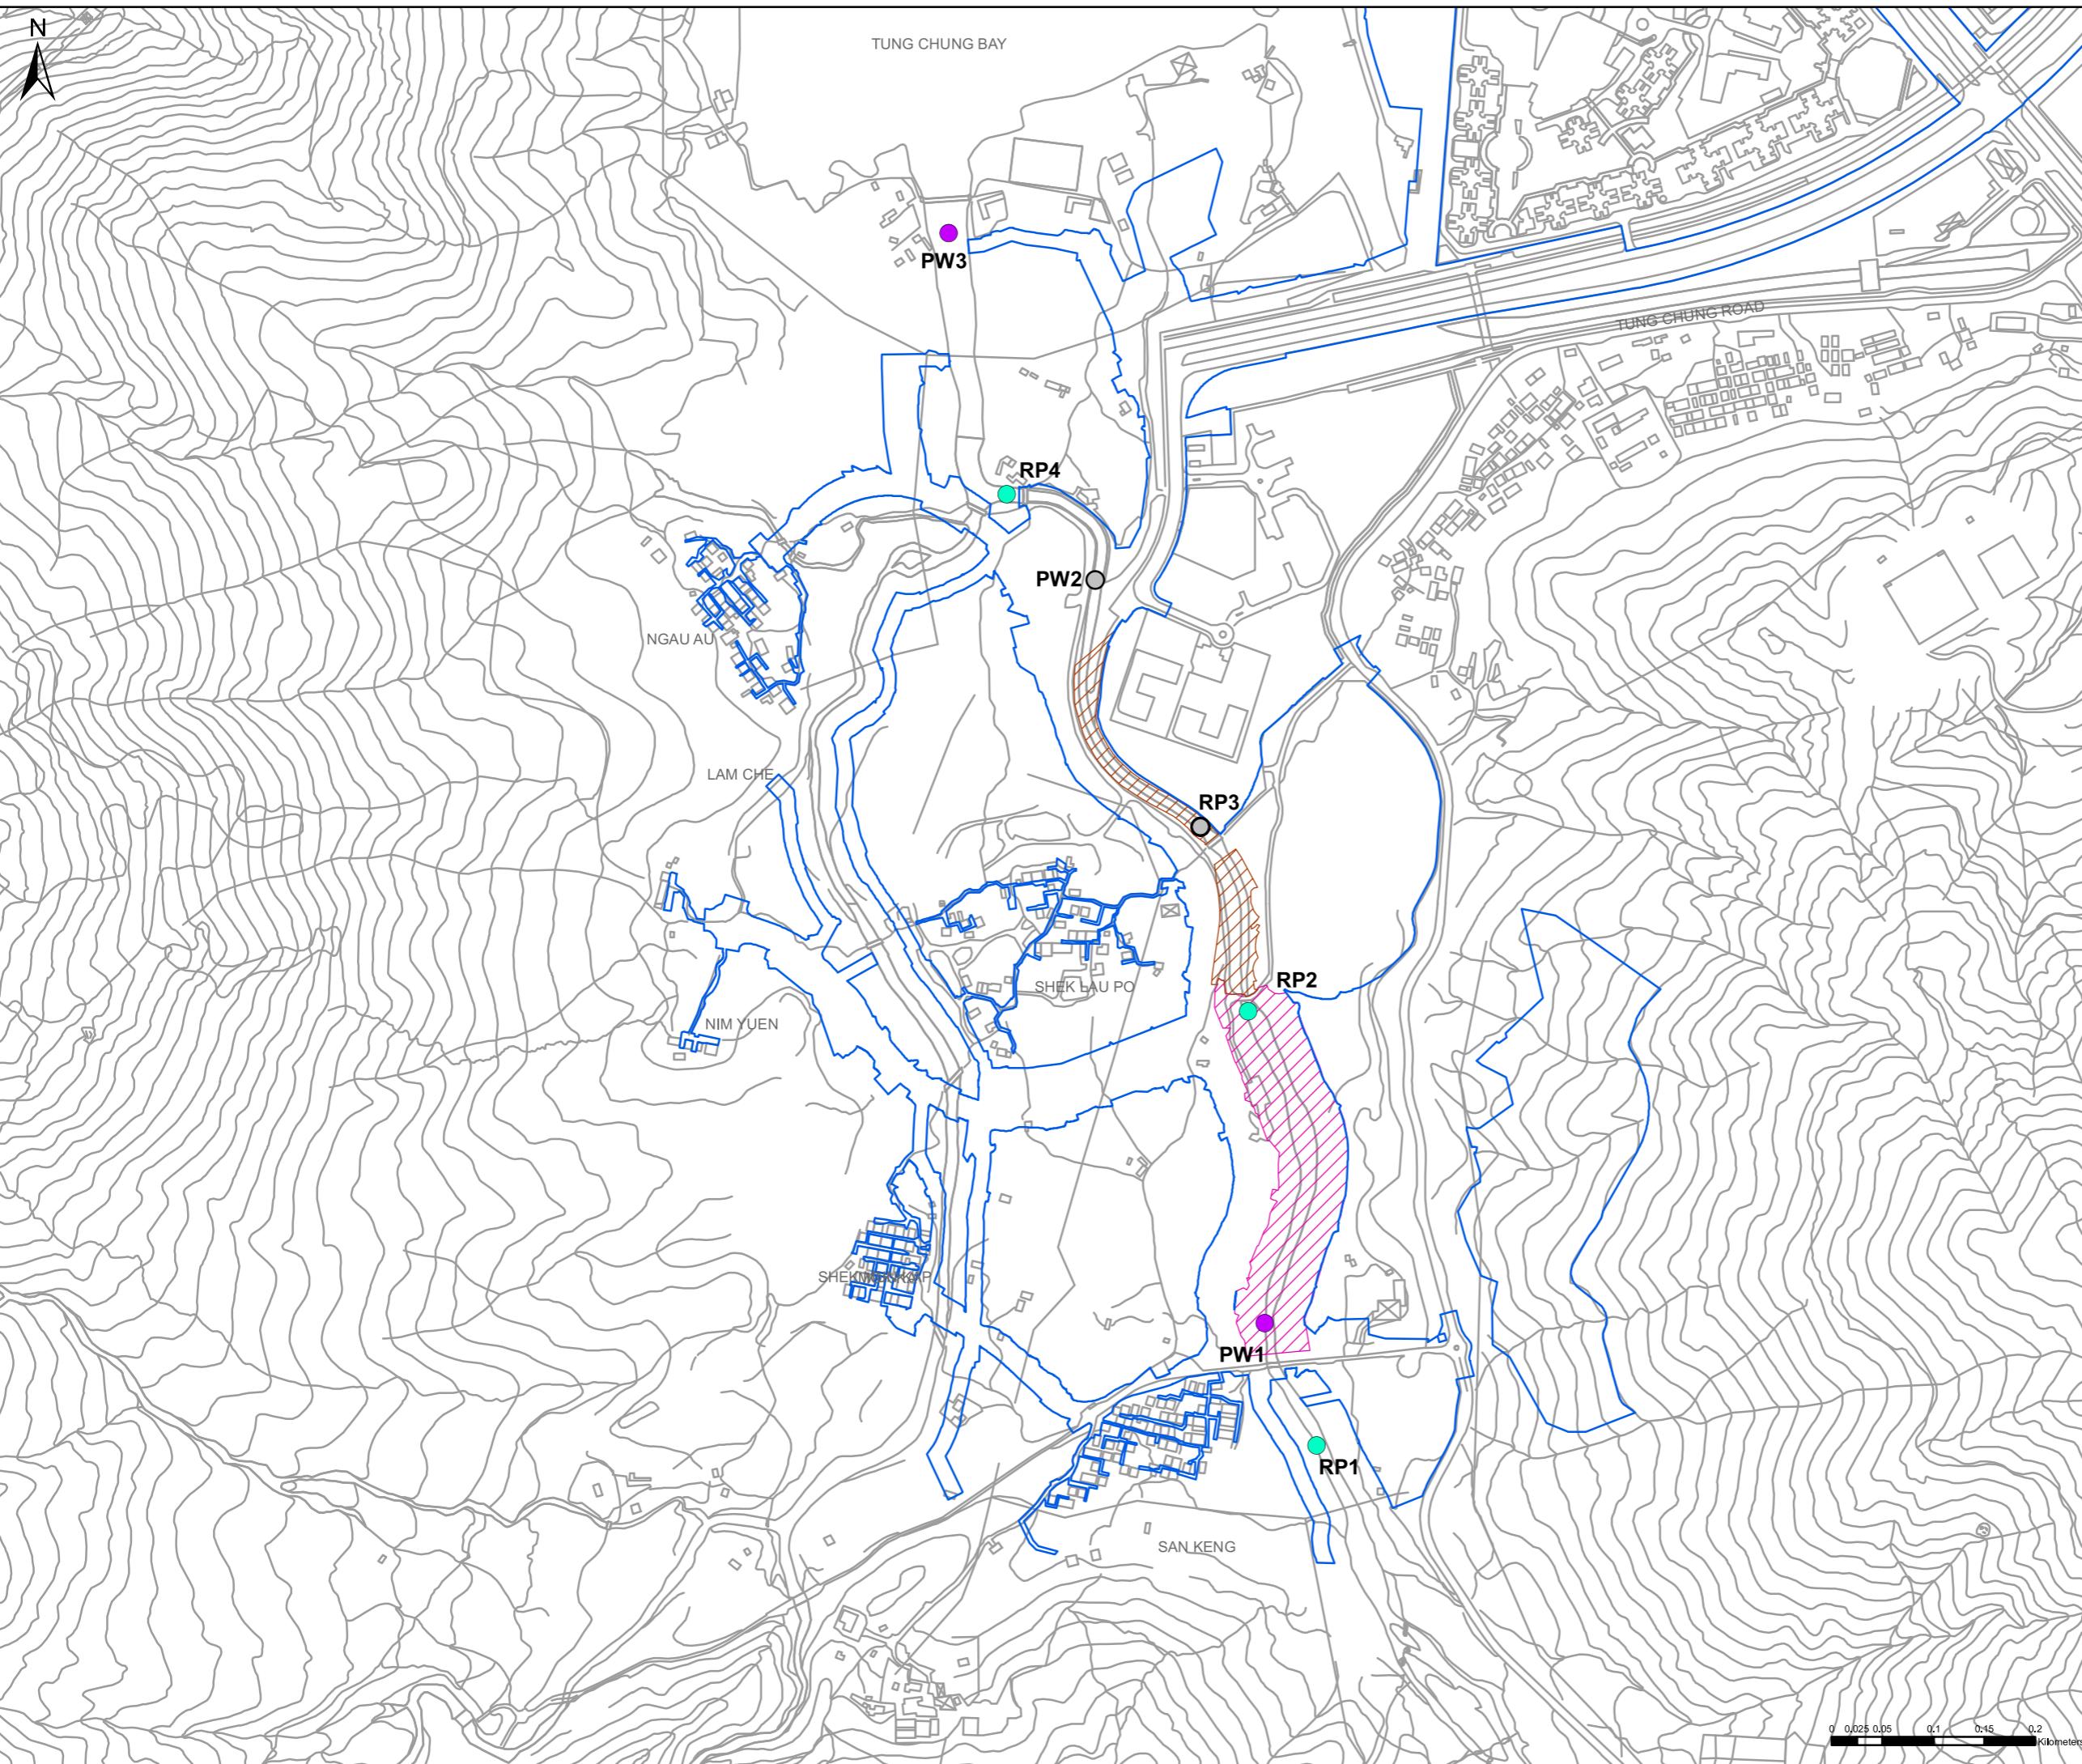
I1. Location of Ecological Impact Monitoring Stations

1. Ecological monitoring at the monitoring station RP3 and PW2 were suspended since March 2023 with the commencement of temporary river diversion in Tung Chung Stream.

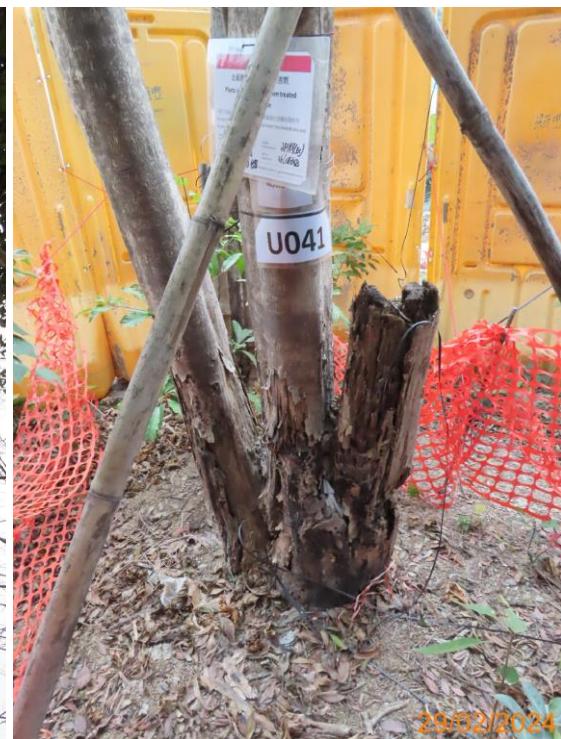
8: U041_Dead stump

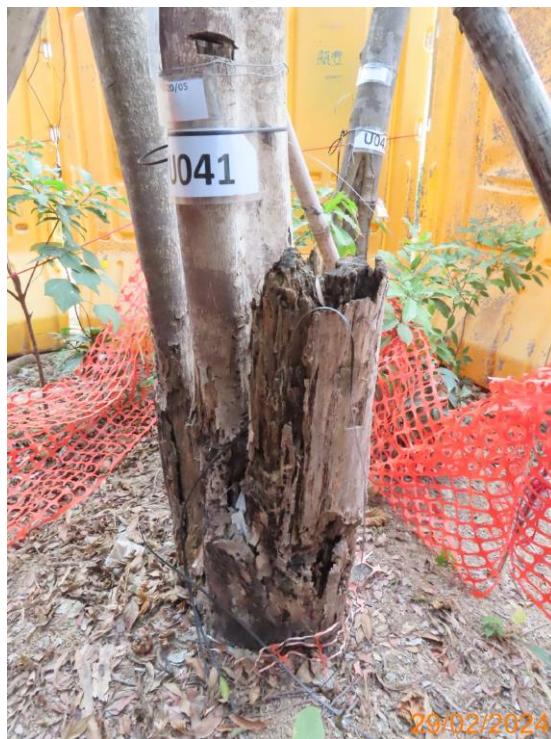
9: U041_Dead stump_Close up

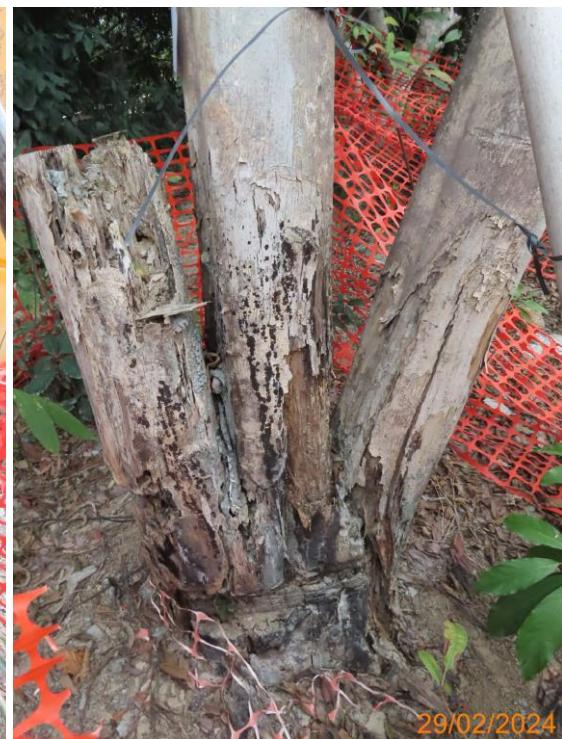
10: U041_Wood damage at trunk union

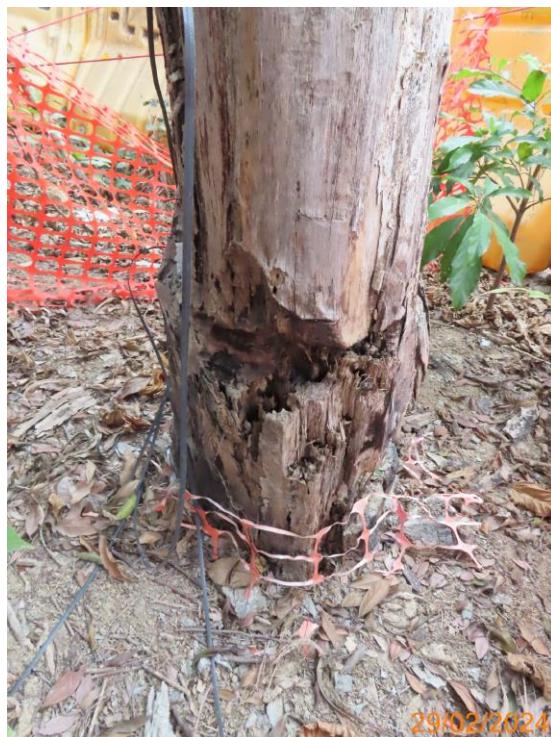
11: U041_Wood damage by termite

The condition of the individual was closely monitored and reviewed by QB. Monthly monitoring was conducted by QB appointed under Contract 5 on 29 February 2024. Application of termiticide was carried out at the individual of *Aquilaria sinensis* (Tree No. U041) under Contract 5. No obvious old termite tracks were found at the individual during the reporting period. Application of termiticide was conducted by QB. Wound wood development was observed at the individual of *Gmelina chinensis* (Tree No. U042) under Contract 5. Application of pesticide was conducted by QB. No fungal fruiting bodies were found at the individual of *Aquilaria sinensis* (Tree No. U043) under Contract 5. Application of fungicide and termiticide were conducted by QB. No live termite was found at the individual of *Canthium dicoccum* (Tree No. T8217) and application of termiticide was conducted by QB as preventive measure.

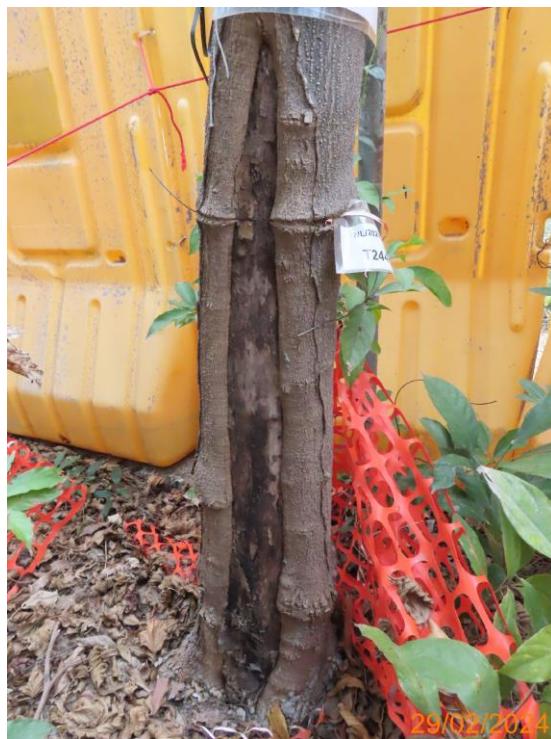
13: U042_Wound on trunk

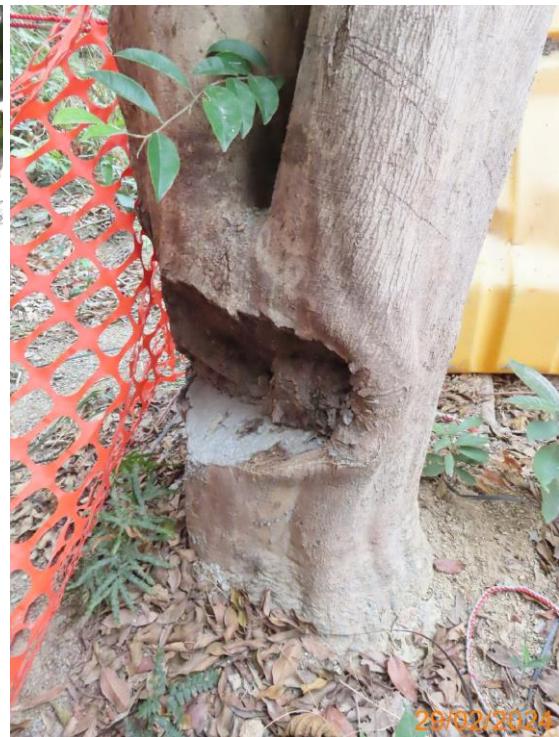
16: U043_Wound on trunk#1

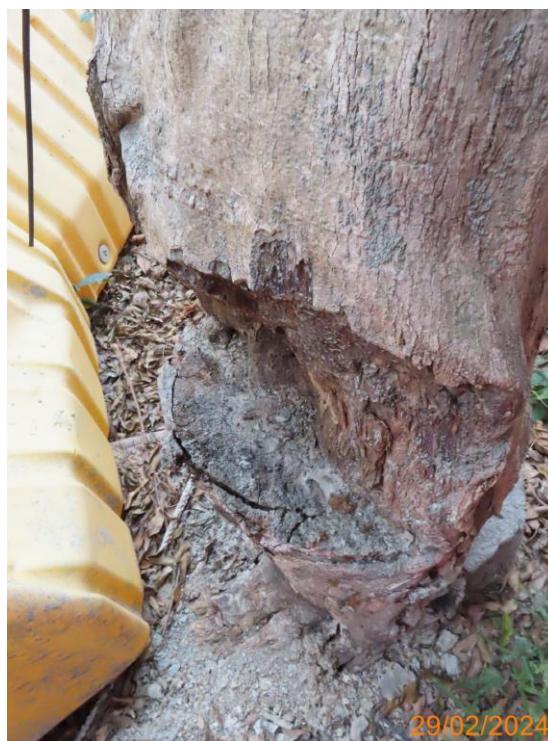
17: U043_Wound on trunk#2

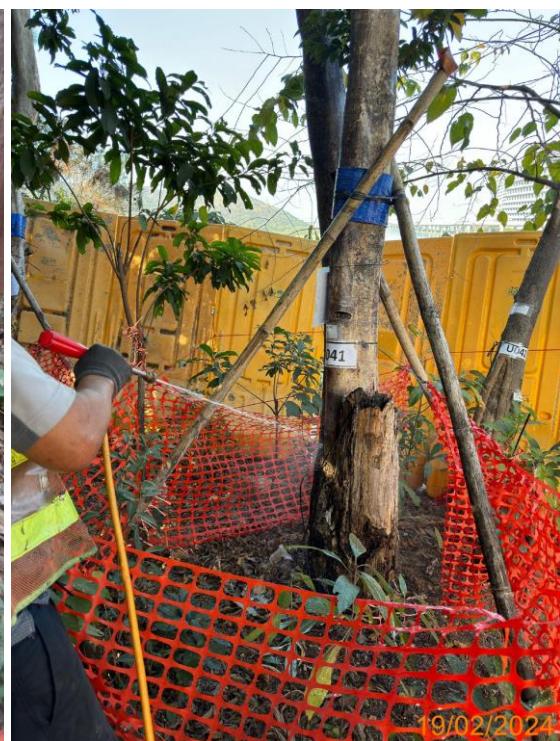
18: Spraying of termiteicide

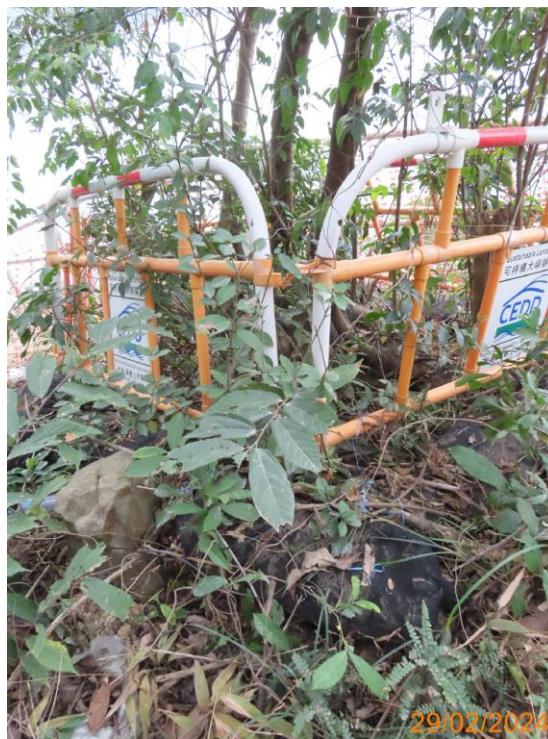
19: Slit rock and protection zone

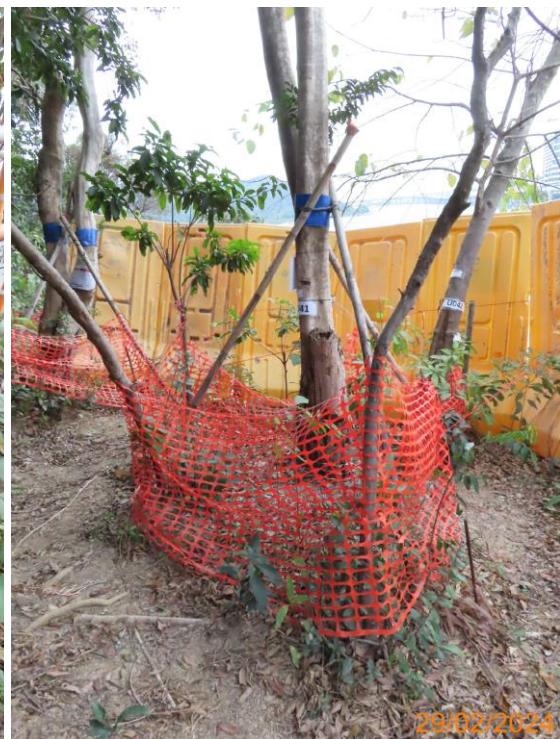
20: Temporary protective fencing for U041, U042 and U043

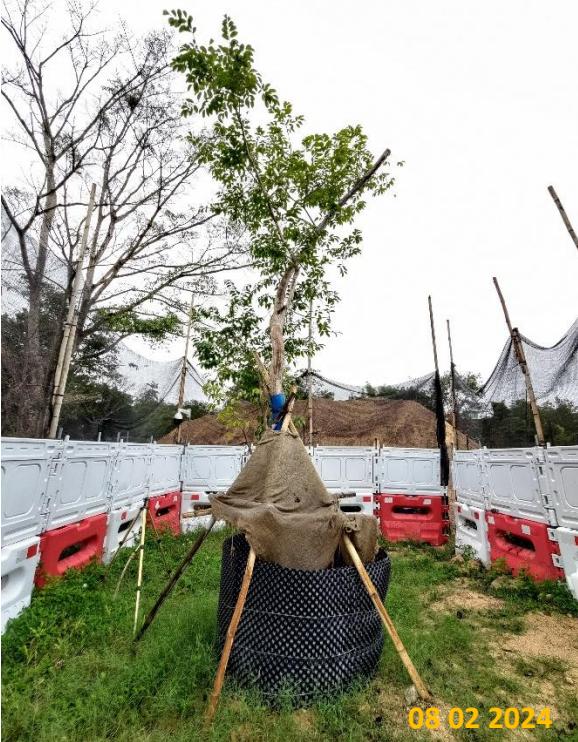
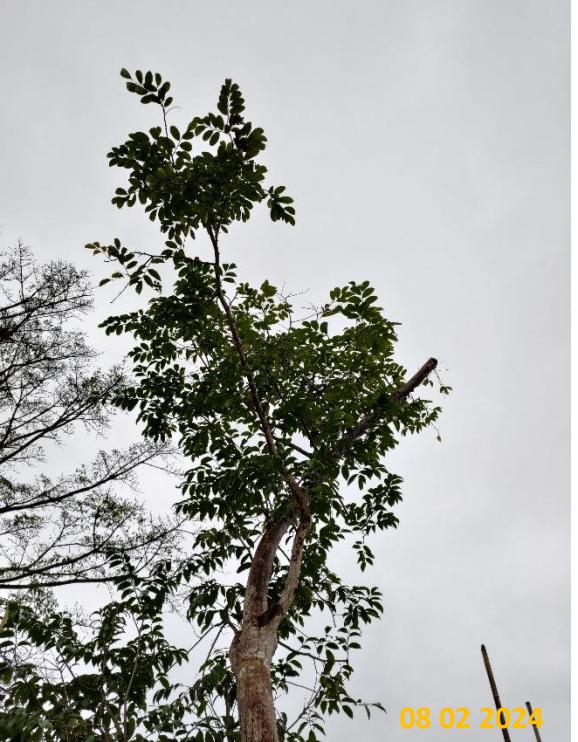
A8 – Overall view	A8 – Foliage density was similar comparing to last inspection photos. While leaves were greener

08 02 2024
A8 – Pruning wound previously damaged by typhoon Koinu (Oct 2023)	A8 – trunk condition.

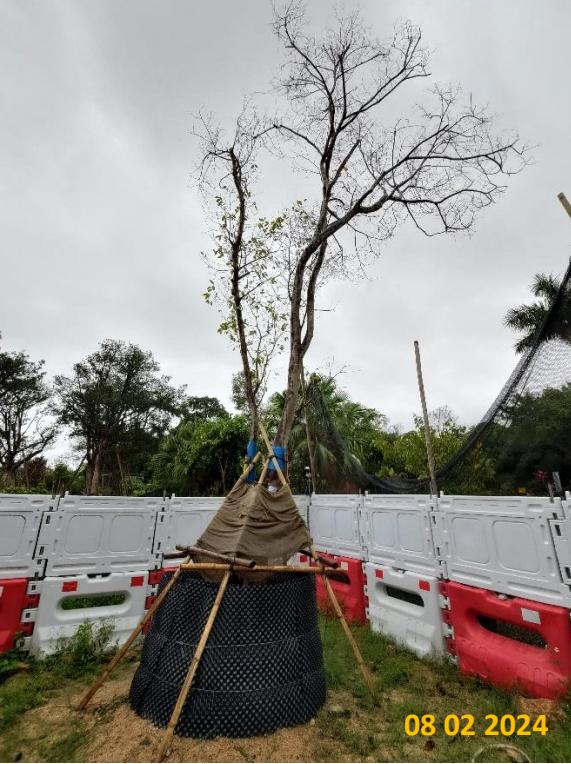
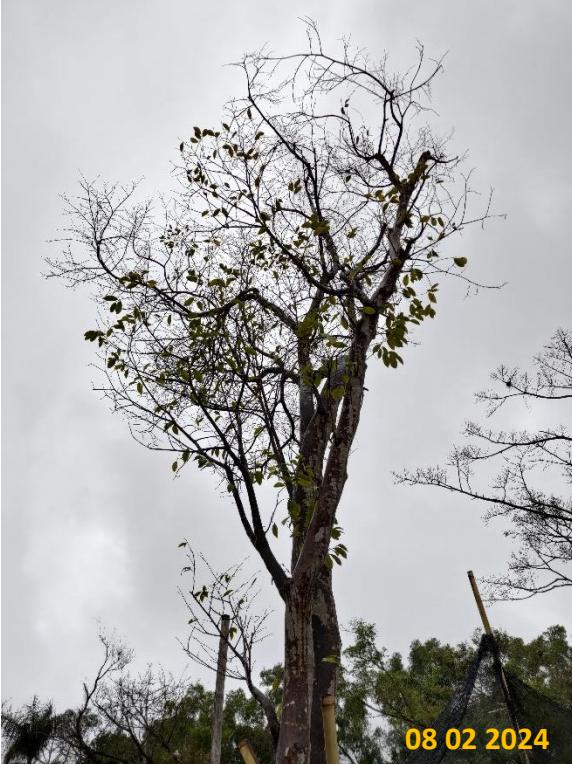
A12 - Overall View	A12 – Foliage density is low since its collapse during Typhoon KINU

08 02 2024
A12 – Codominant branch with included bark	A12 – trunk and root condition

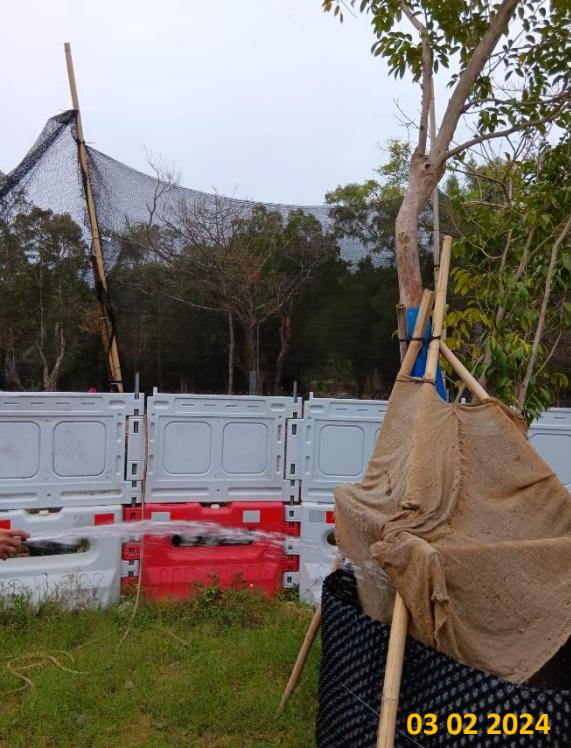
<p>Manual watering was carried out for A8 during the reporting period. The watering frequency is three time per week.</p>

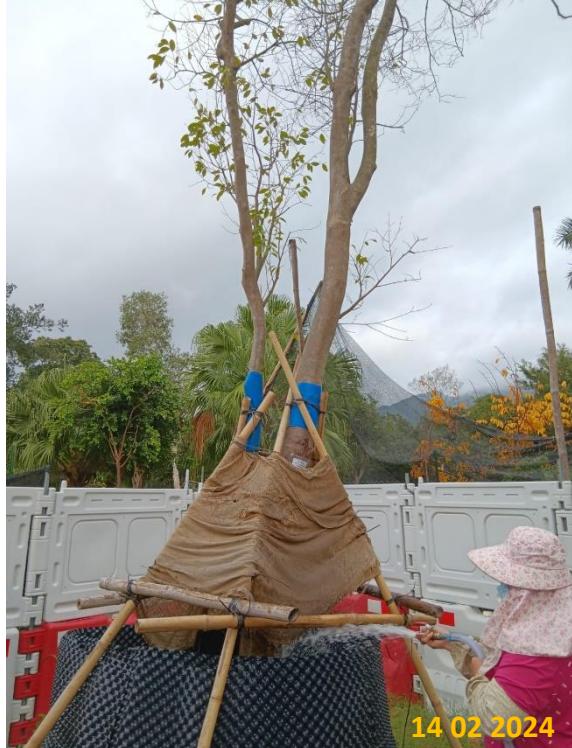
<p>03 02 2024</p>	<p>Manual watering was carried out for A12 during the reporting period. The watering frequency is three time per week.</p>

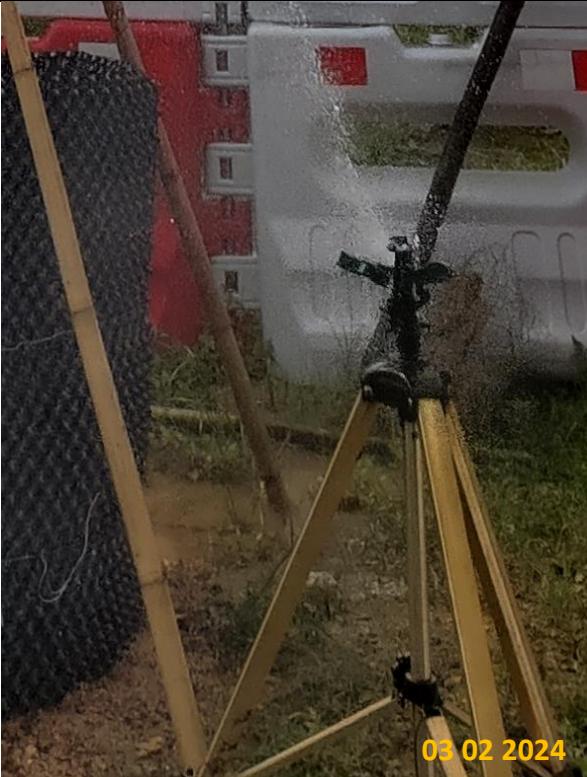
<p>14 02 2024</p>
<p>The semiautomatic irrigation was checked and is in order. The watering frequency is three times per week</p>
