Agreement No. CE 60/2017 (EP)

**Environmental Team for
Tung Chung New Town Extension (East) -
Design and Construction**

**Monthly Environmental Monitoring & Audit Report
for December 2018**

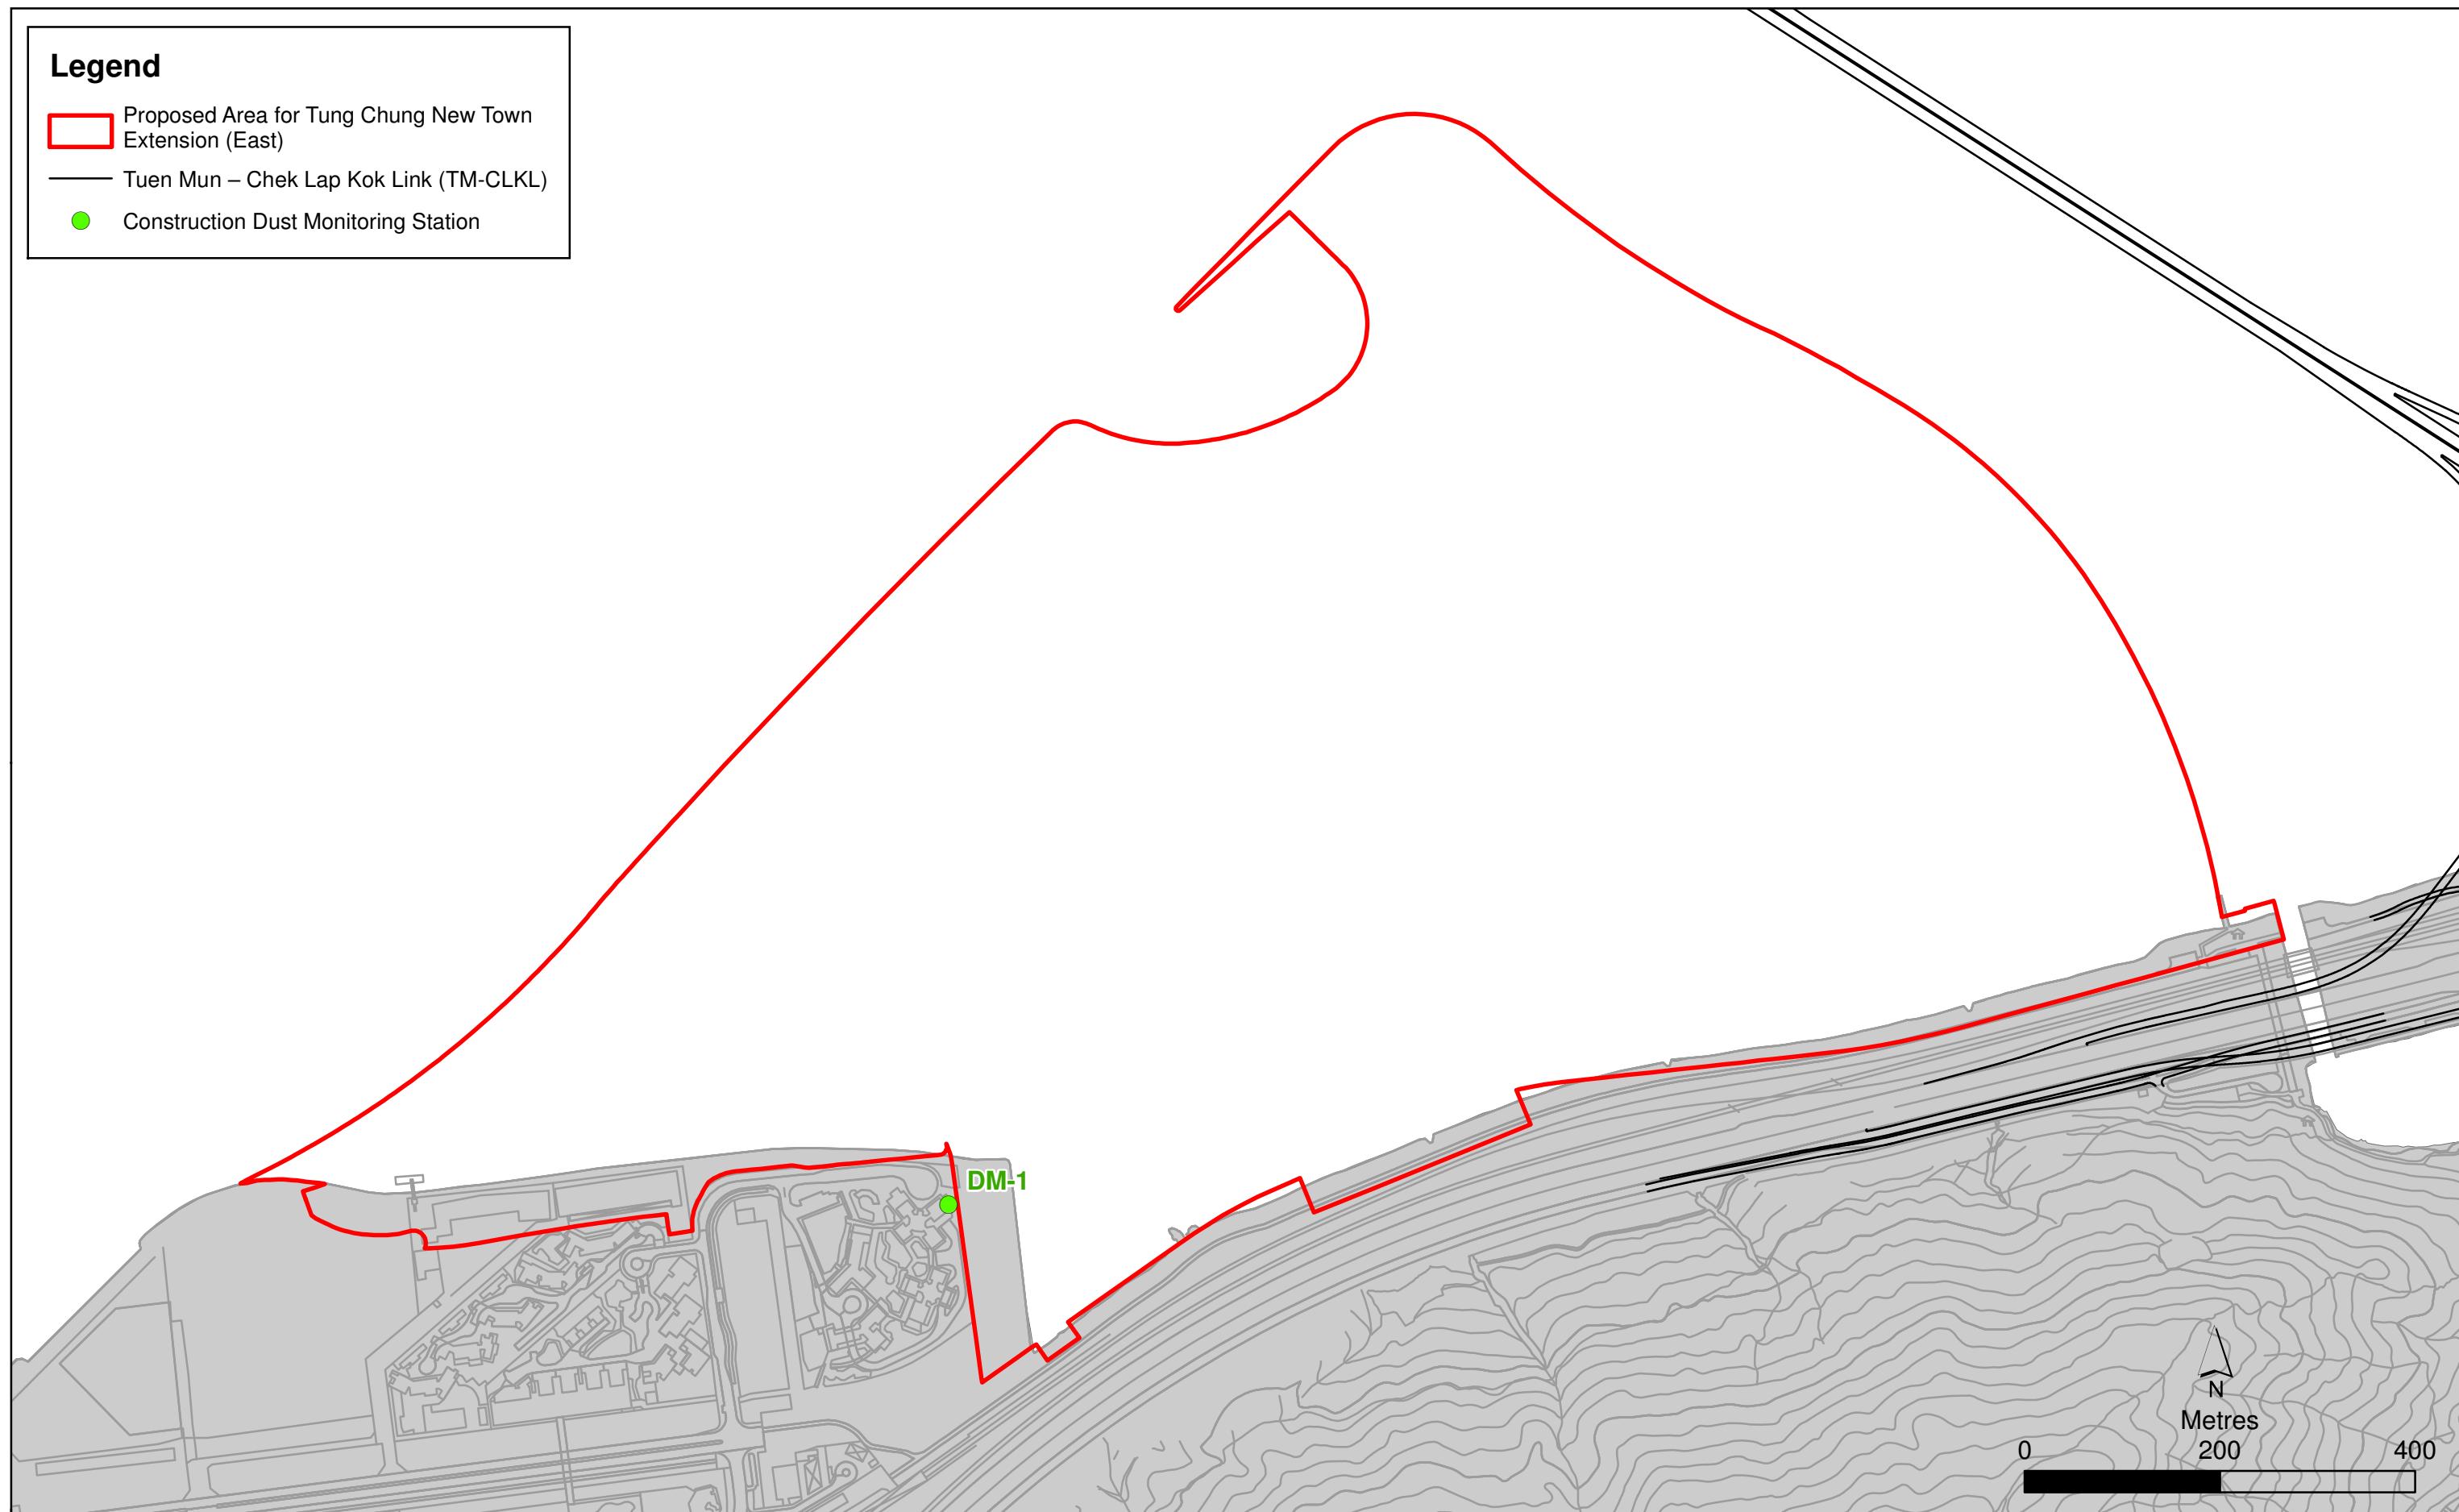
Figure 2.1

Construction Dust Monitoring Station Location

The monitoring location and equipment used in the impact air quality monitoring programme are summarized in *Table 2.2* and illustrated in *Figure 2.1*. Copies of the calibration certificates for the equipment are presented in *Annex D1*, which showed that the portable direct reading dust meter is capable of providing comparable results with that provided by a HVS.

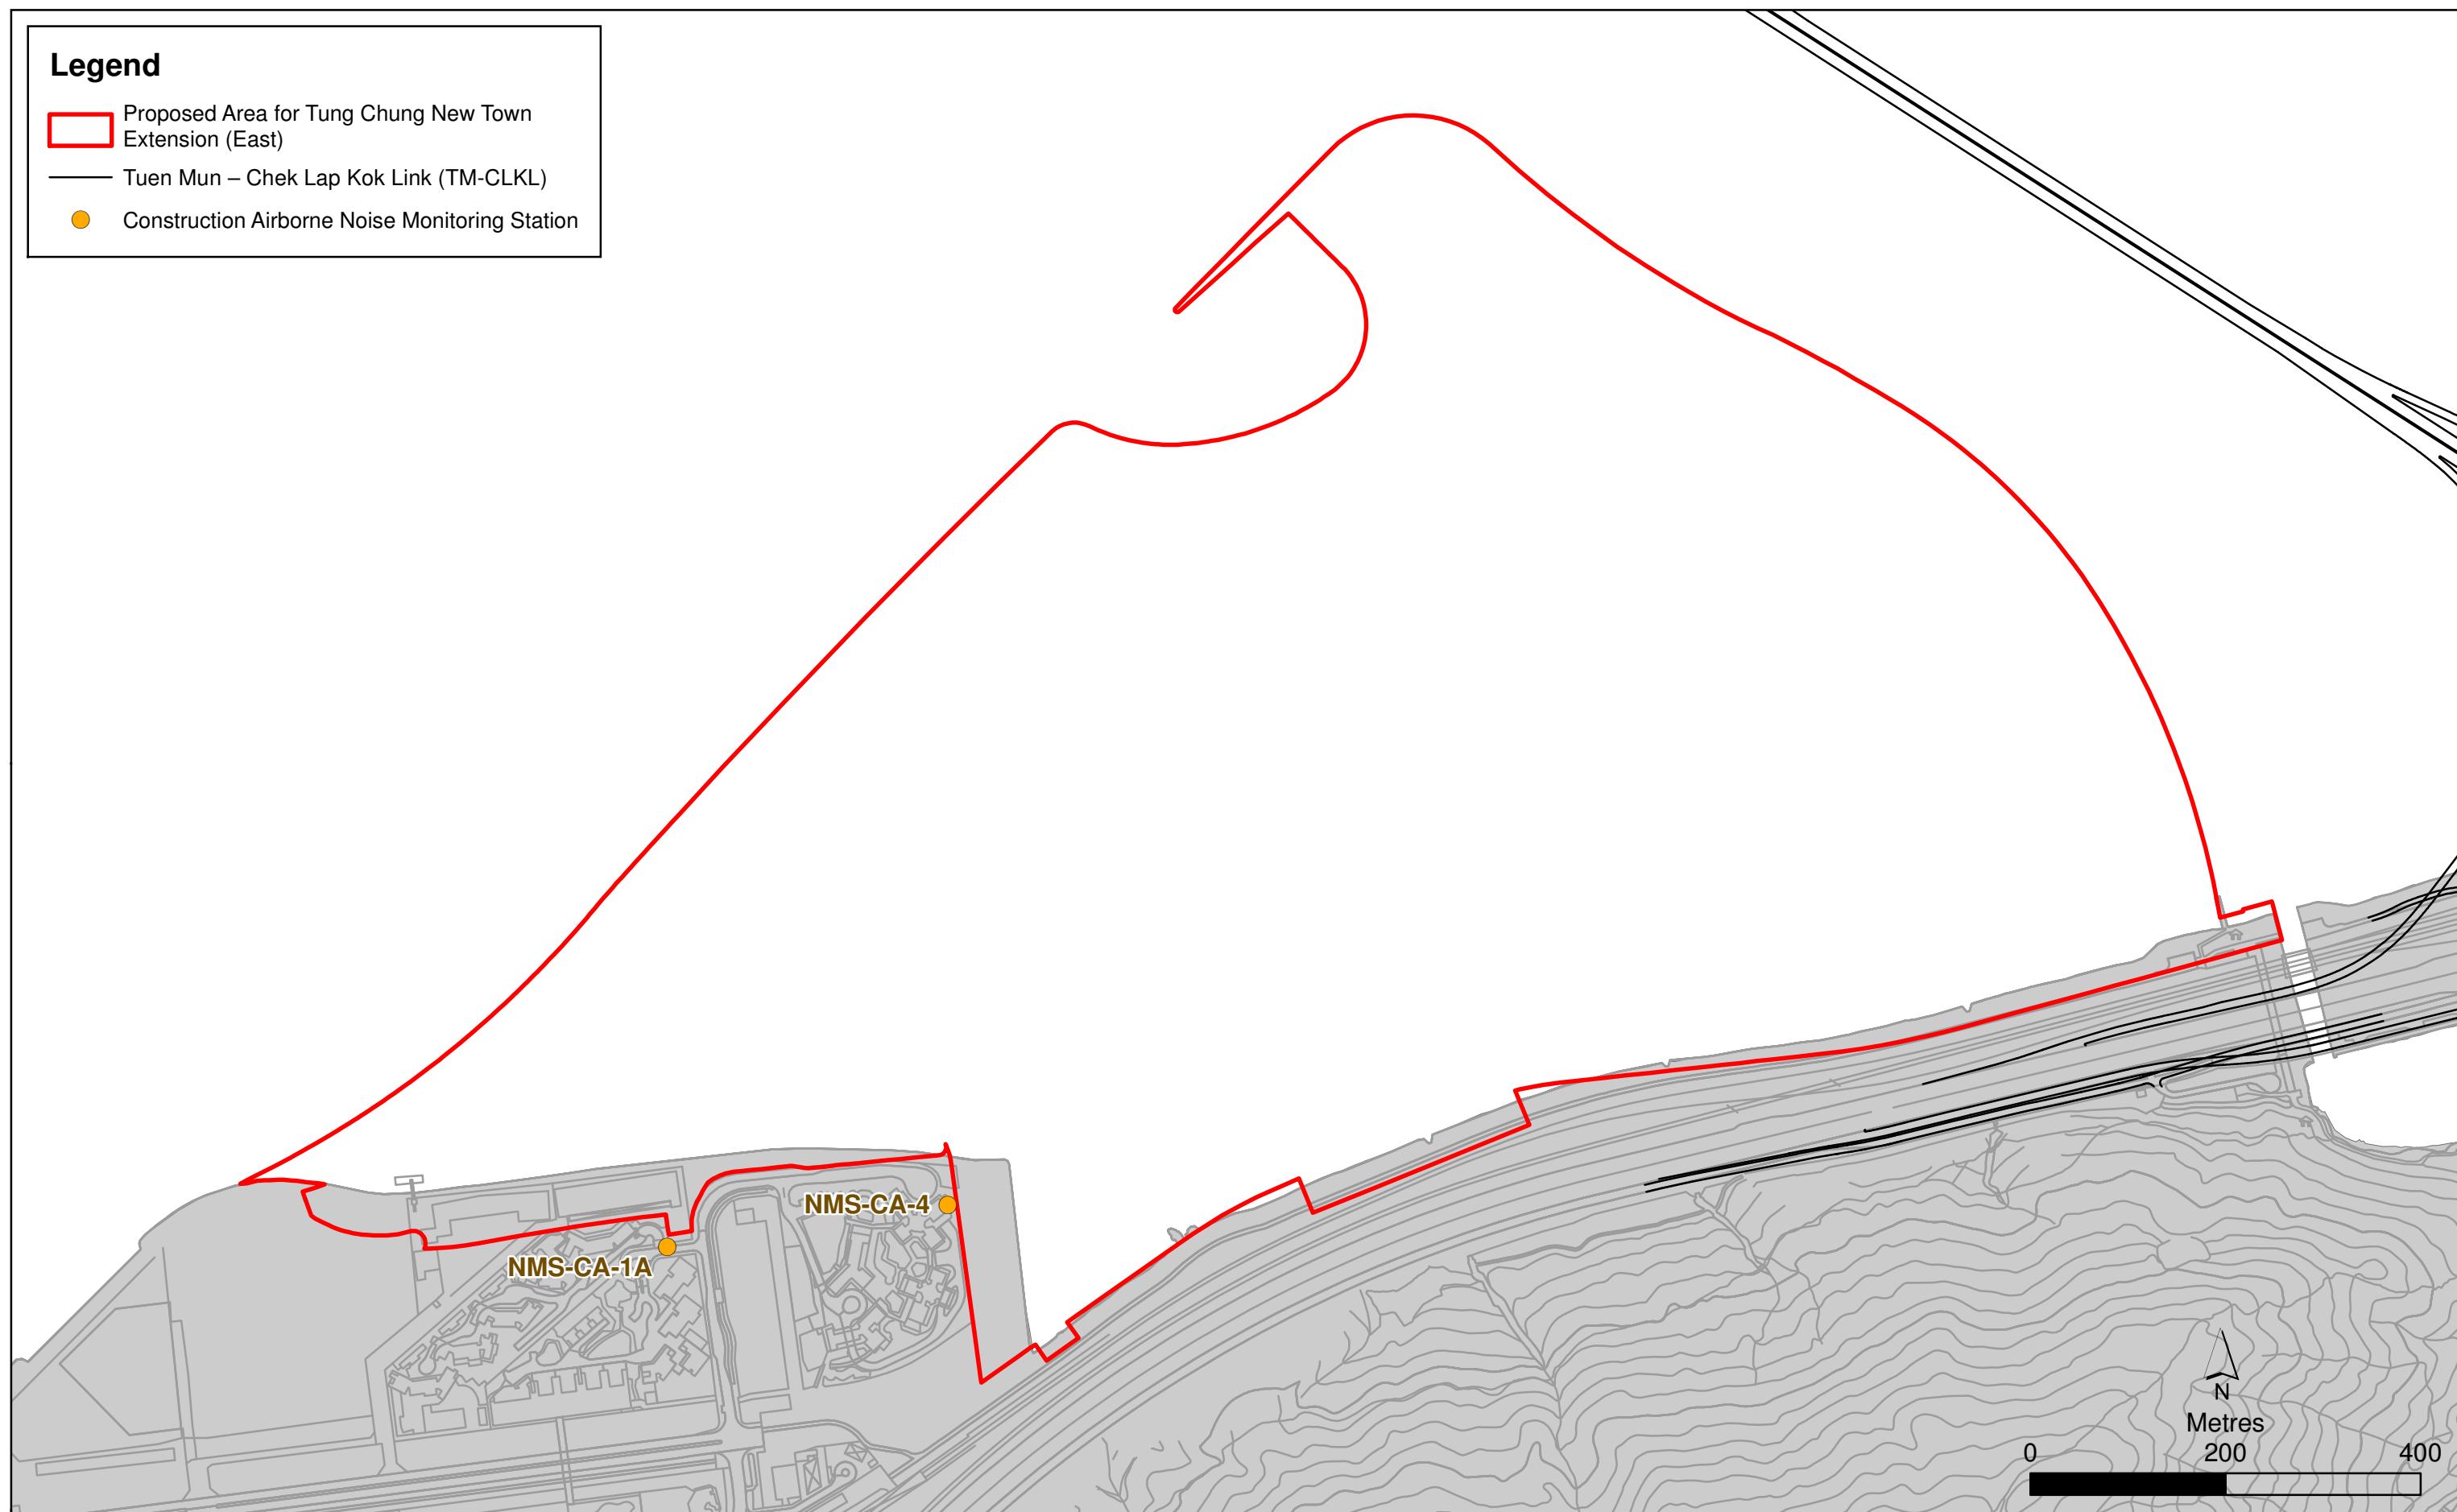
Figure 2.2

Construction Airborne Noise Monitoring Station Location

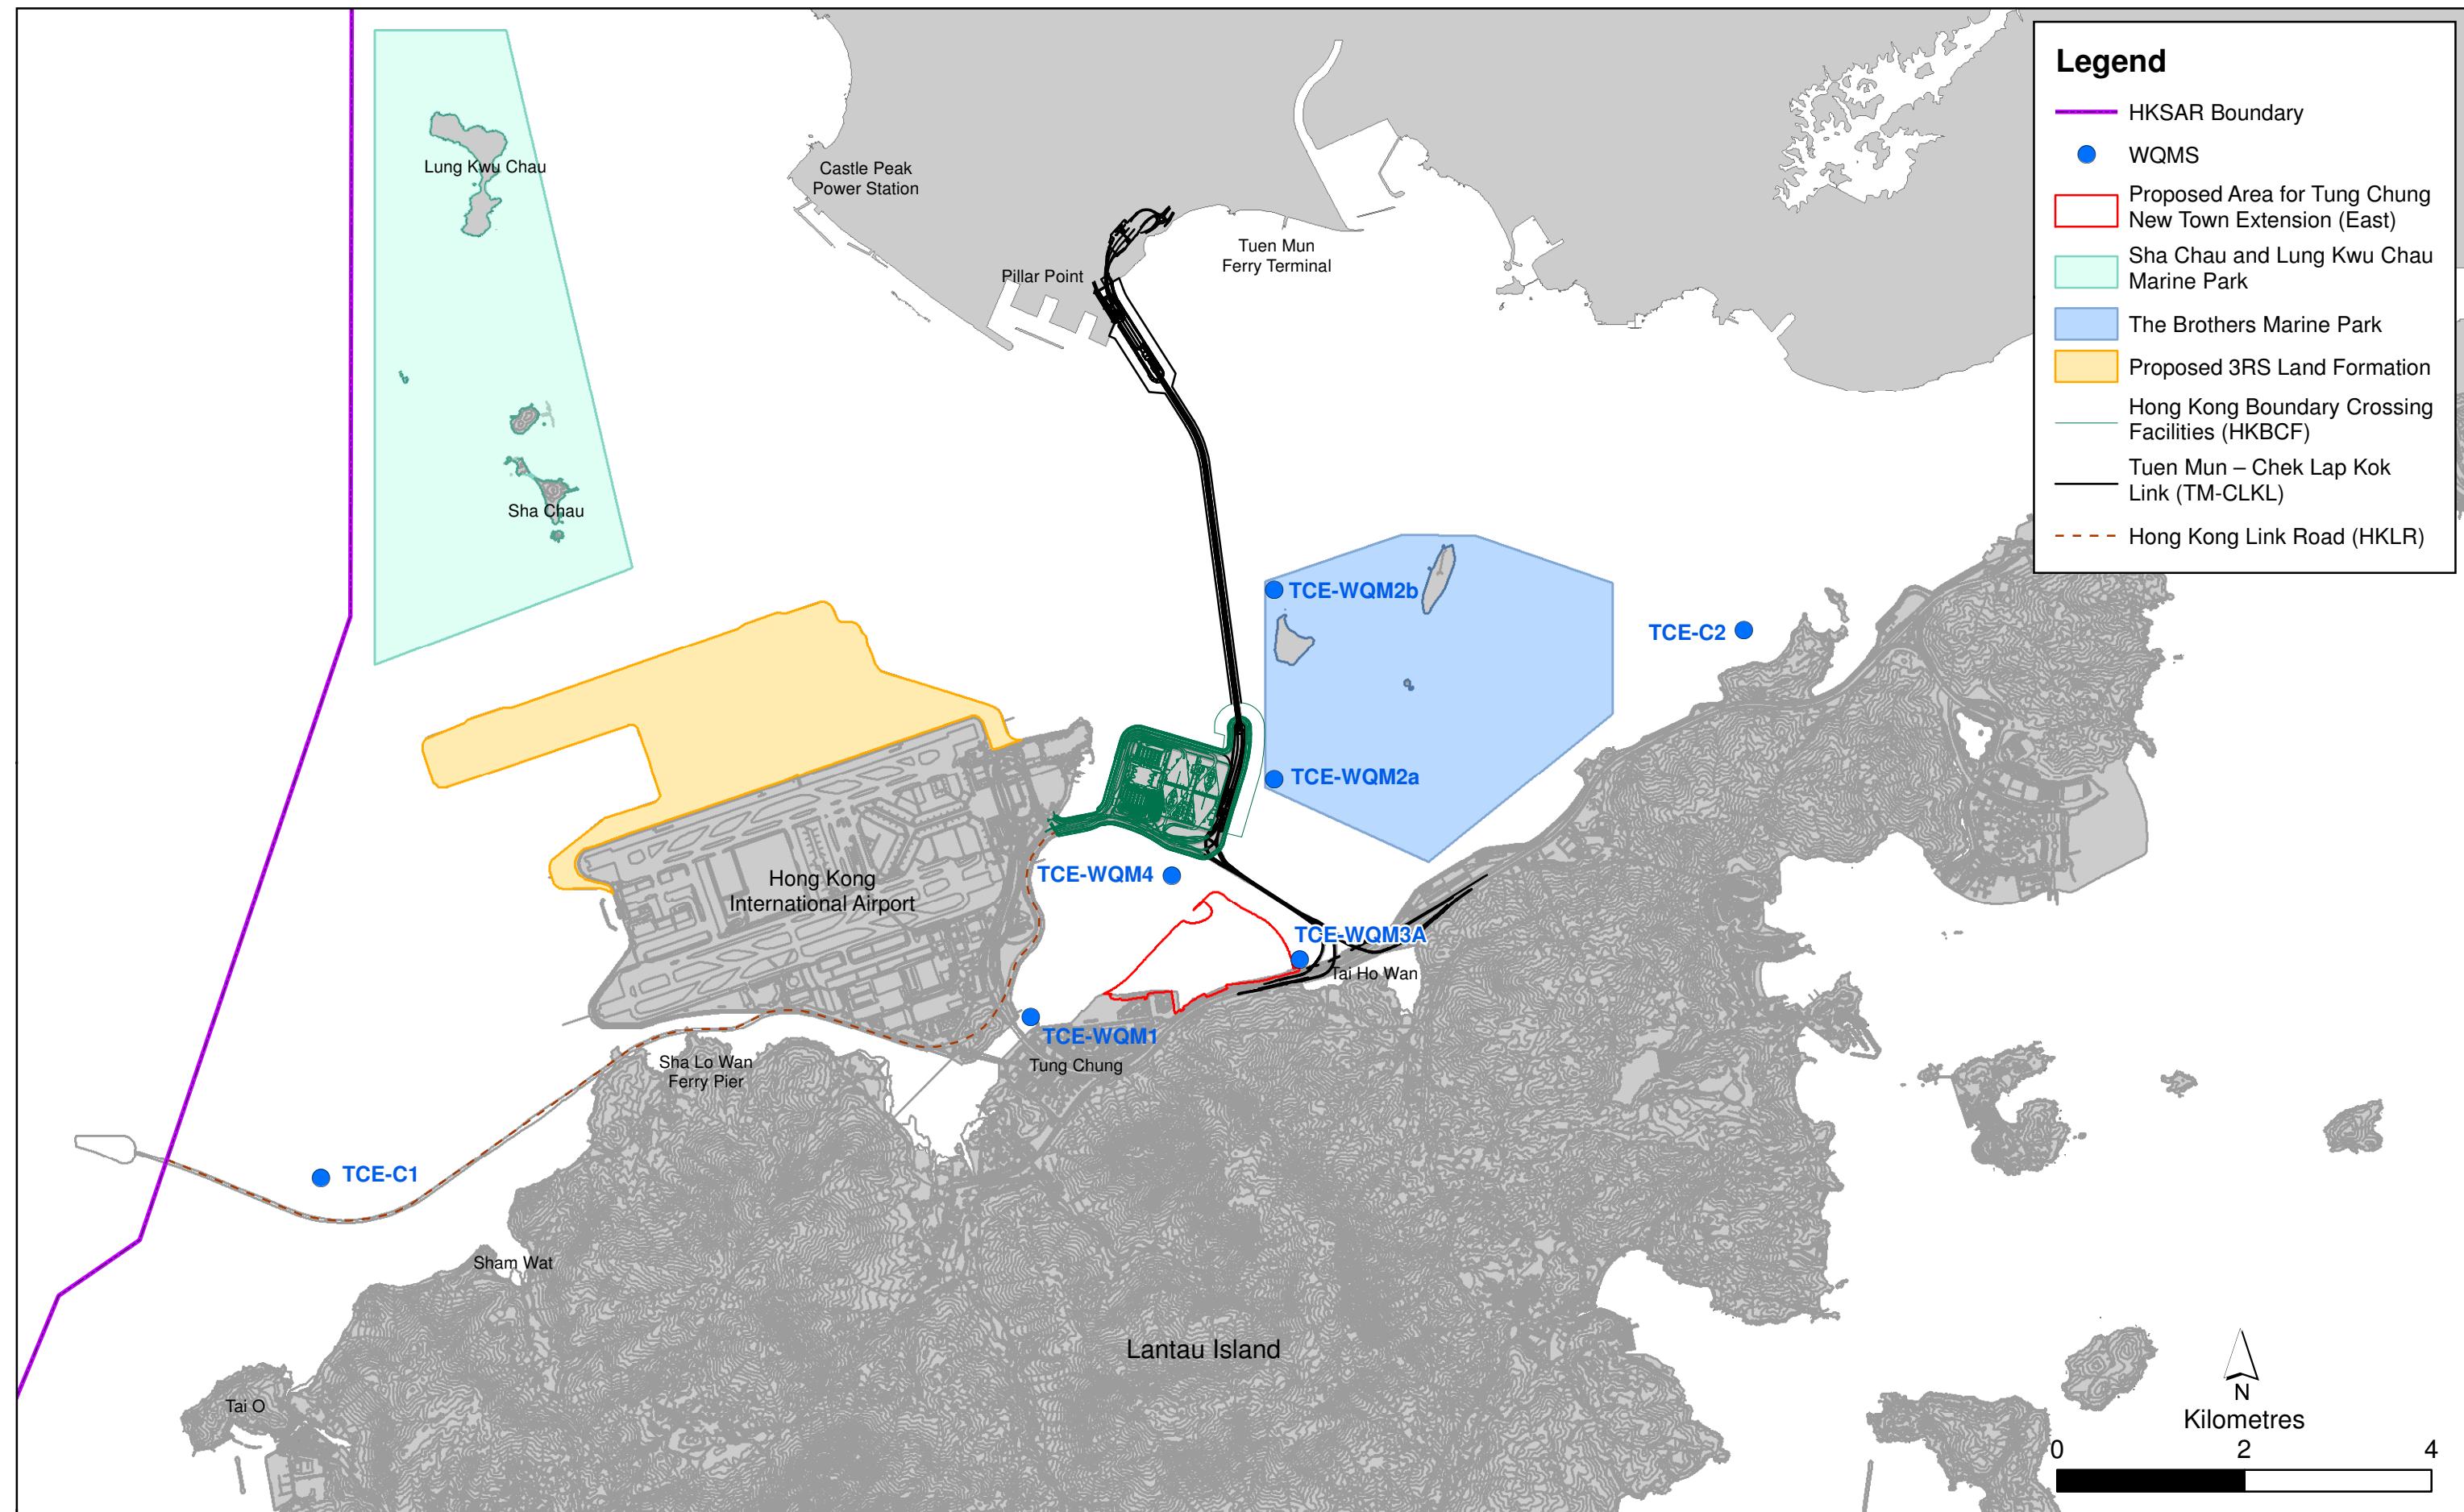
Figure 2.3

Water Quality Monitoring Locations

The locations of the monitoring stations under the Project are shown in *Figure 2.3* and *Table 2.8*.

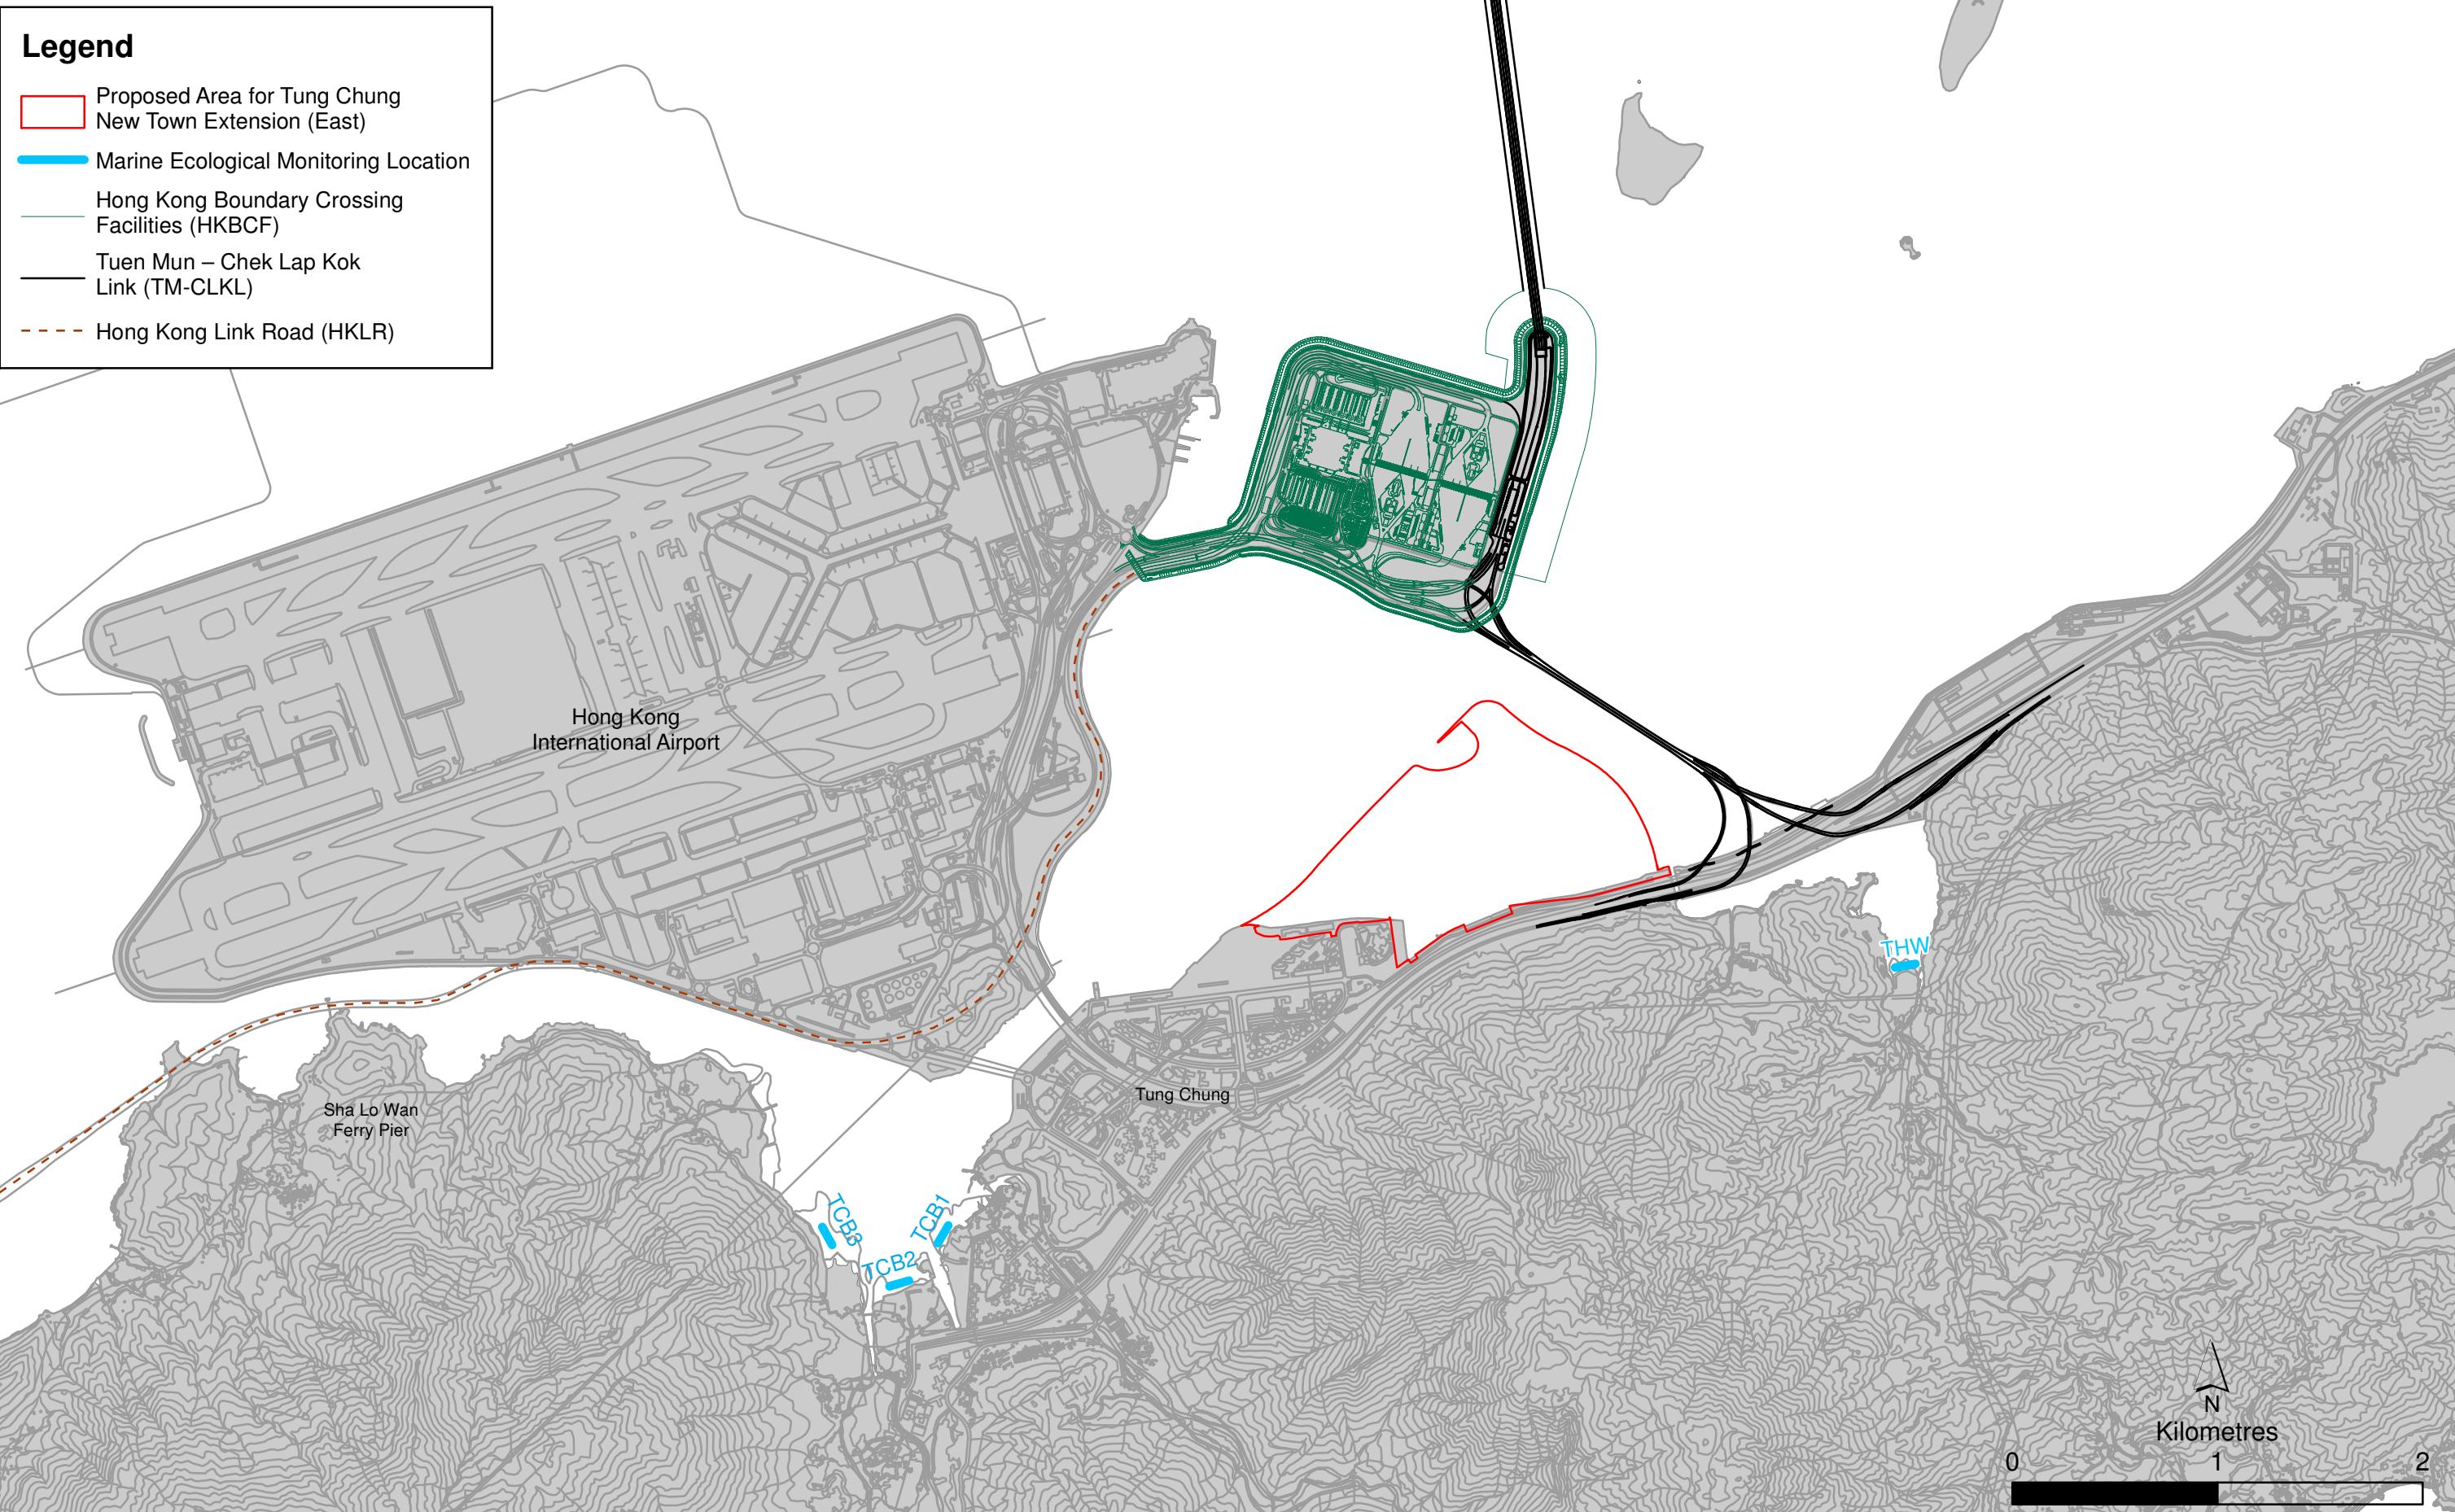
Figure 2.4

Marine Ecological Monitoring (Intertidal Soft-shore Habitats)

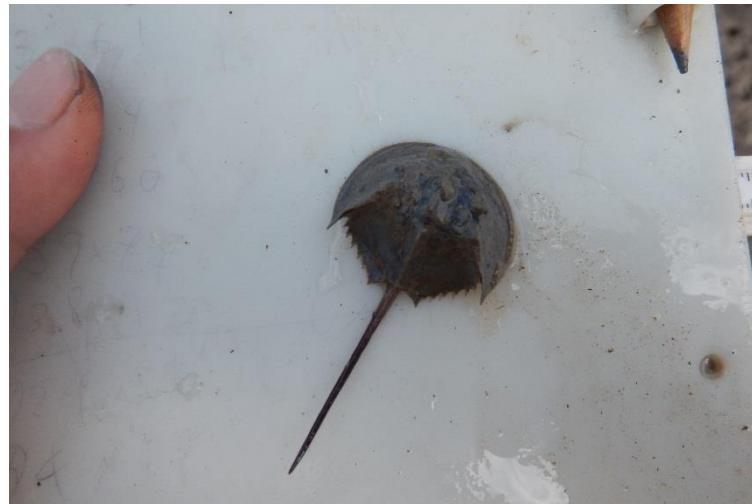
(e) Horseshoe crab *Tachypleus tridentatus* recorded at THW during Qualitative Walk-through Survey

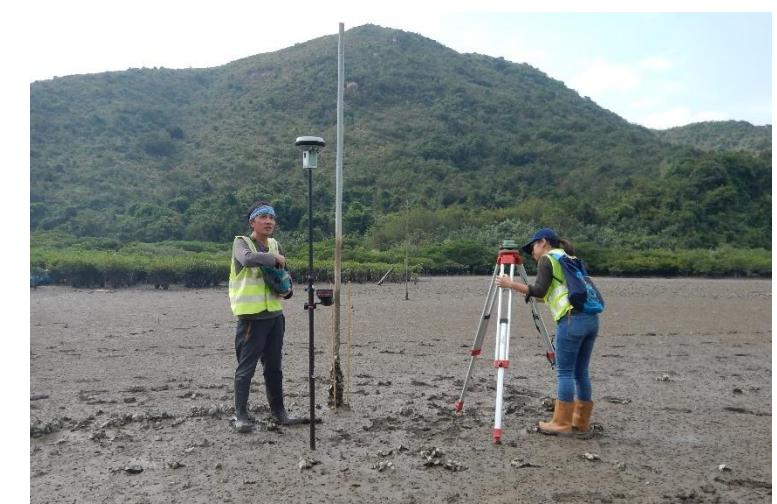
(f) Sedimentation Rate Monitoring

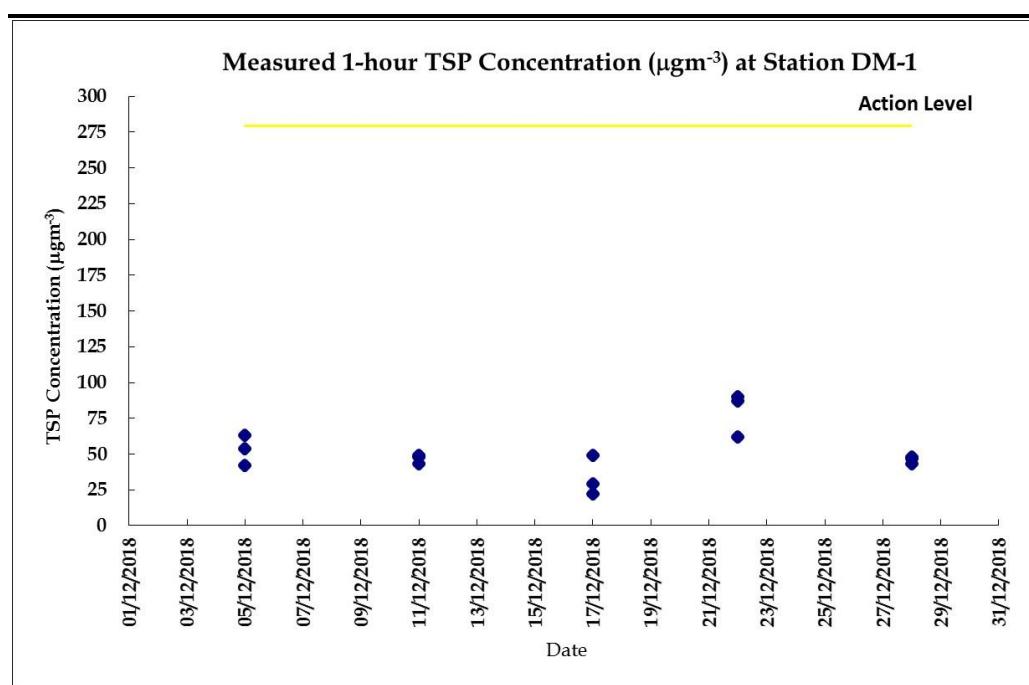
Figure D3 *Graphical Presentation for 1-hr TSP Monitoring at Station DM-1*

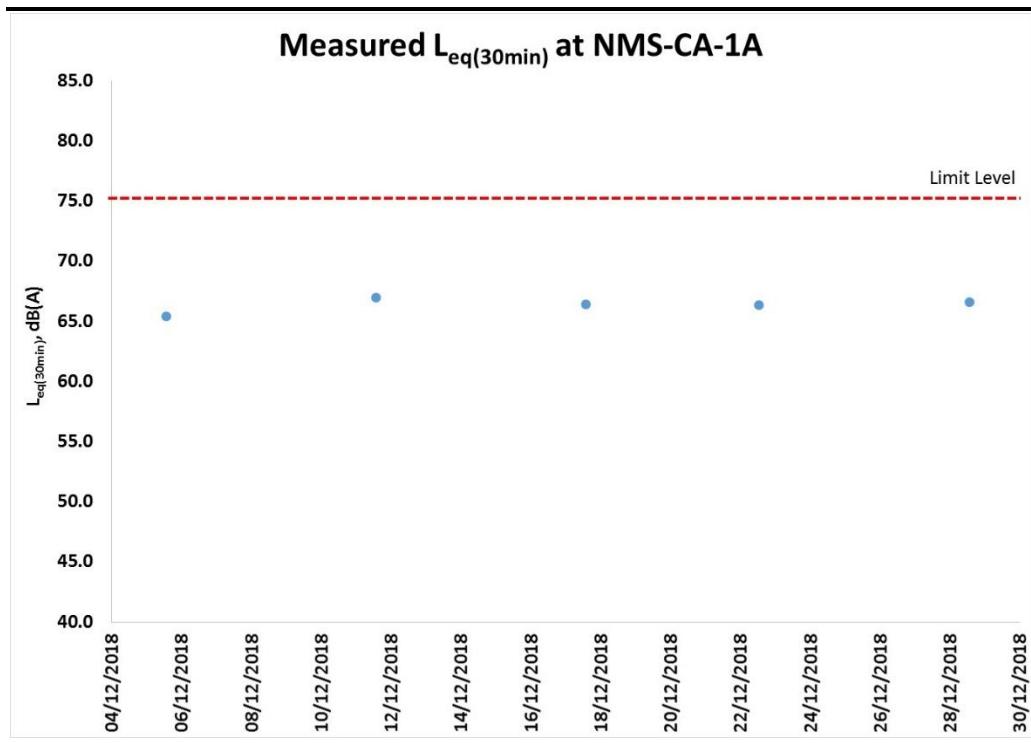
Figure E3.1 Graphical Presentation for Noise Monitoring at Station NMS-CA-1A

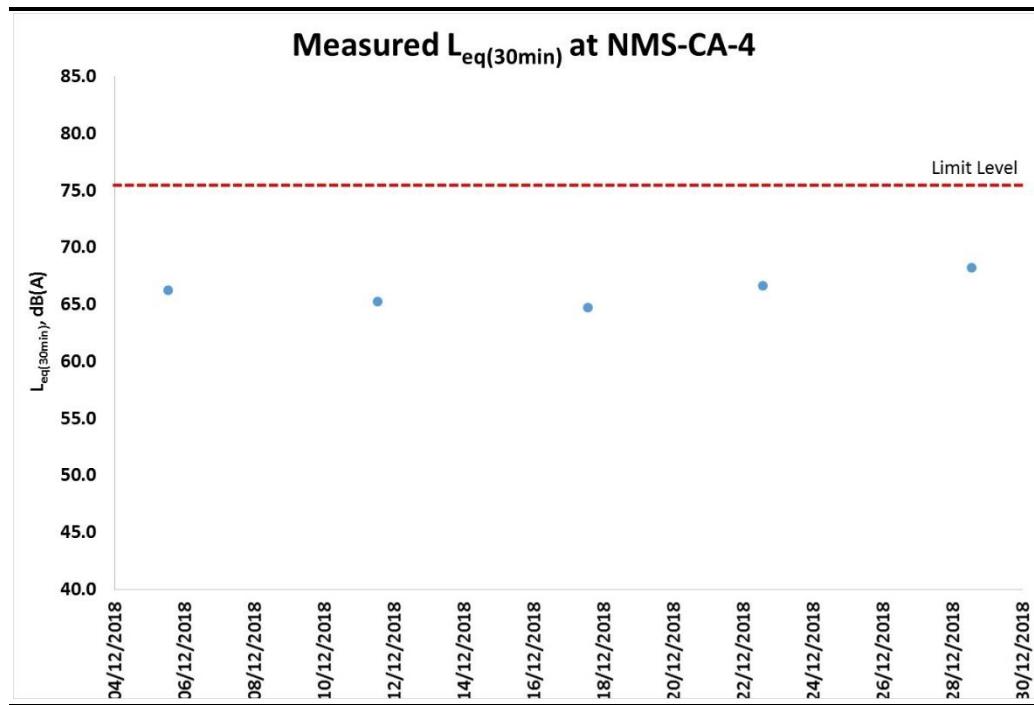
Figure E3.2 Graphical Presentation for Noise Monitoring at Station NMS-CA-4

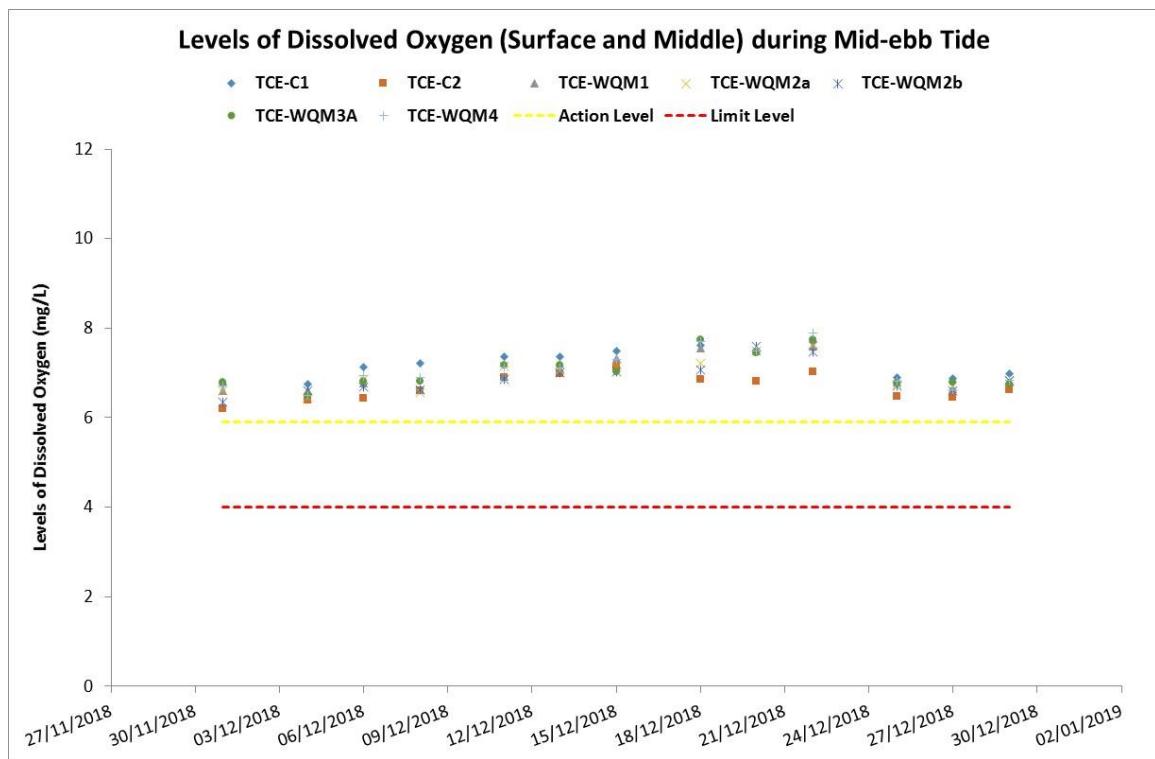
Figure 1: Levels of Dissolved Oxygen (Surface and Middle) (mg/L) recorded at Mid-ebb Tide during the Water Quality Monitoring between 1 and 31 December 2018

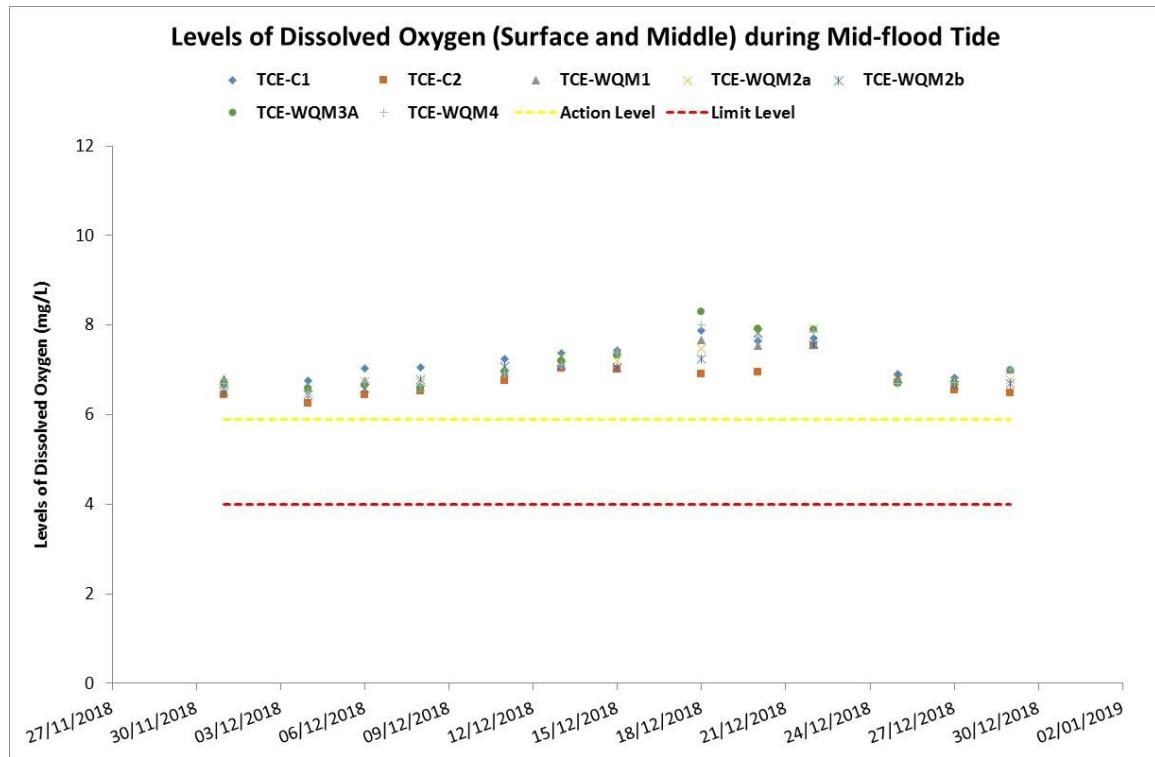
Figure 2: Levels of Dissolved Oxygen (Surface and Middle) (mg/L) recorded at Mid-flood Tide during the Water Quality Monitoring between 1 and 31 December 2018

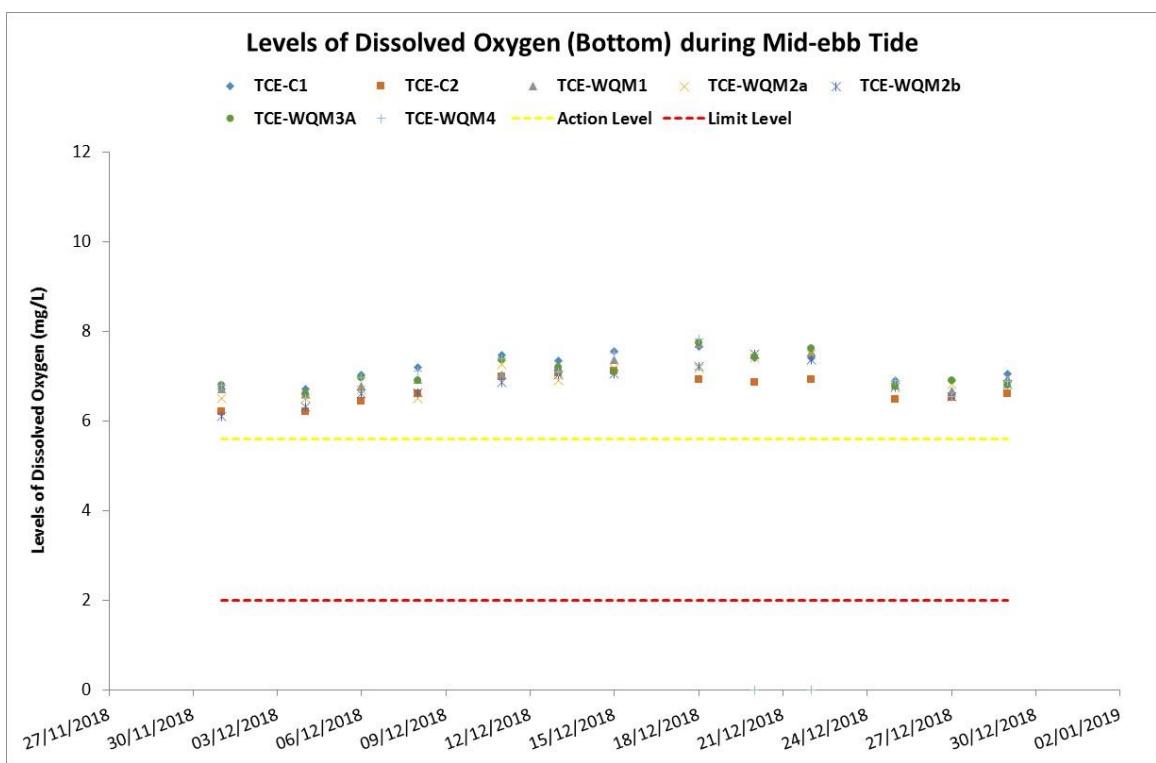
Figure 3: Levels of Dissolved Oxygen (Bottom) (mg/L) recorded at Mid-ebb Tide during the Water Quality Monitoring between 1 and 31 December 2018

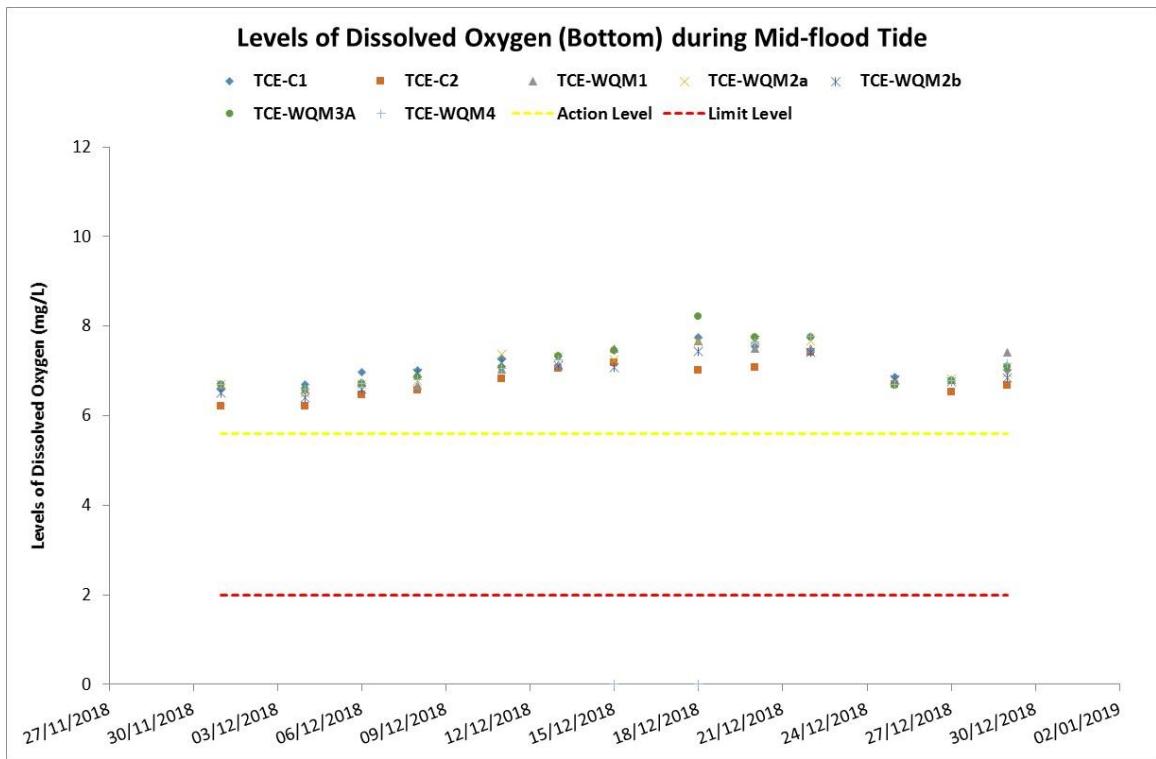
Figure 4: Levels of Dissolved Oxygen (Bottom) (mg/L) recorded at Mid-flood Tide during the Water Quality Monitoring between 1 and 31 December 2018

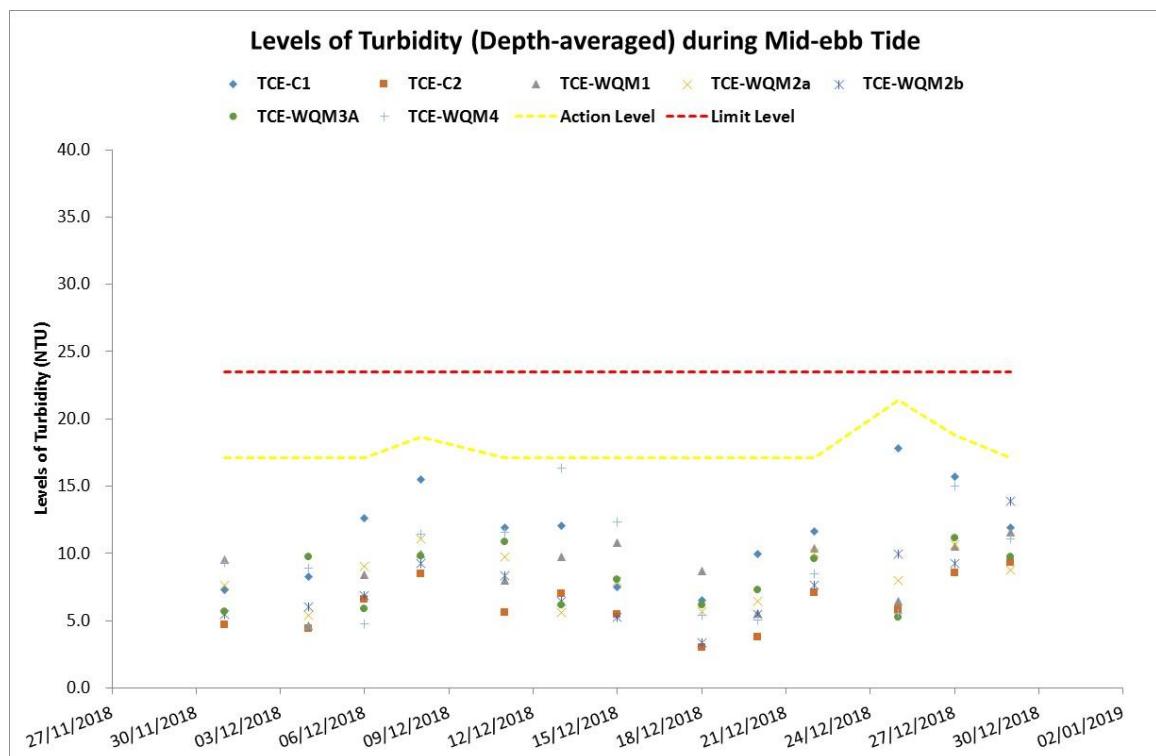
Figure 5: Levels of Turbidity (Depth-averaged) (NTU) recorded at Mid-ebb Tide during the Water Quality Monitoring between 1 and 31 December 2018
