Agreement No. CE 60/2017 (EP)

**Environmental Team for
Tung Chung New Town Extension (East) -
Design and Construction**

**Monthly Environmental Monitoring & Audit Report
for December 2018**

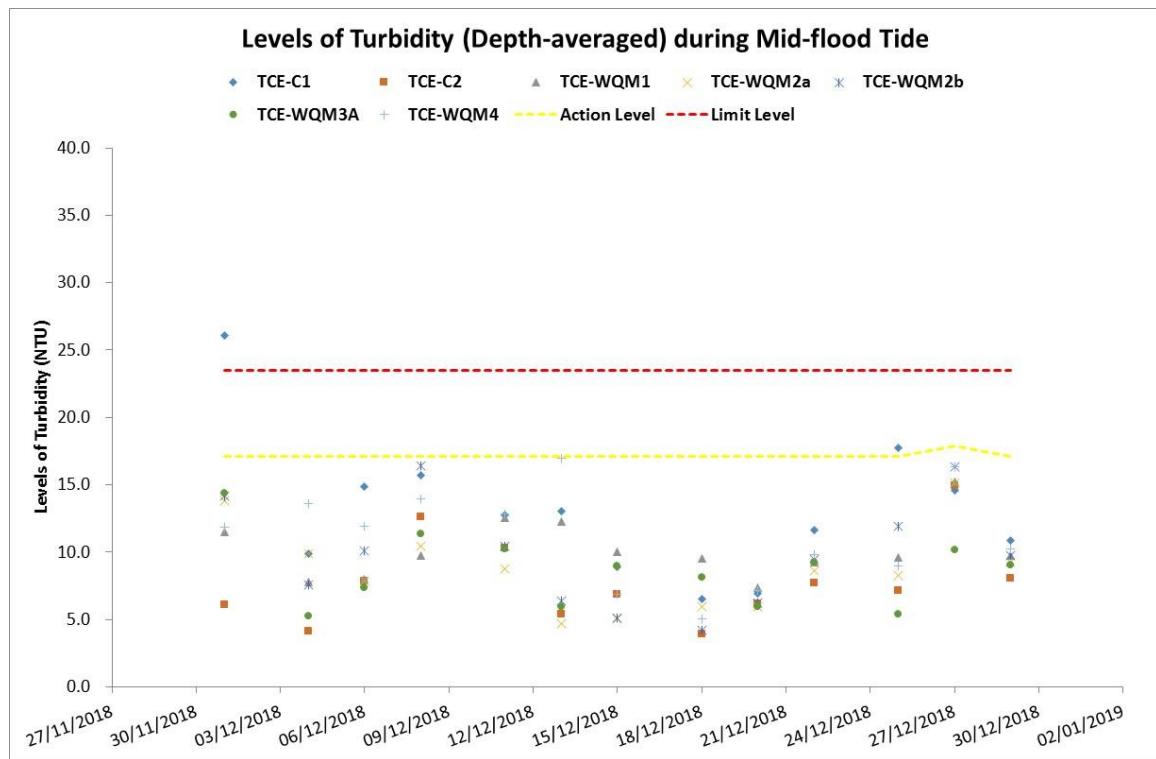
Figure 6: Levels of Turbidity (Depth-averaged) (NTU) recorded at Mid-flood Tide during the Water Quality Monitoring between 1 and 31 December 2018

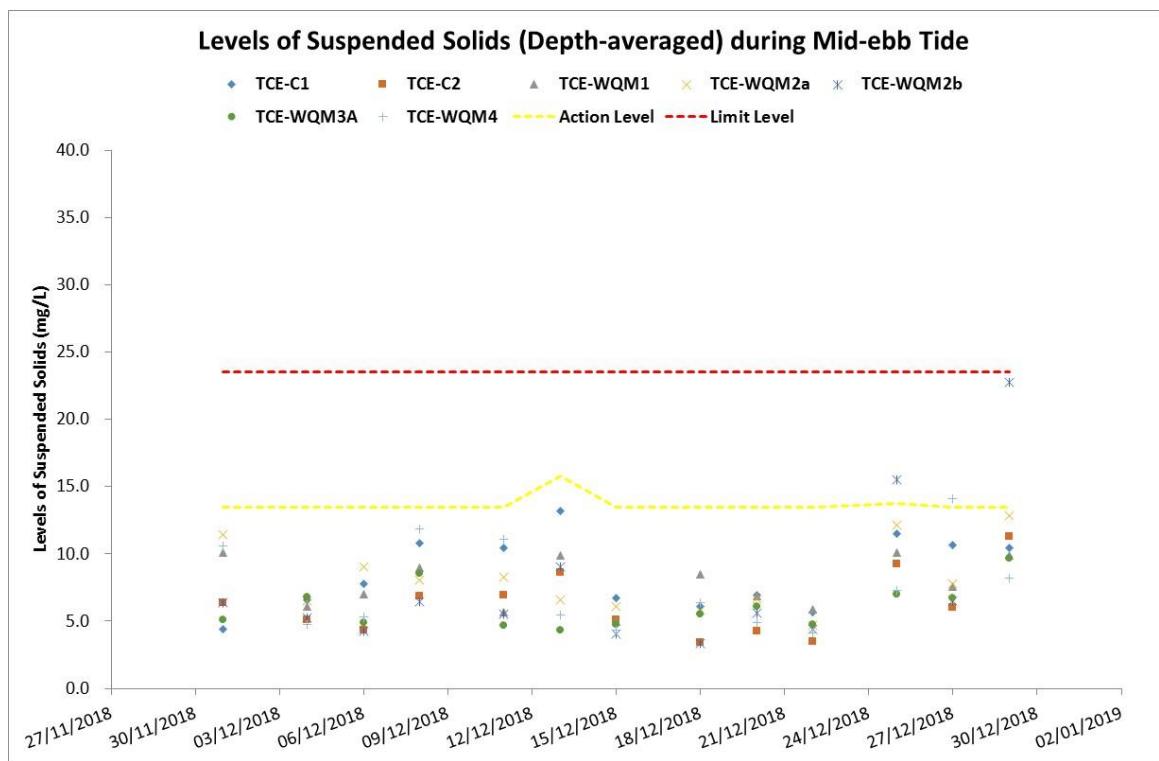
Figure 7: Levels of Suspended Solids (Depth-averaged) (mg/L) recorded at Mid-ebb Tide during the Water Quality Monitoring between 1 and 31 December 2018

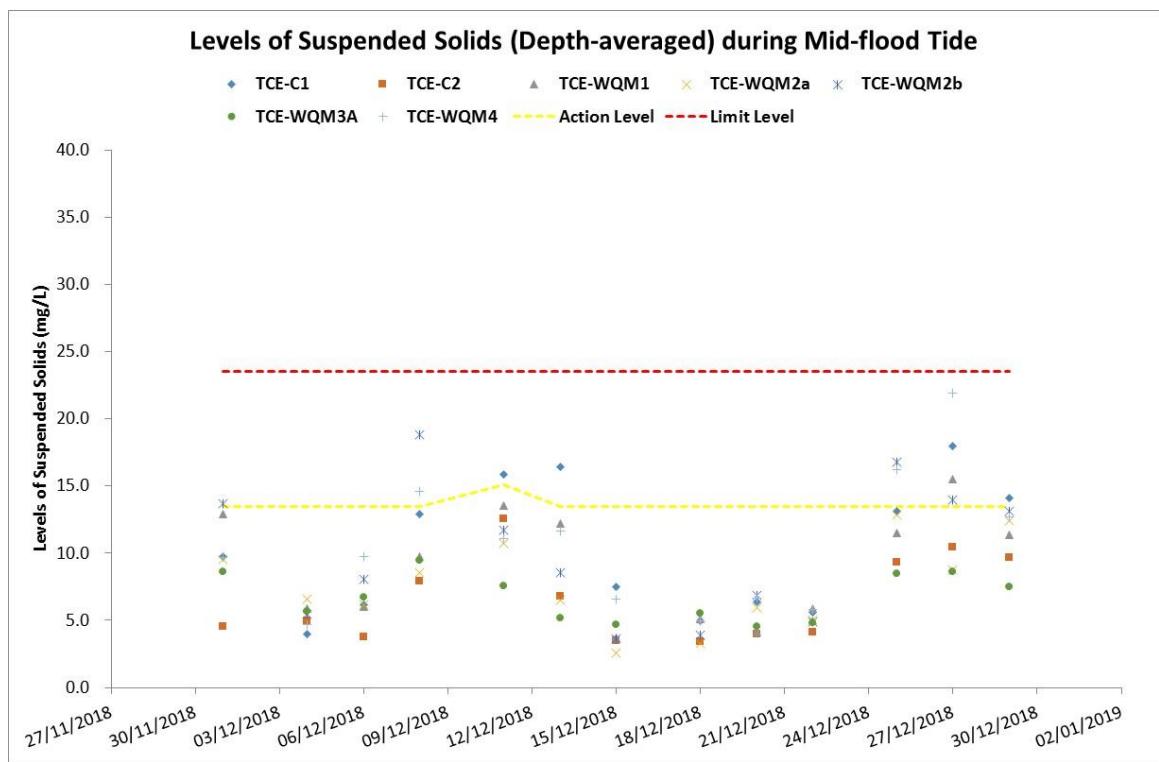
Figure 8: Levels of Suspended Solids (Depth-averaged) (mg/L) recorded at Mid-flood Tide during the Water Quality Monitoring between 1 and 31 December 2018
