**Civil Engineering and
Development Department**

Agreement No. CE 60/2017 (EP)

**Environmental Team for
Tung Chung New Town Extension (East) -
Design and Construction**

**Monthly Environmental Monitoring & Audit Report
for June 2019**

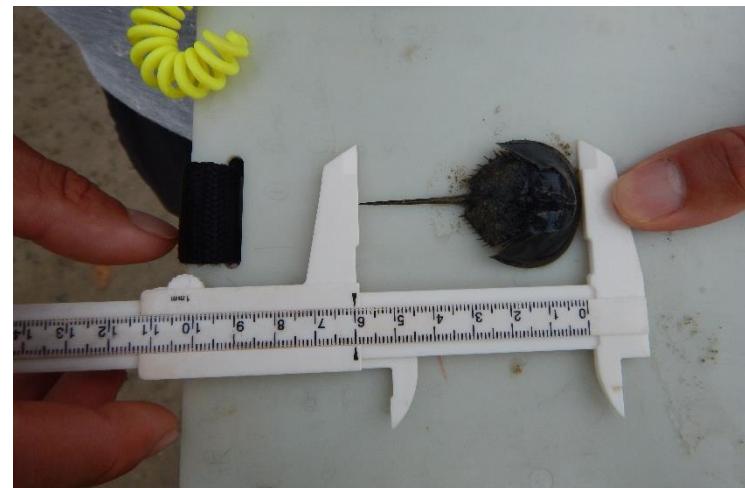
(e) Horseshoe crab *Tachypleus tridentatus* recorded at TCB3 during Qualitative Walk-through Survey

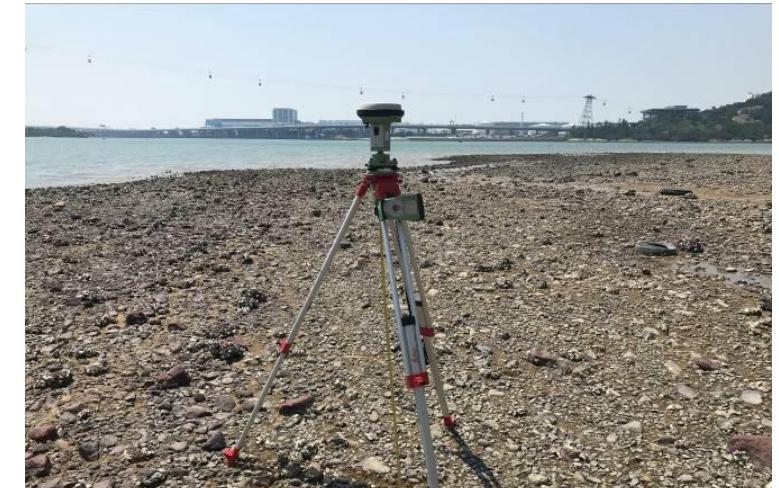
(f) Sedimentation Rate Monitoring

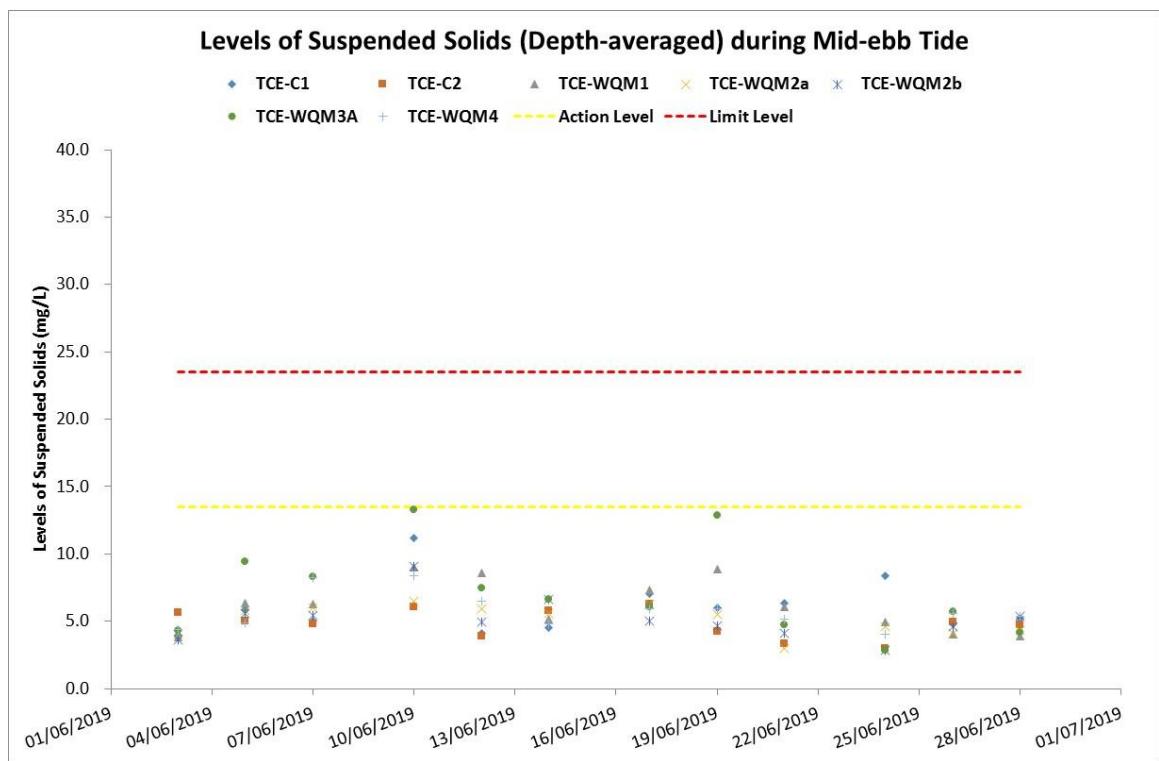
Figure 7: Levels of Suspended Solids (Depth-averaged) (mg/L) recorded at Mid-ebb Tide during the Water Quality Monitoring between 1 and 30 June 2019
