Civil Engineering and  
Development Department

Agreement No. CE 60/2017 (EP)

**Environmental Team for  
Tung Chung New Town Extension (East) -  
Design and Construction**

**Monthly Environmental Monitoring & Audit Report  
for September 2021**

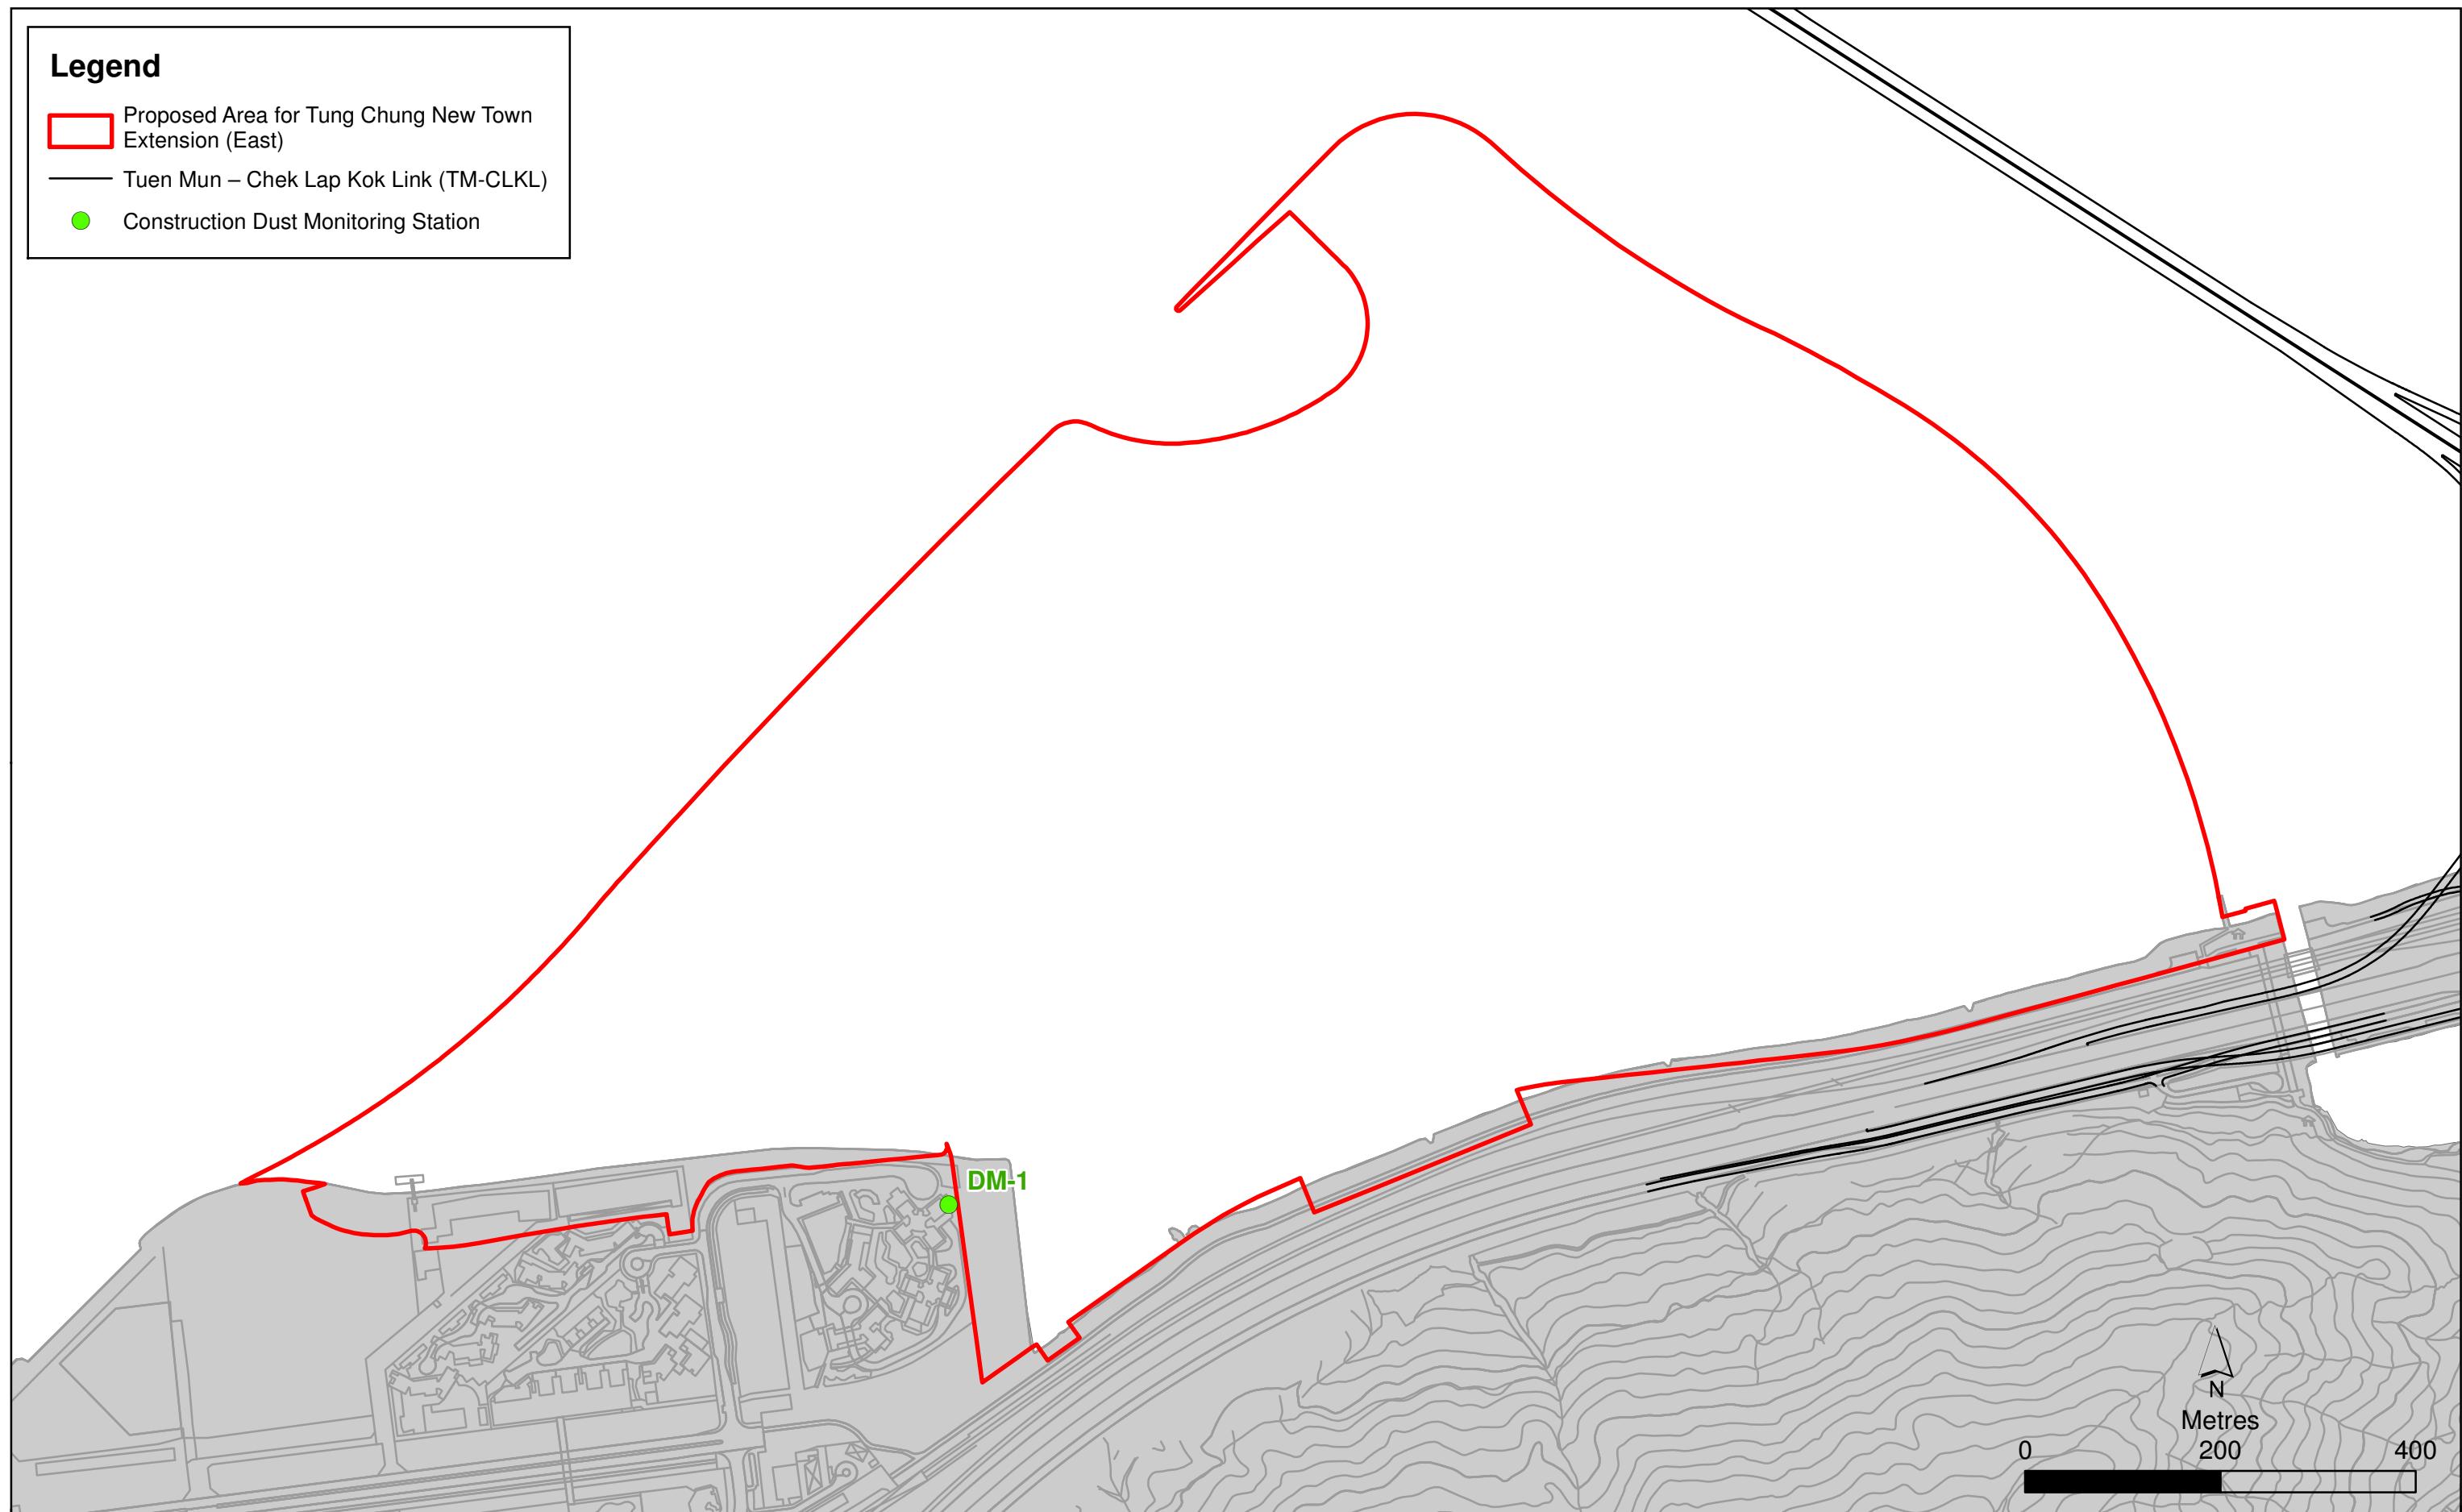
Figure 2.1

Construction Dust Monitoring Station Location

The monitoring location and equipment used in the impact air quality monitoring programme are summarized in *Table 2.2* and illustrated in *Figure 2.1*. Copies of the calibration certificates for the equipment are presented in *Annex E1*, which showed that the portable direct reading dust meter is capable of providing comparable results with that provided by a HVS.

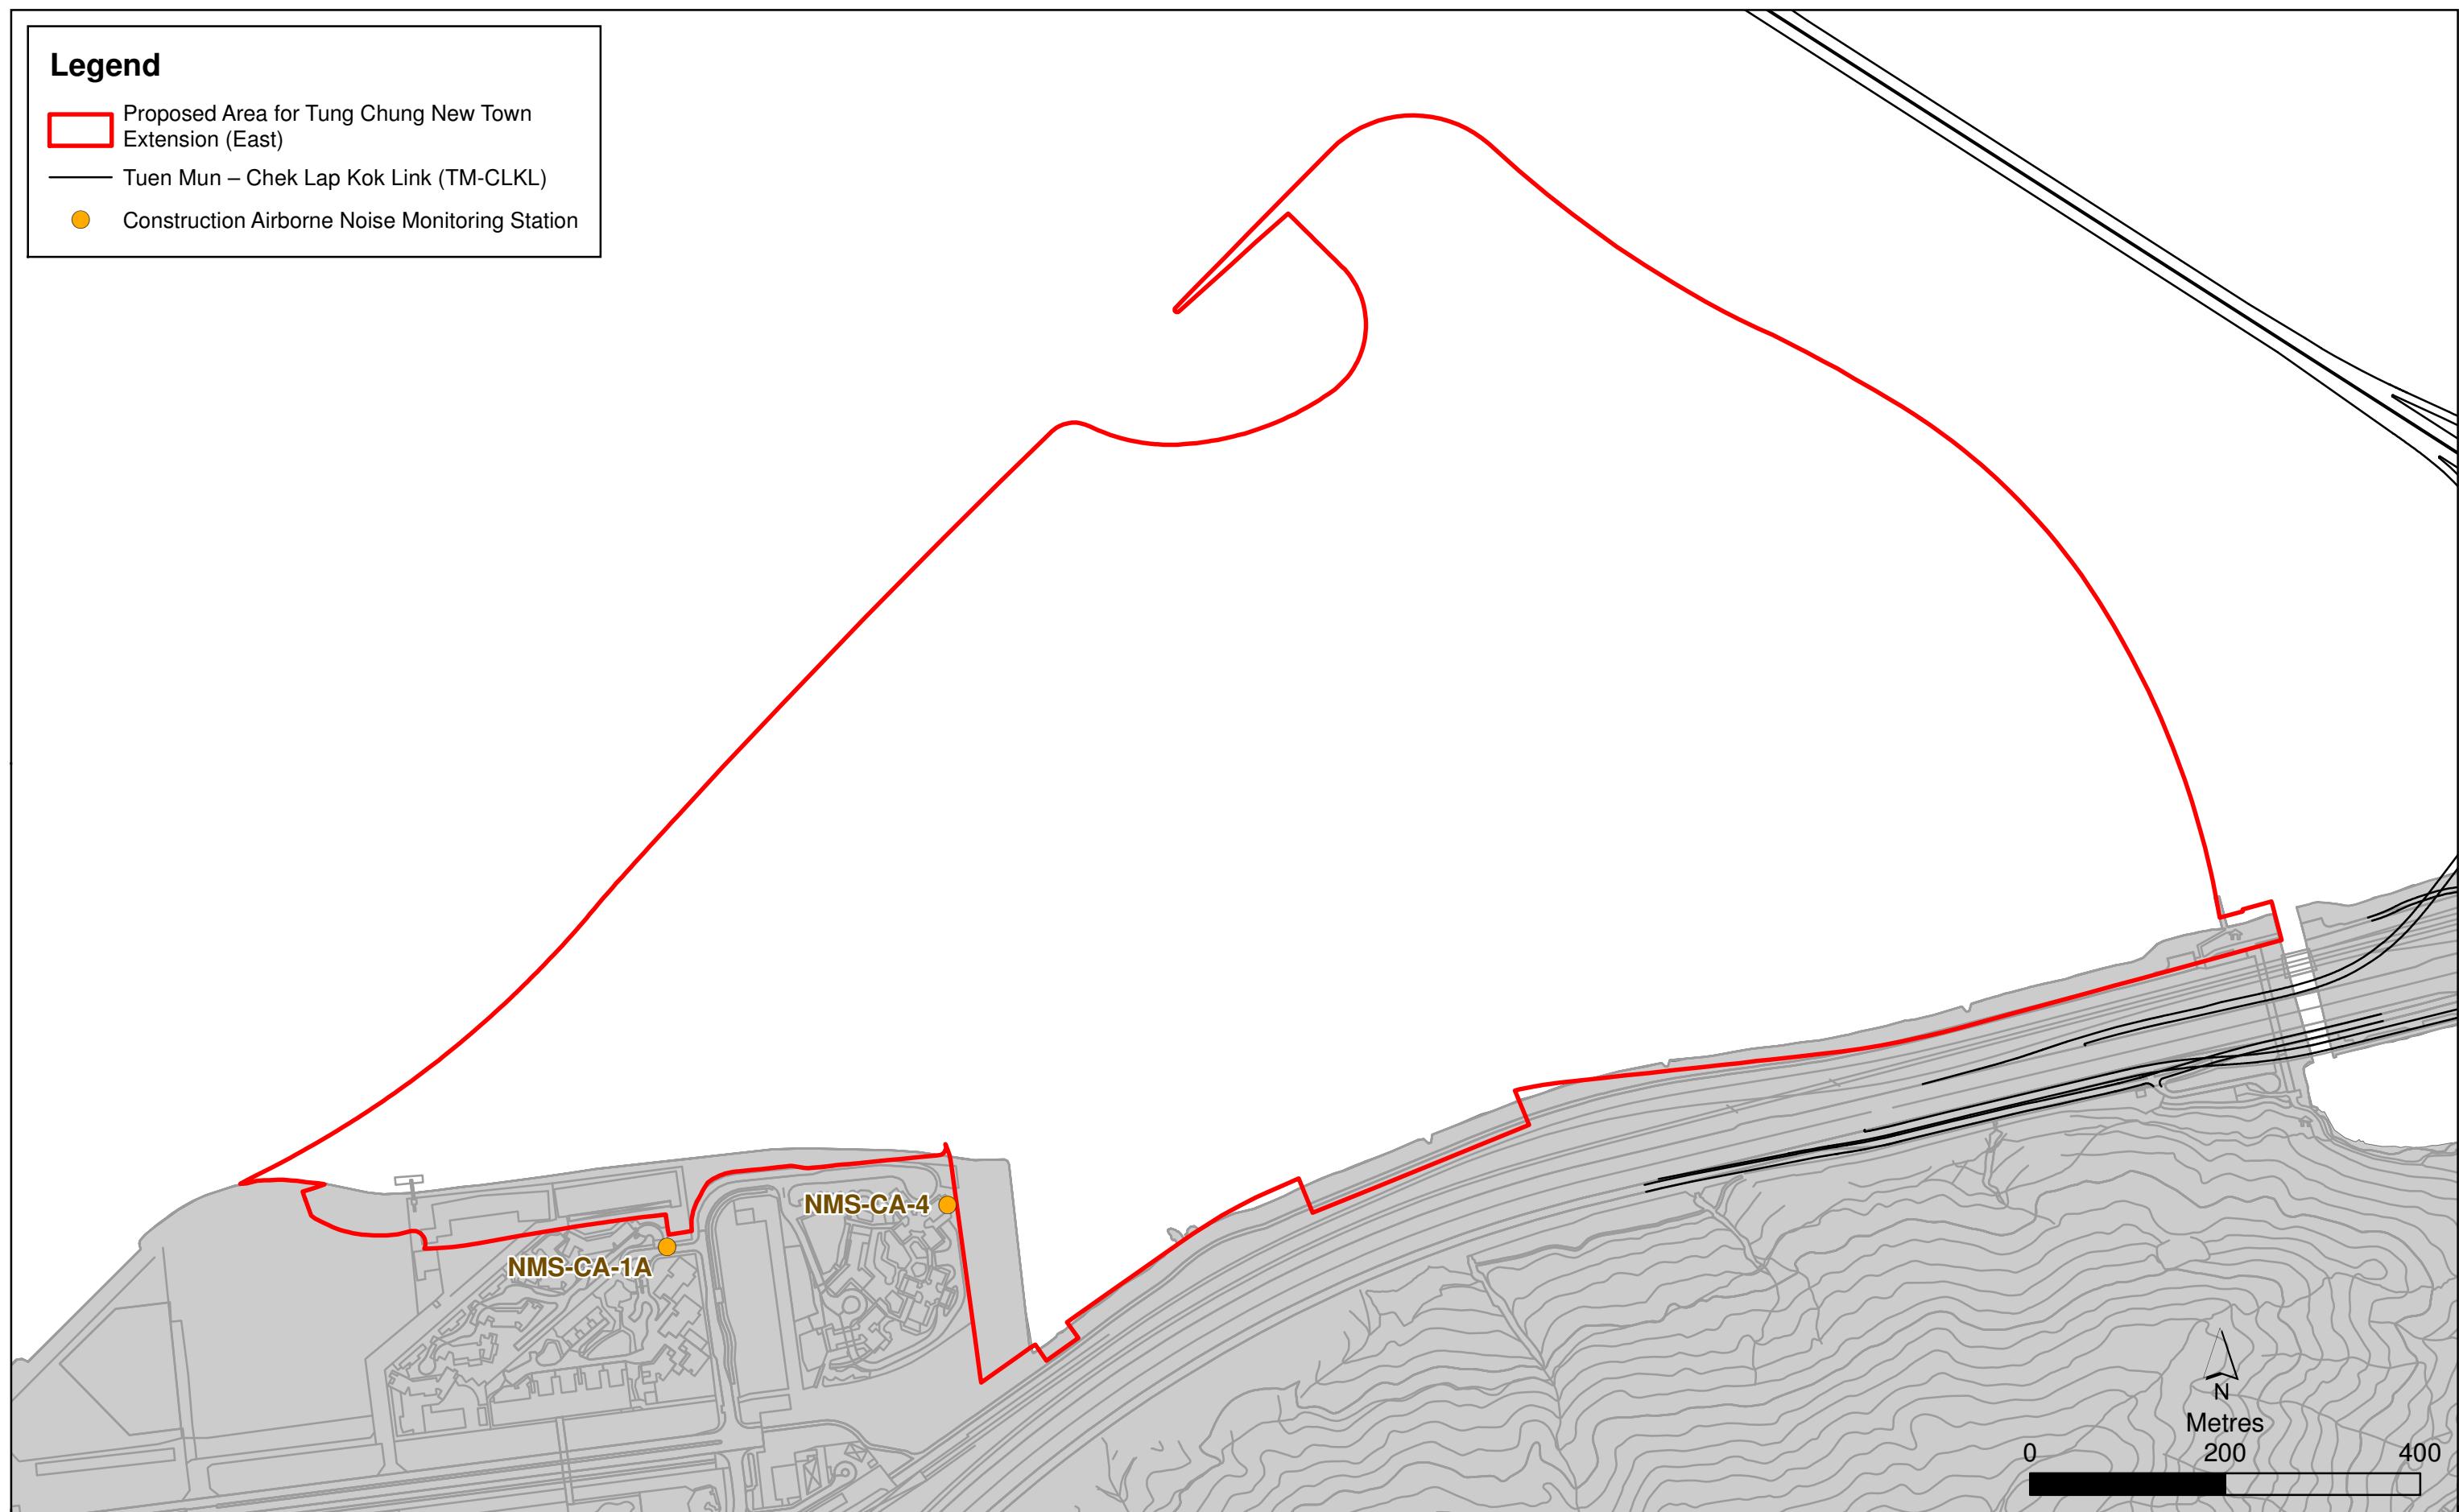
Figure 2.2

### Construction Airborne Noise Monitoring Station Location

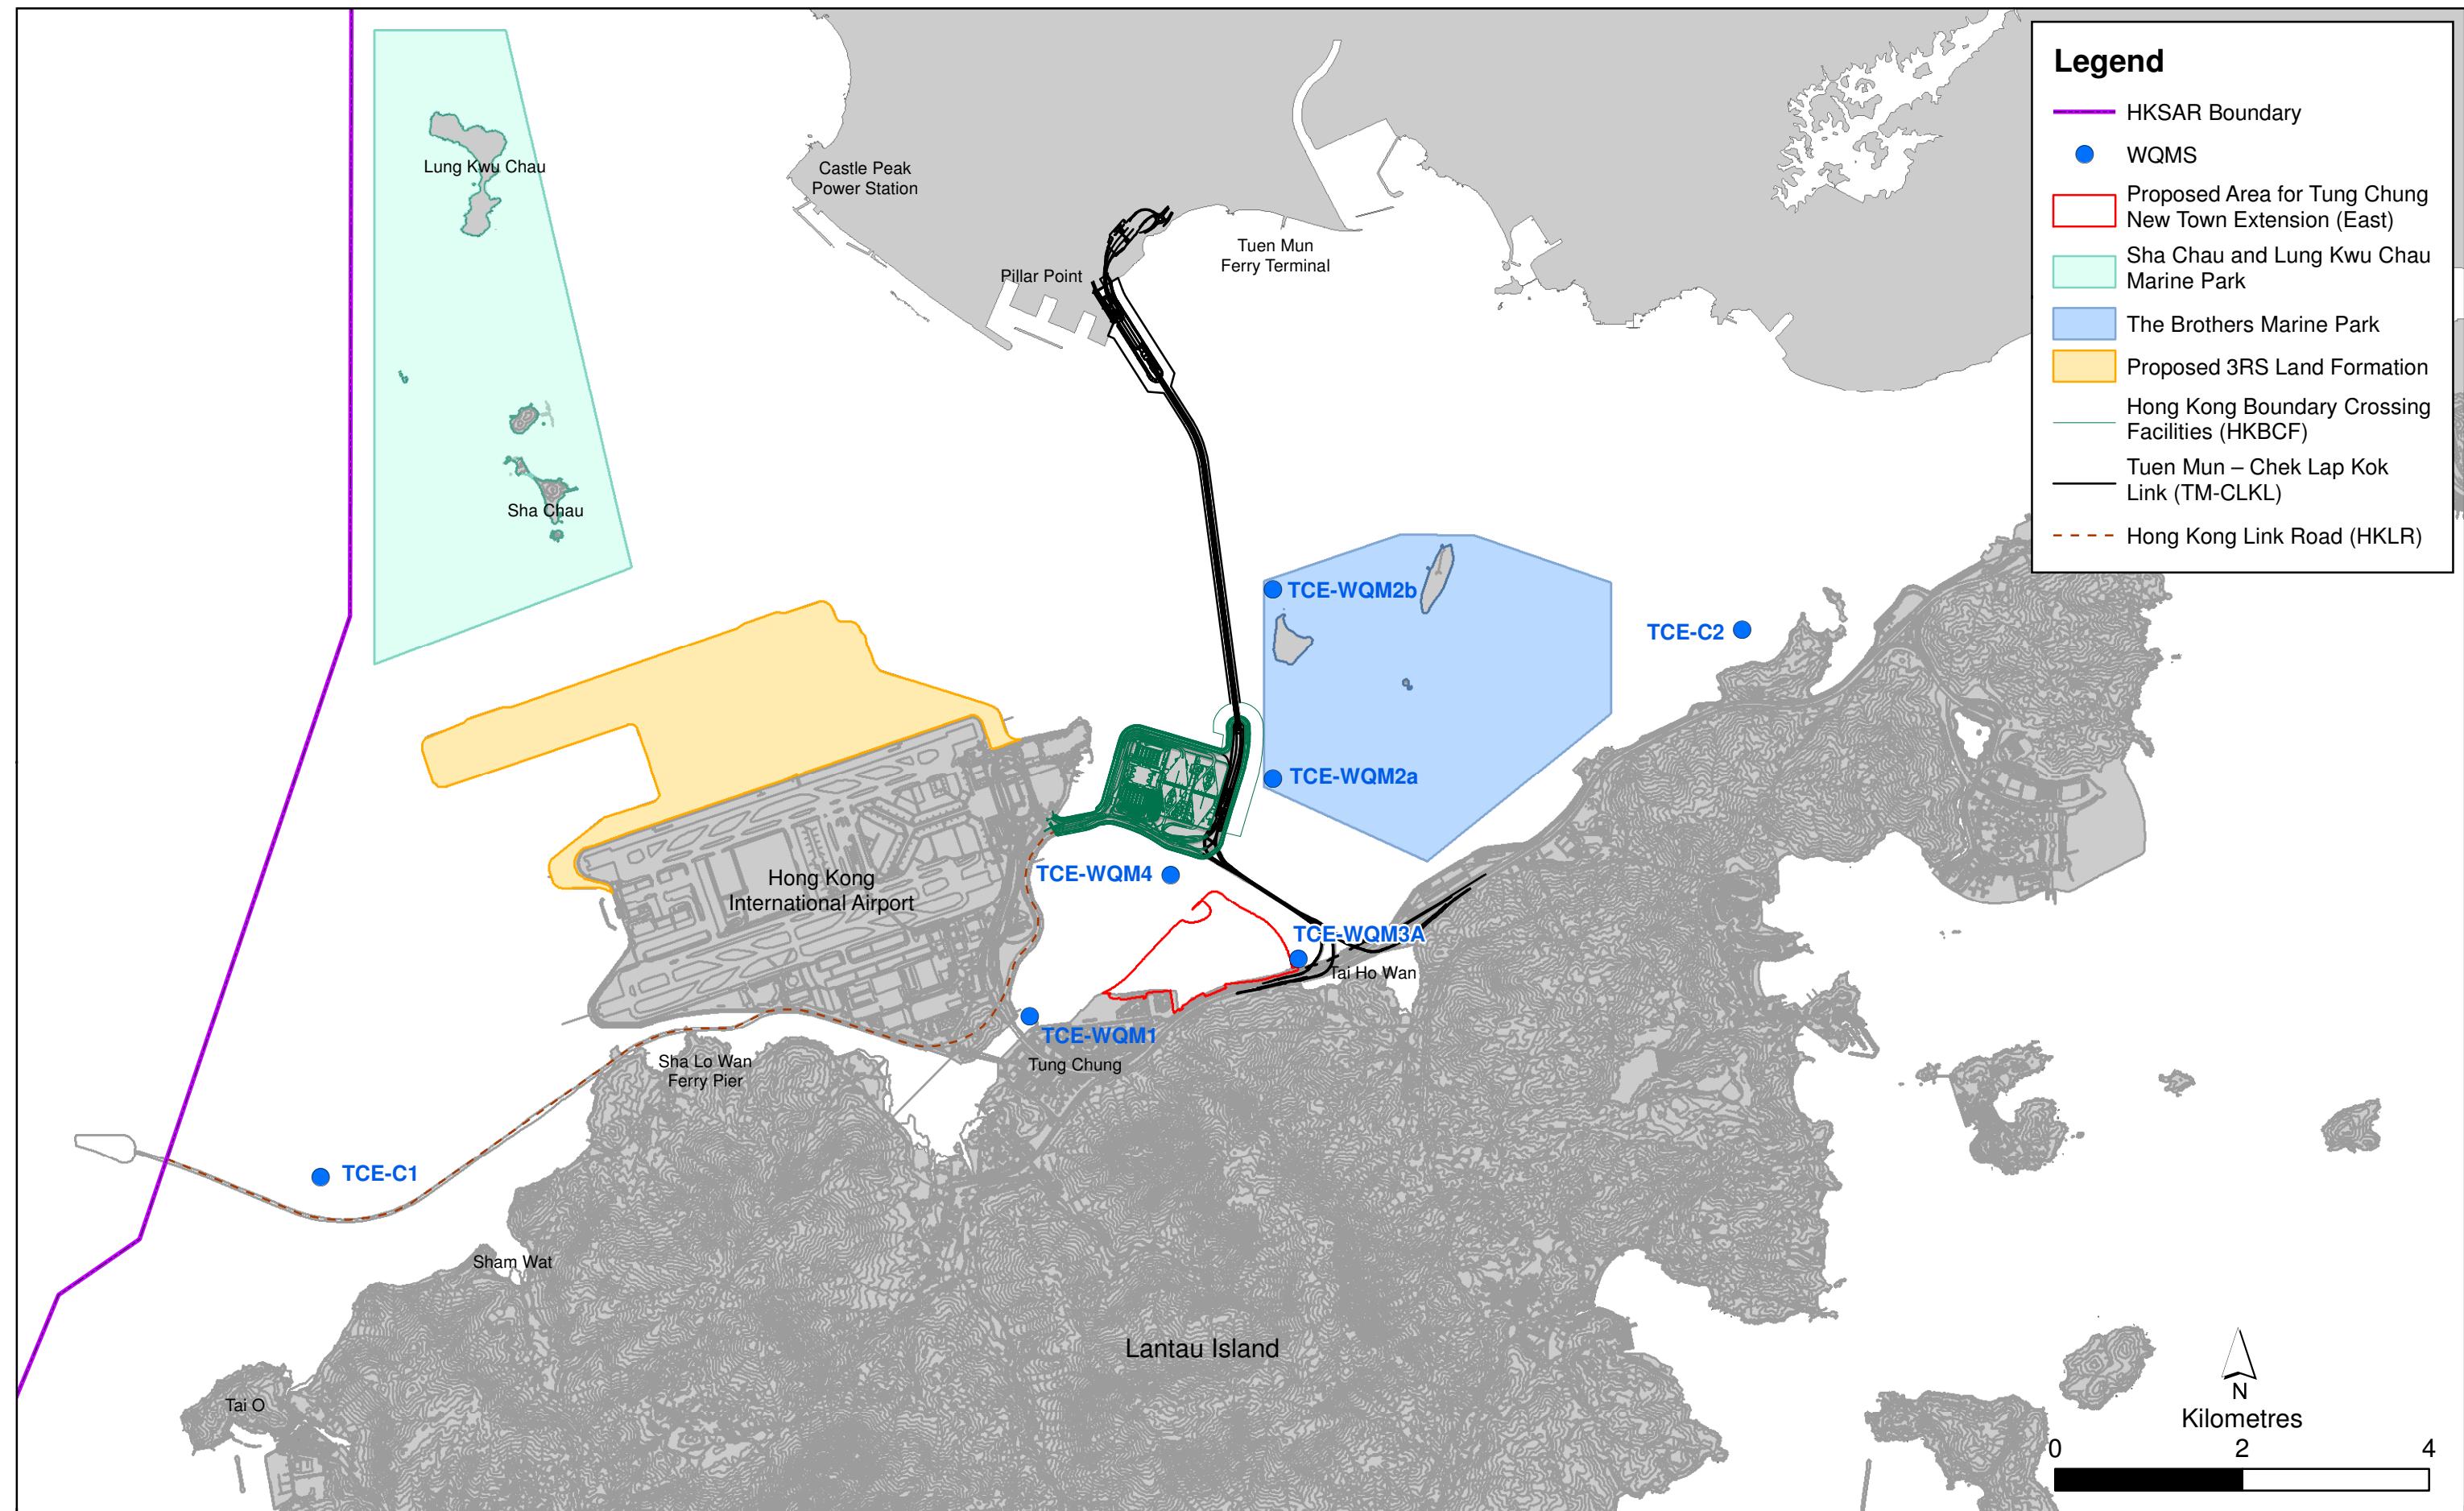
Figure 2.3

### Water Quality Monitoring Locations

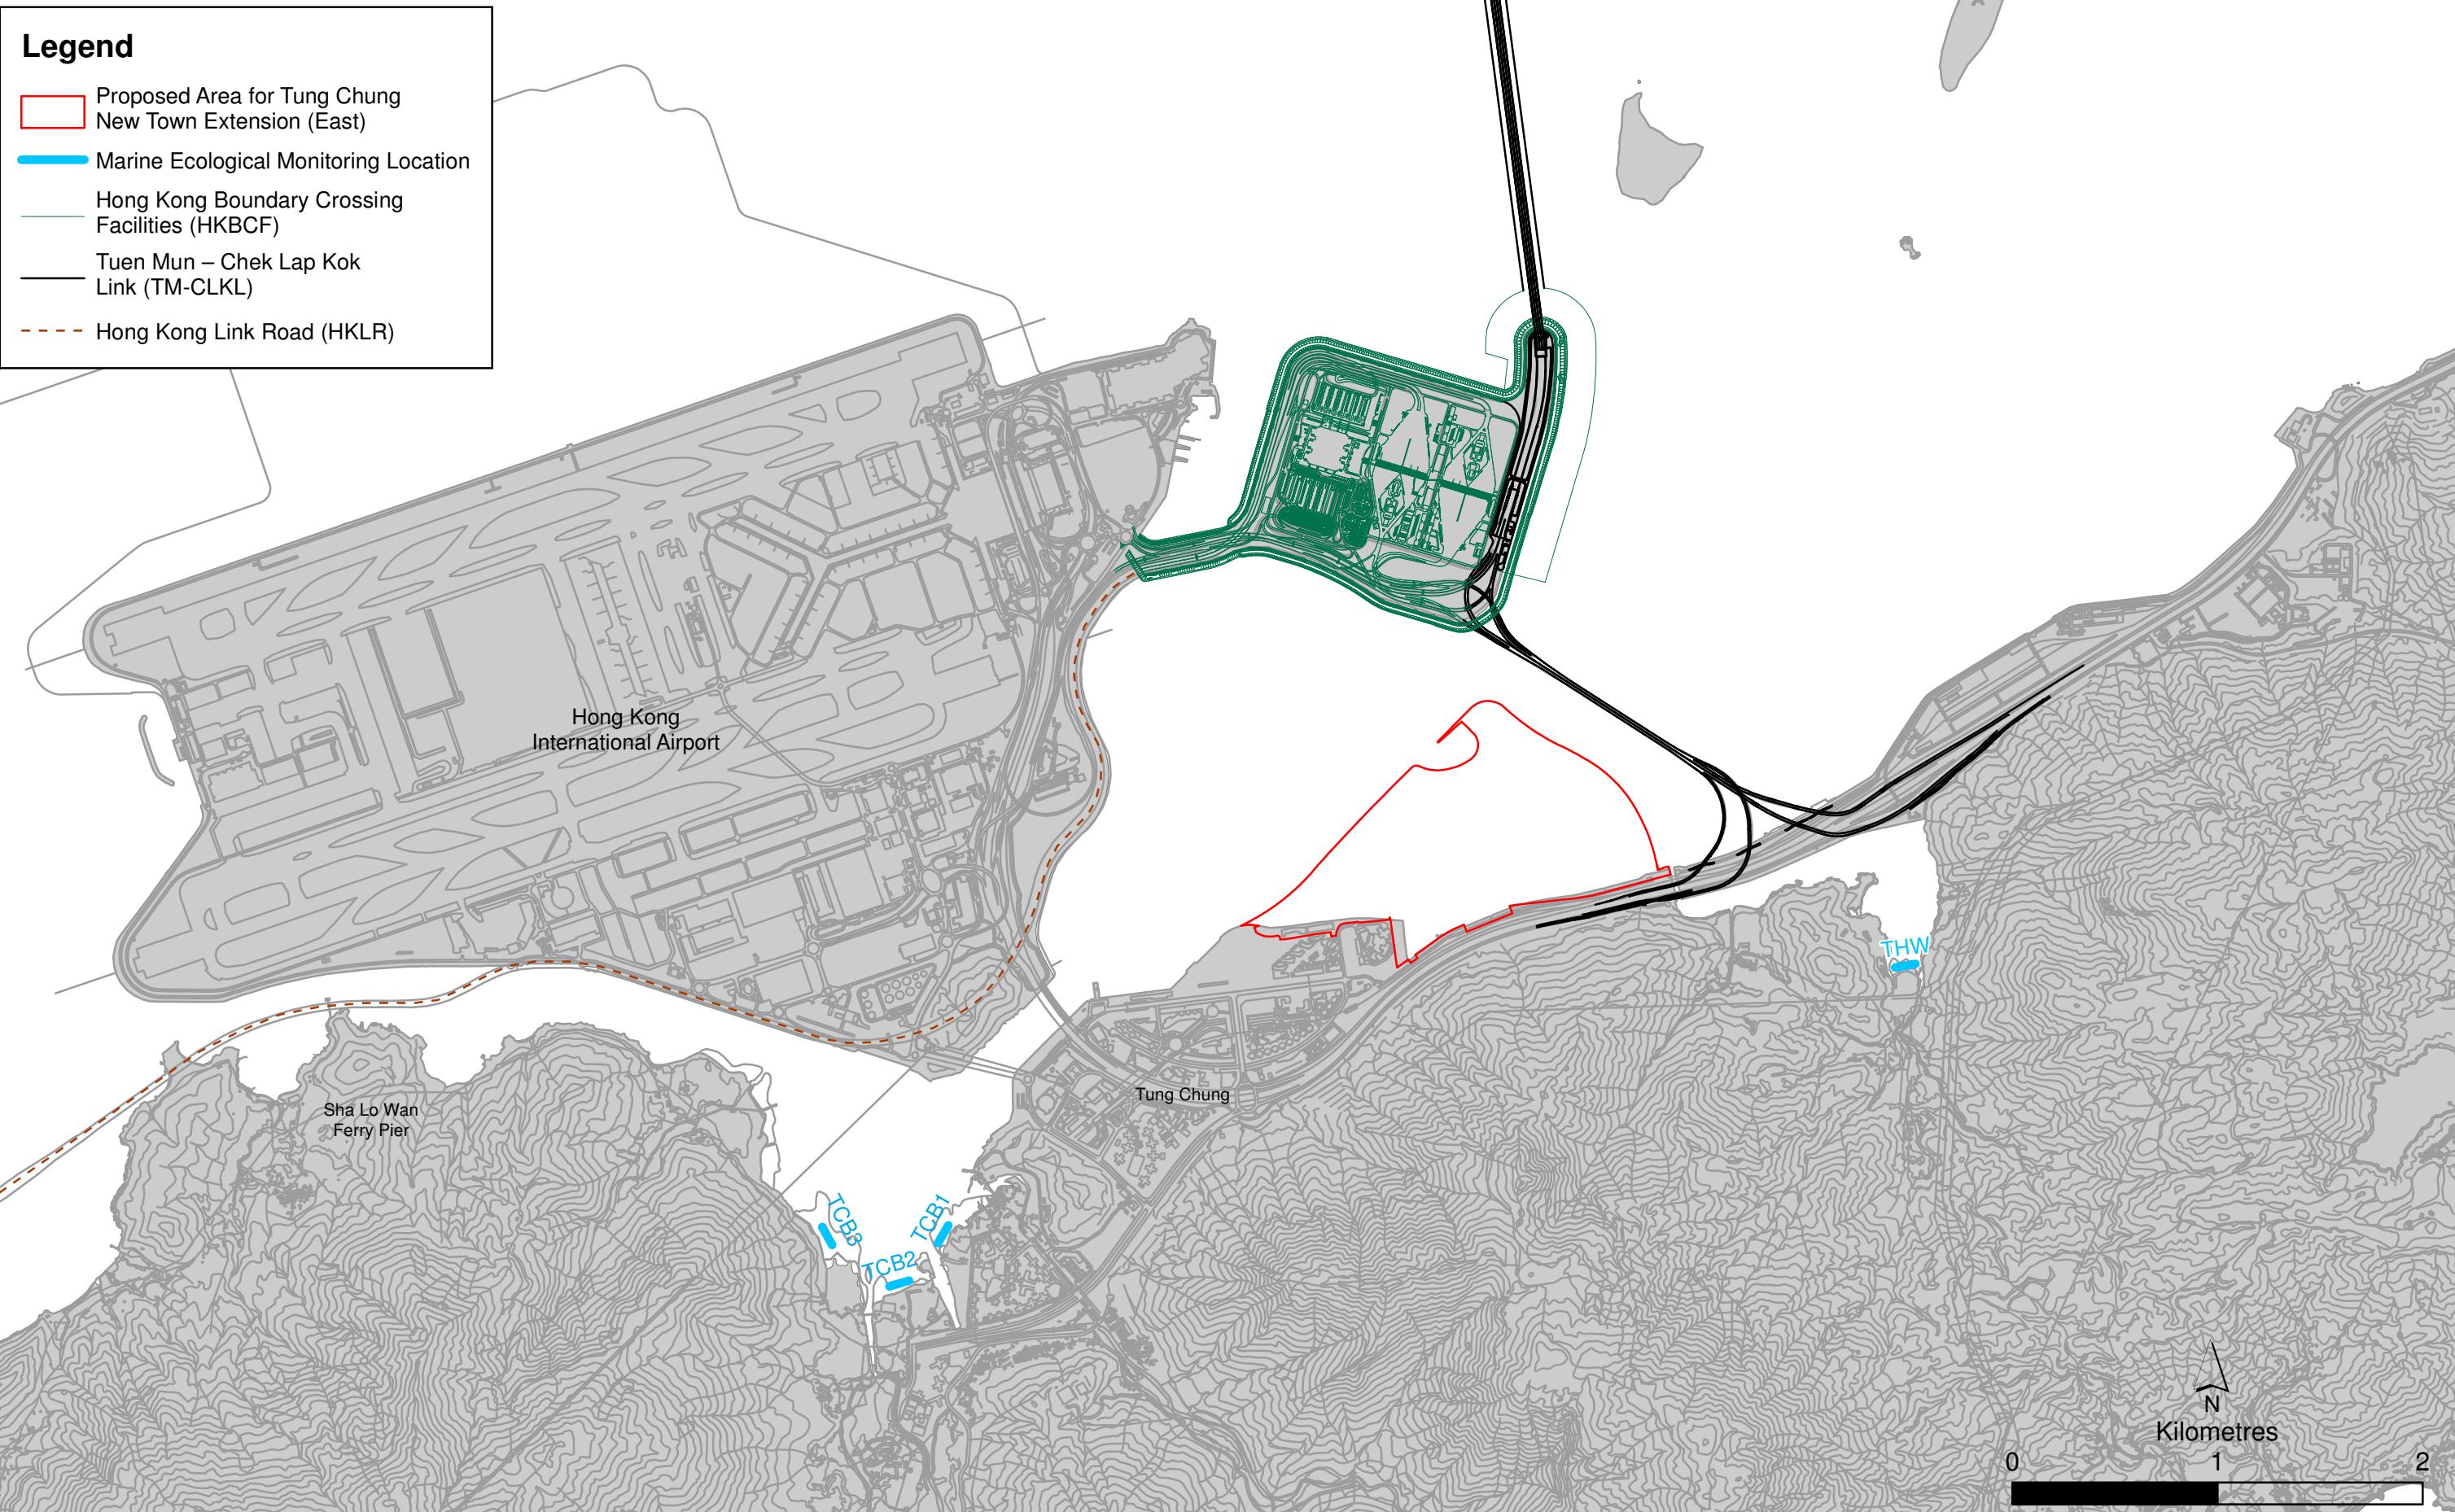
Figure 2.4

### Marine Ecological Monitoring (Intertidal Soft-shore Habitats)

Impact soft shore ecological monitoring was conducted at three (3) monitoring locations at Tung Chung Bay (TCB), situated in the eastern side (TCB1), southern side (TCB2) and western side (TCB3) as well as one (1) monitoring location at Tai Ho Wan (THW) as shown in *Figure 2.4* during the reporting period. Representative photographs taken during the impact monitoring are presented in *Figure 2.5*.

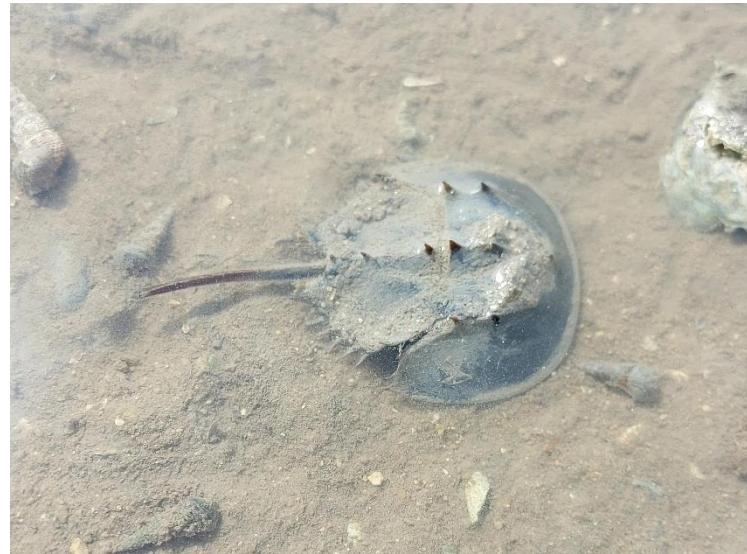
(e) Horseshoe crab *Tachypleus tridentatus* recorded at TCB3 during the Qualitative Walk-through Survey

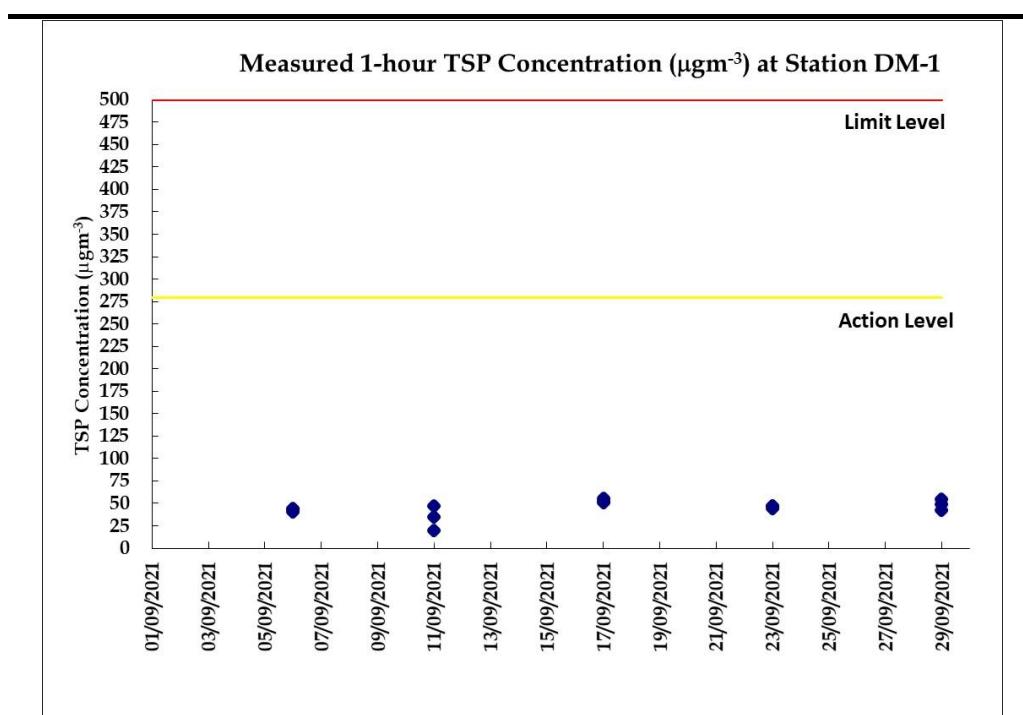
**Figure E3** *Graphical Presentation for 1-hr TSP Monitoring at Station DM-1*

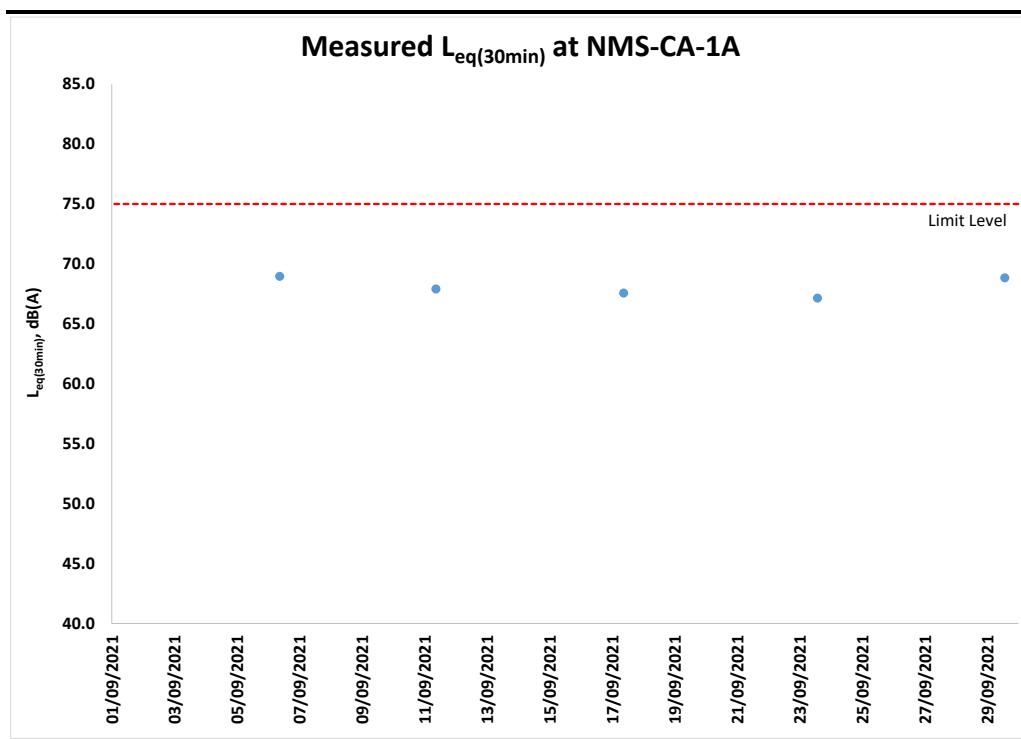
**Figure F3.1 Graphical Presentation for Noise Monitoring at Station NMS-CA-1A**

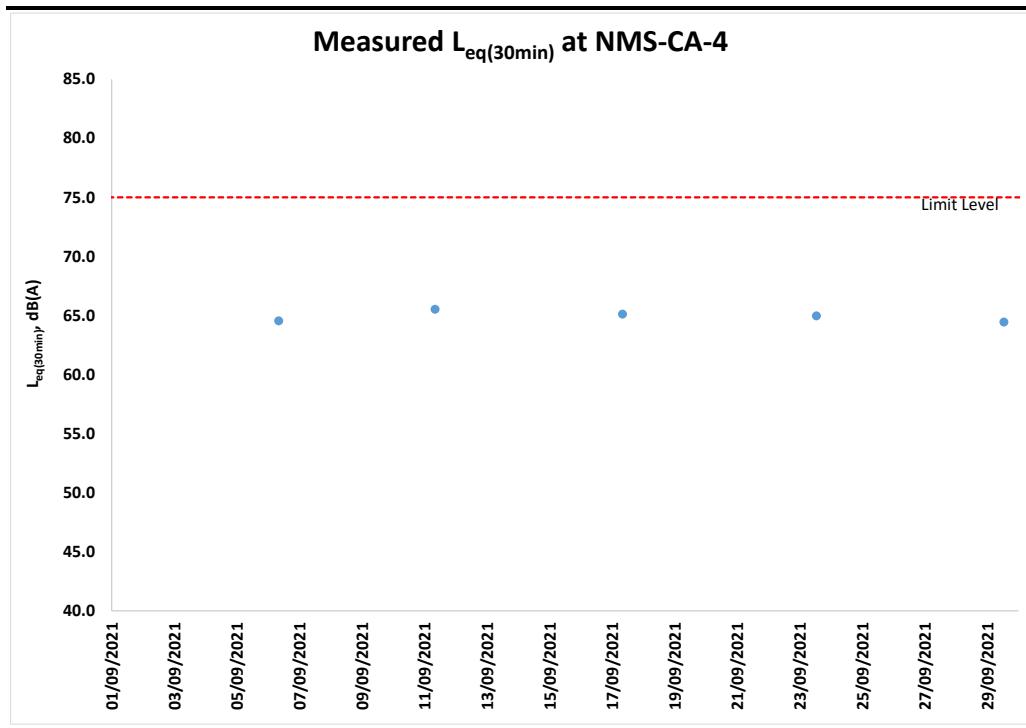
**Figure F3.2 Graphical Presentation for Noise Monitoring at Station NMS-CA-4**

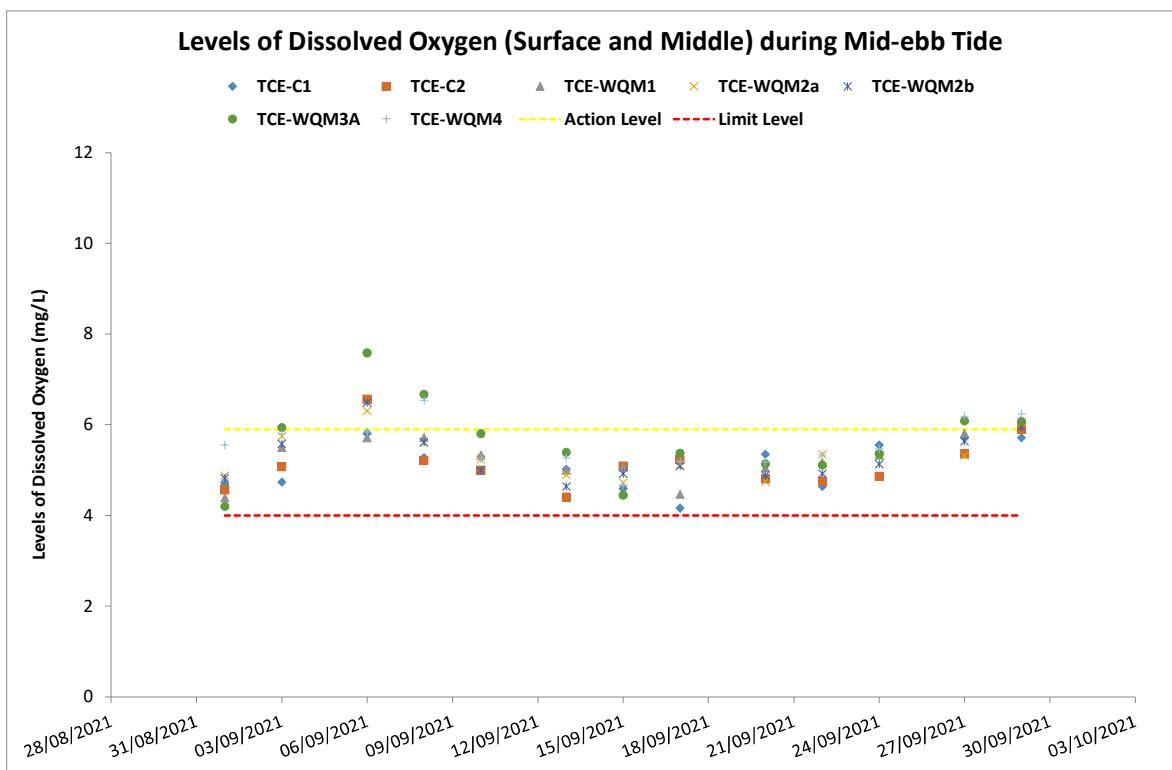
Figure 1: Levels of Dissolved Oxygen (Surface and Middle) (mg/L) recorded at Mid-ebb Tide during the Water Quality Monitoring between 1 to 30 September 2021

In addition, low levels of DO were recorded during previous three summer periods. This further suggested that exceedances of DO are likely caused by seasonal fluctuation and a similar trend of lower levels of DO would likely occur again during this summer period.

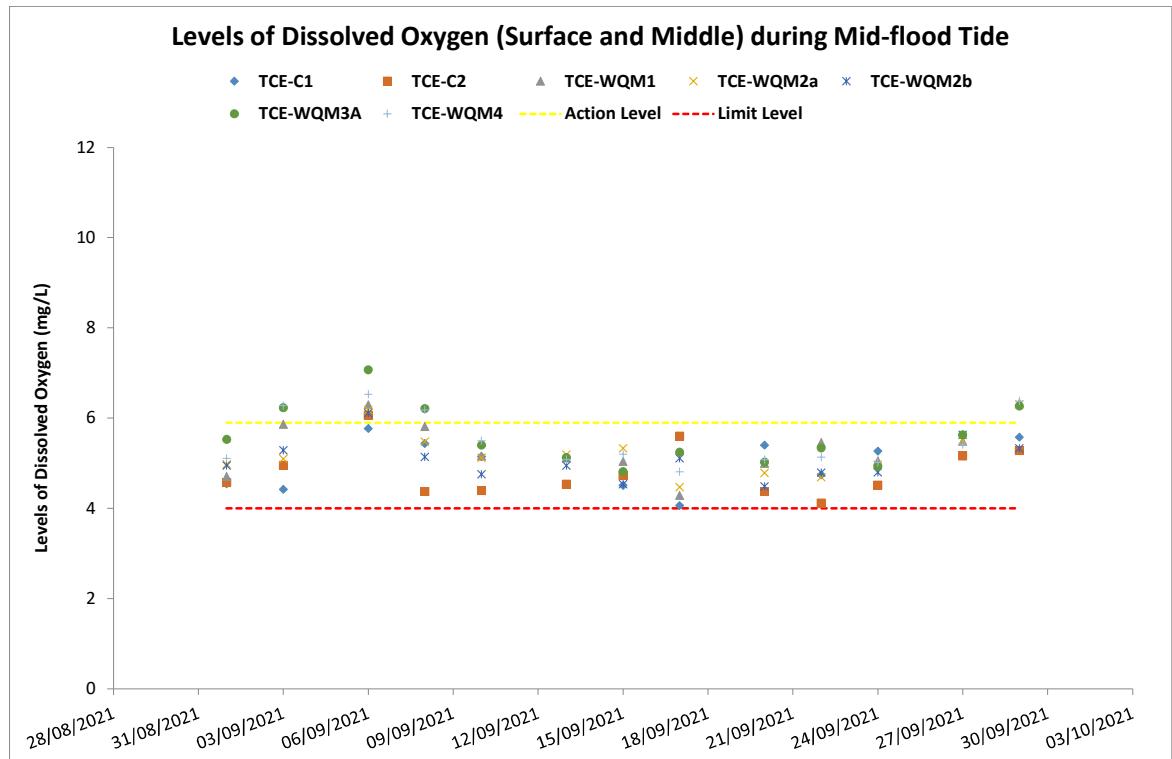
Figure 2: Levels of Dissolved Oxygen (Surface and Middle) (mg/L) recorded at Mid-flood Tide during the Water Quality Monitoring between 1 to 30 September 2021

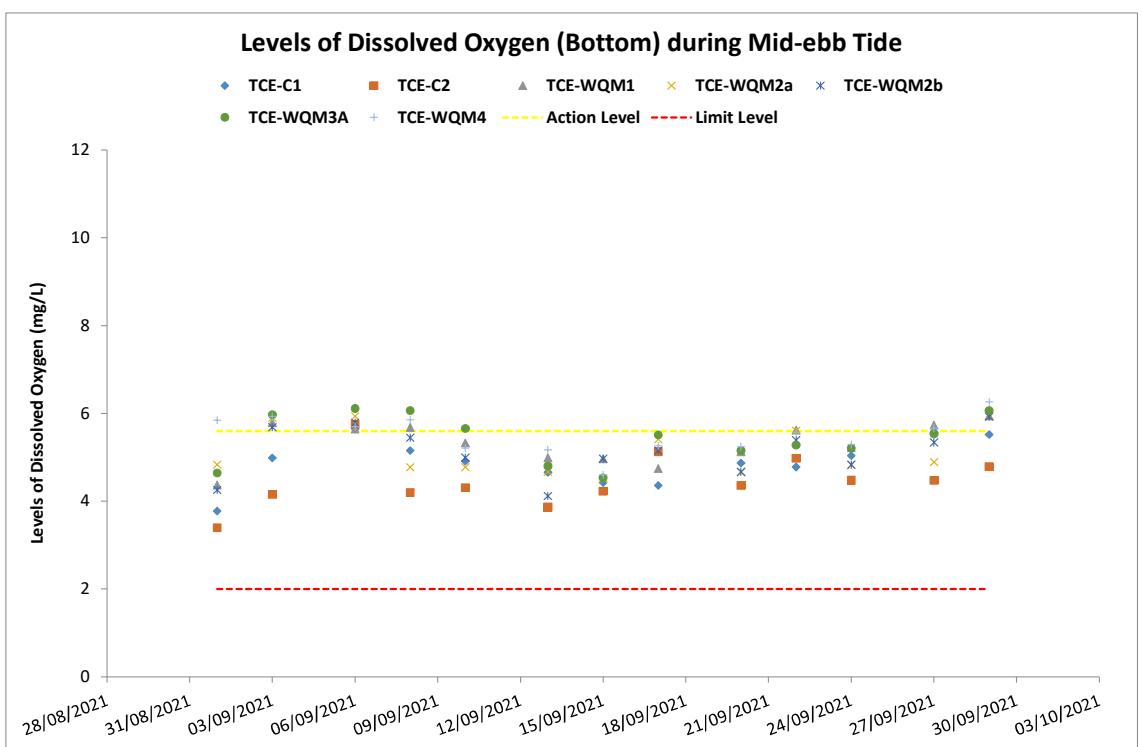
Figure 3: Levels of Dissolved Oxygen (Bottom) (mg/L) recorded at Mid-ebb Tide during the Water Quality Monitoring between 1 to 30 September 2021

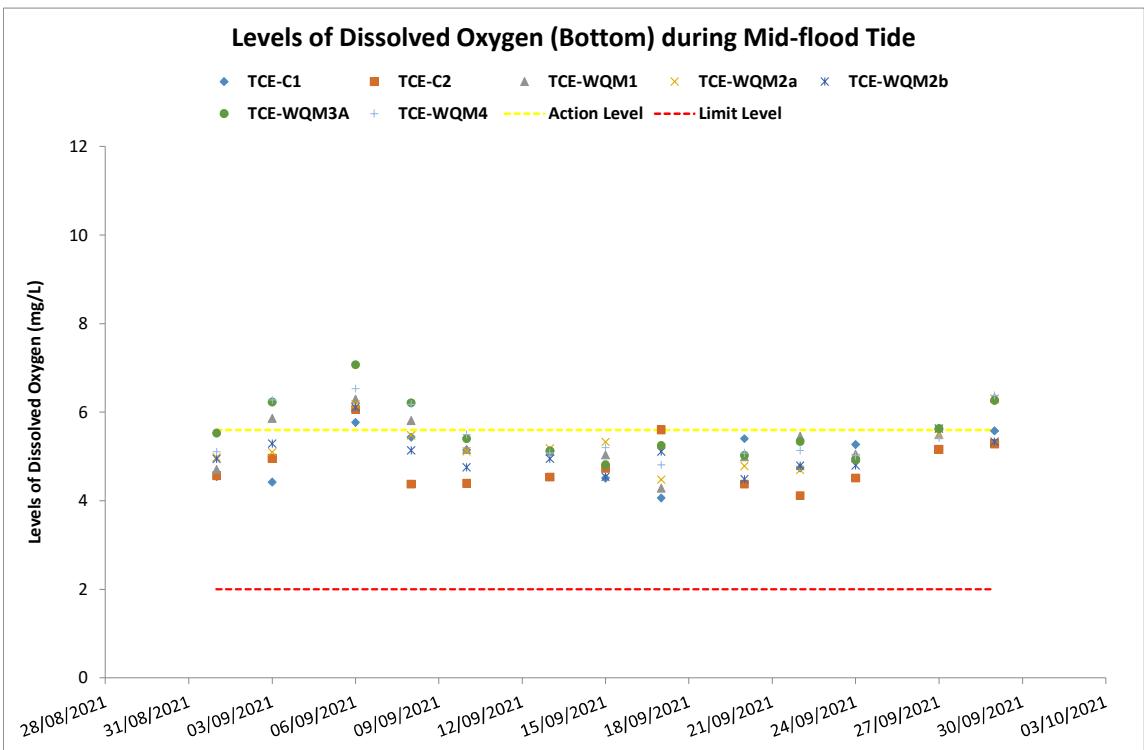
Figure 4: Levels of Dissolved Oxygen (Bottom) (mg/L) recorded at Mid-flood Tide during the Water Quality Monitoring between 1 to 30 September 2021

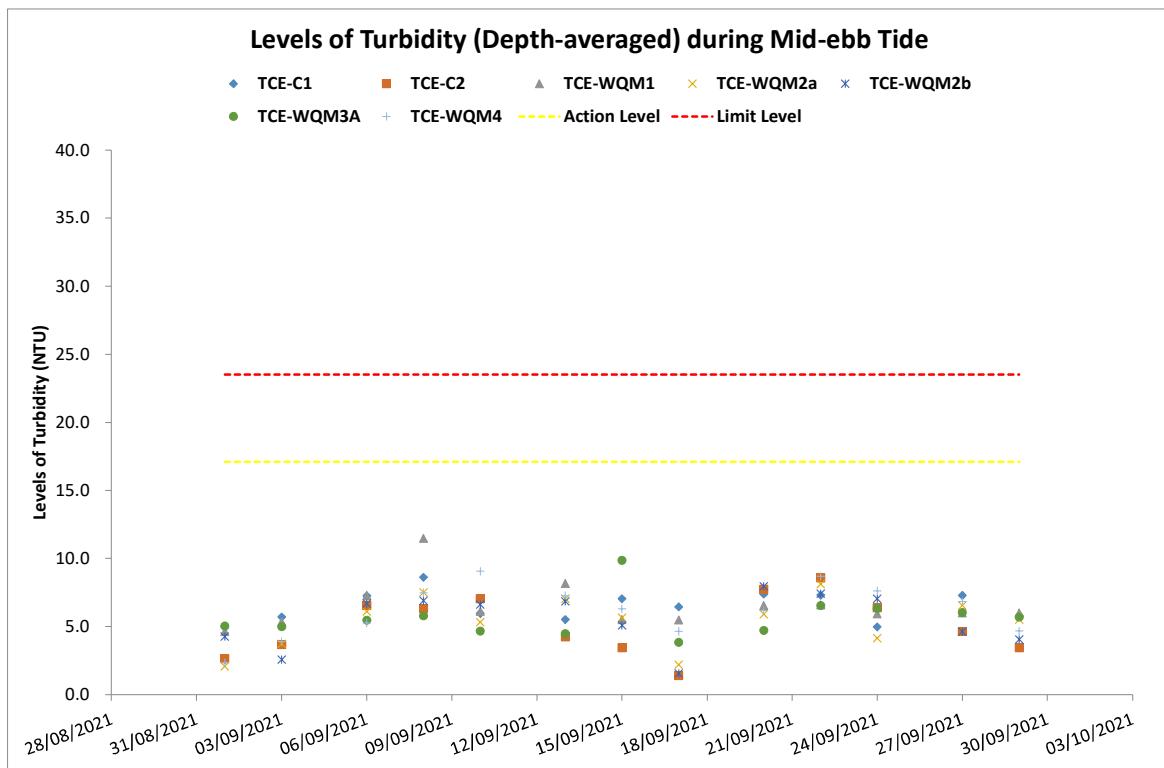
Figure 5: Levels of Turbidity (Depth-averaged) (NTU) recorded at Mid-ebb Tide during the Water Quality Monitoring between 1 to 30 September 2021
