Civil Engineering and  
Development Department

Agreement No. CE 60/2017 (EP)

**Environmental Team for  
Tung Chung New Town Extension (East) -  
Design and Construction**

**Monthly Environmental Monitoring & Audit Report  
for September 2021**

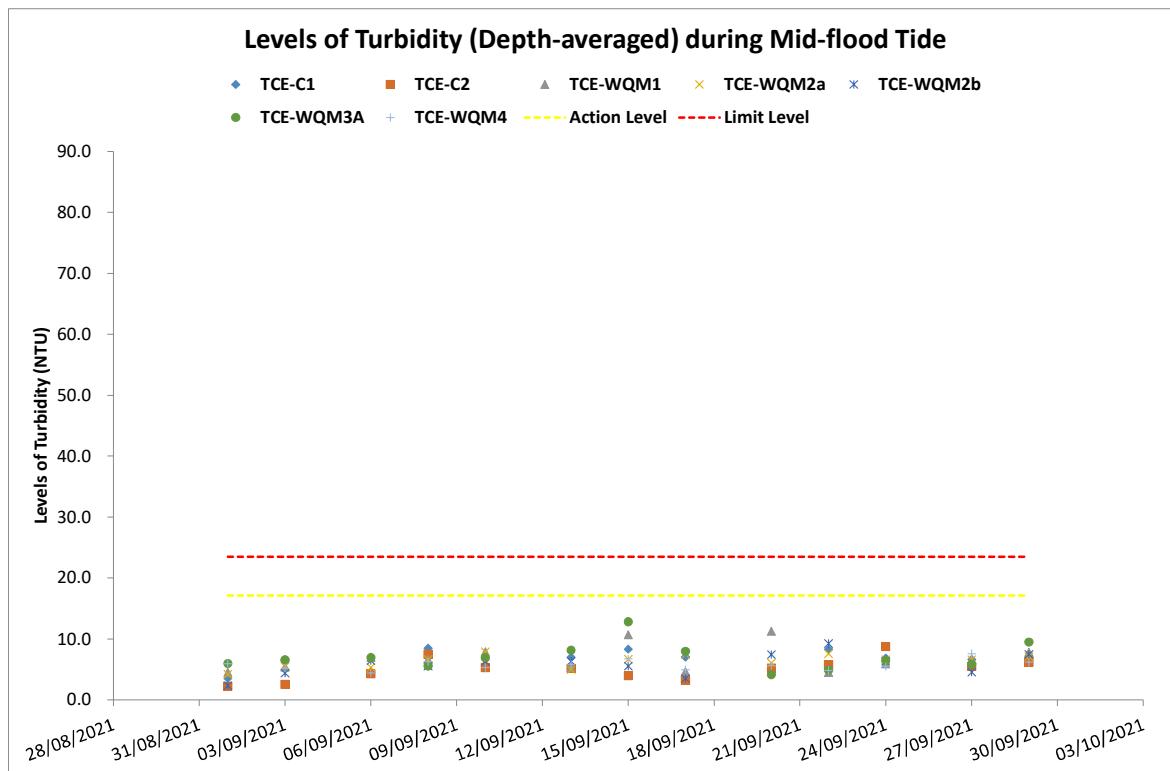
Figure 6: Levels of Turbidity (Depth-averaged) (NTU) recorded at Mid-flood Tide during the Water Quality Monitoring between 1 to 30 September 2021

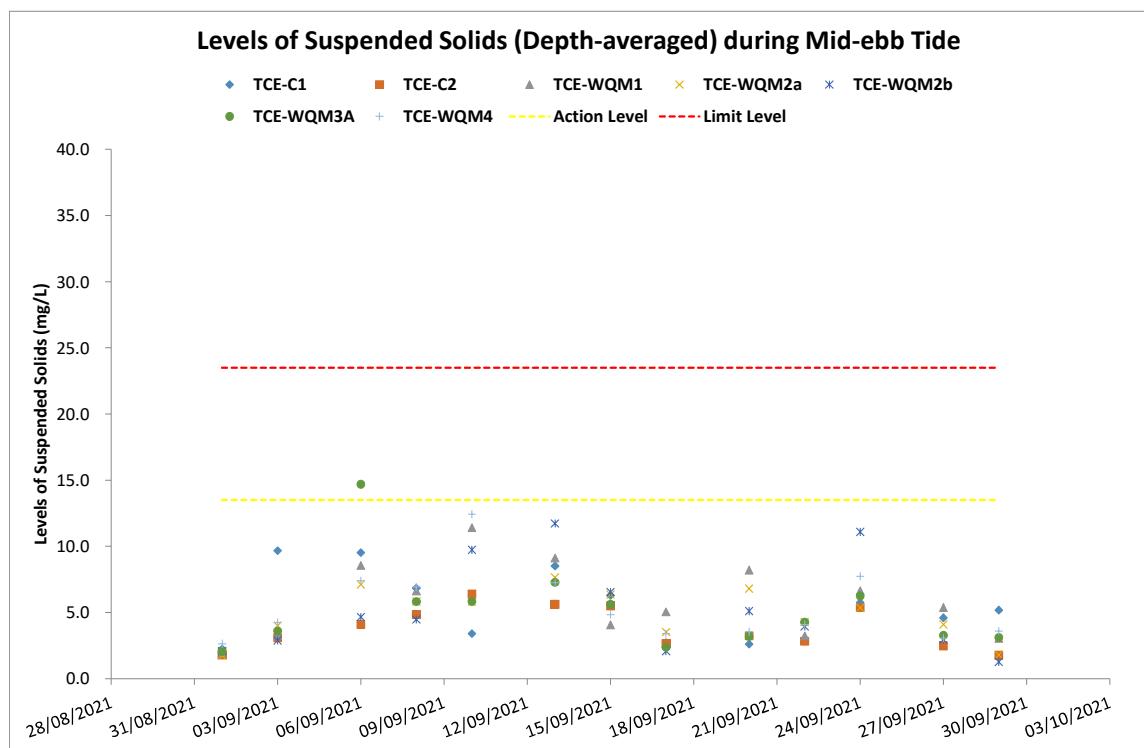
Figure 7: Levels of Suspended Solids (Depth-averaged) (mg/L) recorded at Mid-ebb Tide during the Water Quality Monitoring between 1 to 30 September 2021

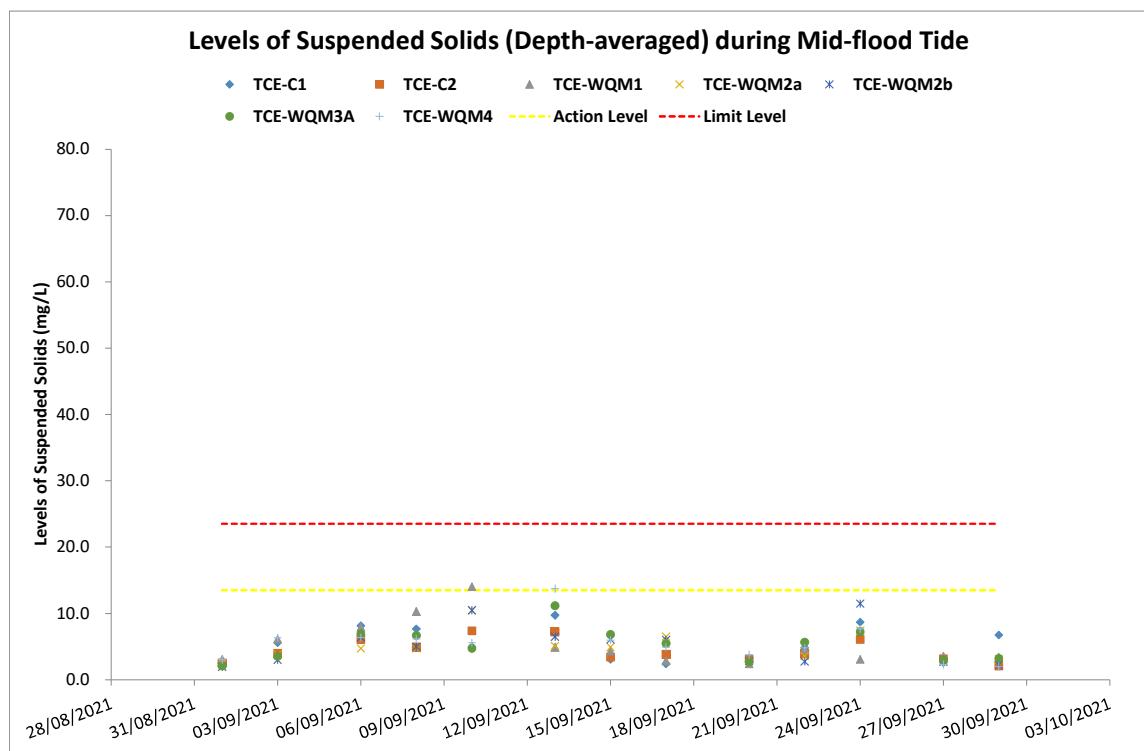
Figure 8: Levels of Suspended Solids (Depth-averaged) (mg/L) recorded at Mid-flood Tide during the Water Quality Monitoring between 1 to 30 September 2021
