Agreement No. CE 60/2017 (EP)

**Environmental Team for  
Tung Chung New Town Extension (East) -  
Design and Construction**

**Monthly Environmental Monitoring & Audit Report  
for March 2022**

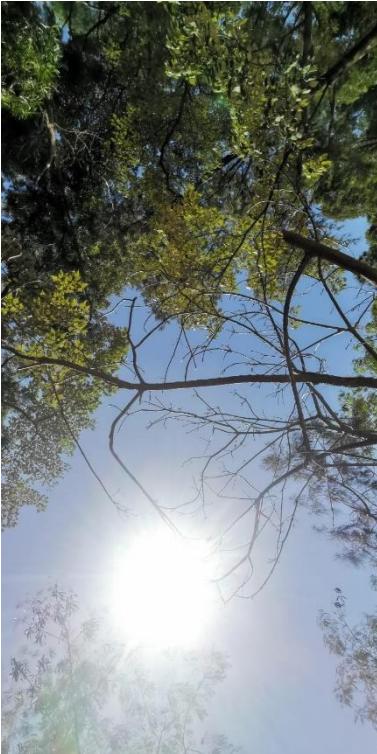
Photo 06:Crown condition of G62/RT-08

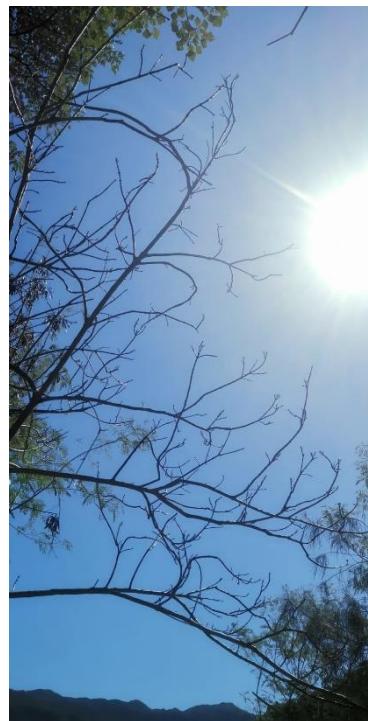
Photo 07:Crown condition of G62/RT-08

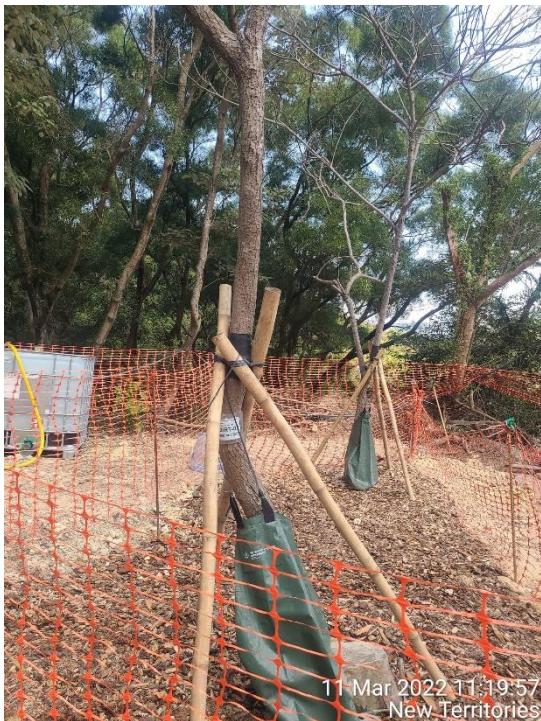
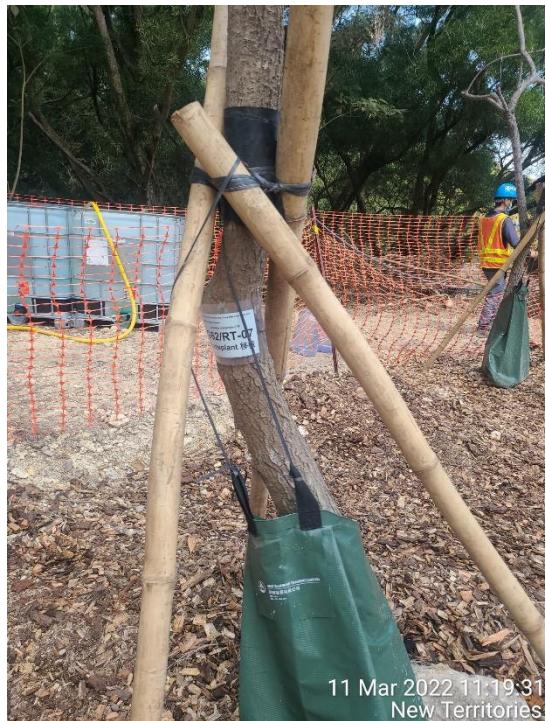
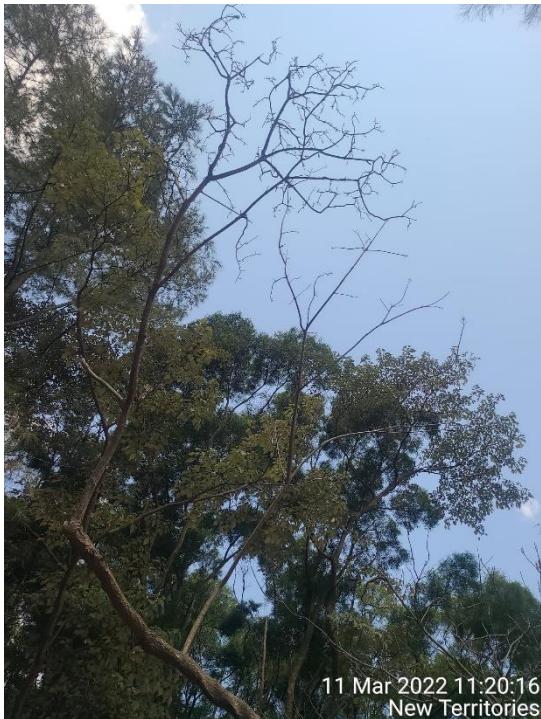
Contract 2	2 March 2022	Portion 3 <ul style="list-style-type: none"> <li>• The health condition of the transplanted plant species of conservation importance was poor (RT-07 and RT-08).</li> <li>• Labels were not observed on chemical containers.</li> </ul>	<ul style="list-style-type: none"> <li>• Portion 3</li> <li>• The Contractor was reminded to provide mitigation measures (i.e. daily watering, use of mulch and pruning/weeding) when necessary, keep close monitoring of the plants in terms of their health condition and report to relevant parties in the event of deterioration immediately.</li> <li>• The Contractor was reminded to affix appropriate labels on chemical containers</li> </ul>
	9 March 2022	Portion 3 <ul style="list-style-type: none"> <li>• Drainage blockage was observed.</li> <li>• The health condition of the transplanted plant species of conservation importance was poor (RT-07 and RT-08).</li> </ul>	<ul style="list-style-type: none"> <li>• Portion 3</li> <li>• The Contractor was reminded to keep the drainage clear and provide proper drainage arrangement to prevent discharge/runoff.</li> <li>• The Contractor was reminded to provide mitigation measures (i.e. daily watering, use of mulch and pruning/weeding) when necessary, keep close monitoring of the plants in terms of their health condition and report to relevant parties in the event of deterioration immediately.</li> </ul>

Photo 08:Tree tag of G62/ RT-07

Photo 09:Root collar of G62/RT-07

Photo 10:Crown condition of G62/RT-07

Photo 11:Whole view for G62/RT-07

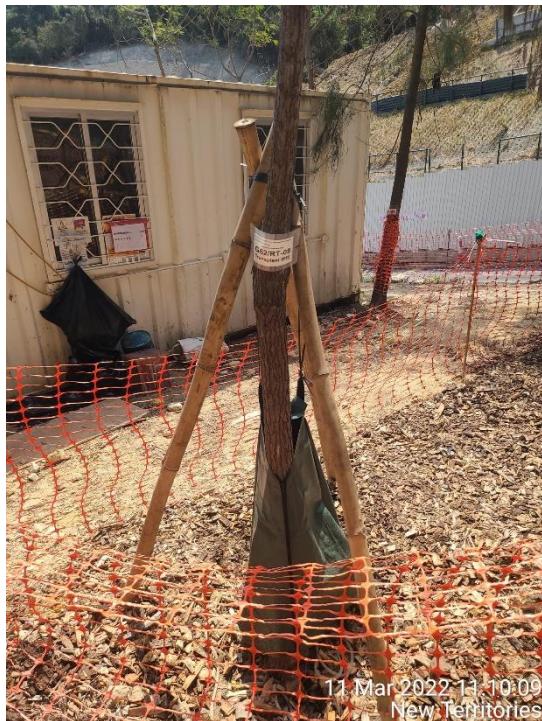
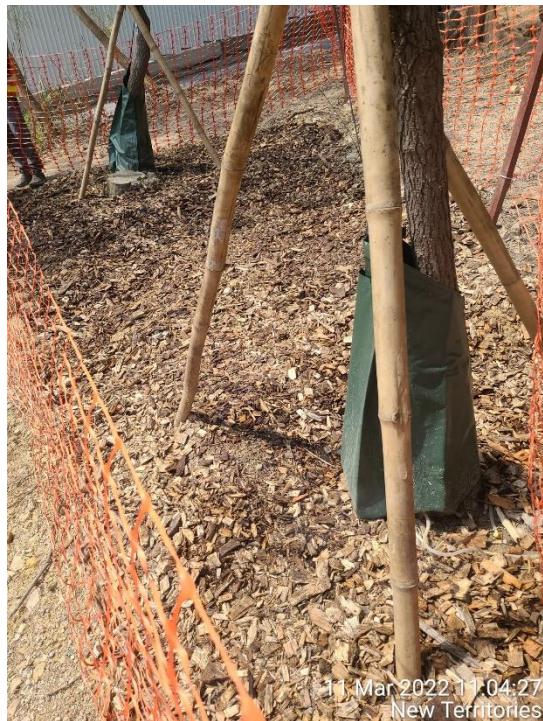
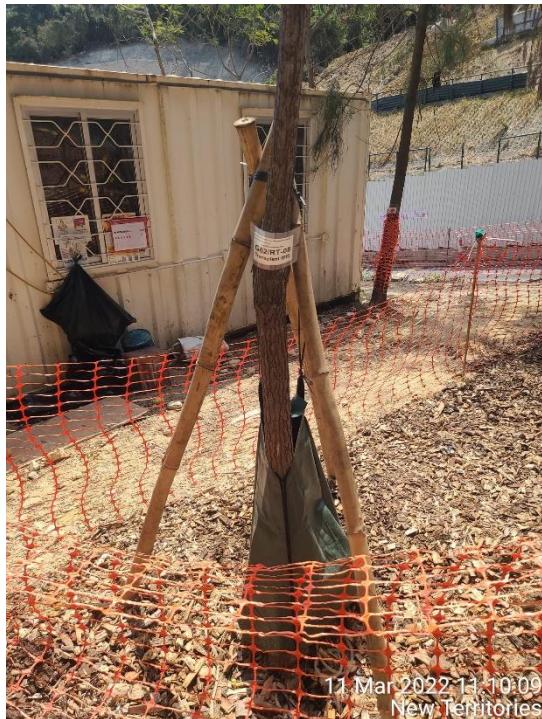
Photo 12:Tree tag of G62/ RT-08

Photo 13:Root collar of G62/RT-08

Photo 14:Trunk condition of G62/RT-08

Photo 15:Whole view of G62/RT-08

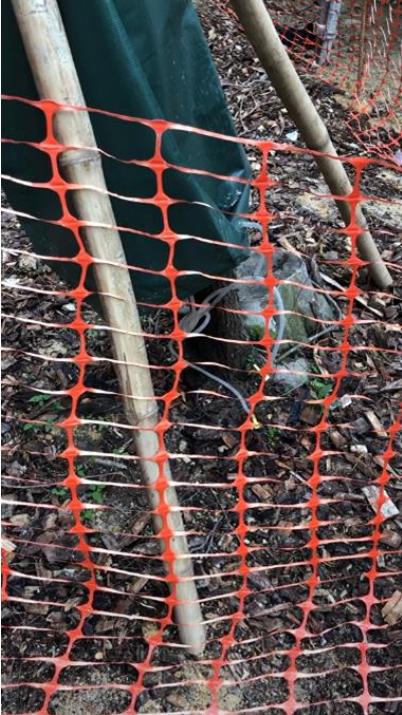
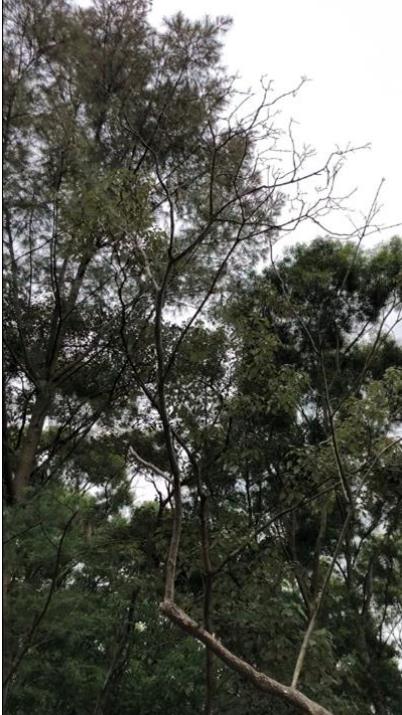
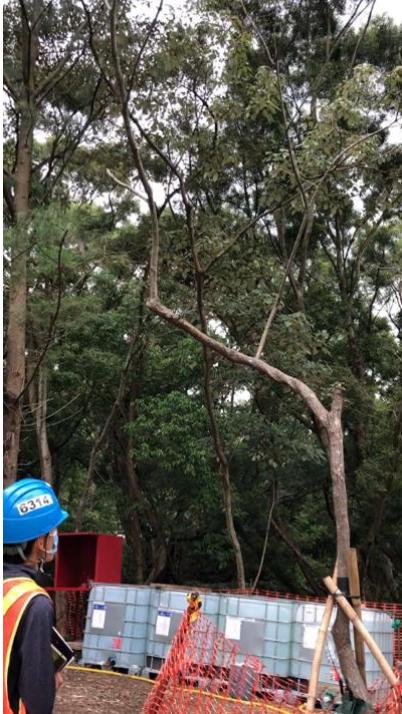
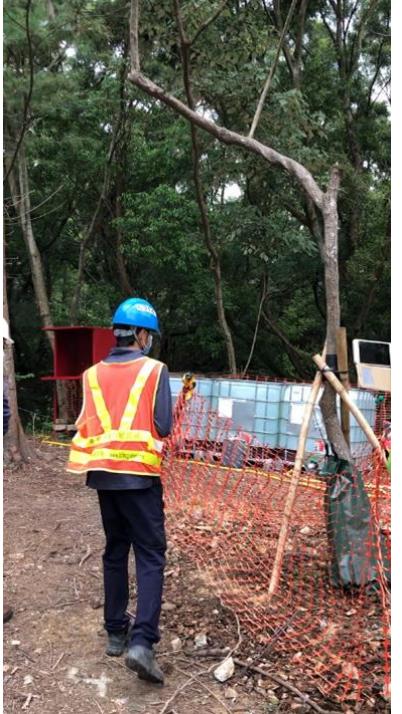
30 March 2022	Portion 3 <ul style="list-style-type: none"> <li>The health condition of the transplanted plant species of conservation importance was poor (RT-07 and RT-08).</li> </ul> HDD <ul style="list-style-type: none"> <li>Environmental permit was not observed on the gate.</li> <li>Construction materials were observed placing nearby the retained trees and no tree protection was observed.</li> </ul>	Portion 3 <ul style="list-style-type: none"> <li>The Contractor was reminded to provide mitigation measures (i.e. daily watering, use of mulch and pruning/weeding) when necessary, keep close monitoring of the plants in terms of their health condition and report to relevant parties in the event of deterioration immediately.</li> </ul> HDD <ul style="list-style-type: none"> <li>The Contractor was reminded to affix environmental permit on the gate.</li> <li>The Contractor was urged to remove the materials and provide tree protection.</li> </ul>

Photo 32: Root collar of G62/ RT-07	Photo 33: Crown condition of G62/RT-07

Photo 34: Crown condition of G62/RT-07	Photo 35: Trunk condition for G62/RT-07

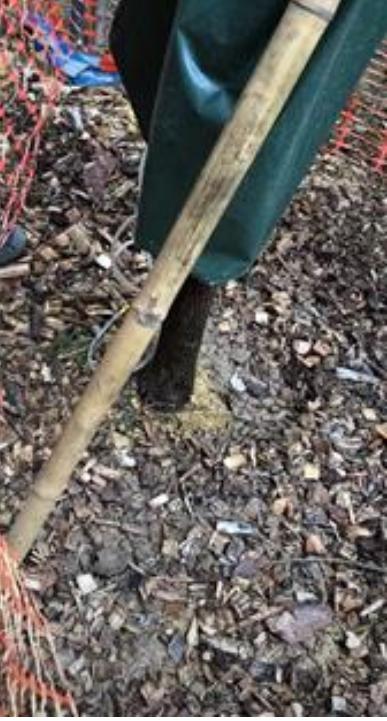
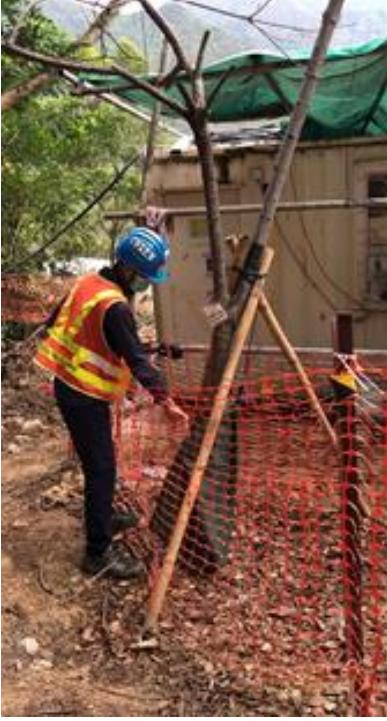
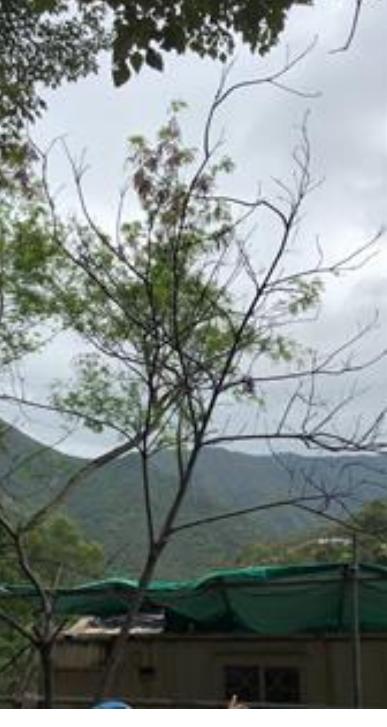
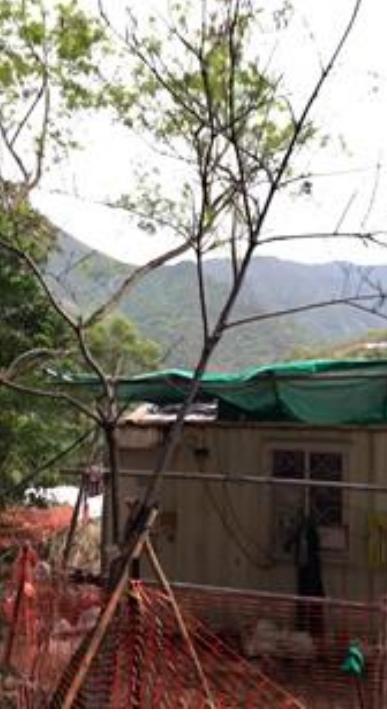
Photo 36: Root collar of G62/ RT-08	Photo 37: Trunk condition of G62/RT-08

Photo 38: Crown condition of G62/RT-08	Photo 39: Crown condition of G62/RT-08
