**Agreement No. CE 64/2020 (EP)  
Environmental Team for  
Tung Chung New Town  
Extension (West) –  
Design and Construction**

Monthly Environmental Monitoring & Audit Report  
for April 2022

**Environmental Permit No. EP-519/2016**

**Tung Chung New Town Extension (West)**

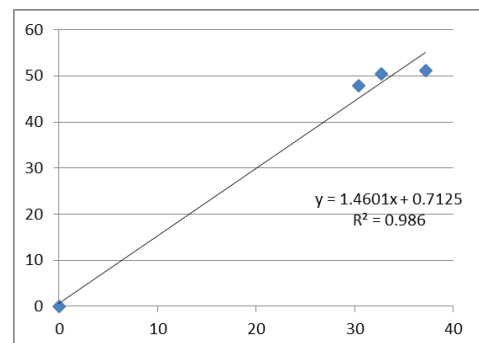
Slope (K-factor): 1.4601 (µg/m<sup>3</sup>)/CPM  
Correlation Coefficient (R) 0.9930  
Date of Issue 8 November 2021

1. **Strong** Correlation ( $R > 0.8$ )
2. Factor 1.4601 (µg/m<sup>3</sup>)/CPM should be applied for TSP monitoring

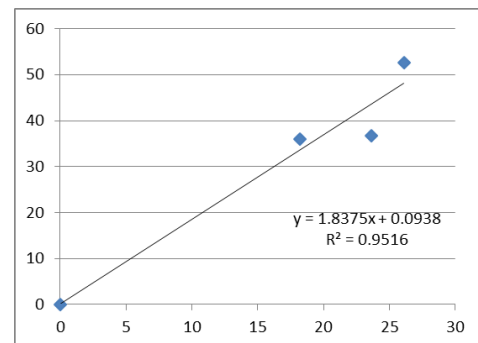
Slope (K-factor): 1.8375 (µg/m<sup>3</sup>)/CPM  
Correlation Coefficient (R) 0.9755  
Date of Issue 19 November 2021

1. **Strong** Correlation ( $R > 0.8$ )
2. Factor 1.8375 (µg/m<sup>3</sup>)/CPM should be applied for TSP monitoring

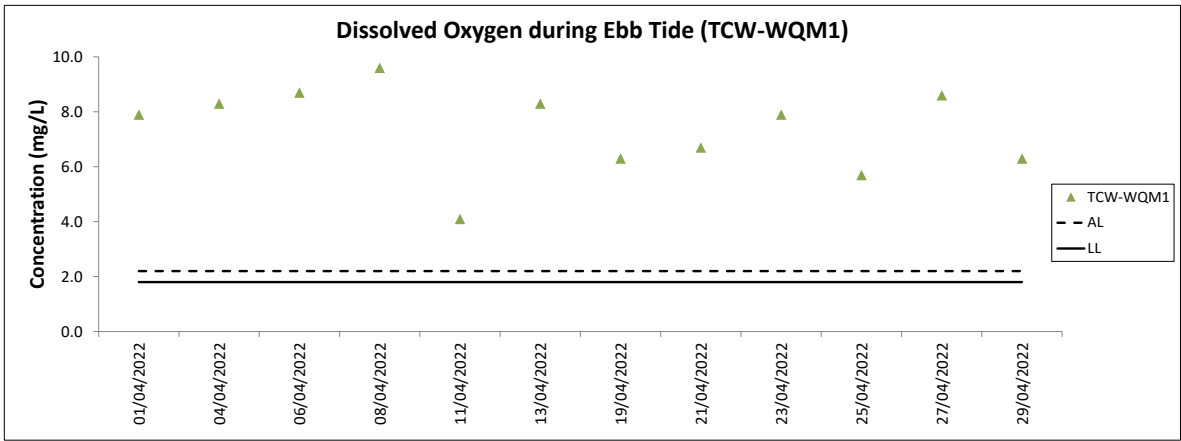
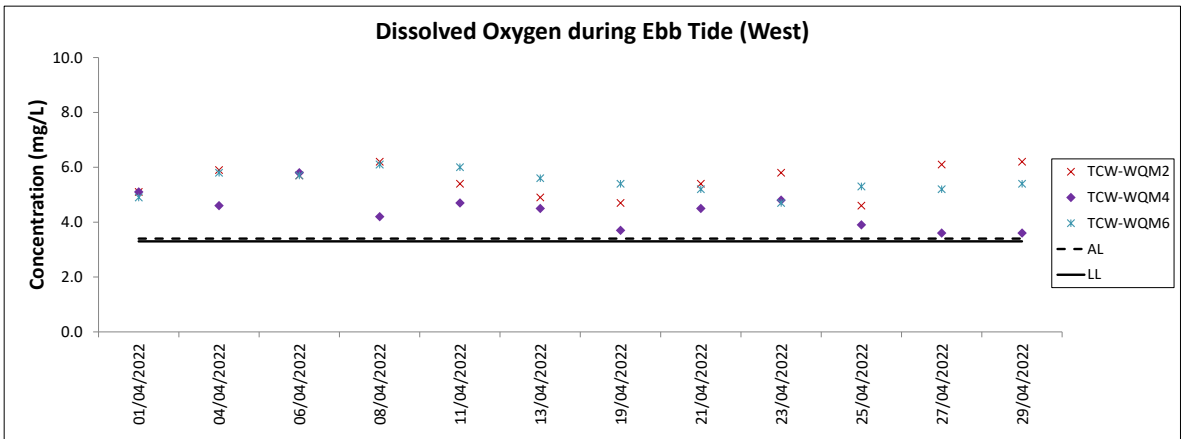
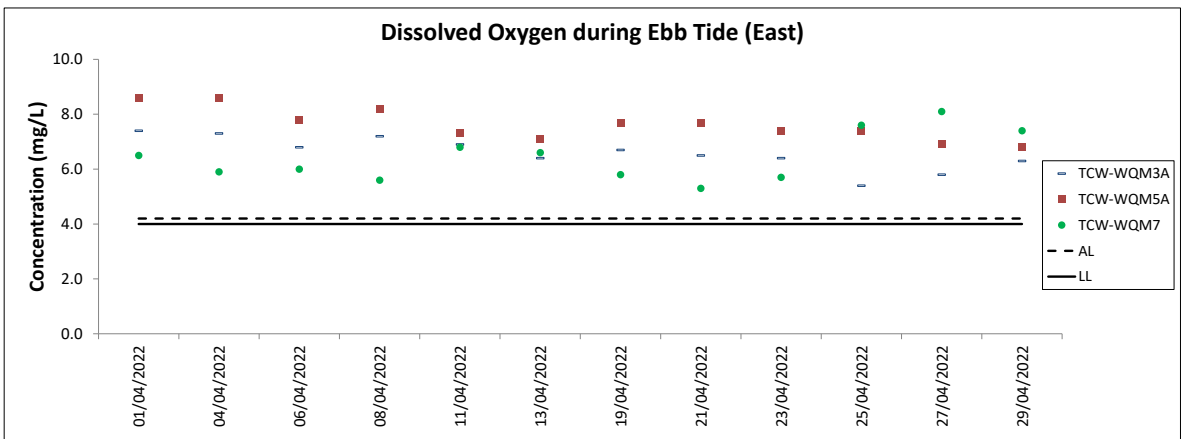
Note: The Action and Limit Level of dissolved oxygen can be referred to Table 4.3 of the monthly EM&A report.  
 Major site activities carried out during the reporting period are summarized in Section 1.4 of the monthly EM&A report.  
 Weather conditions during monitoring are presented in the data tables above.  
 QA/ QC requirements as stipulated in the EM&A Manual were carried out during measurement.

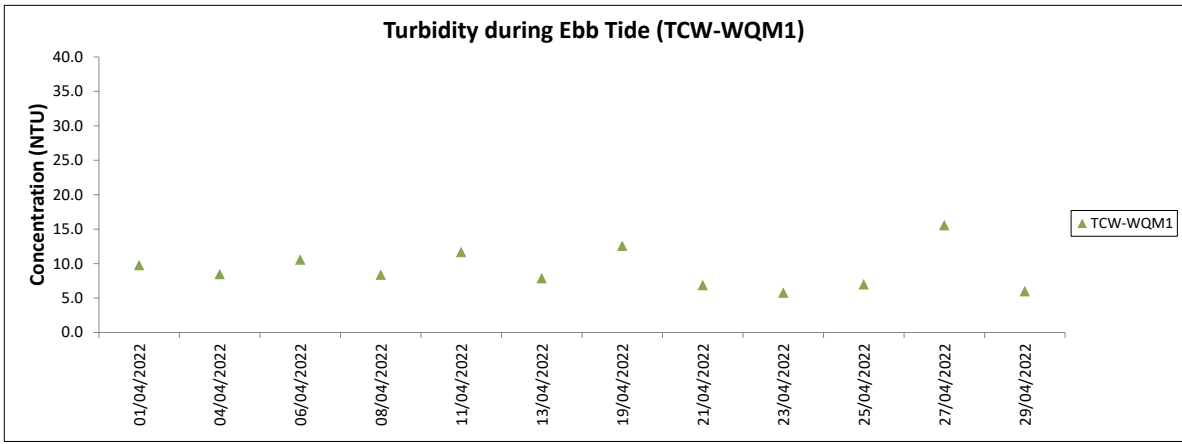
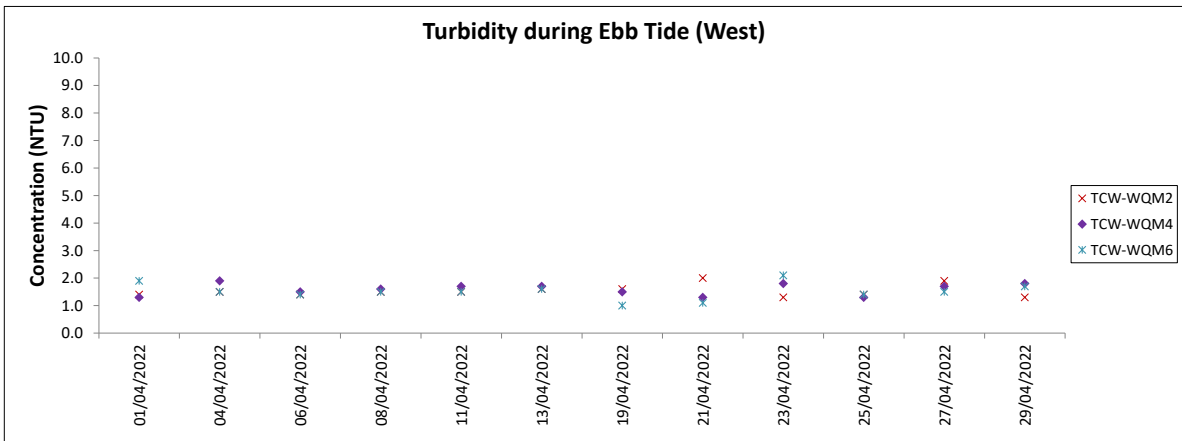
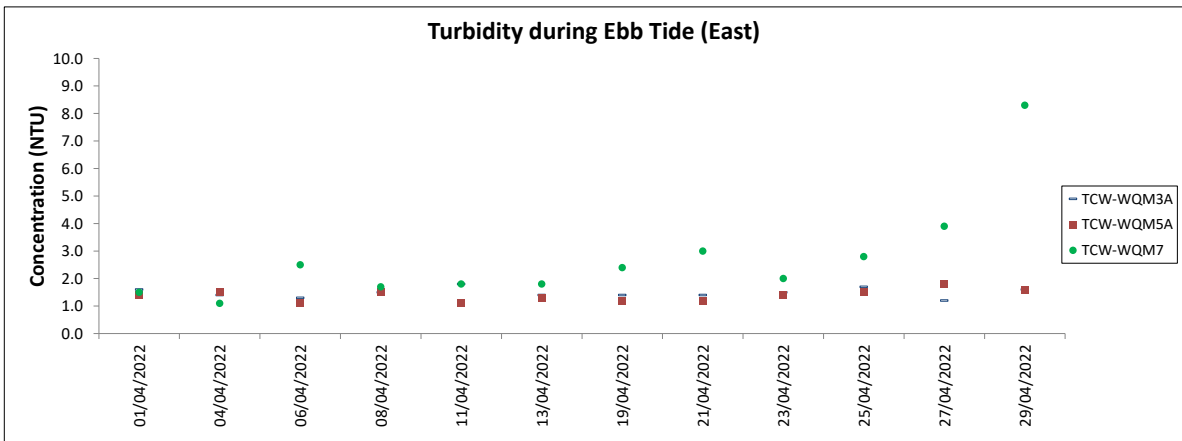
Note: The Action and Limit Level of turbidity can be referred to Table 4.3 of the monthly EM&A report.  
Major site activities carried out during the reporting period are summarized in Section 1.4 of the monthly EM&A report.  
Weather conditions during monitoring are presented in the data tables above.  
QA/ QC requirements as stipulated in the EM&A Manual were carried out during measurement.

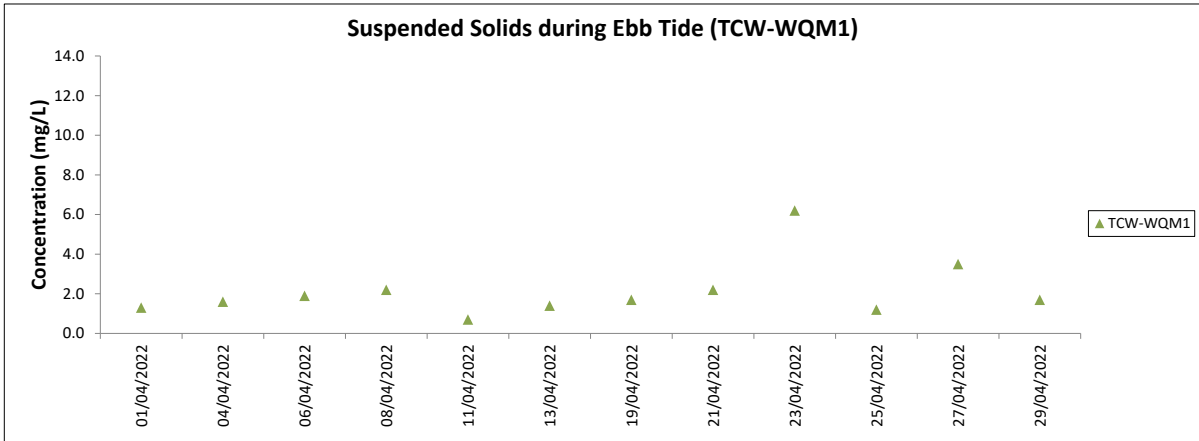
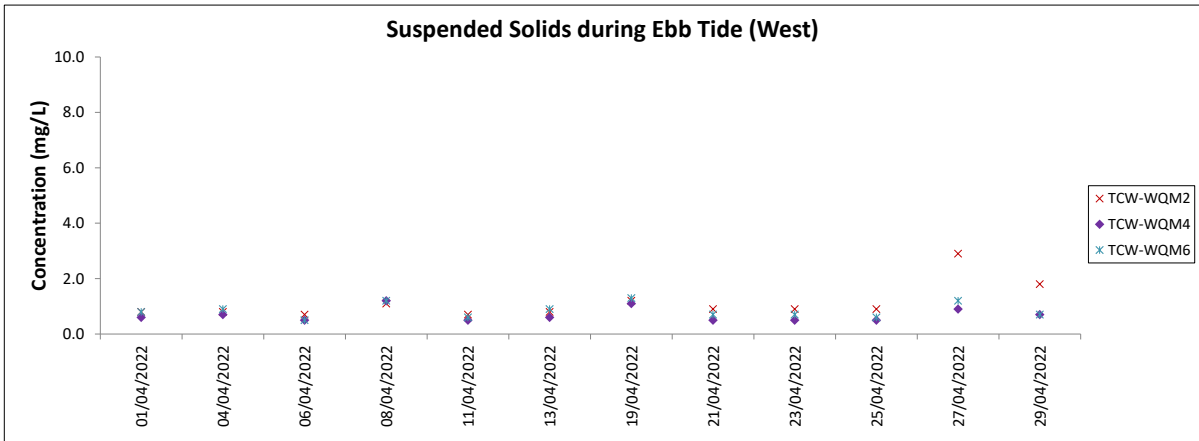
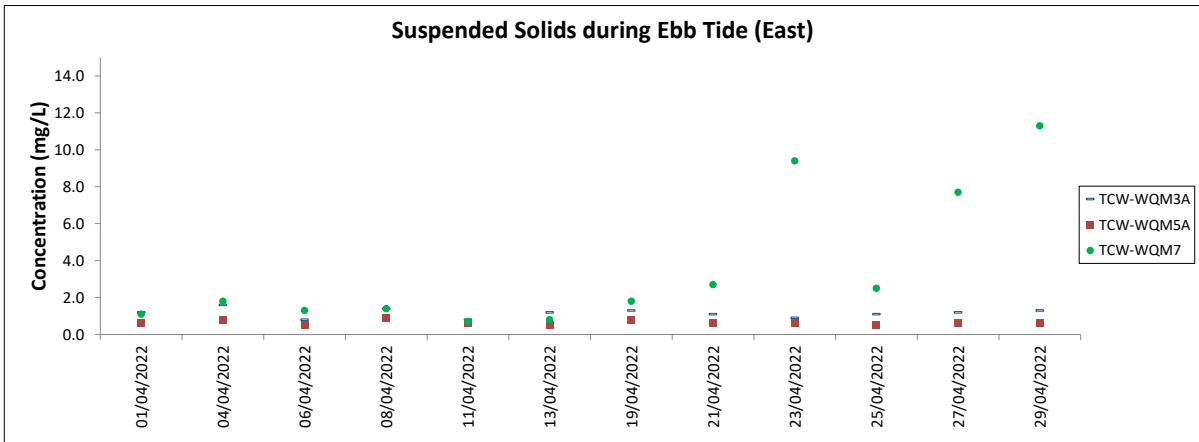
Note: The Action and Limit Level of suspended solids can be referred to Table 4.3 of the monthly EM&A report.  
 Major site activities carried out during the reporting period are summarized in Section 1.4 of the monthly EM&A report.  
 Weather conditions during monitoring are presented in the data tables above.  
 QA/ QC requirements as stipulated in the EM&A Manual were carried out during measurement.
