**Agreement No. CE 64/2020 (EP)  
Environmental Team for  
Tung Chung New Town  
Extension (West) –  
Design and Construction**

Monthly Environmental Monitoring & Audit Report  
for June 2023

**Environmental Permit No. EP-519/2016**

**Tung Chung New Town Extension (West)**

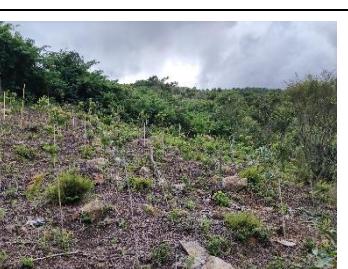
**Table 7.3: Examples of Landscape and Visual Mitigation Measures in the Reporting Period**

Erection of site hoardings around works area in unobtrusive colours	General view of tree protection zone for retained tree	Transplanting of existing trees to temporary nursery site

Control of night-time lighting using light hooding	Protection of Natural Rivers and Streams	Compensatory Planting and Woodland Restoration

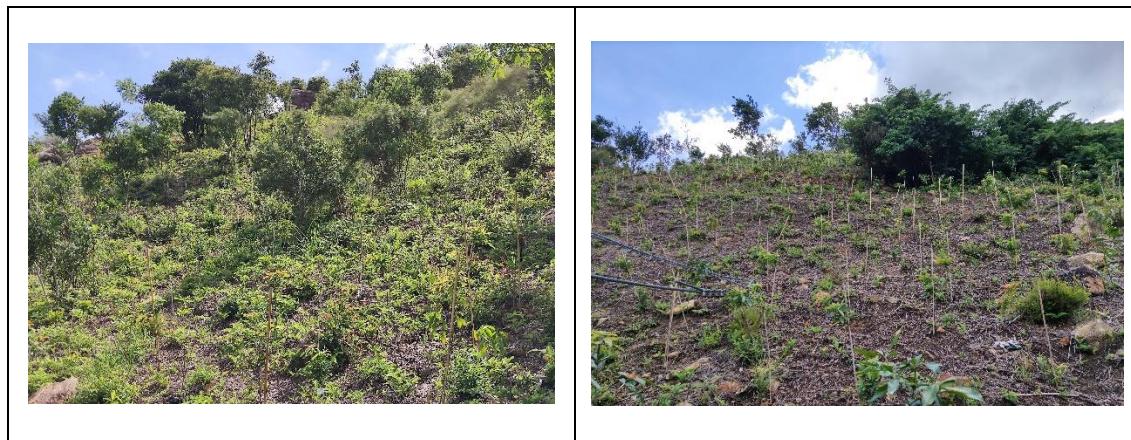
**Table 7.6: Photos of the Compensation Woodland Planting**

Compensation Woodland Planting was completed in May 2022. With the approval from EPD on the monitoring proposal in October 2022, the monitoring for Compensation Woodland was commenced in November 2022. Quarterly post-planting monitoring report for February 2023 was submitted to EPD on 31 May 2023. Quarterly post-planting monitoring for the compensation woodland was carried out in May 2023. Photos of the Compensation Woodland planting are shown in **Table 7.6**.

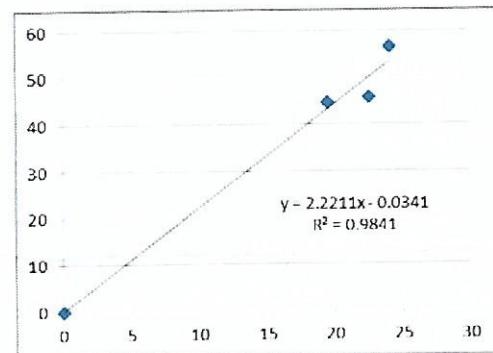
Correlation Coefficient (R) 0.9920

1. **Strong Correlation (R>0.8)**
2. Factor 2.2211 (ug/m<sup>3</sup>)/CPM should be applied for TSP monitoring

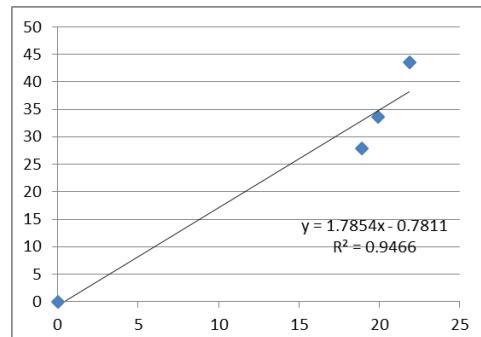
Correlation Coefficient (R) 0.9729

- Strong Correlation ( $R > 0.8$ )
- Factor 1.7854 (µg/m<sup>3</sup>)/CPM should be applied for TSP monitoring

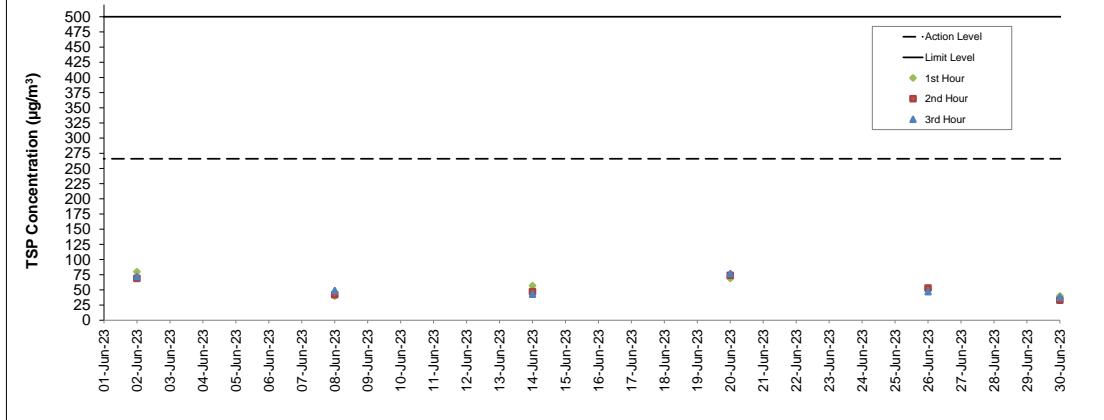
DM5 1-Hour TSP

Date	Start Time	Finish Time	Weather	1-hr TSP ( $\mu\text{g}/\text{m}^3$ )	Action Level ( $\mu\text{g}/\text{m}^3$ )	Limit Level ( $\mu\text{g}/\text{m}^3$ )
02-Jun-23	08:44	09:44	Sunny	48.0	260	500
02-Jun-23	09:44	10:44	Sunny	56.0	260	500
02-Jun-23	10:44	11:44	Sunny	59.0	260	500
08-Jun-23	08:41	09:41	Cloudy	16.0	260	500
08-Jun-23	09:41	10:41	Cloudy	26.0	260	500
08-Jun-23	10:41	11:41	Cloudy	25.0	260	500
14-Jun-23	08:50	09:50	Cloudy	36.0	260	500
14-Jun-23	09:50	10:50	Cloudy	33.0	260	500
14-Jun-23	10:50	11:50	Cloudy	27.0	260	500
20-Jun-23	08:53	09:53	Sunny	32.0	260	500
20-Jun-23	09:53	10:53	Sunny	30.0	260	500
20-Jun-23	10:53	11:53	Sunny	35.0	260	500
26-Jun-23	09:00	10:00	Sunny	30.0	260	500
26-Jun-23	10:00	11:00	Sunny	27.0	260	500
26-Jun-23	11:00	12:00	Sunny	29.0	260	500
30-Jun-23	08:46	09:46	Fine	33.0	260	500
30-Jun-23	09:46	10:46	Fine	31.0	260	500
30-Jun-23	10:46	11:46	Fine	30.0	260	500

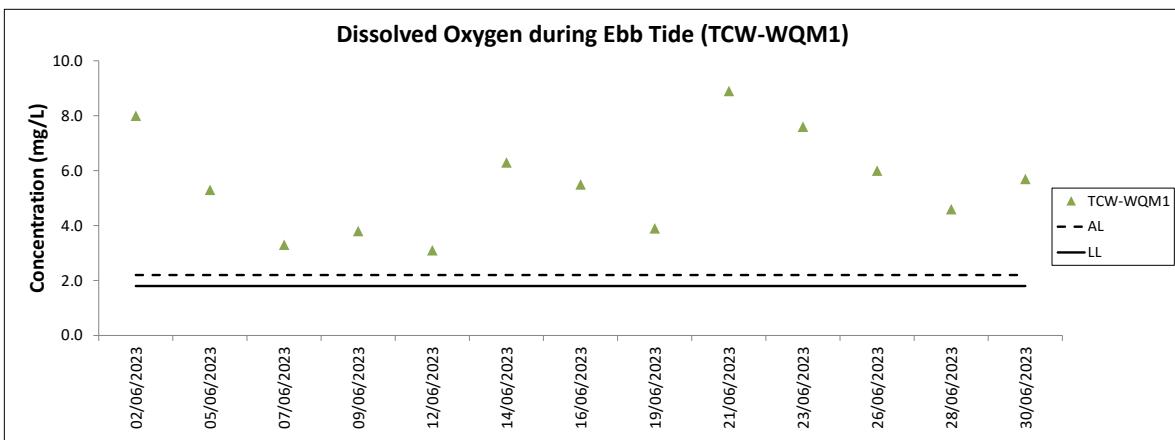
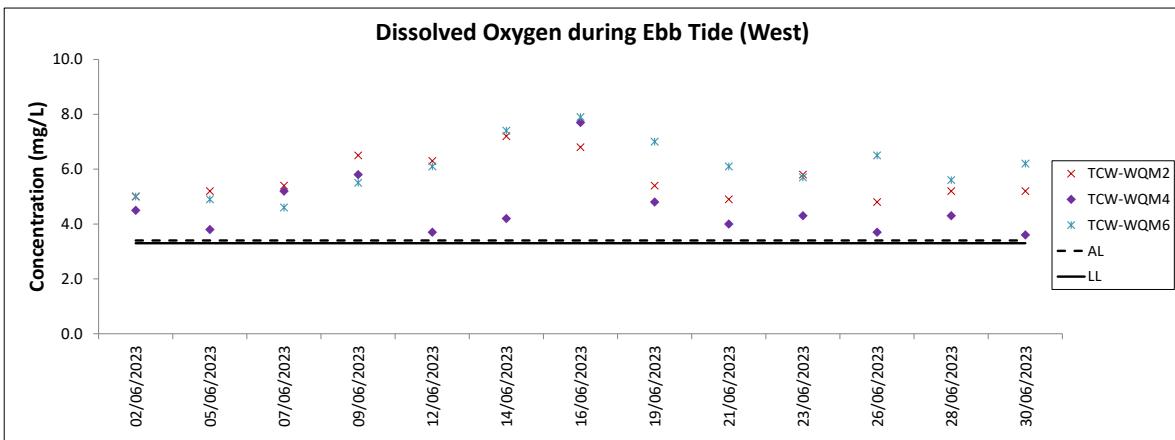
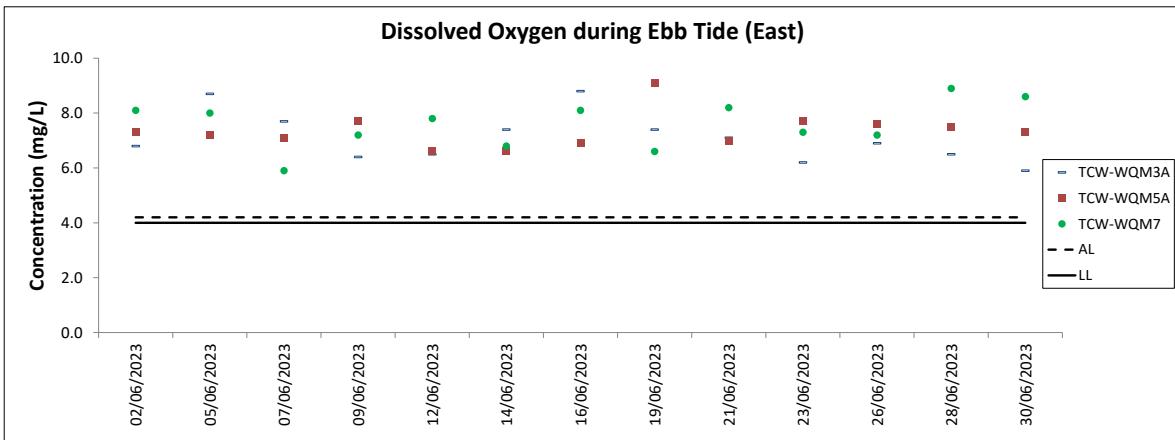
Note: The Action and Limit Level of dissolved oxygen can be referred to Table 4.3 of the monthly EM&A report.  
 Major site activities carried out during the reporting period are summarized in Section 1.4 of the monthly EM&A report.  
 Weather conditions during monitoring are presented in the data tables above.  
 QA/ QC requirements as stipulated in the EM&A Manual were carried out during measurement.

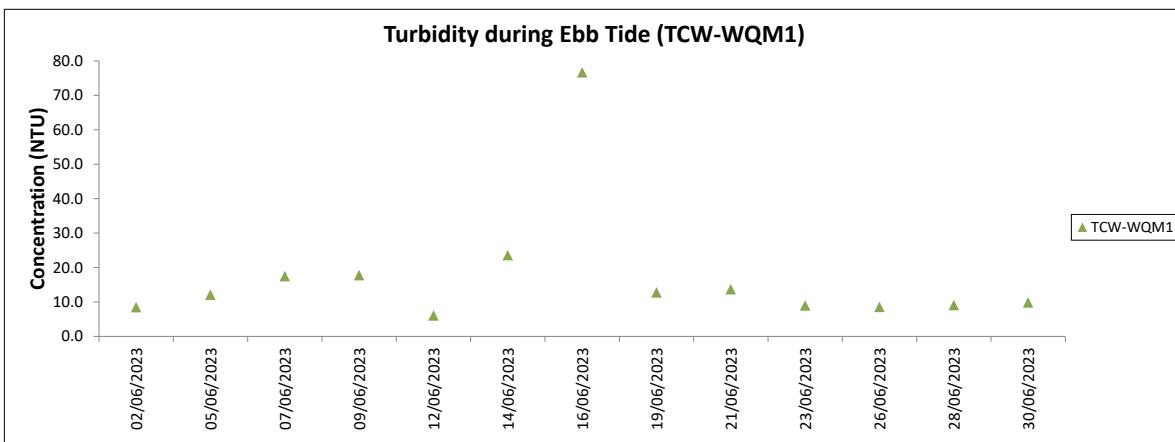
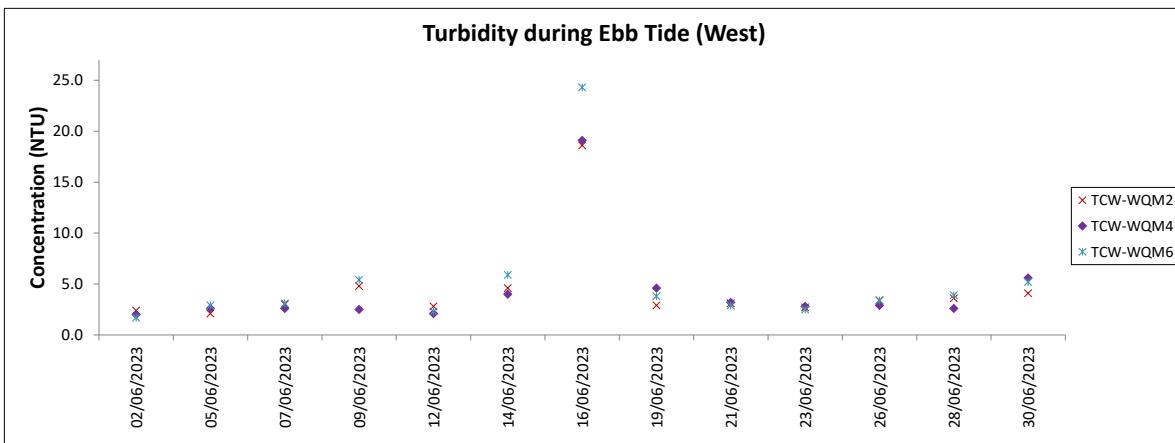
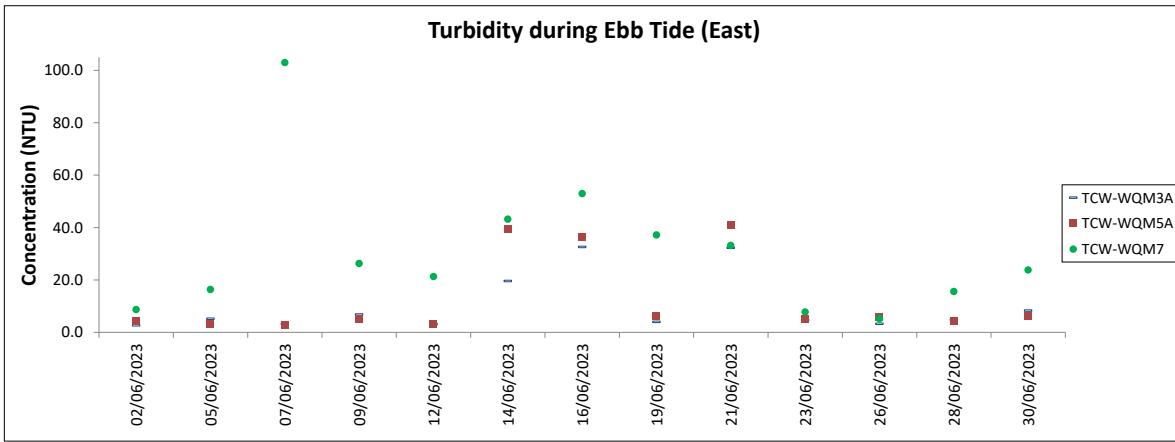
Note: The Action and Limit Level of turbidity can be referred to Table 4.3 of the monthly EM&A report.  
 Major site activities carried out during the reporting period are summarized in Section 1.4 of the monthly EM&A report.  
 Weather conditions during monitoring are presented in the data tables above.  
 QA/ QC requirements as stipulated in the EM&A Manual were carried out during measurement.

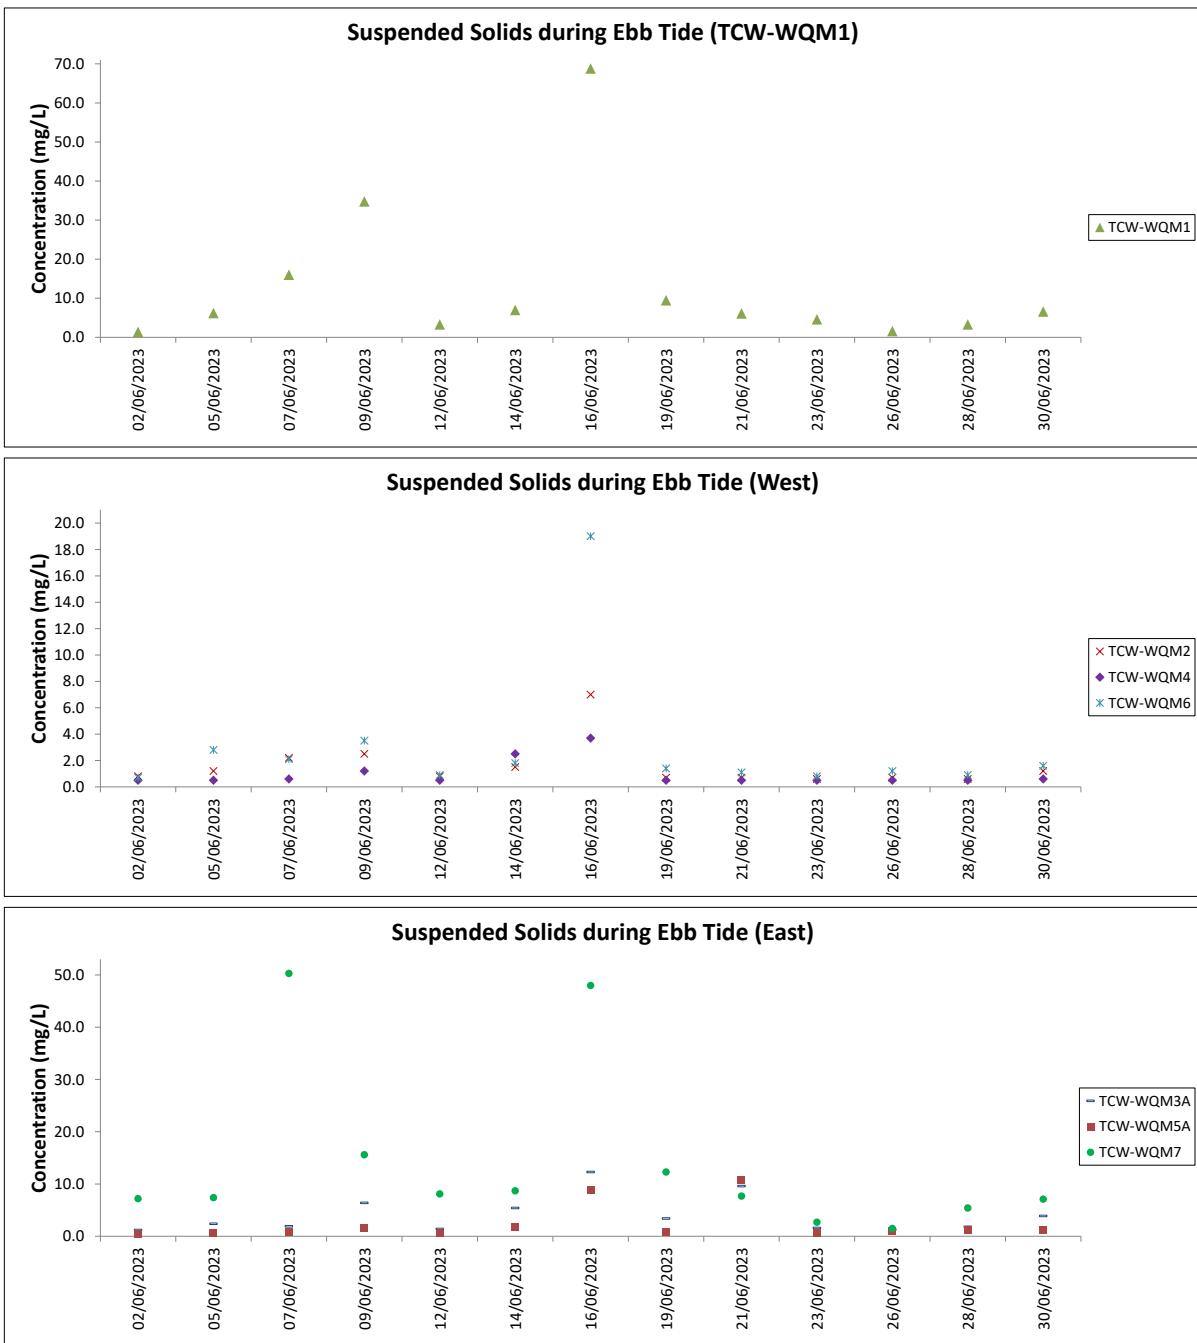
Note: The Action and Limit Level of suspended solids can be referred to Table 4.3 of the monthly EM&A report.  
 Major site activities carried out during the reporting period are summarized in Section 1.4 of the monthly EM&A report.  
 Weather conditions during monitoring are presented in the data tables above.  
 QA/ QC requirements as stipulated in the EM&A Manual were carried out during measurement.

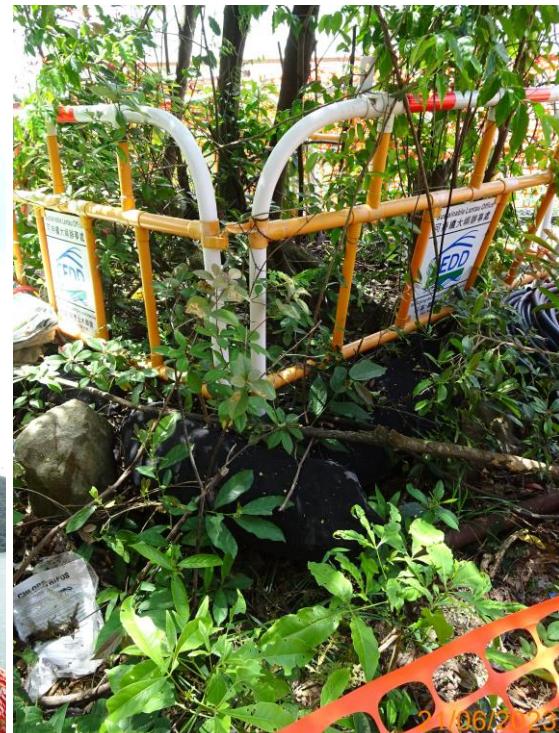
4: T8231\_Silt rock added near trunk base

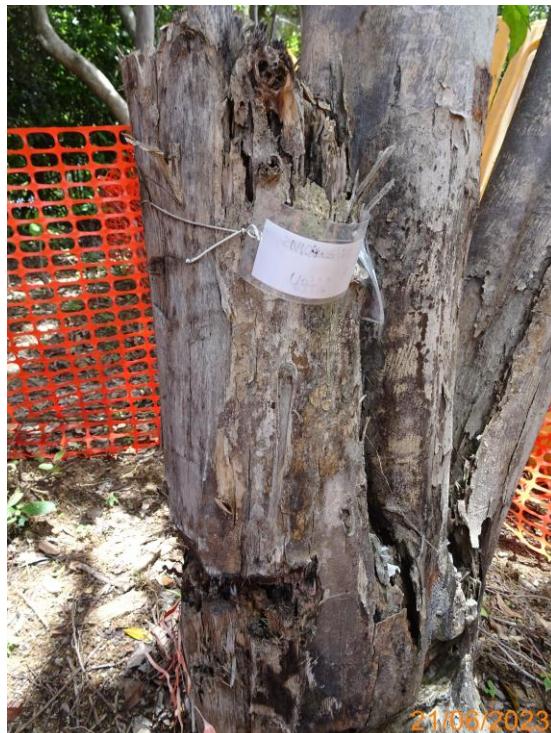
7: U041\_Dead stump

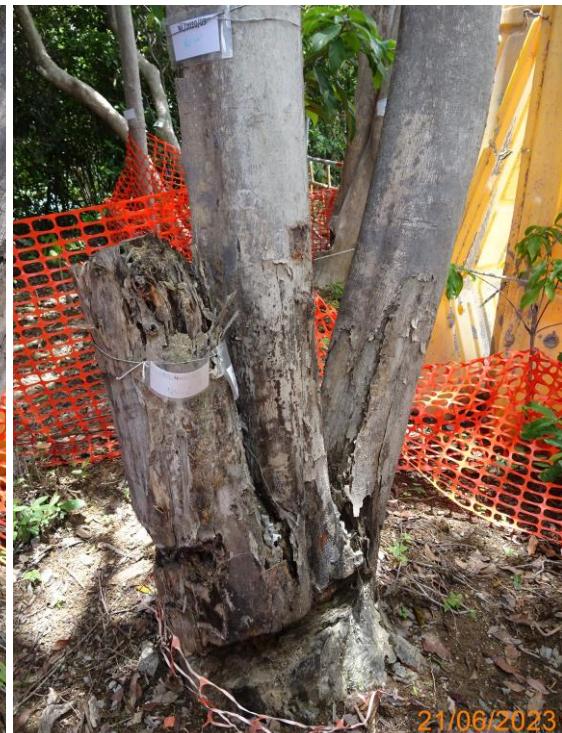
8: U041\_Wood damage at union

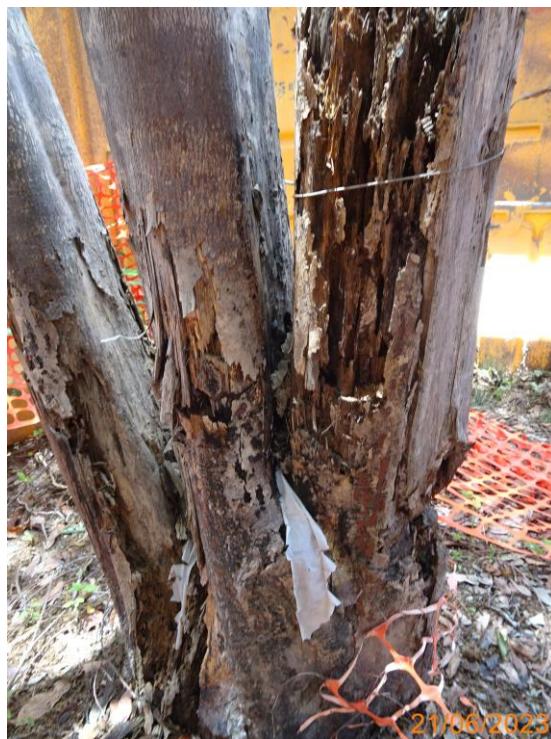
9: U041\_Wood damaged by termite

Monthly monitoring of the *in-situ* preserved plant species of conservation importance by the Qualified Botanist (QB) appointed under Contract 5 and Contract 6 respectively were implemented in the reporting period. Application of termiteicide was carried out at the individual of *Aquilaria sinensis* (Tree No. U041) under Contract 5. No obvious old termite tracks were found at the individual during the reporting period. Bark peeling which was suspected to be caused by heavy rain was recorded at the individual. The condition of the individual would be closely monitored and reviewed by QB. Wound wood development was observed at the individual of *Gmelina chinensis* (Tree No. U042) under Contract 5. Application of insecticide was recommended by QB as preventive measures. Fungal fruiting bodies were found at the individual of *Aquilaria sinensis* (Tree No. U043) under Contract 5 and application of fungicide was recommended by QB. The individual of *Aquilaria sinensis* (Tree No. A8) under Contract 6 which was observed in poor health in previous reporting month was improved in health during the reporting period after fertilization and daily watering.

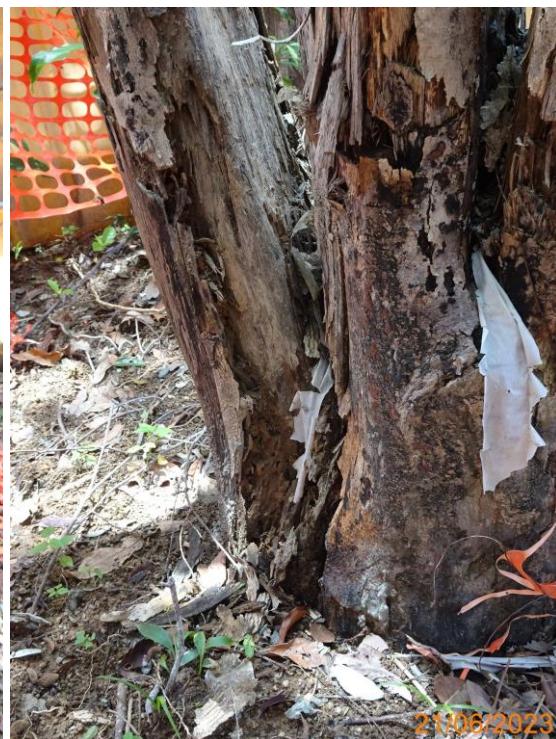
10: U041\_Bark peeling caused by heavy rain

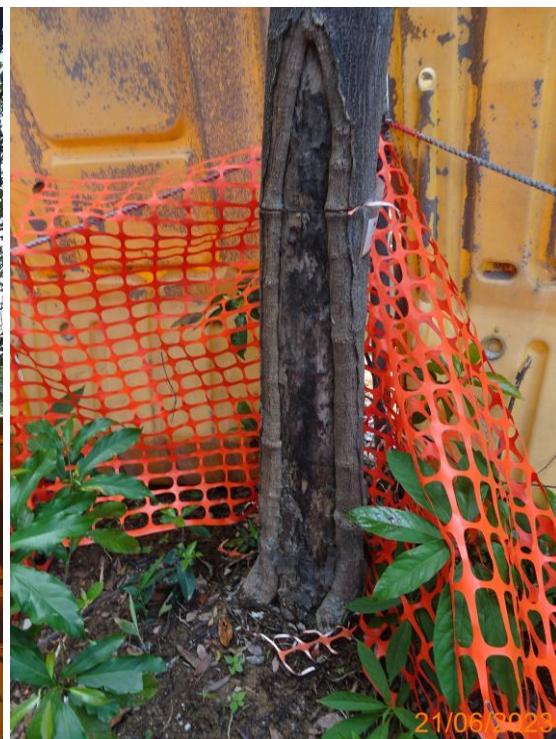
12: U042\_Wound on trunk

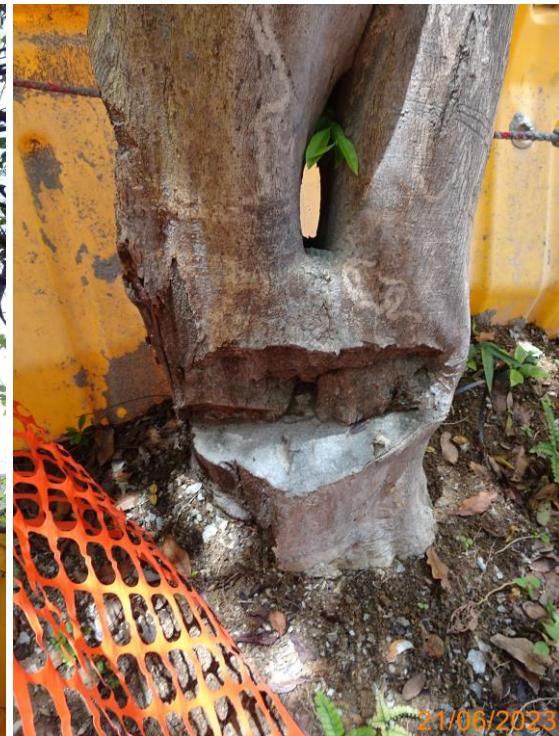
14: U043\_Wound on trunk base#1

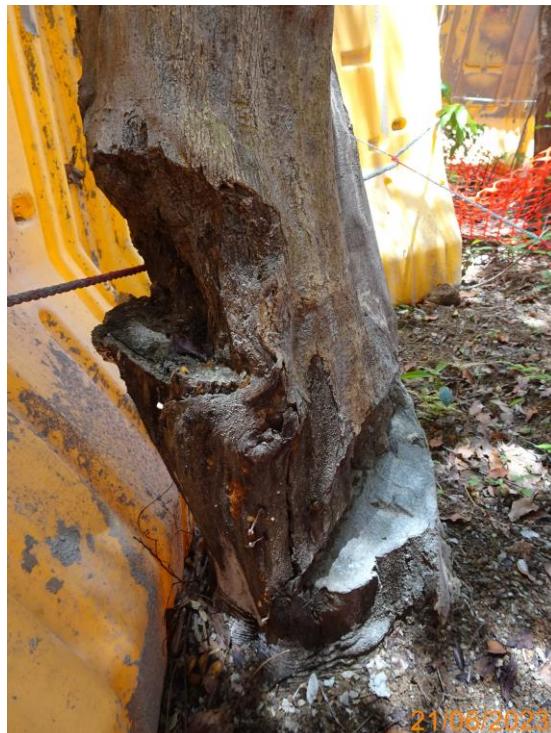
15: U043\_Wound on trunk base#2

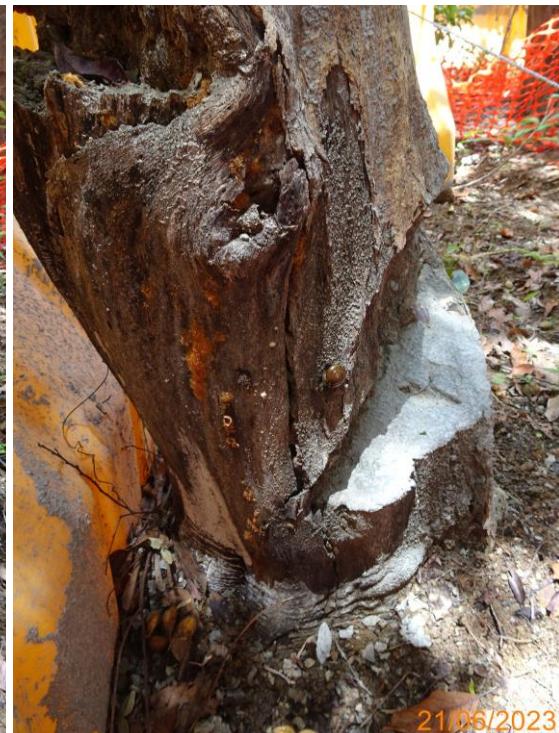
16: Fungal fruiting bodies on trunk base.

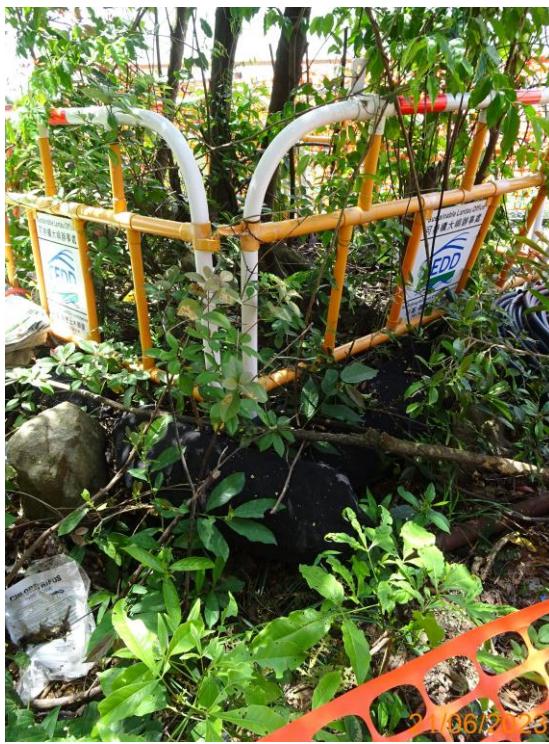
17: Silt rock composed of wood chip was added

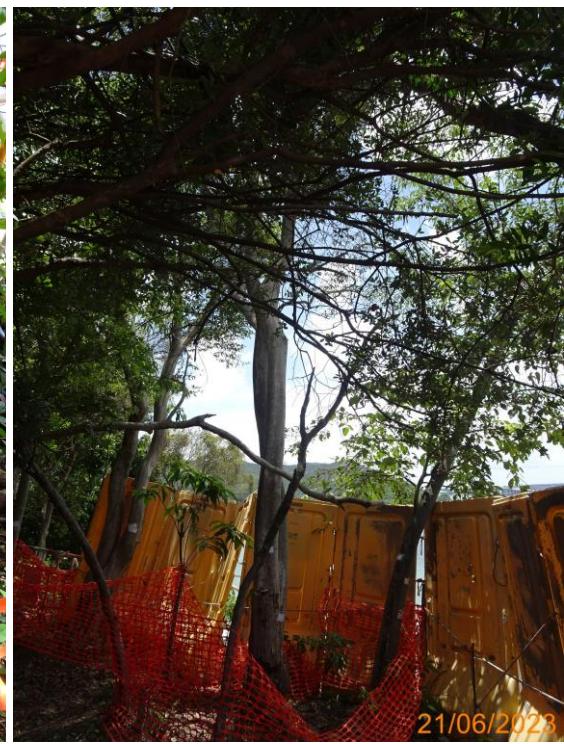
18: Temporary protective fencing for U041, U042 and U043

Tree protection zones for the *in-situ* preserved plant species of conservation importance were demarcated. No injuries and/or damages to the individuals of the *in-situ* preserved plant species of conservation importance were reported by the QB during the reporting period. Photographic record and tree schedule of the preserved plant species of conservation importance monitoring are provided in **Appendix J**.
