Figure 12.14

Sonar Contact D-SC008 in Segment D

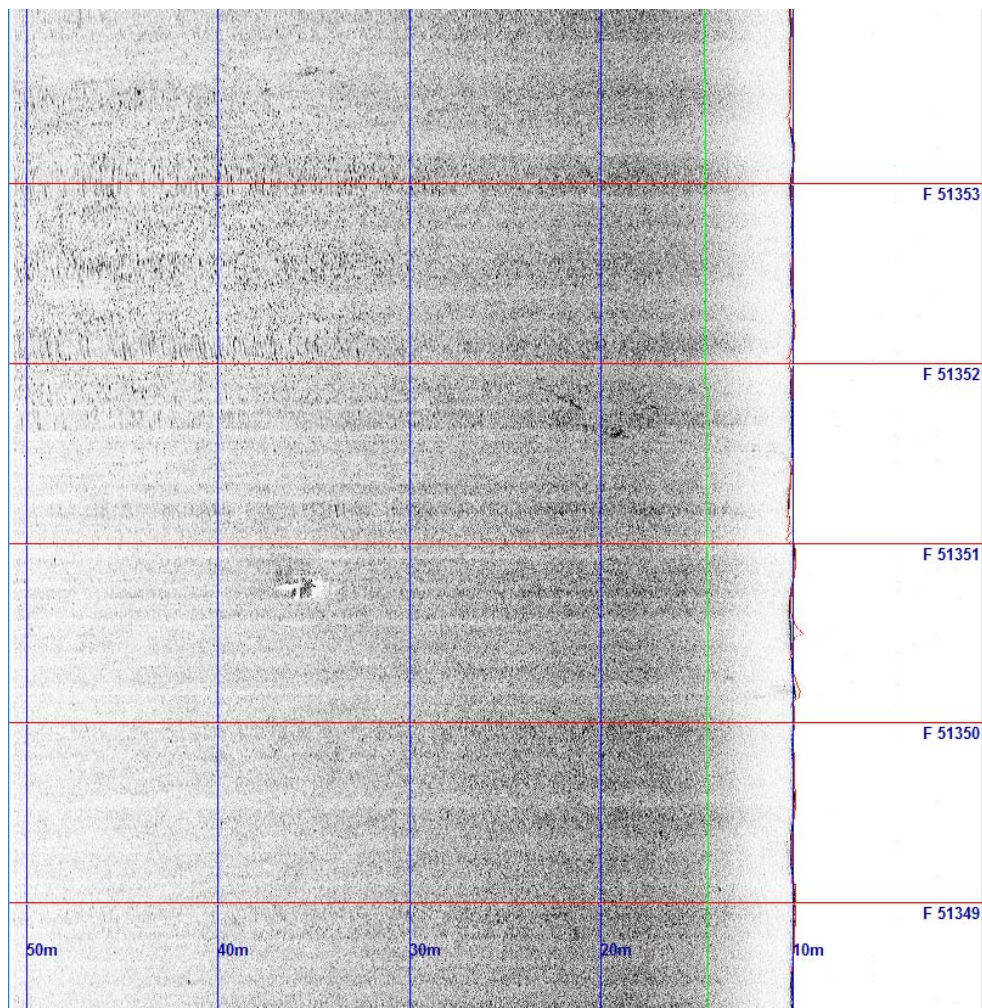
(a) Sonar Contact D-SC008 interpreted as debris, in Segment D

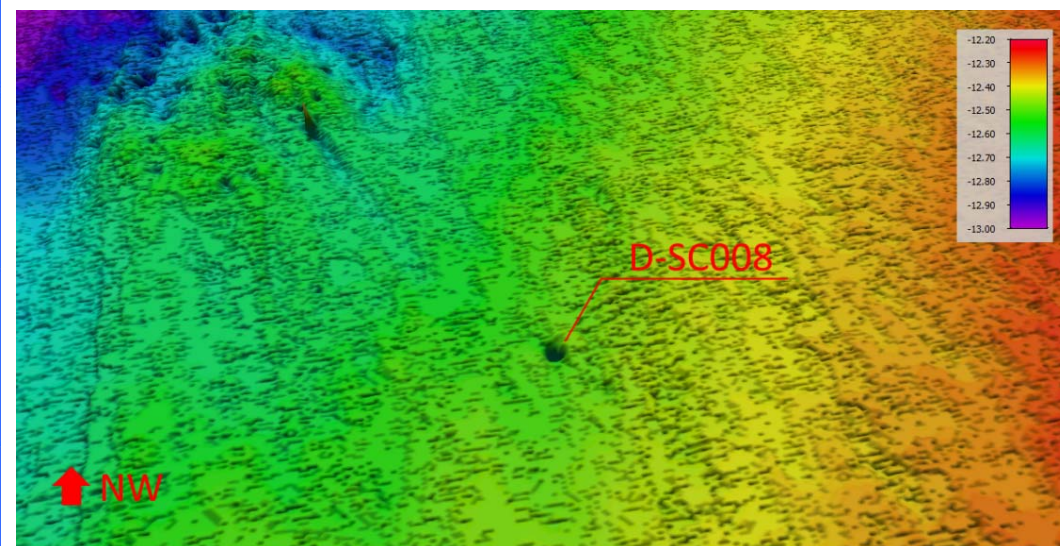
(b) Digital terrain model showing Sonar Contact D-SC008, in Segment D
