**DELIVERY OF RECLAMATION MATERIAL TO  
MAINLAND—  
ENVIRONMENTAL MONITORING AND ADUIT  
(CONTRACT NO.: CV/2005/01)**

**TUEN MUN AREA 38 FILL BANK**

**MONTHLY EM&A REPORT**

**(SEPTEMBER 2008)**

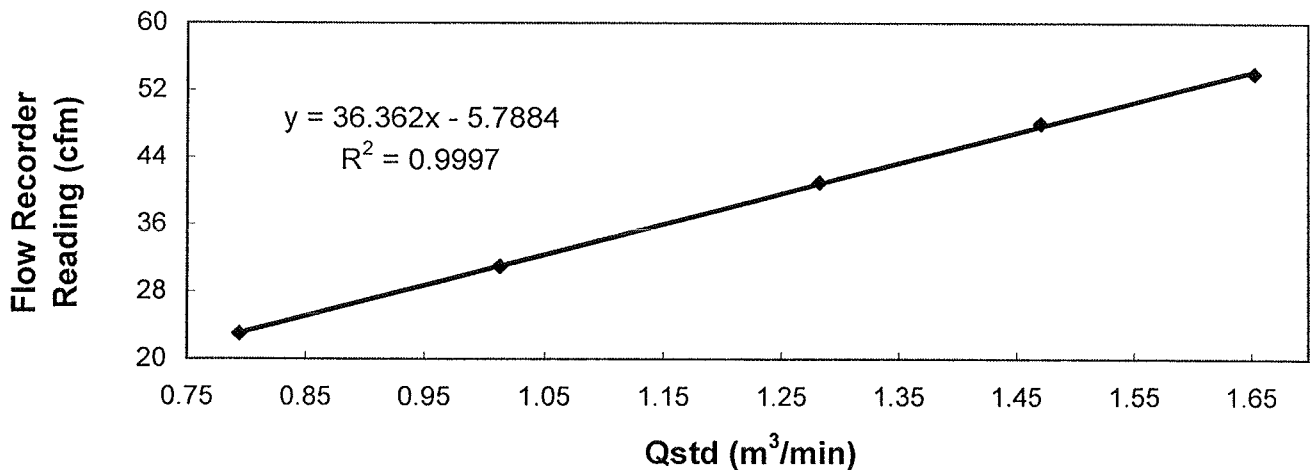
**Sampler 9503 Calibration Curve**  
**Site: Tuen Mun 38 (TM-A1)**  
**Date of Calibration: 10 July 2008**

Flow recorder reading (cfm)	54	48	41	31	23
Qstd (Actual flow rate, m <sup>3</sup> /min)	1.65	1.47	1.28	1.01	0.79
Pressure :	761.31 mm Hg		Temp. :	302 K

Acceptance Criteria : Correlation coefficient (r) of the calibration curve greater than 0.990 after a 5-point calibration

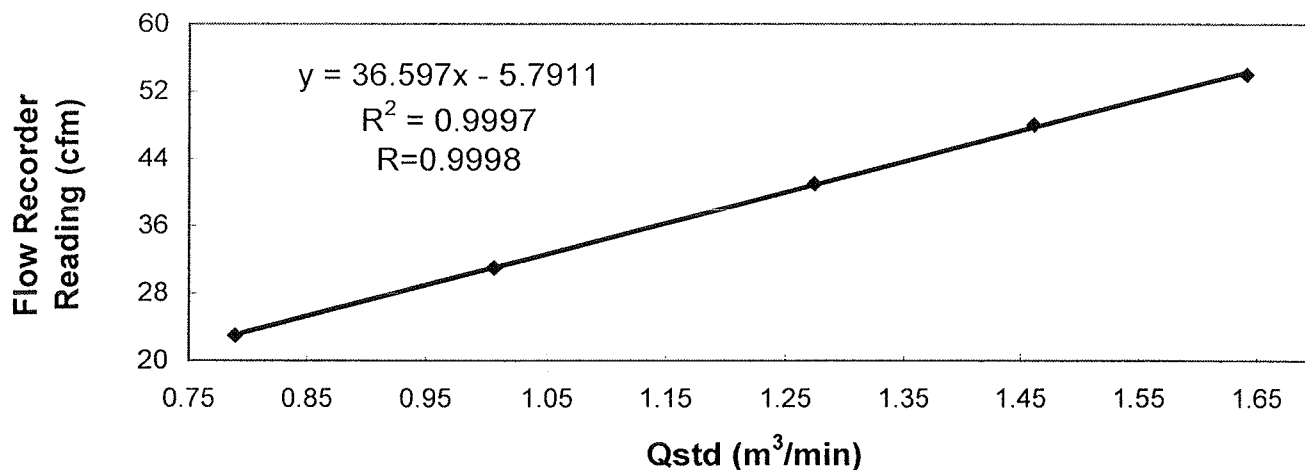
**Sampler 9503 Calibration Curve**  
**Site: Tuen Mun 38 (TM-A1)**  
**Date of Calibration: 11 September 2008**

Flow recorder reading (cfm)	54	48	41	31	23
Qstd (Actual flow rate, m <sup>3</sup> /min)	1.64	1.46	1.27	1.01	0.79
Pressure :	759.06 mm Hg		Temp. :	305 K

Acceptance Criteria : Correlation coefficient (r) of the calibration curve greater than 0.990 after a 5-point calibration

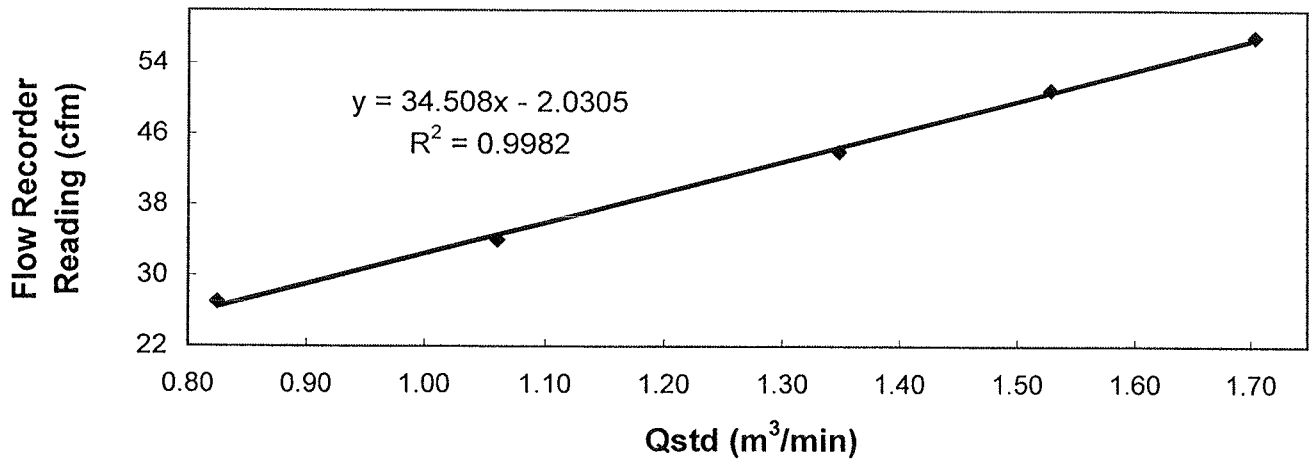
**Sampler 8115 Calibration Curve**  
**Site: Tuen Mun 38 (TM-A2)**  
**Date of Calibration: 10 July 2008**

Flow recorder reading (cfm)	57	51	44	34	27
Qstd (Actual flow rate, m <sup>3</sup> /min)	1.70	1.53	1.35	1.06	0.82
Pressure :	761.31 mm Hg			Temp. :	302 K

Acceptance Criteria : Correlation coefficient (r) of the calibration curve greater than 0.990 after a 5-point calibration

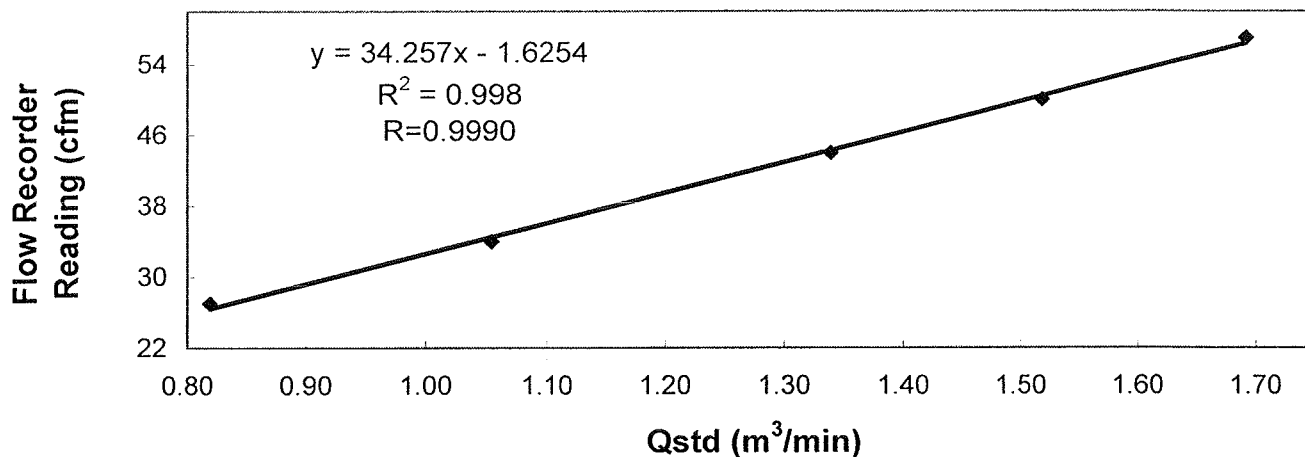
Site: Tuen Mun 38 (TM-A2)

Date of Calibration: 11 September 2008

Acceptance Criteria : Correlation coefficient (r) of the calibration curve greater than 0.990 after a 5-point calibration

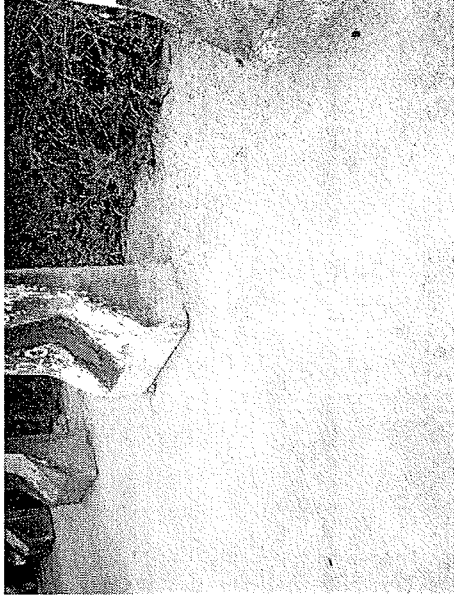
Photo 080923\_009

6	Follow up action to the previous site inspection item 10 on 09/09/08 and item 5 on 16/09/08, the 200L chemical container at the chemical waste storage area was still found without chemical label. The Contractor was reminded to provide appropriate chemical labels for all chemical containers.	080923_006	Yes
7	Oil stains were noted on the ground at workshop. The Contractor was reminded to clean up and treat the stains as chemical waste.	080923_007	Yes
8	Follow up action to the previous site inspection item 7 on 16/09/08, no stagnant water was noted in the main drainage channel.	080923_008	No
9	Follow up action to the previous site inspection item 10 on 16/09/08, no stagnant water with moss was noted on the ground at dump truck parking area.	080923_009	No
