ATAL-DEGREMONT-CHINA HARBOUR JOINT VENTURE

CONTRACT NO. DC/2013/10 - DESIGN, BUILD AND OPERATE SAN WAI SEWAGE TREATMENT WORKS – PHASE 1

> MONTHLY EM&A REPORT NO. 11

(01 MARCH - 31 MARCH 2018)

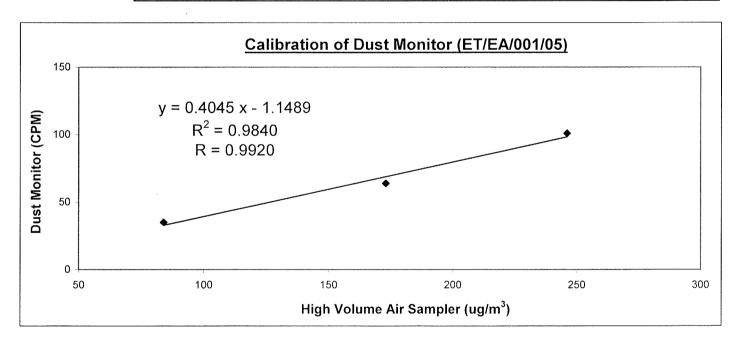
Dust Monitor (CPM)	35	64	101	
High Volume Air Sampler (ug/m³)	84	173	246	
High Volume Air Sampler Serail No.: 1177	Calibration Due Date: 13 December 201

Correlation coefficient (r) of the calibration curve greater than 0.990

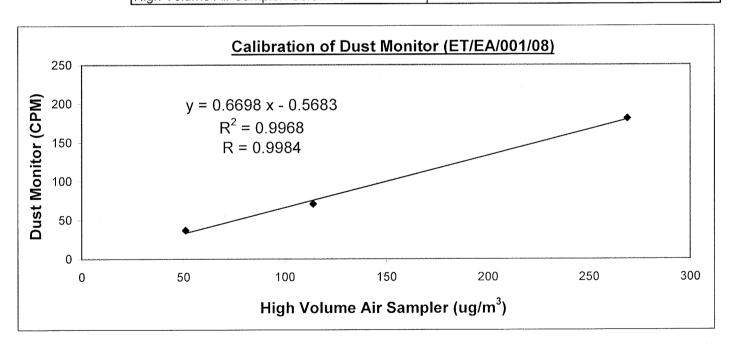
Dust Monitor (CPM)	37	71	181
High Volume Air Sampler (ug/m³)	51	114	269
High Volume Air Sampler Serail No.:11	77 Calibratio	on Due Date: 14 Oc	tober 2017

Correlation coefficient (r) of the calibration curve greater than 0.990

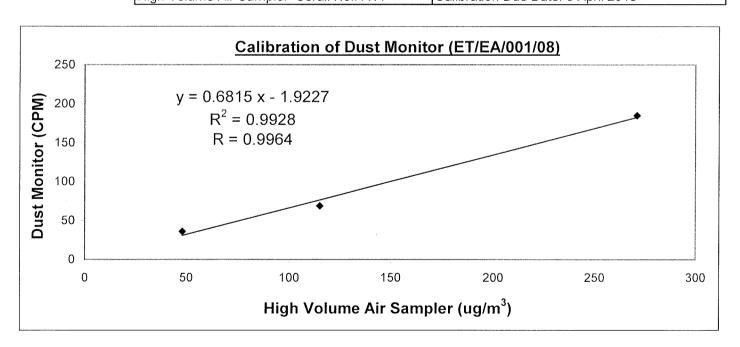
Dust Monitor (CPM)	36	69	185
High Volume Air Sampler (ug/m³)	48	115	271
High Volume Air Sampler, Serail No.:1:	177 Calibratio	on Due Date: 8 Anri	1 2018

Correlation coefficient (r) of the calibration curve greater than 0.990

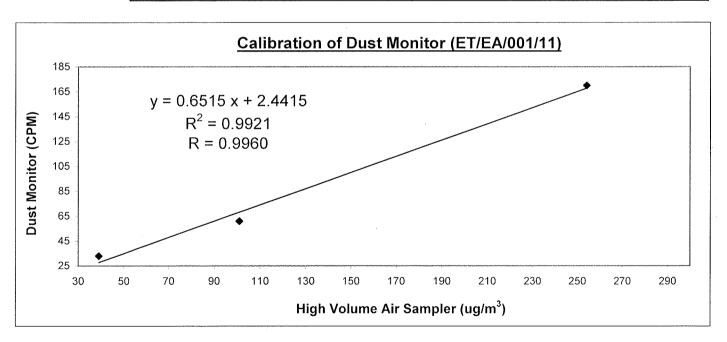
Dust Monitor (CPM)	33	61	170					
High Volume Air Sampler (ug/m³)	39	101	254					
High Volume Air Sampler Serail No :1177	Calibratio	Calibration Due Date: 13 December 2017

Correlation coefficient (r) of the calibration curve greater than 0.990 after a three-point

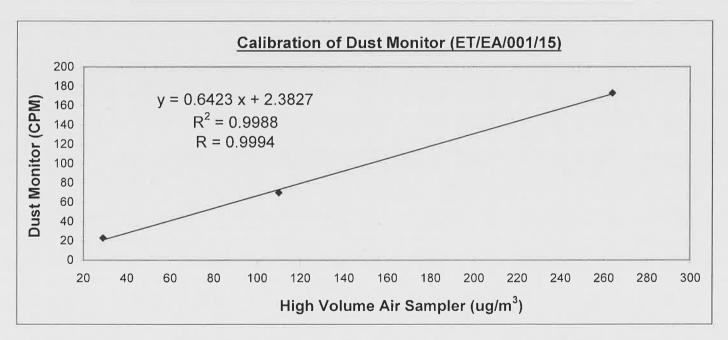
Dust Monitor (CPM)	23	70	173				
High Volume Air Sampler (ug/m³)	29	110	264				
High Volume Air Sampler Serail No : 1177	Calibration	Calibration Due Date: 11 February 2018

Correlation coefficient (r) of the calibration curve greater than 0.990 after a three-point

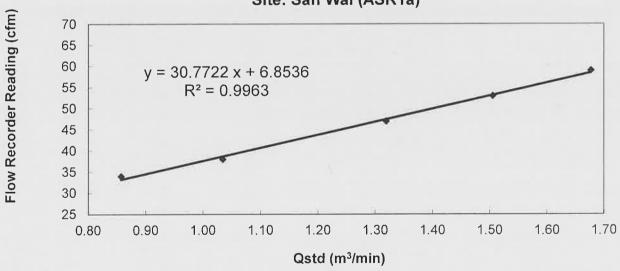
Sampler 1934 Calibration Curve Site: San Wai (ASR1a)

Flow recorder reading (c	fm)		59	53	47	38	34
Qstd (Actual flow rate, m	n³/min)		1.68	1.51	1.32	1.03	0.86
Pressure :	765.06	mm	Hg	Temp.:		288	K

Acceptance Criteria: Correlation coefficient (r) of the calibration curve greater than 0.990 after a 5-point calibration.

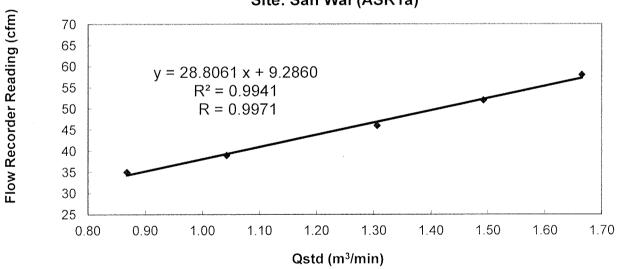
Sampler 1934 Calibration Curve Site: San Wai (ASR1a)

Flow recorder reading (cfm)		58	52	46	39	35
Qstd (Actual flow rate, r	m³/min)		1.66	1.49	1.31	1.04	0.87
Pressure :	765.06	mm	Hg	Temp. :		290	K

Acceptance Criteria: Correlation coefficient (r) of the calibration curve greater than 0.990 after a 5-point calibration.

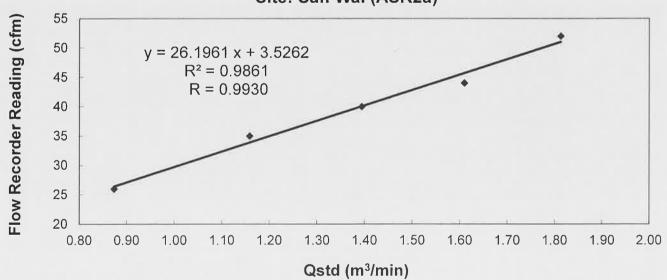
Sampler 9998 Calibration Curve Site: San Wai (ASR2a)

Flow recorder	reading (cfm)	52	44	40	35	26
Qstd (Actual fl	ow rate, m³/min)	1.81	1.61	1.39	1.16	0.87
Pressure	769.56 mm Hg		Temp.:	288	K

Acceptance Criteria: Correlation coefficient (r) of the calibration curve greater than 0.990 after a 5-point calibration.

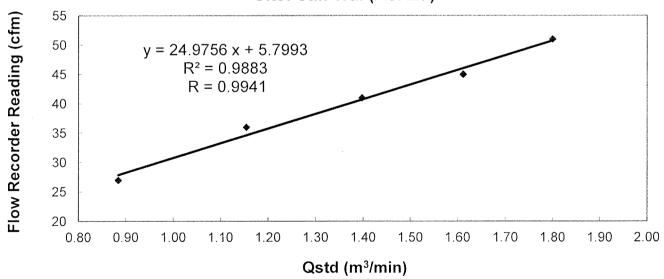
Sampler 9998 Calibration Curve Site: San Wai (ASR2a)

Flow recorder	reading (cfm)	51	45	41	36	27
Qstd (Actual fl	ow rate, m³/min)	1.80	1.61	1.40	1.15	0.88
Pressure :	769.56 mm Hg		Temp.:	290	K

Acceptance Criteria: Correlation coefficient (r) of the calibration curve greater than 0.990 after a 5-point calibration.

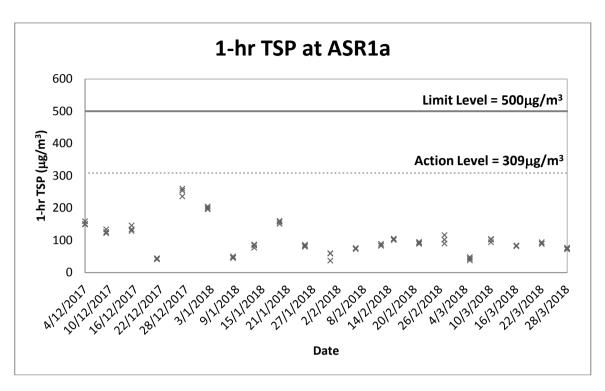
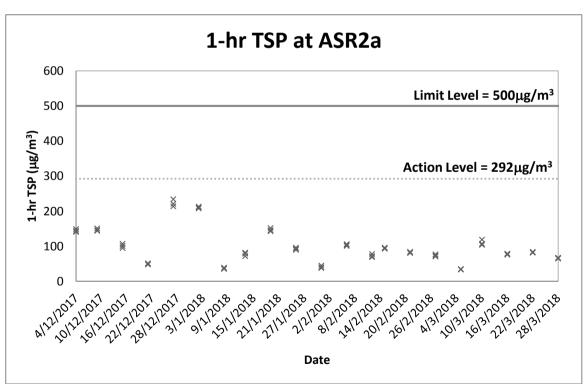
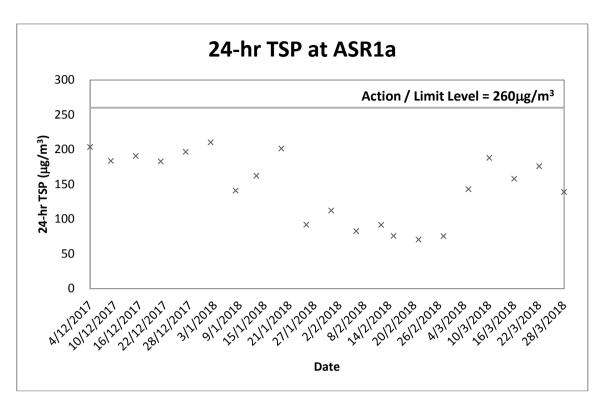
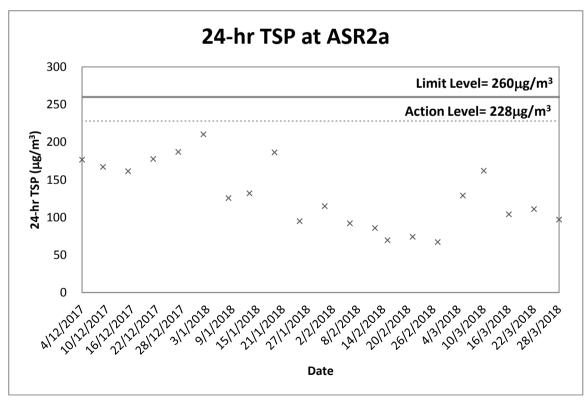
Graphical Plots of Impact Air Quality Monitoring Results

Generally, 1-hour TSP and 24-hour TSP monitoring results fluctuated well below the Action Level in this reporting period. The major dust source observed near the monitoring stations was mainly from vehicles passing by the container yards and general earth works. It can be concluded that the contractor implemented sufficient dust mitigation measures during this reporting month.

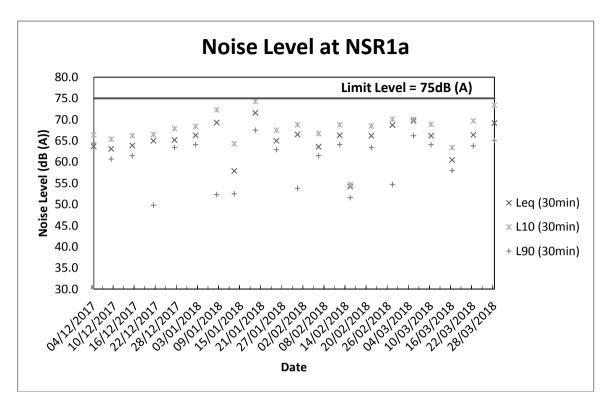
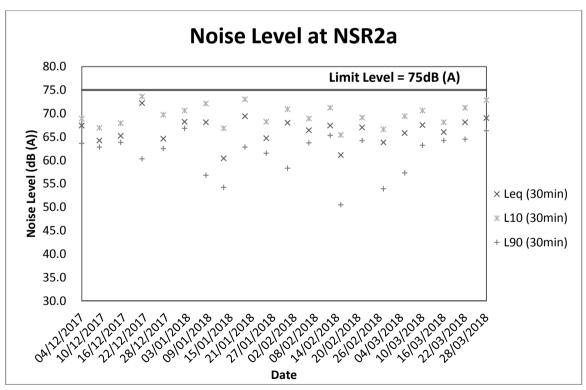
Graphical Plots of Impact Noise Monitoring Data

The noise monitoring data were found to be lower than the limit level. The major noise source during the monitoring event was the vehicles passing through the container yard entrance and the general earth works inside the construction site.

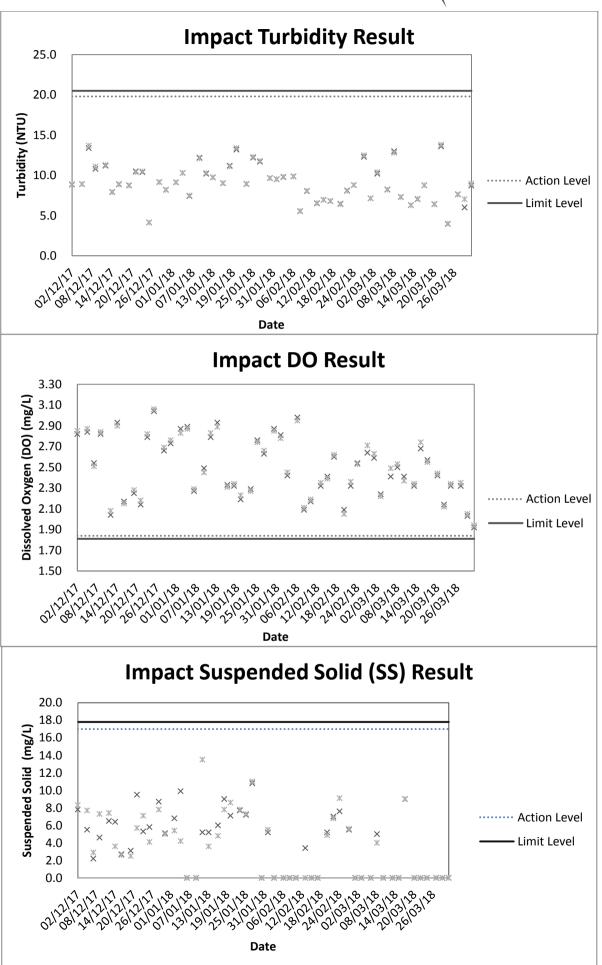
Graphical Plots of Impact Water Quality Monitoring Data

Generally, the turbidity and suspended solids were found to be lower than the action level. Besides, all results of dissolved oxygen measured in this reporting month were higher than the action level.

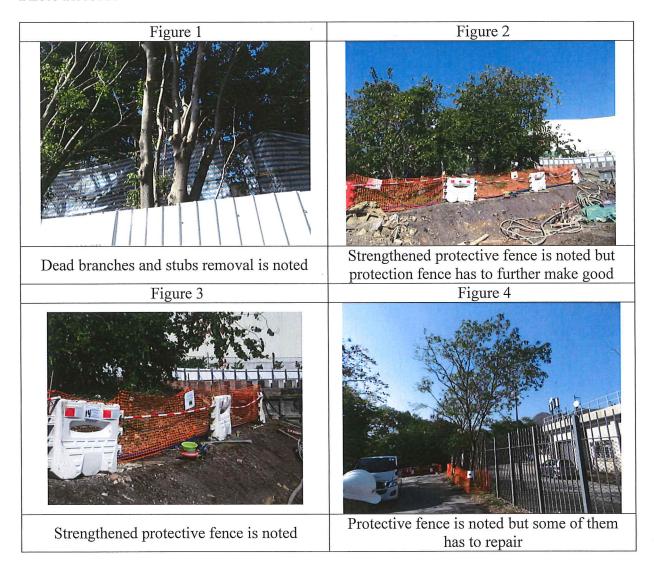
Photo Record:

1. Contractor was reminded to provide TPZ with robust fence at the dripline of all retained trees until the trees are well beyond the extend of construction activities.

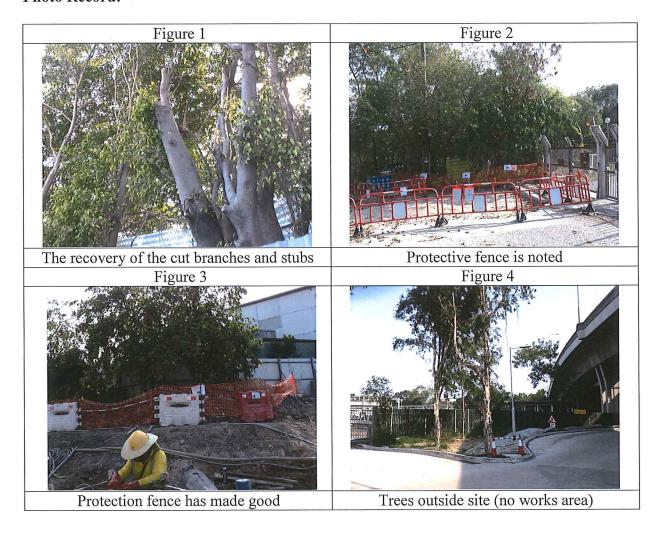
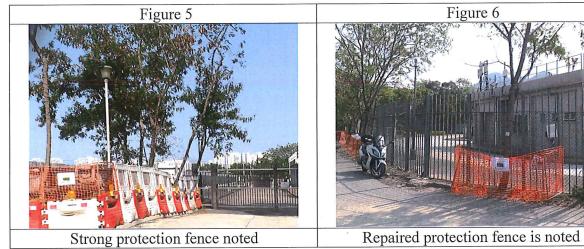
Photo Record:

1. Contractor was reminded to provide TPZ with robust fence at the dripline of all retained trees unless the trees are well beyond the extent of construction activities.

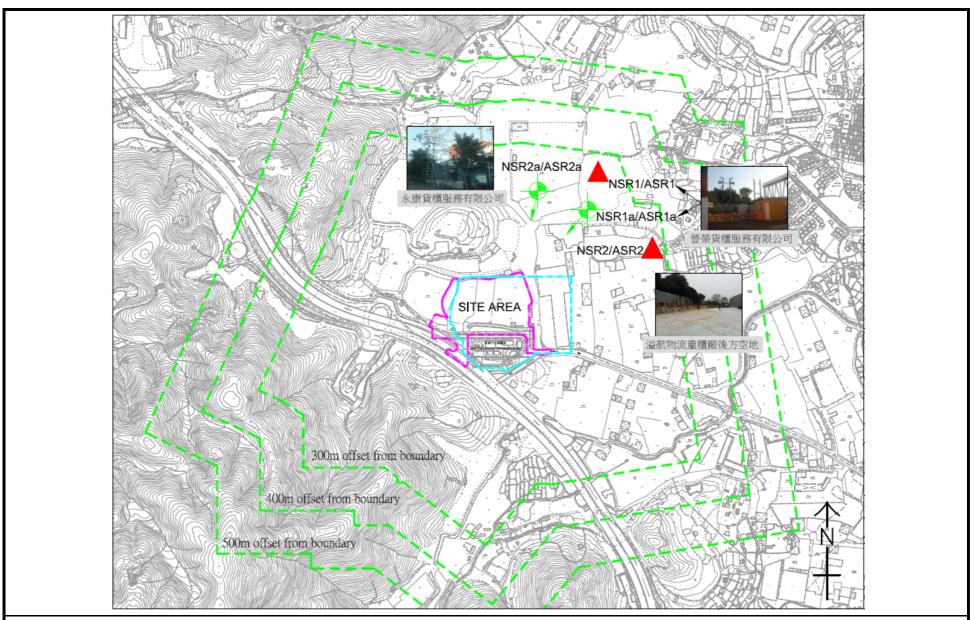
Project: Contract No. DC/2013/10 -Design, Build and Operate San Wai Sewage Treatment Works – Phase 1 Figure 1 Locations of Air Quality and Noise Monitoring Stations

Locations of Air Quality and Noise Monitoring Stations

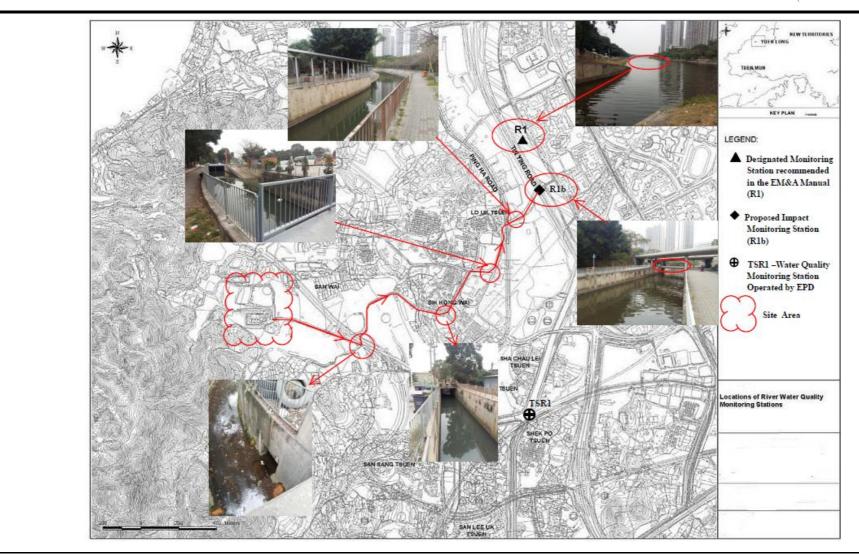
Project: Contract No. DC/2013/10 - Design, Build and Operate San Wai Sewage Treatment Works - Phase 1 Figure 2 Locations of Water Quality Monitoring Station

Figure 2 Locations of Water Quality Monitoring Station
