ATAL-DEGREMONT-CHINA HARBOUR JOINT VENTURE

CONTRACT NO. DC/2013/10 - DESIGN, BUILD AND OPERATE SAN WAI SEWAGE TREATMENT WORKS -PHASE 1

> MONTHLY EM&A REPORT NO. 15

(01 JULY - 31 JULY 2018)

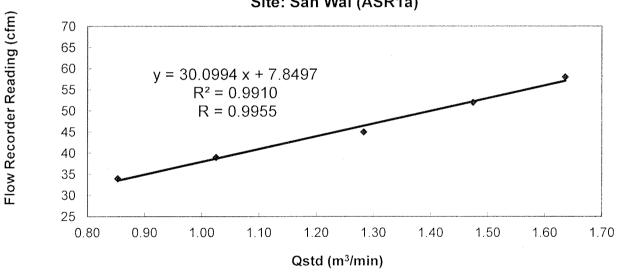
Sampler 1934 Calibration Curve Site: San Wai (ASR1a)

Flow recorder reading	ı (cfm)		58	52	45	39	34
Qstd (Actual flow rate	, m³/min)		1.64	1.47	1.28	1.02	0.85
Pressure :	759.06	mm	Hg	Temp.:		298	K

Acceptance Criteria: Correlation coefficient (r) of the calibration curve greater than 0.990 after a 5-point calibration.

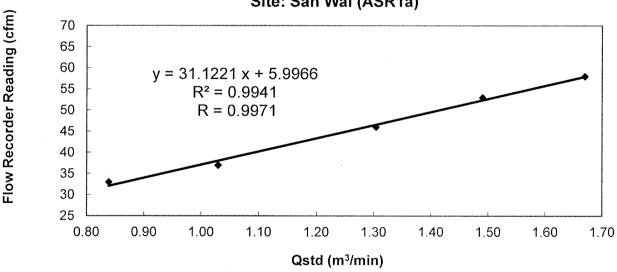
Sampler 1934 Calibration Curve Site: San Wai (ASR1a)

Flow recorder reading	58	53	46	37	33		
Qstd (Actual flow rate	, m³/min)		1.67	1.49	1.30	1.03	0.84
Pressure :	757.56	mm	Hg	Temp. :		305	K

Acceptance Criteria: Correlation coefficient (r) of the calibration curve greater than 0.990 after a 5-point calibration.

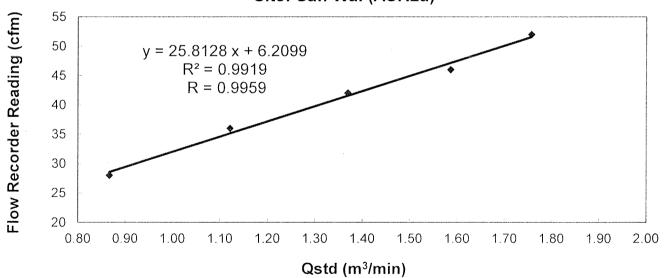
Sampler 9998 Calibration Curve Site: San Wai (ASR2a)

Flow recorder	reading (cfm)	52	46	42	36	28
Qstd (Actual fle	1.76	1.59	1.37	1.12	0.87	
Pressure :			Temp.:	298	K

Acceptance Criteria: Correlation coefficient (r) of the calibration curve greater than 0.990 after a 5-point calibration.

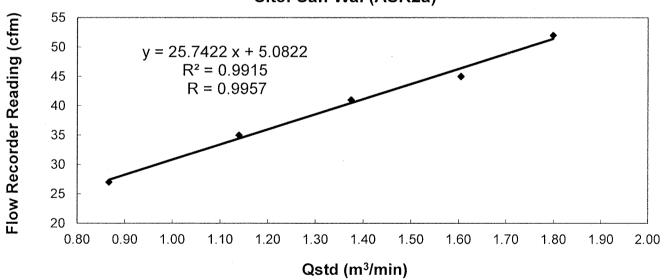
Sampler 9998 Calibration Curve Site: San Wai (ASR2a)

Flow recorder	reading (cfm)	52	45	41	35	27
Qstd (Actual fle	ow rate, m³/min)	1.80	1.60	1.37	1.14	0.87
Pressure :	757.56 mm Hg		Temp.:	305	K

Acceptance Criteria: Correlation coefficient (r) of the calibration curve greater than 0.990 after a 5-point calibration.

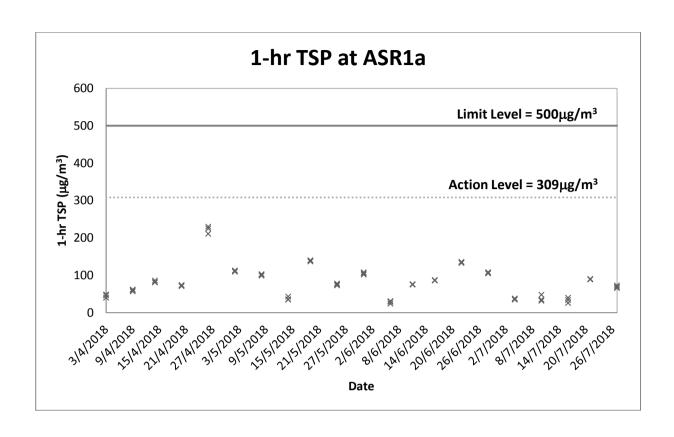
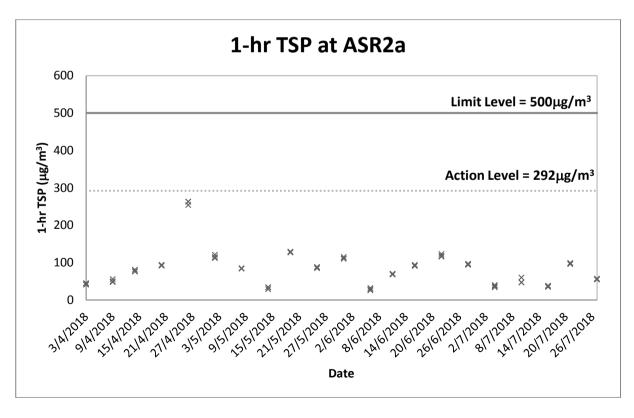
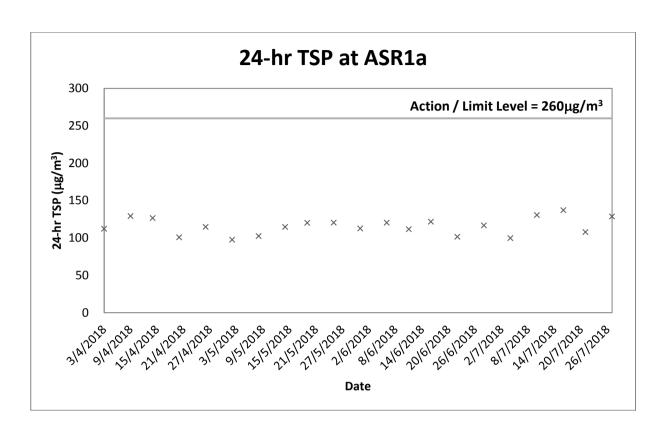
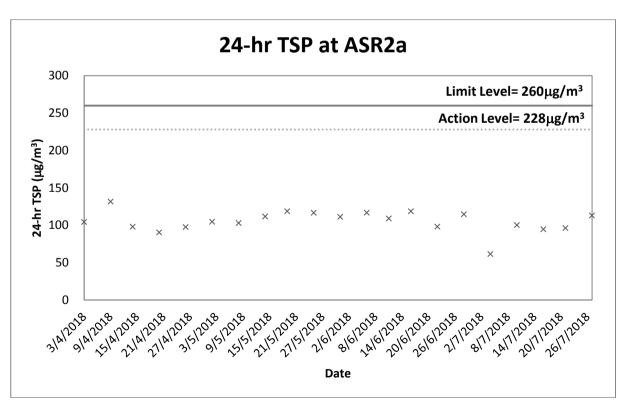
Graphical Plots of Impact Air Quality Monitoring Results

Generally, 1-hour TSP and 24-hour TSP monitoring results fluctuated well below the Action Level in this reporting period. The major dust source observed near the monitoring stations was mainly from vehicles passing by the container yards and general earth works. It can be concluded that the contractor implemented sufficient dust mitigation measures during this reporting month.

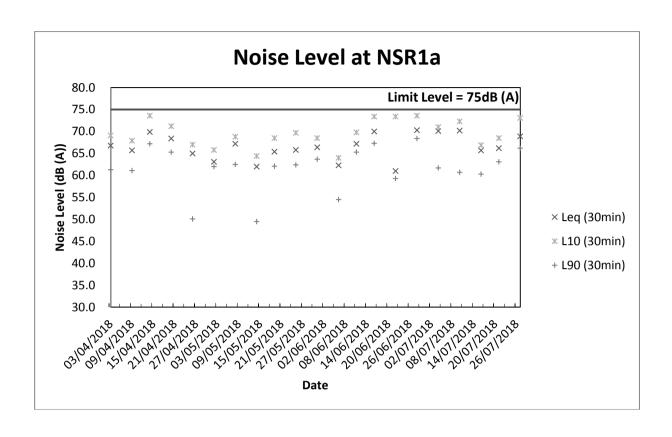
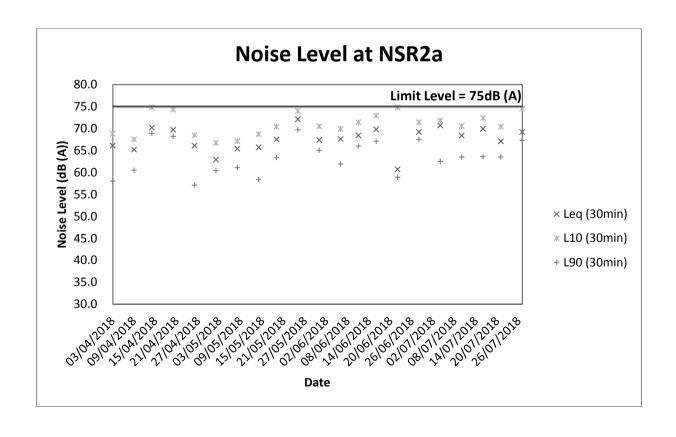
Graphical Plots of Impact Noise Monitoring Data

The noise monitoring data were found to be lower than the limit level. The major noise source during the monitoring event was the vehicles passing through the container yard entrance and the general earth works inside the construction site.

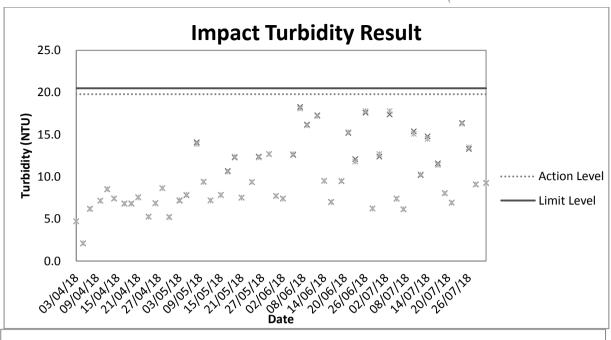
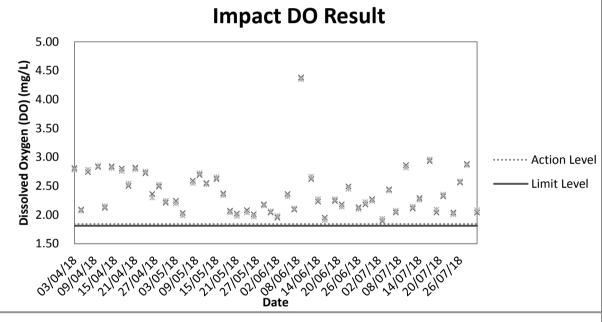
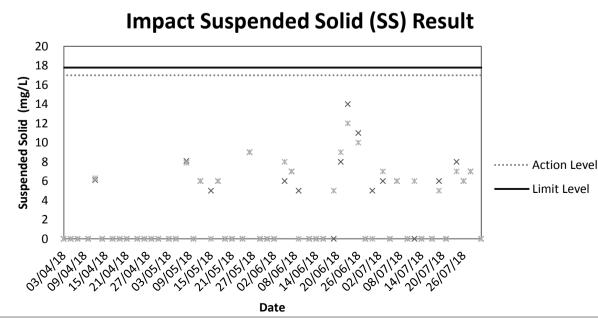
Graphical Plots of Impact Water Quality Monitoring Data

Generally, the turbidity and suspended solids were found to be lower than the action level. Besides, all results of dissolved oxygen measured in this reporting month were higher than the action level.

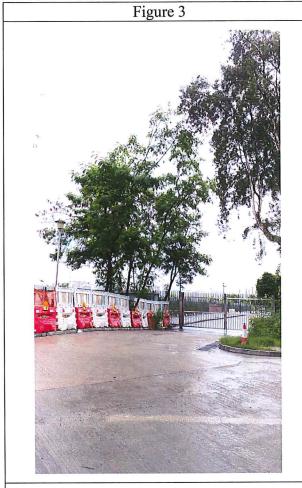
Figure 4

Condition of trace at the entrance of the

Trees inside robust TPZ

1. Contractor was reminded to provide TPZ with robust fence, whenever possible, at the drip line of all retained trees unless the trees are well beyond the extend of construction activities.

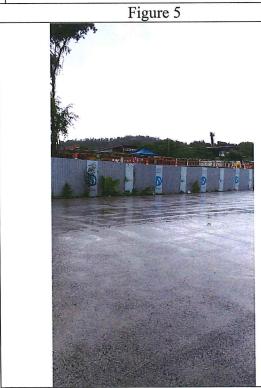
Some of the trees were removed at eastern boundary

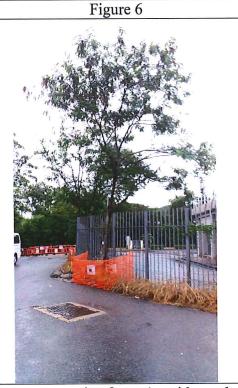
Proper protective fence (outside works extent) is noted

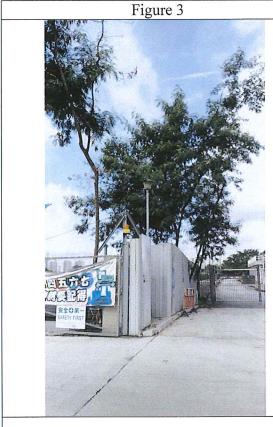
Trees inside robust TPZ

1. Contractor was reminded to provide TPZ with robust fence, whenever possible, at the drip line of all retained trees unless the trees are well beyond the extend of construction activities.

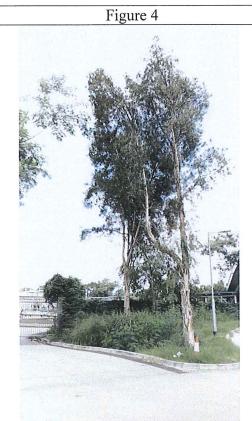
Condition of trees at the entrance of the existing treatment plant

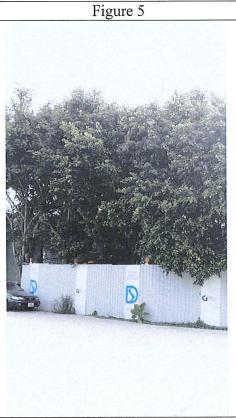
General condition of the remaining existing trees at eastern boundary

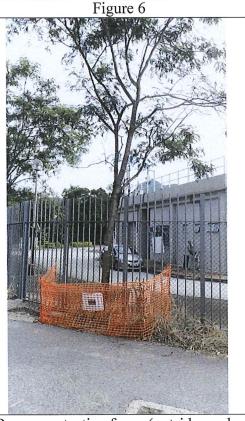
Proper protective fence (outside works extent) is noted. Weeding is required to be carried out.
