# ATAL-DEGREMONT-CHINA HARBOUR JOINT VENTURE

CONTRACT NO. DC/2013/10 - DESIGN, BUILD AND OPERATE SAN WAI SEWAGE TREATMENT WORKS -PHASE 1

> MONTHLY EM&A REPORT NO. 17

(01 SEPTEMBER - 30 SEPTEMBER 2018)

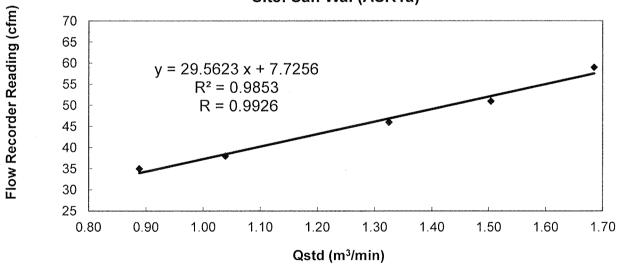
#### Sampler 1934 Calibration Curve Site: San Wai (ASR1a)

Flow recorder reading	g (cfm)		59	51	46	38	35
Qstd (Actual flow rate	e, m³/min)		1.68	1.50	1.32	1.04	0.89
Pressure :	759.06	mm	Hg	Temp.:		300	K

Acceptance Criteria: Correlation coefficient (r) of the calibration curve greater than 0.990 after a 5-point calibration.

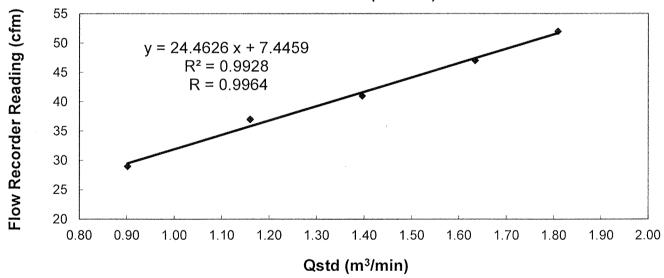
#### Sampler 9998 Calibration Curve Site: San Wai (ASR2a)

Flow recorder	reading (cfm)	52	47	41	37	29
Qstd (Actual fl	1.81	1.63	1.40	1.16	0.90	
Pressure :	759.06 mm Hg		Temp.:	300	K

Acceptance Criteria: Correlation coefficient (r) of the calibration curve greater than 0.990 after a 5-point calibration.

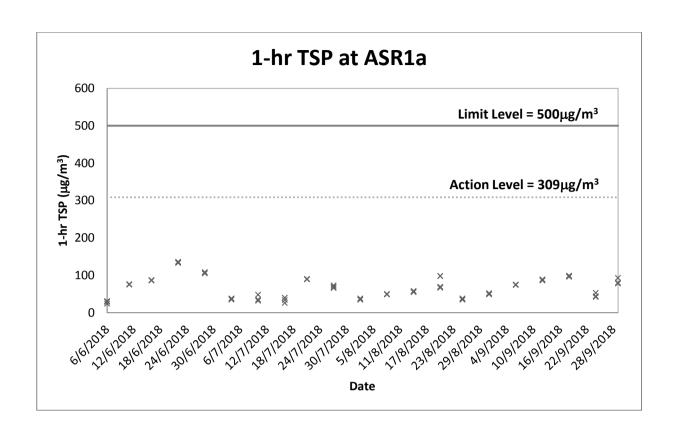
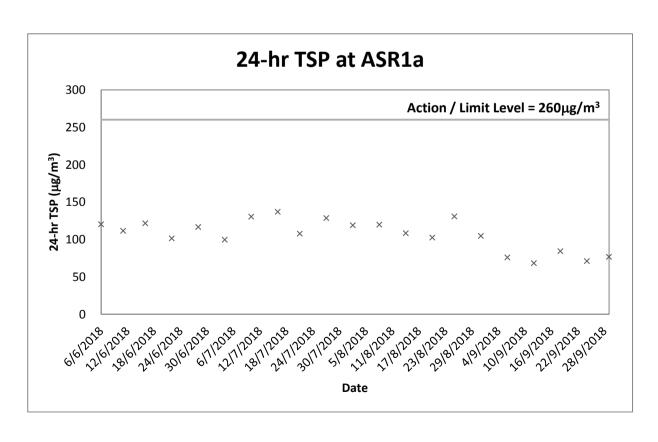
**Graphical Plots of Impact Air Quality Monitoring Results**

Generally, 1-hour TSP and 24-hour TSP monitoring results fluctuated well below the Action Level in this reporting period. The major dust source observed near the monitoring stations was mainly from vehicles passing by the container yards and general earth works. It can be concluded that the contractor implemented sufficient dust mitigation measures during this reporting month.

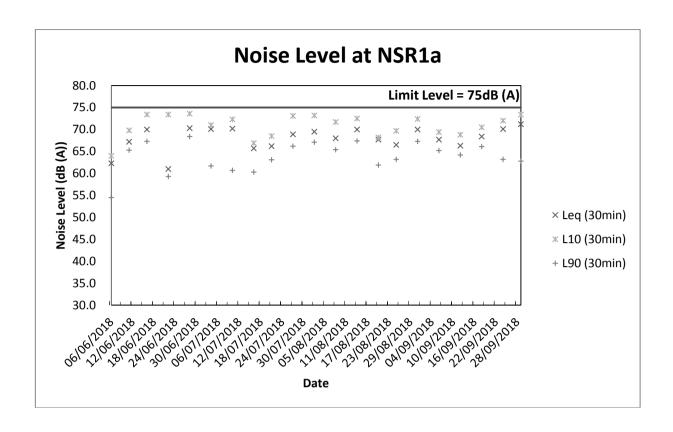
**Graphical Plots of Impact Noise Monitoring Data**

The noise monitoring data were found to be lower than the limit level. The major noise source during the monitoring event was the vehicles passing through the container yard entrance and the general earth works inside the construction site.

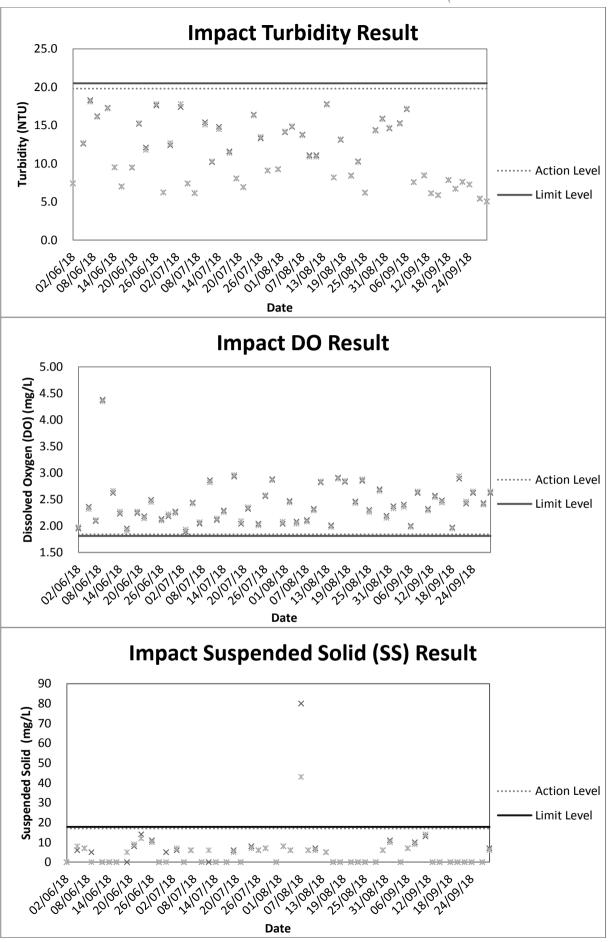
**Graphical Plots of Impact Water Quality Monitoring Data**

Generally, the turbidity and suspended solids were found to be lower than the action level. Besides, all results of dissolved oxygen measured in this reporting month were higher than the action level.

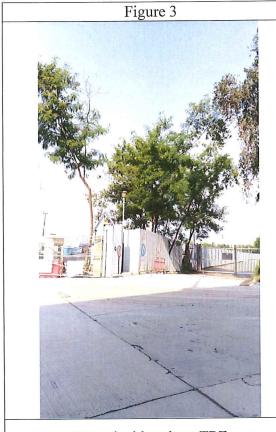
Figure 5

Trees inside robust TPZ

1. Contractor was reminded to provide TPZ with robust fence, whenever possible, at the drip line of all retained trees unless the trees are well beyond the extend of construction activities.

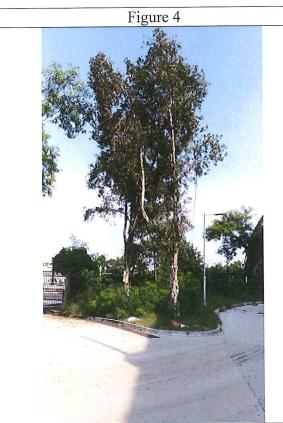
Condition of trees at the entrance of the existing treatment plant

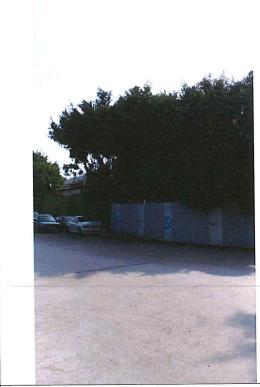
General condition of the existing trees at eastern boundary

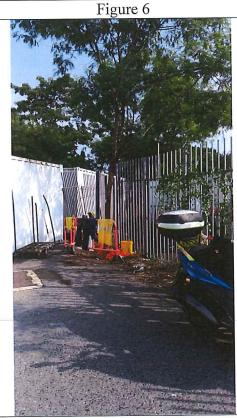
Proper protective fence (outside works extent) is noted
