**CONTRACT NO. DC/2013/10 - DESIGN,
BUILD AND OPERATE SAN WAI
SEWAGE TREATMENT WORKS –
PHASE 1**

**MONTHLY EM&A REPORT
NO. 20**

(01 DECEMBER – 31 DECEMBER 2018)

Report No.: ENA90010

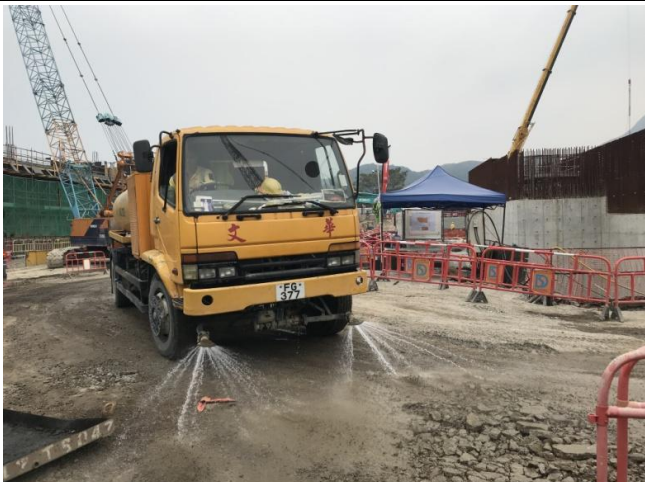
<p>Follow up action to Item 1 on 30/11/2018, watering was provided.</p>	--	181207_001	No	--
--

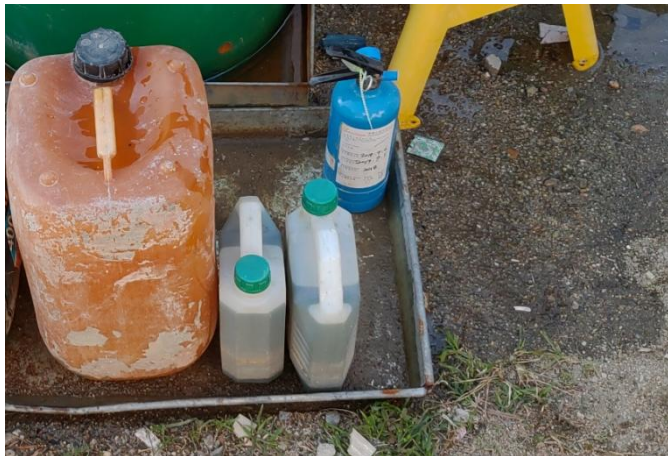
<p>Follow up action to Item 2 on 30/11/2018, drip tray was provided for chemical container storage.</p>	--	181207_002	No	--

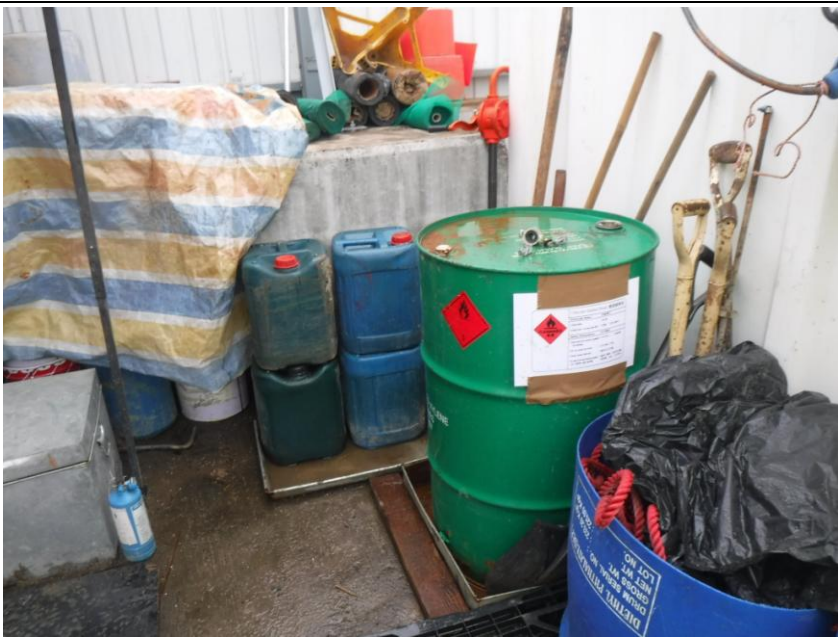
1

Item 2: Chemical wastes was observed without chemical label near P3.

<p>Chemical wastes was observed without chemical label near P3.</p>	To provide valid chemical label for the chemical waste	181207_003	Yes	12/12/2018
---	--	--	------------	-----	------------

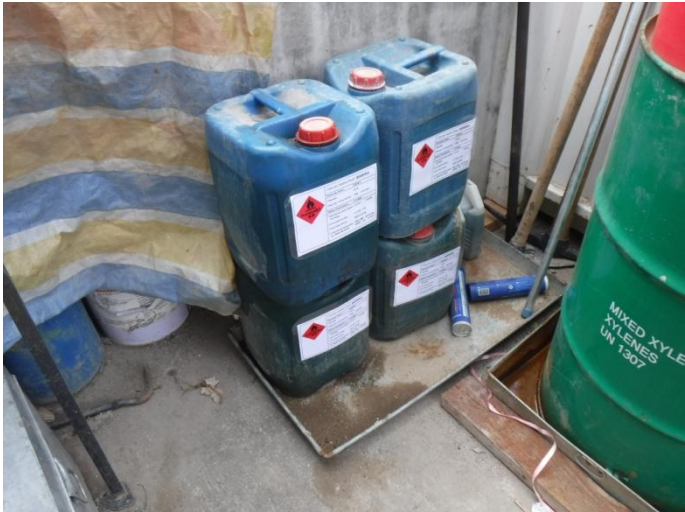
<p>Follow up action to Item 1 on 07/12/2018, valid chemical labels were provided.</p>	--	181212_001	No	--

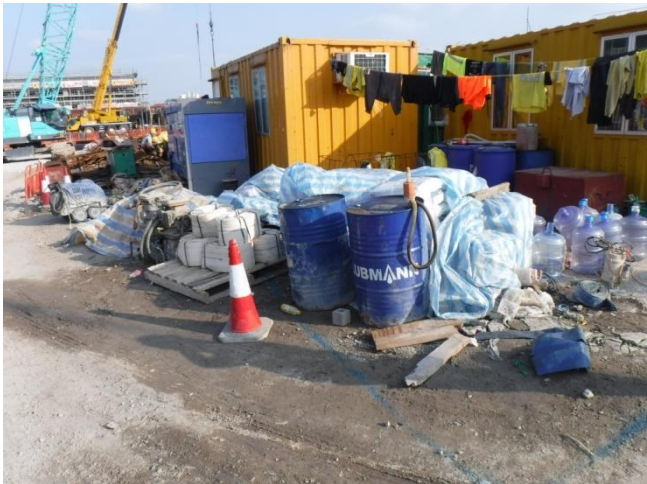
<p>Chemical containers without drip tray were observed</p>	To provide drip tray for the chemical containers.	181227_002	Yes	04/01/2019

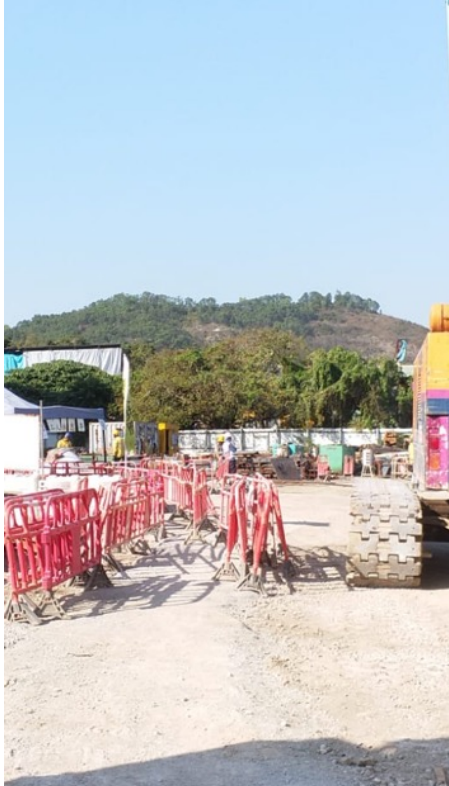
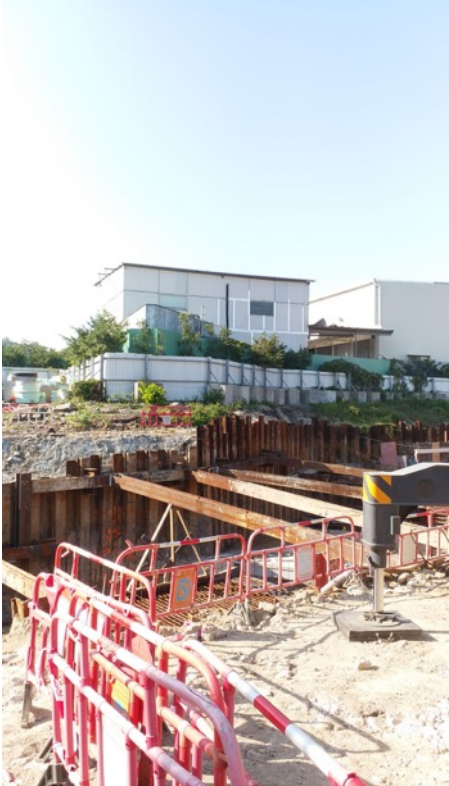
Figure 1	Figure 2

General condition of the trees at northern side of the site	General condition of the trees at south-west corner of the site

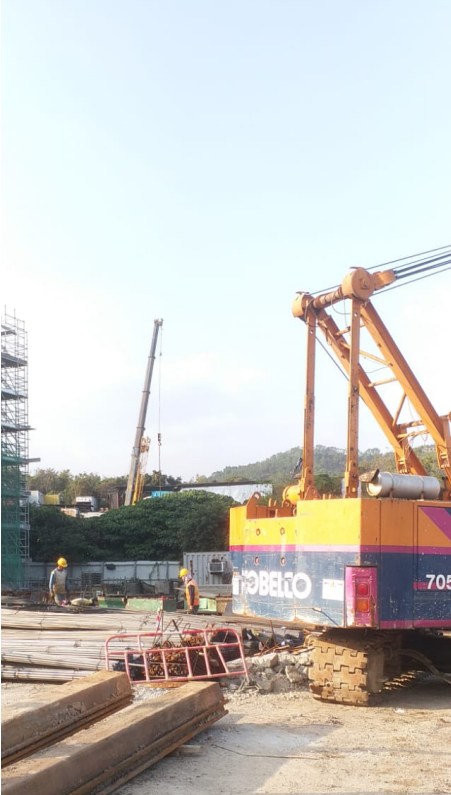
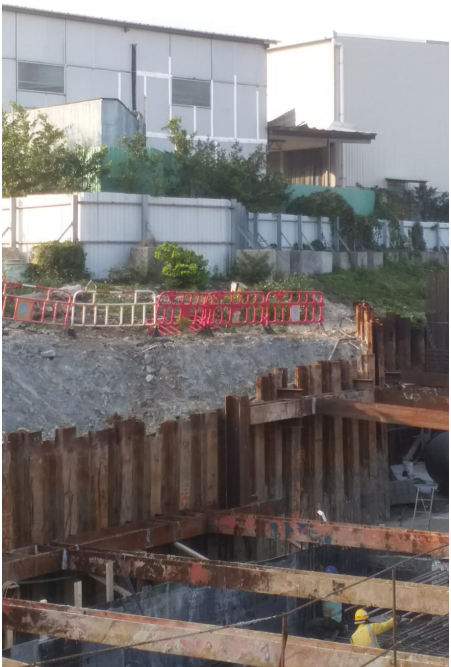
Figure 1	Figure 2

General condition of the tress at northern side of the site	General condition of the trees at south-west corner of the site
