**CONTRACT NO. DC/2013/10 - DESIGN,
BUILD AND OPERATE SAN WAI
SEWAGE TREATMENT WORKS –
PHASE 1**

**MONTHLY EM&A REPORT
NO. 34**

(01 FEBRUARY – 29 FEBRUARY 2020)

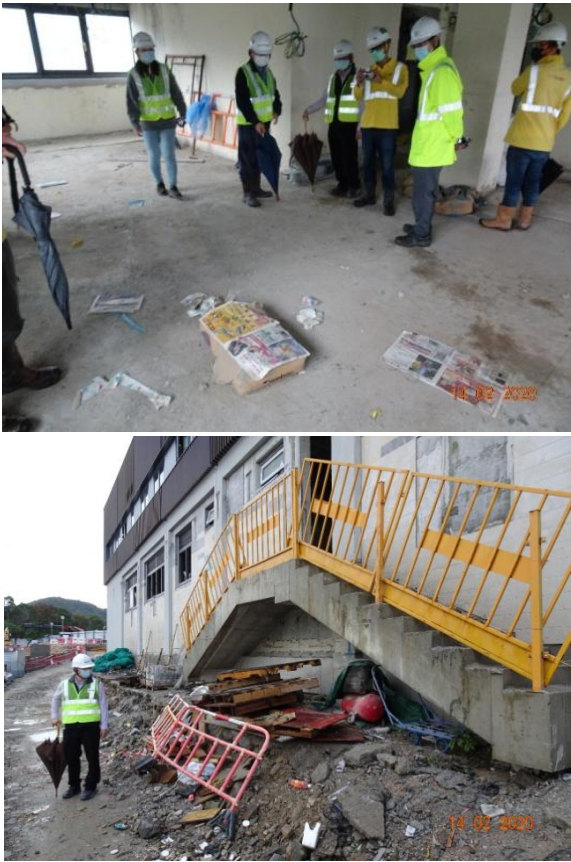
<p>Improper disposal of general refuse was observed at AB and east of AB.</p>	To collect the general refuse properly	200214_001	Yes	21/02/2020

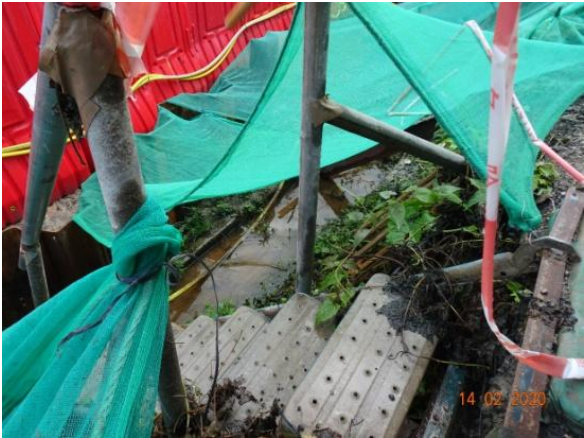
2

<p>Stagnant water and general refuse was observed inside U-channel at east of AB.</p>	To clear the stagnant water and general refuse properly	200214_002	Yes	21/02/2020
---	---	---	------------	-----	------------

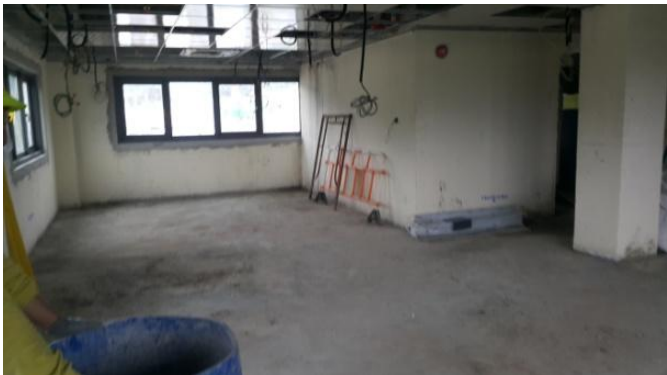
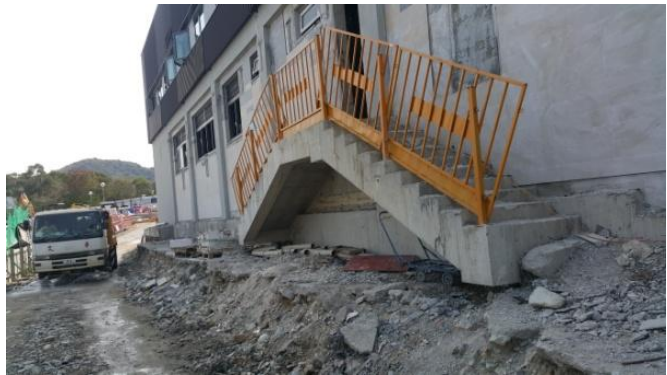
<p>Follow up action to item 1 on 14/02/2020, general refuse was collected.</p>	---	200221_001	No	---

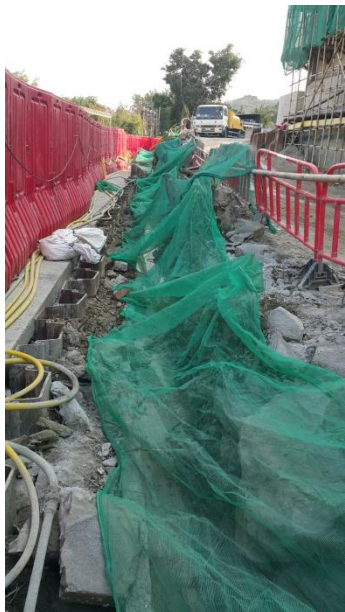
<p>Follow up action to item 2 on 14/02/2020, general refuse and stagnant water was cleared.</p>	---	200221_002	No	---
1

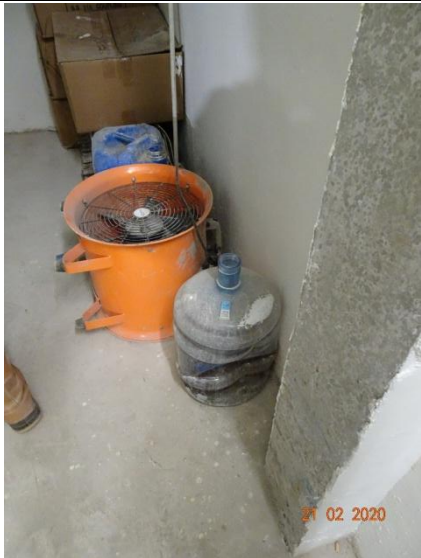
<p>Liquid container was found without label near SDB.</p>	To provide proper identification label for liquid container	200221_003	Yes	28/02/2020

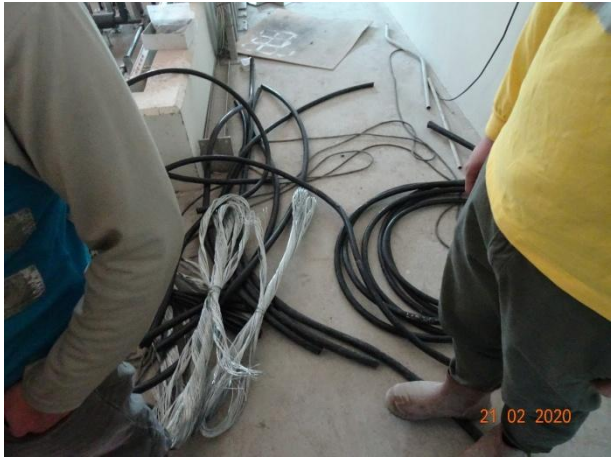
2

<p>General refuse were observed near EB4.</p>	To clean the general refuse properly	200221_004	Yes	28/02/2020
---	---	--------------------------------------	------------	-----	------------

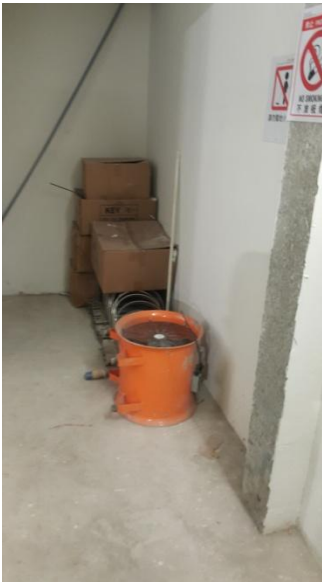
<p>Follow up action to item 1 on 21/02/2020, liquid container was removed.</p>	---	200228_001	No	---

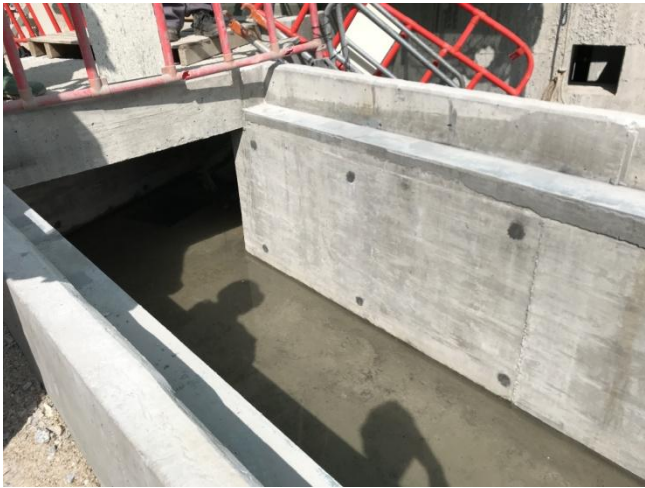
<p>Stagnant water was observed near CB area.</p>	To clear the stagnant water properly	200228_003	Yes	06/03/2020

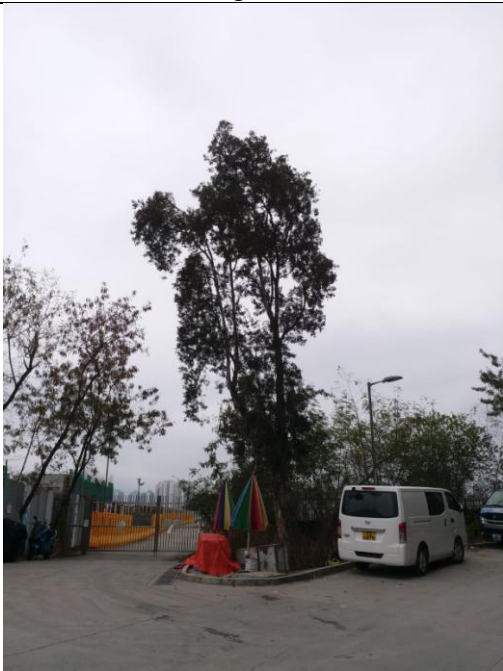
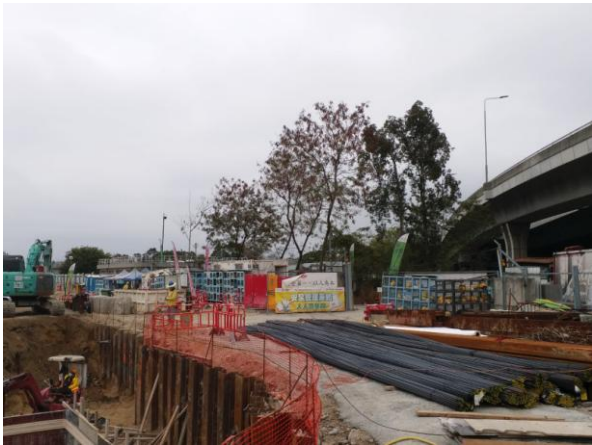
Figure 3	Figure 4

Condition of trees at the entrance of the existing treatment plant	Existing trees at the site entrance
Figure 5	Figure 6

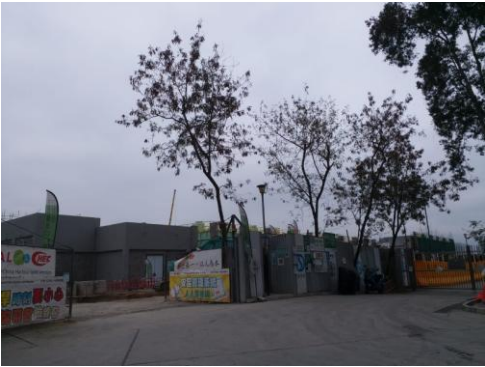
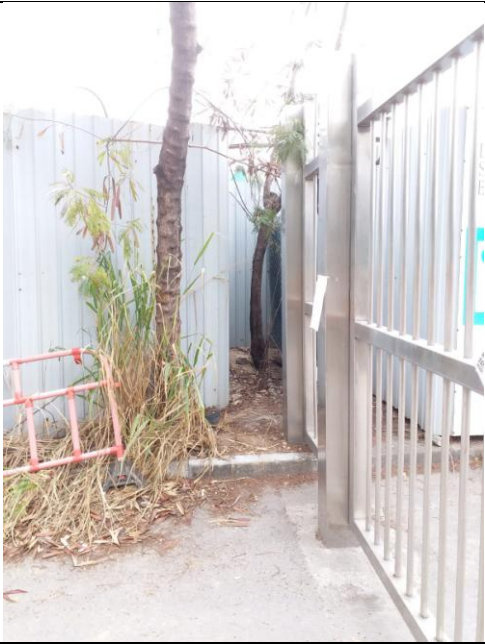
Existing trees at the site entrance near the hoarding fence	Clearance of stored piles is noted in tree protection area

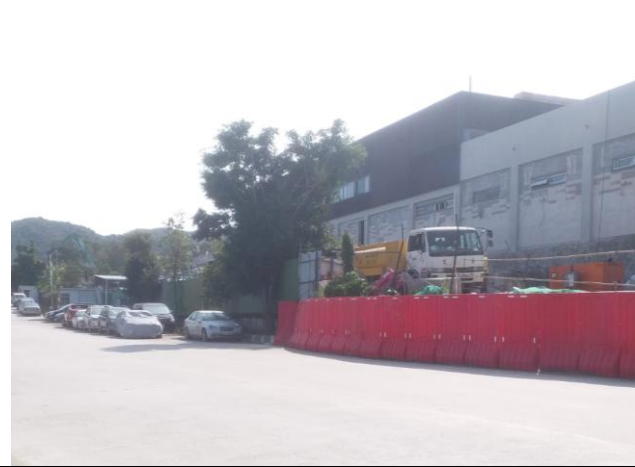
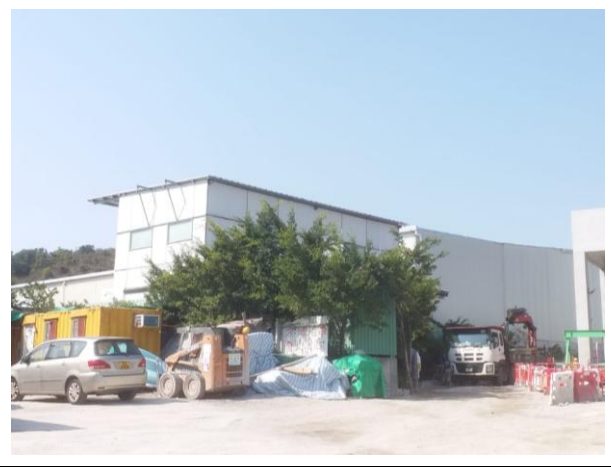
Figure 1	Figure 2

<p>Most of the trees are removed at the eastern boundary</p>	<p>Trees located adjacent to our site (outside site)</p>
