CONTRACT NO. DC/2013/10 - DESIGN,
BUILD AND OPERATE SAN WAI
SEWAGE TREATMENT WORKS –
PHASE 1

**MONTHLY EM&A REPORT
NO. 39**

(01 JULY – 31 JULY 2020)

Report No.: ENA06117

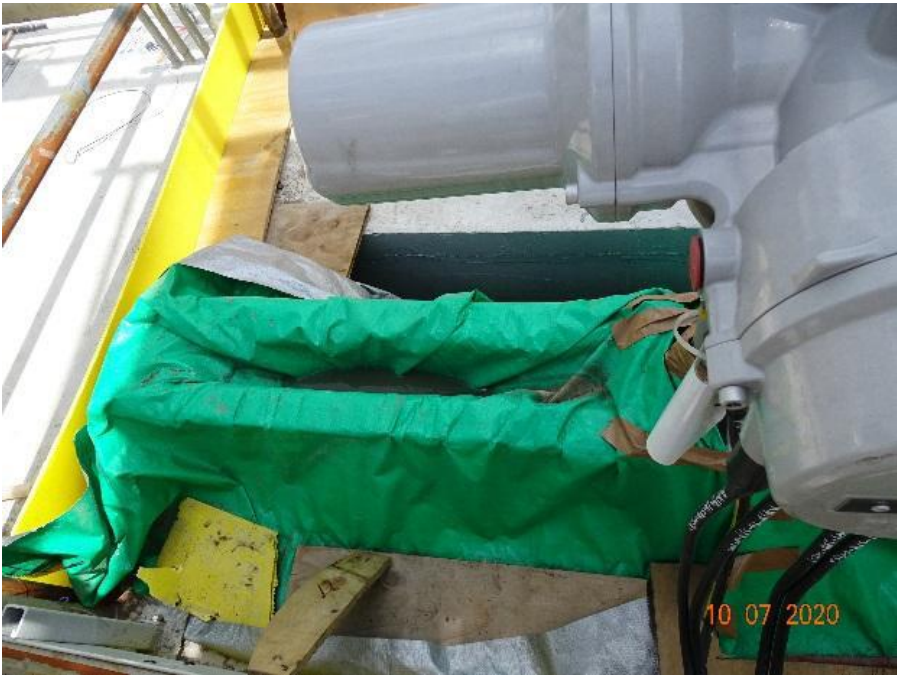
<p>Stagnant water were observed near PTW.</p>	To clear the stagnant water	200710_001	Yes	16/07/2020

Date	Observations/Reminders	Follow-up Action	Closed Date
03 July 2020	--	--	10 July 2020
10 July 2020	1. Stagnant water were observed near PTW.	1. Stagnant water were cleared.	16 July 2020
16 July 2020	1. General refuse were observed near SDB and CEPT. 2. Stagnant water were observed near SDB and CEPT.	1. General refuse were collected properly. 2. Stagnant water was cleared.	23 July 2020
23 July 2020	1. C&D materials were observed near the entrance at south-west of UV.	1. C&D materials were collected.	30 July 2020
30 July 2020	1. General refuse were found discarded improperly near GH. 2. C&D materials were observed discarded improperly near WS and CEPT.	Follow-up actions for outstanding observation will be inspected during the next site inspection.	05 August 2020

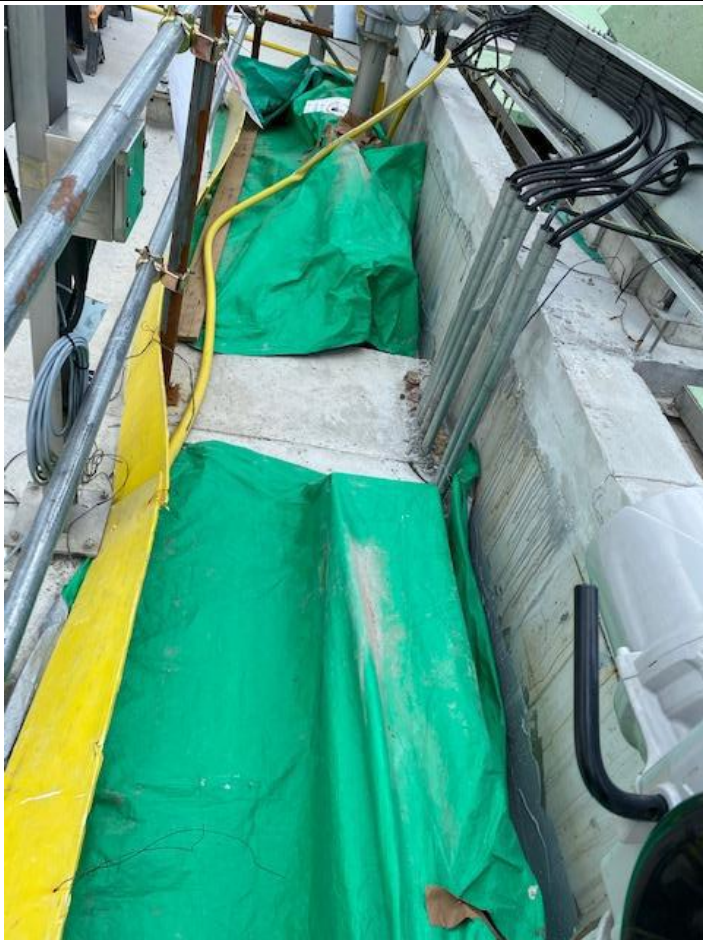
<p>Follow up action to item 1 on 10/07/2020, stagnant water was cleared.</p>	---	200716_001	No	---

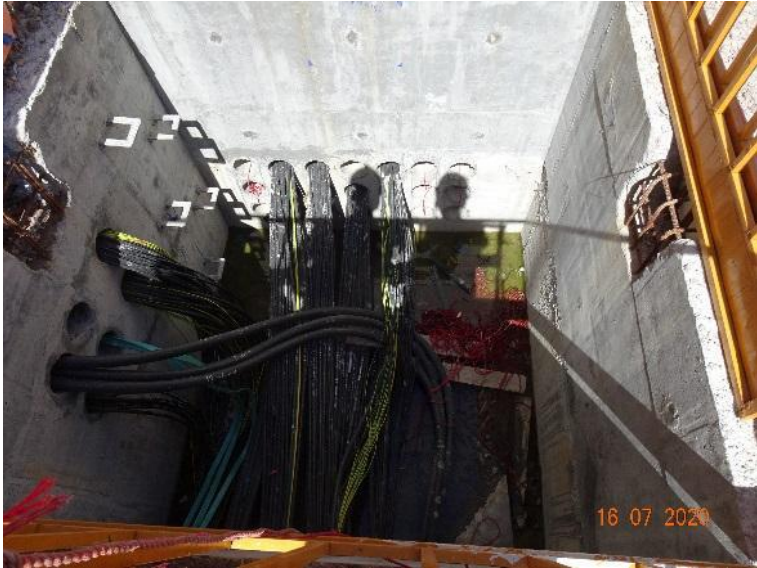
1

<p>General refuse were observed near SDB and CEPT.</p>	To collect the general refuse properly	200716_002	Yes	23/07/2020
2

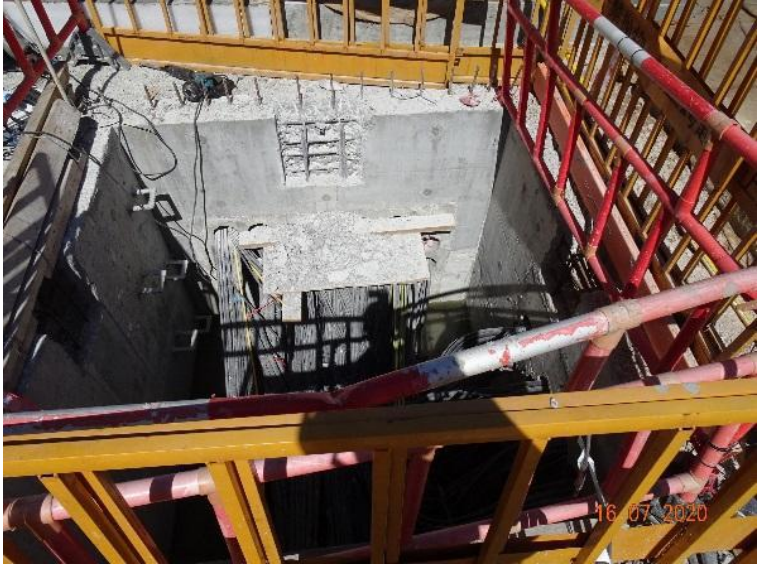
<p>Stagnant water were observed near SDB and CEPT.</p>	To clear the stagnant water	200716_003	Yes	23/07/2020

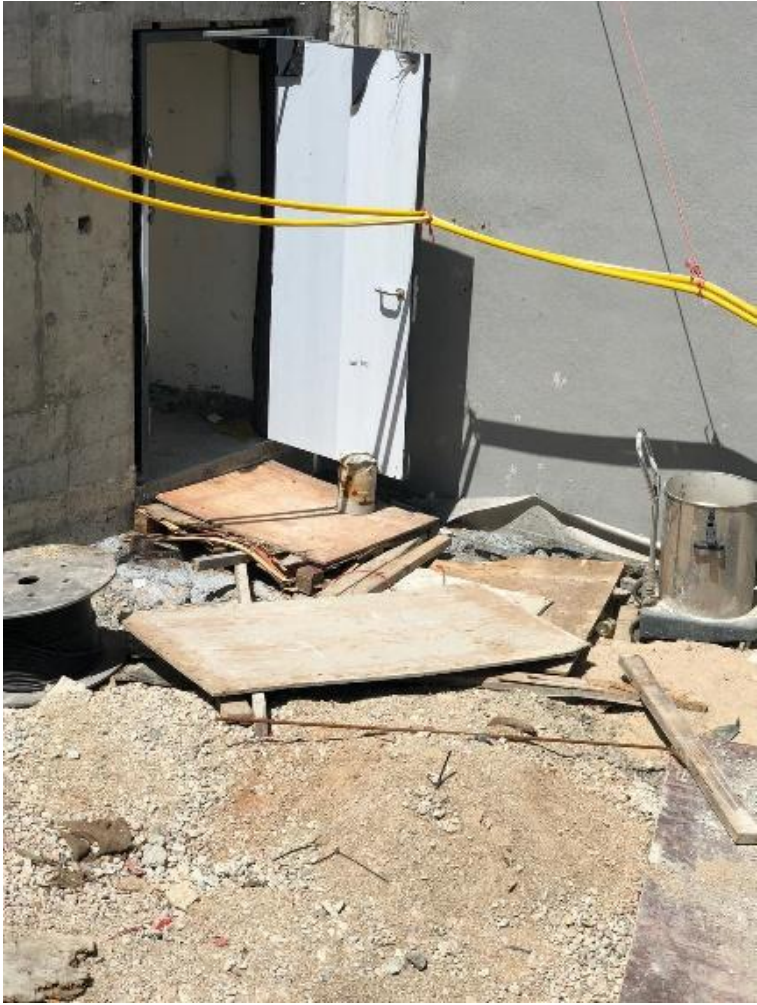
1

<p>C&D materials were observed near the entrance at south-west of UV.</p>	To collect the C&D materials properly	200723_003	Yes	30/07/2020

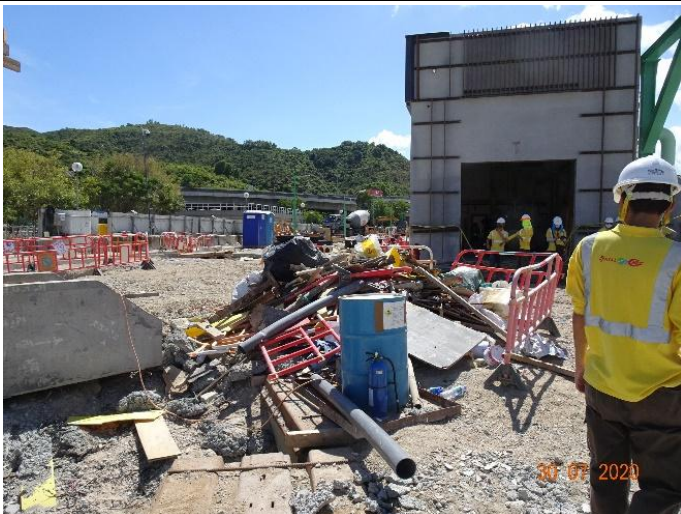
<p>General refuse were found discarded improperly near GH.</p>	To collect the general refuse properly	200730_002	Yes	07/08/2020

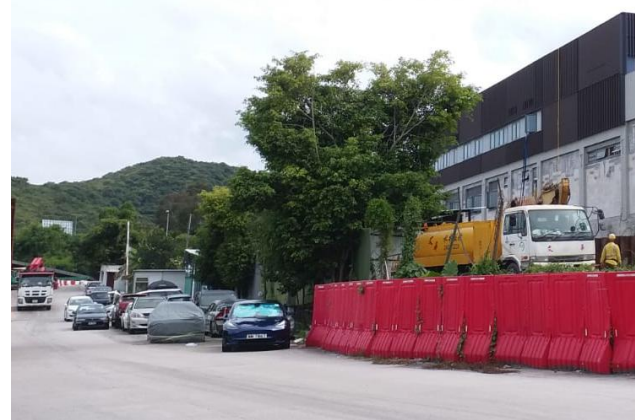
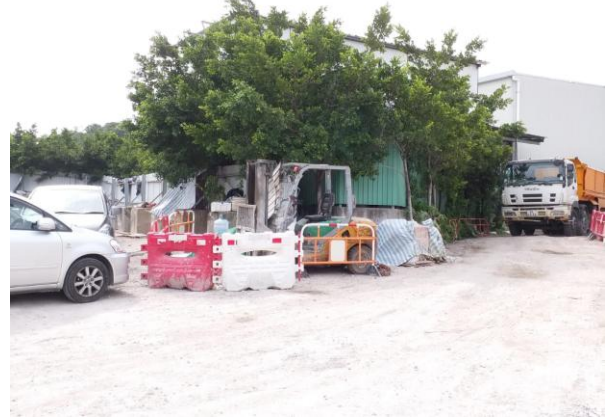
Figure 1	Figure 2

<p>Most of the trees are removed at the eastern boundary</p>	<p>Trees located adjacent to our site (outside site)</p>

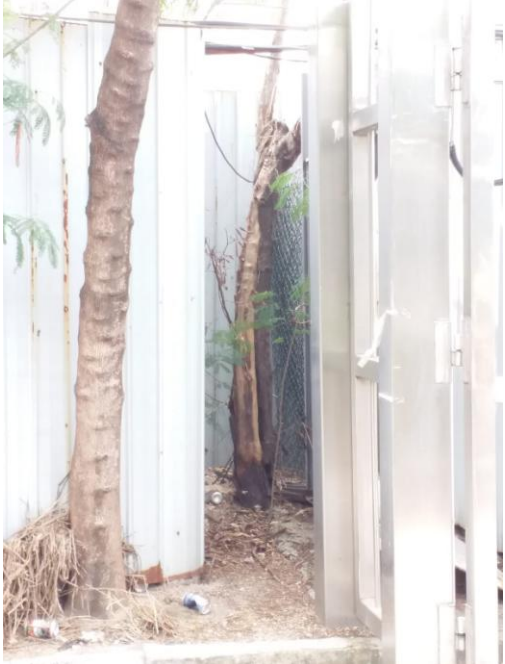
Existing trees at the site entrance near the hoarding fence	The tree in the tree protection area is drying and has peeling bark. It is in poor health condition. There is high risk of tree felling.

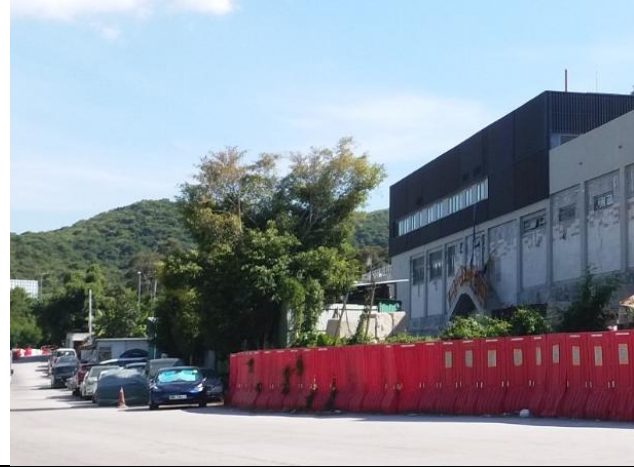
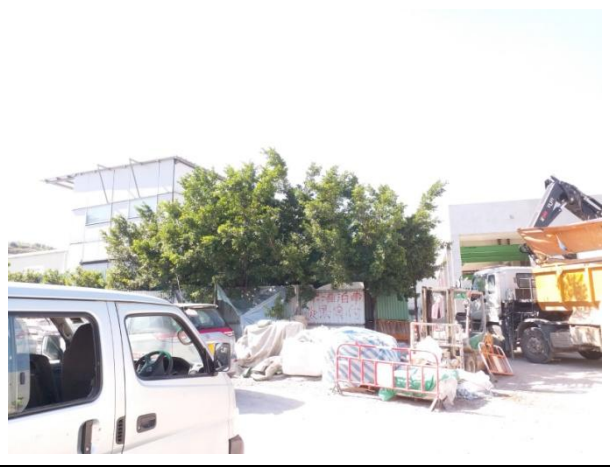
Figure 1	Figure 2

Most of the trees are removed at the eastern boundary	Trees located adjacent to our site (outside site)

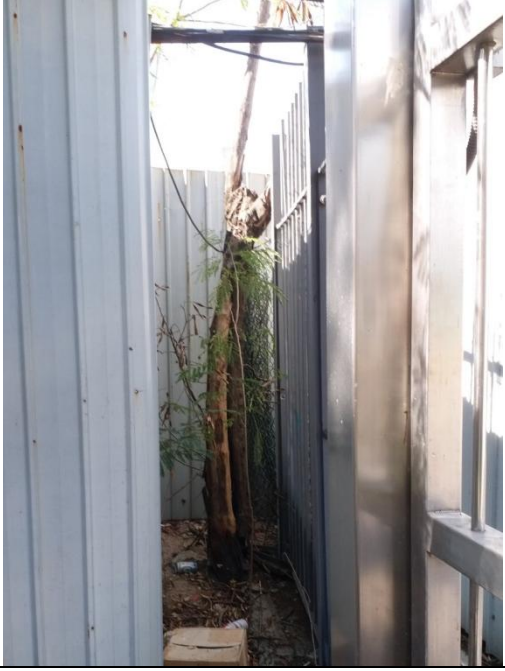
Existing trees at the site entrance near the hoarding fence	The tree in the tree protection area is drying and has peeling bark. It is in poor health condition. There is high risk of tree felling.
