CONTRACT NO. DC/2013/10 - DESIGN,
BUILD AND OPERATE SAN WAI
SEWAGE TREATMENT WORKS –
PHASE 1

**MONTHLY EM&A REPORT
NO. 40**

(01 AUGUST – 31 AUGUST 2020)

Report No.: ENA06445

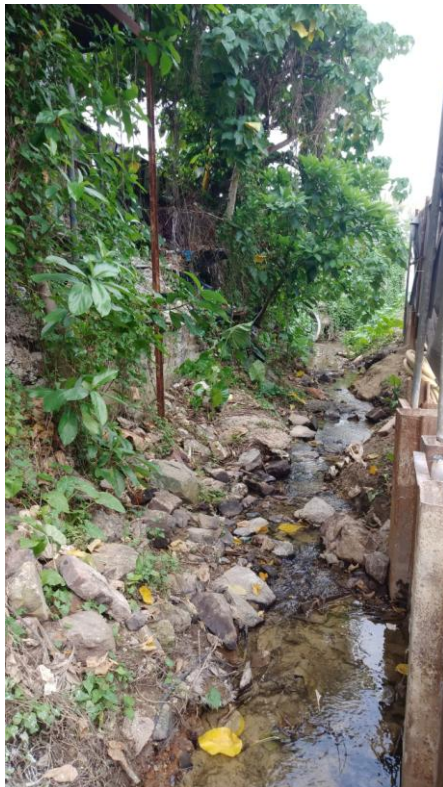
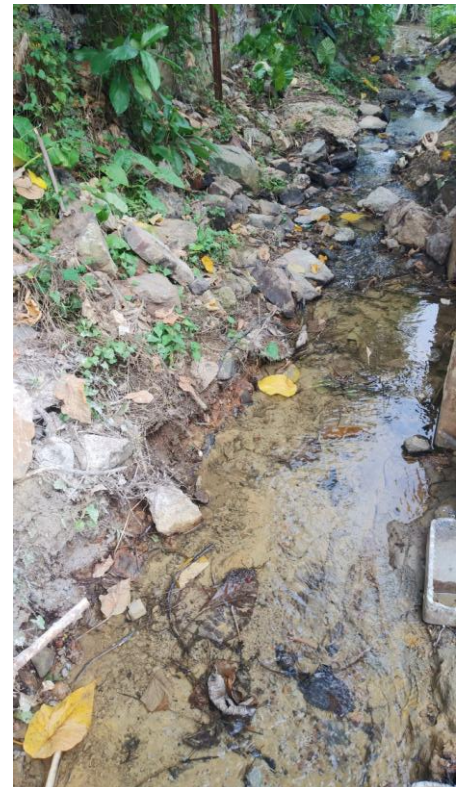
- 5.1.3. An additional site inspection was carried out on 28 August 2020 by ET, IEC and the contractor regarding to two public enquiries. The first public enquiry was related to an occurrence happened on 15 August 2020 which was about the overflowing of fresh water from a manhole in front of the Electrical Building 4 and the second public enquiry was related to an occurrence happened on 24 August 2020 which was about the leakage of very little amount of treated sewage through a sand bag barrier at the end of a pipe near Electrical Building 4. Immediate actions had been taken and no adverse impacts were found due to these two occurrences according to our routine water quality monitoring data as shown in **Appendix F2** and **Appendix N**. During the site inspection on 28 August 2020, no adverse observations in regard to the improper discharge mentioned in the enquiries were recorded. The following photo taken on 28 August 2020 showing the nearby concerning creek:

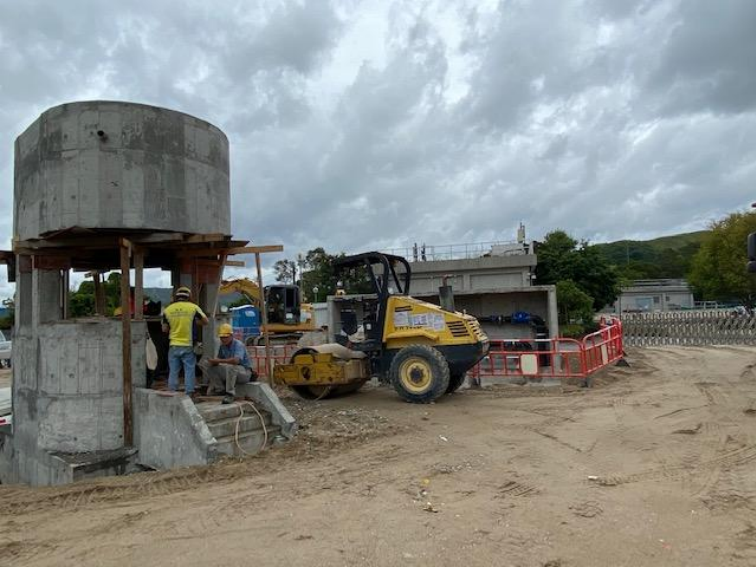
<p>Follow up action to item 1 on 30/07/2020, general refuse were collected.</p>	---	200807_001	No	---

<div> </div> <p>Follow up action to item 2 on 30/07/2020, C&D materials were collected properly.</p>	---	200807_002	No	---
--	--	-----	------------	----	-----

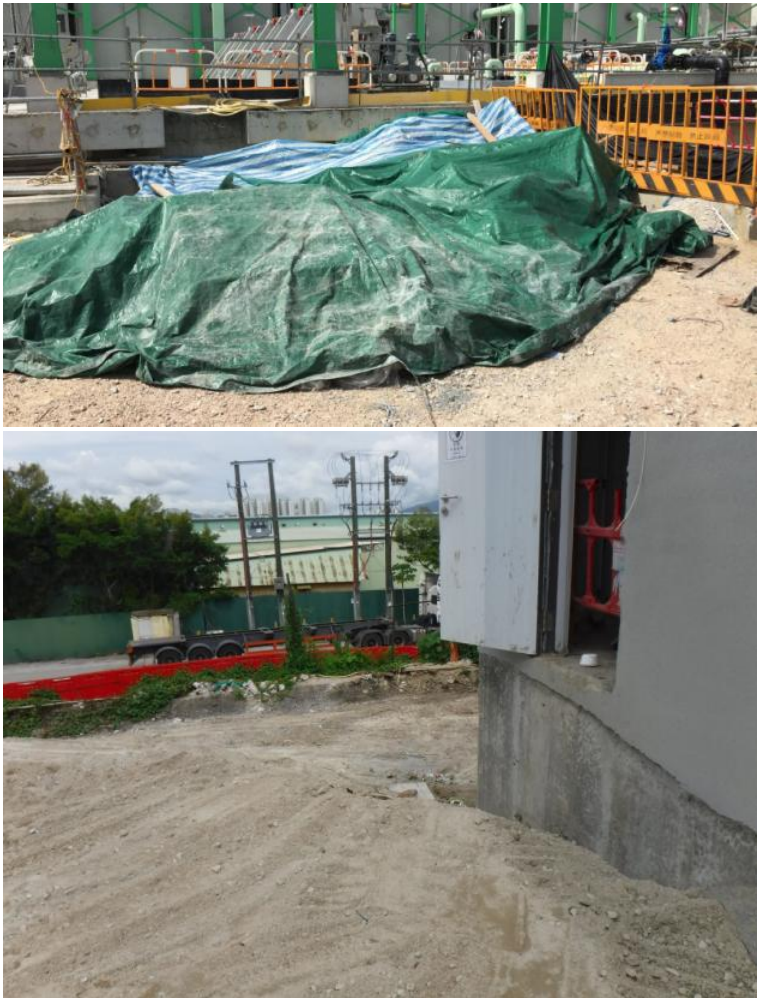
<p>Follow up action to item 1 on 07/08/2020, general refuse were collected.</p>	---	200814_001	No	---

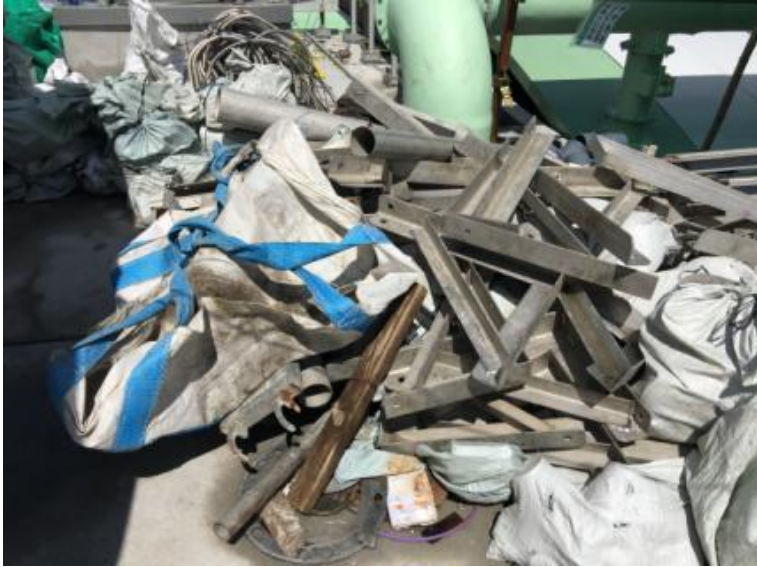
1	  <p>Stagnant water of multi-part cover along the EVA road was observed.</p>	To clear the stagnant water properly or provide larvicidal oil	200814_002	Yes	20/08/2020
2

<p>Improper disposal of C&D materials were observed at CEPT.</p>	To collect the C&D materials properly	200814_003	Yes	20/08/2020

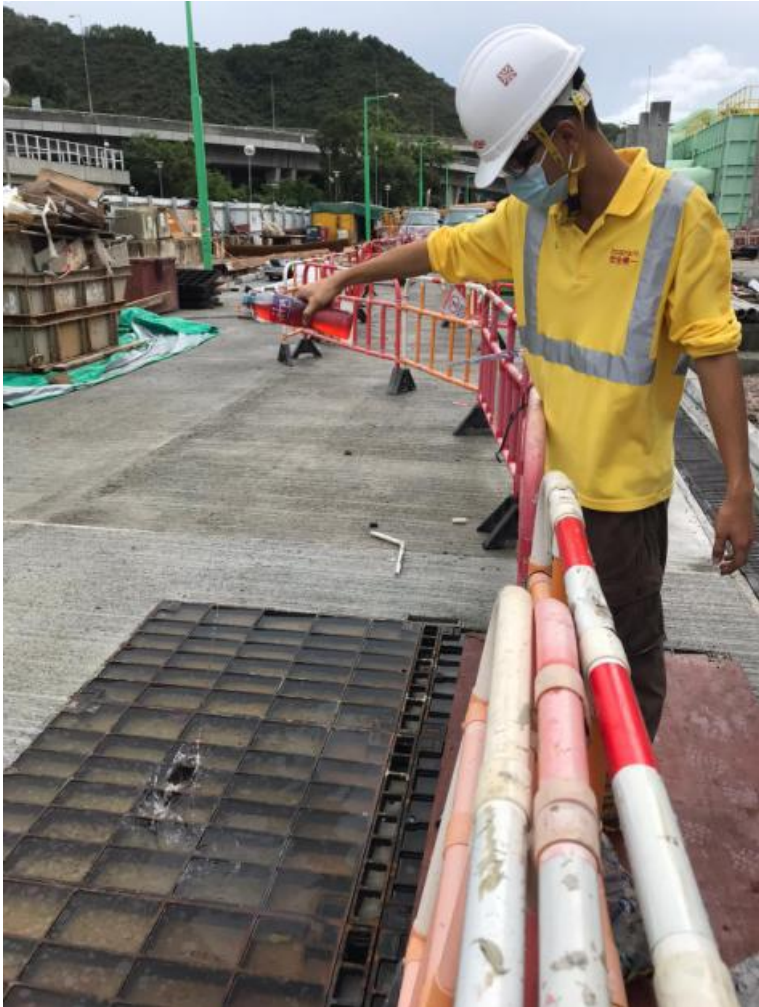
<p>Follow up action to item 1 on 14/08/2020, larvicidal oil was provided.</p>	---	200820_001	No	---

---	  <p>Follow up action to item 2 on 14/08/2020, C&D materials were collected.</p>	---	200820_002	No	---
-----	---	-----	------------	----	-----

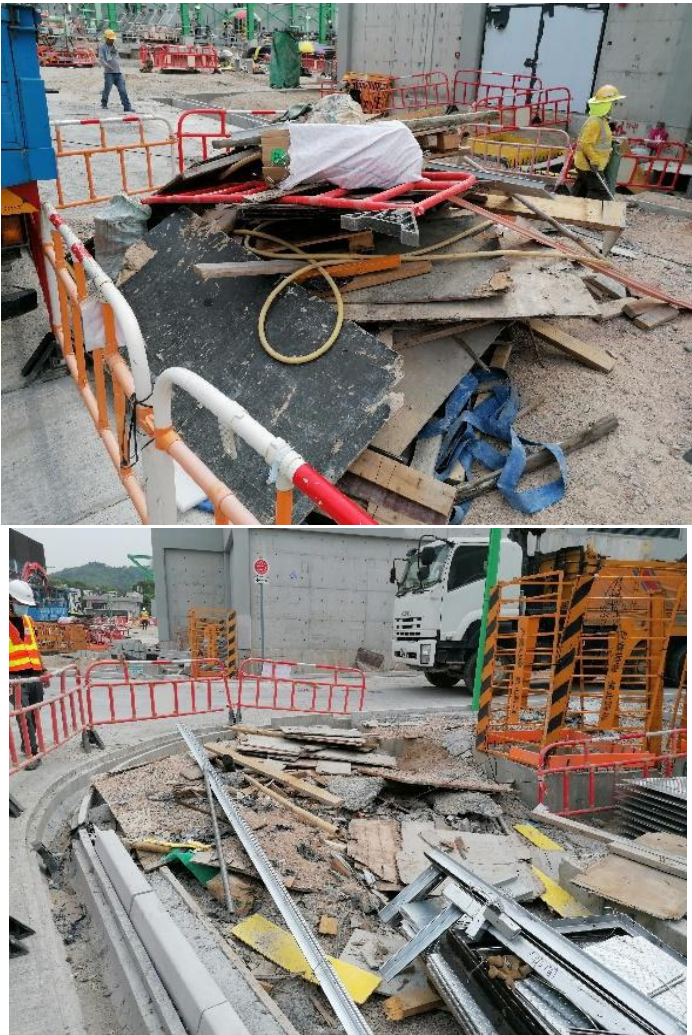
Observations Item I: General refuse and C&D material were observed near Portion 4, AB, FW, SSSB, CB.

<p>General refuse and C&D materials were observed near Portion 4, AB, FW, SSSB, CB.</p>	To collect the general refuse and C&D materials properly	200827_001	Yes	04/09/2020

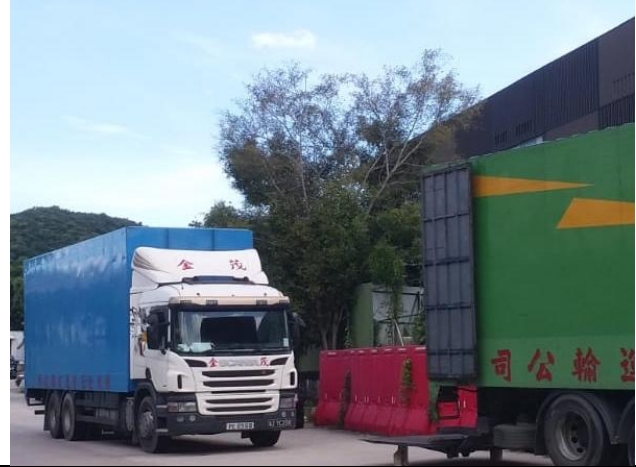
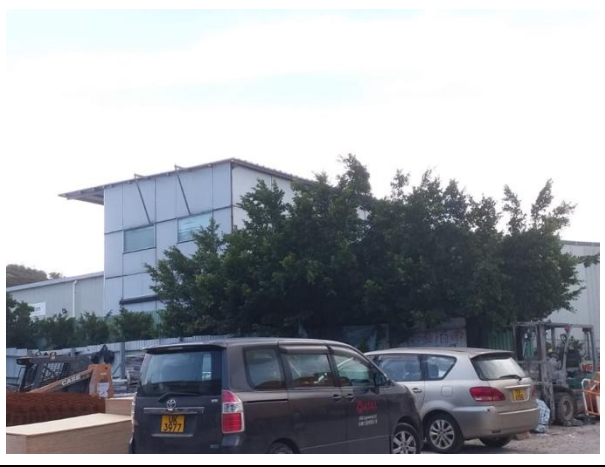
Figure 1	Figure 2

<p>Most of the trees are removed at the eastern boundary</p>	<p>Trees located adjacent to our site (outside site)</p>

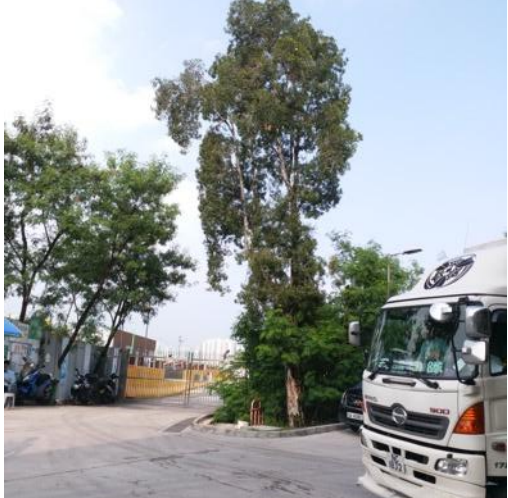
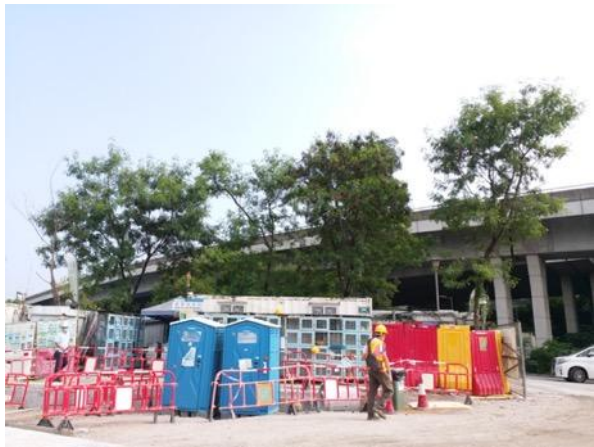
Figure 3	Figure 4

Condition of trees at the entrance of the existing treatment plant	Existing trees at the site entrance
Figure 5	Figure 6

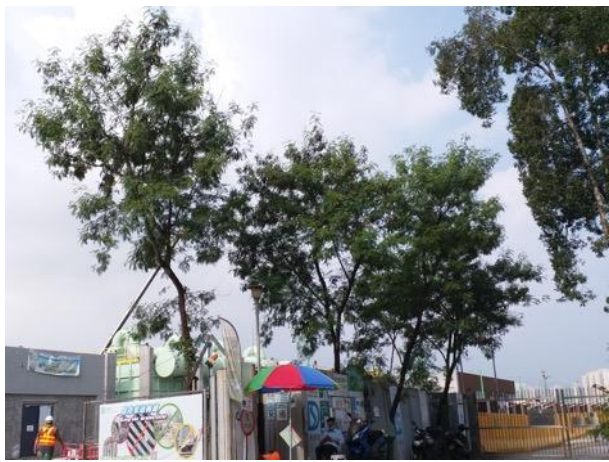
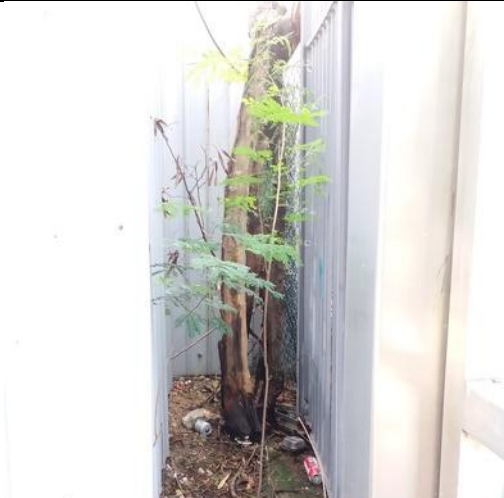
Existing trees at the site entrance near the hoarding fence	The tree in the tree protection area is drying and has peeling bark. It is in poor health condition. There is high risk of tree felling. Stored debris underneath the tree shall be removed.
