**CONTRACT NO. DC/2013/10 - DESIGN,
BUILD AND OPERATE SAN WAI
SEWAGE TREATMENT WORKS –
PHASE 1**

**MONTHLY EM&A REPORT
NO. 42**

(01 OCTOBER – 31 OCTOBER 2020)

Report No.: ENA07318

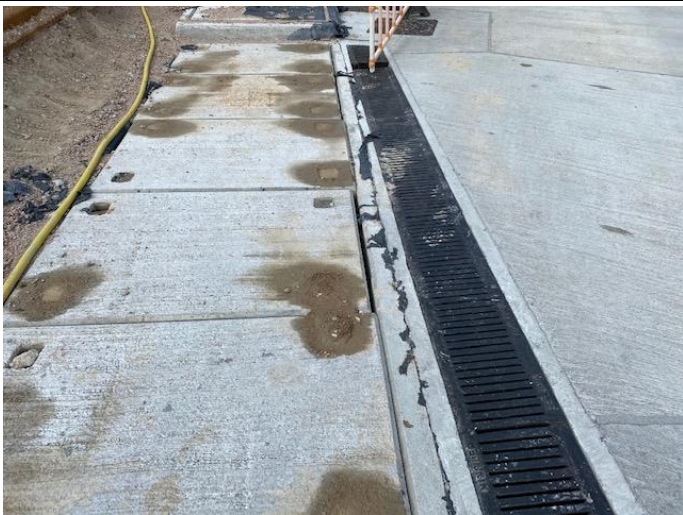
<p>Follow up action to item 1 on 30/09/2020, Keyhole was filled with sand.</p>	--	201009_001	No	--
--	 	--	200930_002	No	--

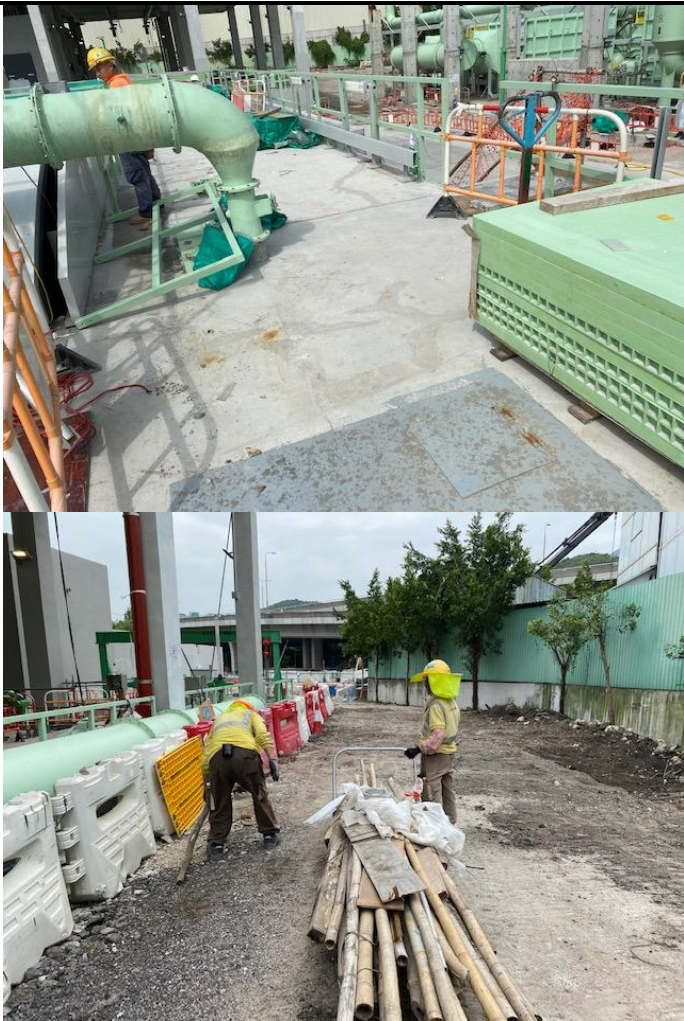
Follow up action to item 2 on 30/09/2020, general refuse and C&D material was collected at CEPT, FH, UV.

--	  <p>Follow up action to item 3 on 30/09/2020, chemical was collected properly.</p>	--	200930_003	No	--
--	  <p>Follow up action to item 3 on 30/09/2020, Oil spillage was handled properly</p>	--	200930_004	No	--

1	  <p>Improper disposal of general refuse was observed at FH and CEPT.</p>	To collect the general refuse properly	200930_005	Yes	16/10/2020
---	--	--	------------	-----	------------

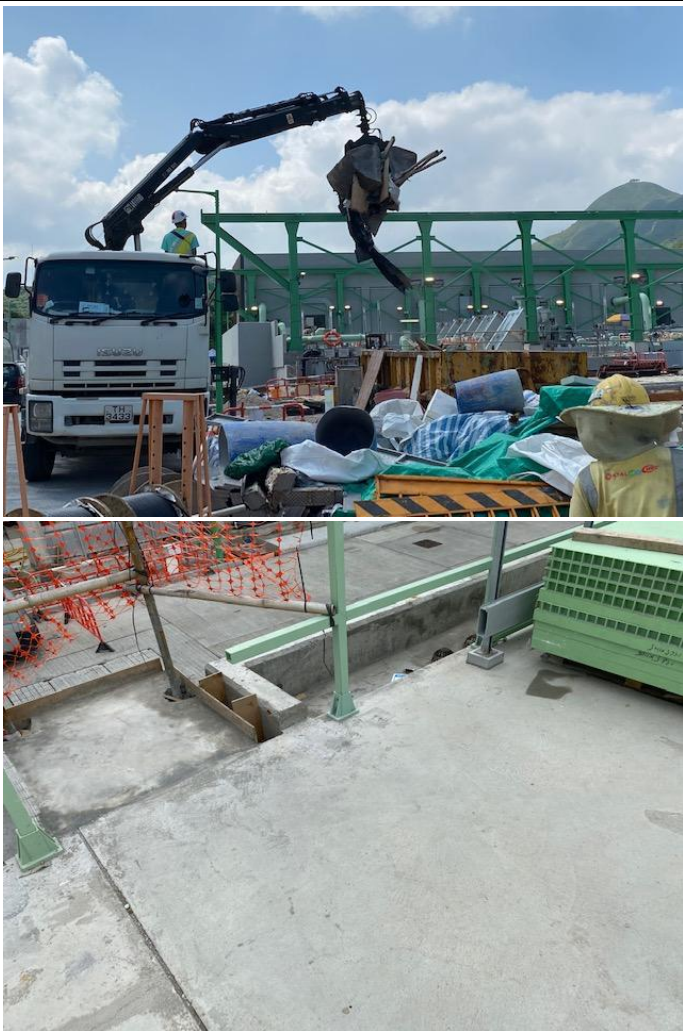
<p>Follow up action to item 1 on 09/10/2020, general refuse were collected.</p>	--	201016_001	No	--

1	  <p>General refuses were observed on the ladder platform near SDB.</p>	To collect the general refuse properly	201016_002	Yes	22/10/2020
---	---	--	------------	-----	------------

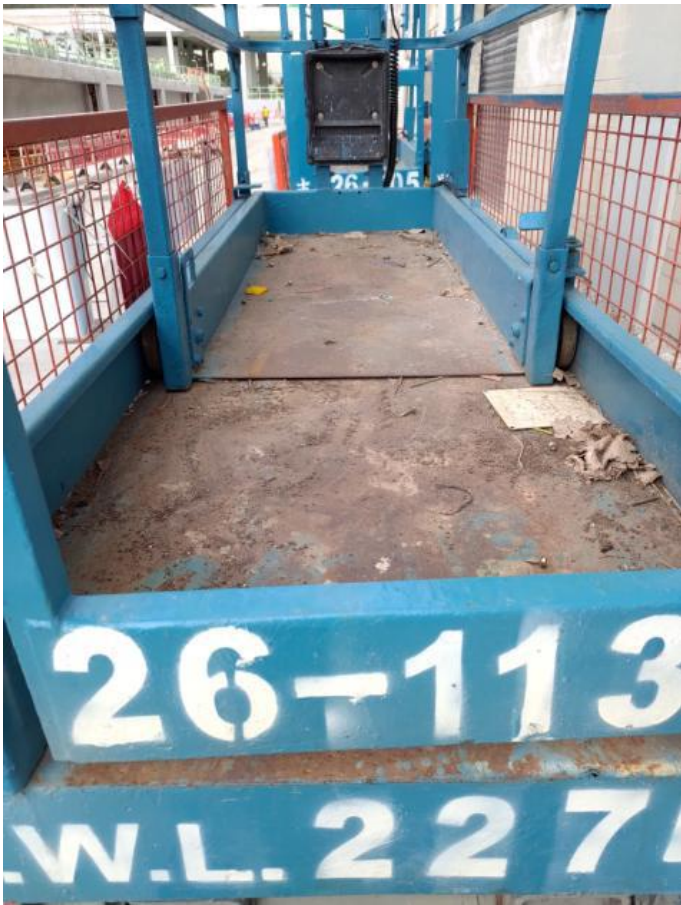
<p>Follow up action to item 1 on 16/10/2020, general refuse were collected.</p>	--	201022_001	No	--

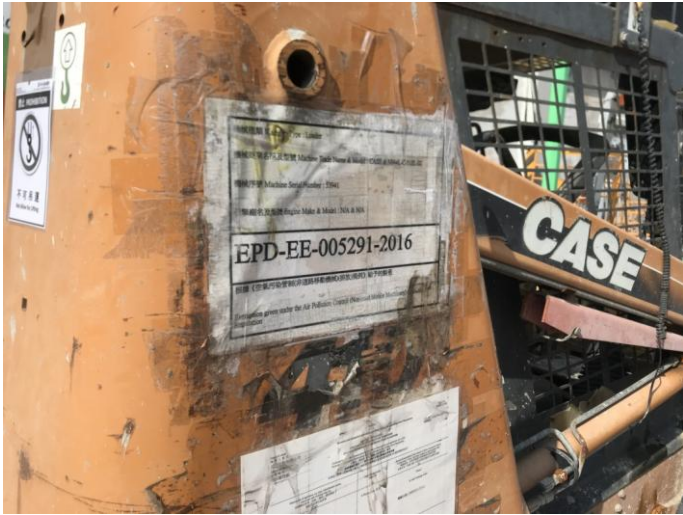
<p>NRMM label was fade near CEPT.</p>	To provide a proper NRMM label	201022_002	Yes	30/10/2020
---	---	--------------------------------	------------	-----	------------

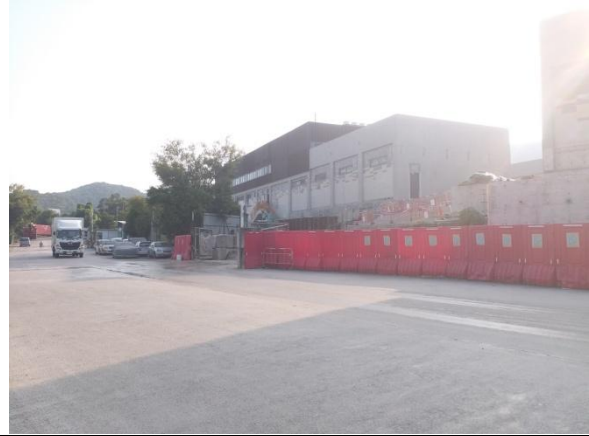
Figure 1	Figure 2

<p>Most of the trees are removed at the eastern boundary</p>	<p>Trees located adjacent to our site (outside site)</p>

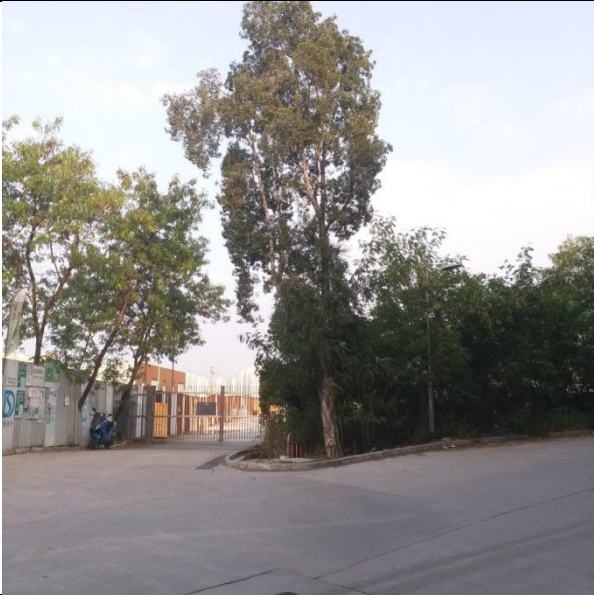
Figure 3	Figure 4

Condition of trees at the entrance of the existing treatment plant	Existing trees at the site entrance
Figure 5	Figure 6

Existing trees at the site entrance near the hoarding fence	The tree (outside site) near the site boundary is drying and has peeling bark. It is in poor health condition. There is high risk of tree felling. Stored debris underneath the tree shall be removed.

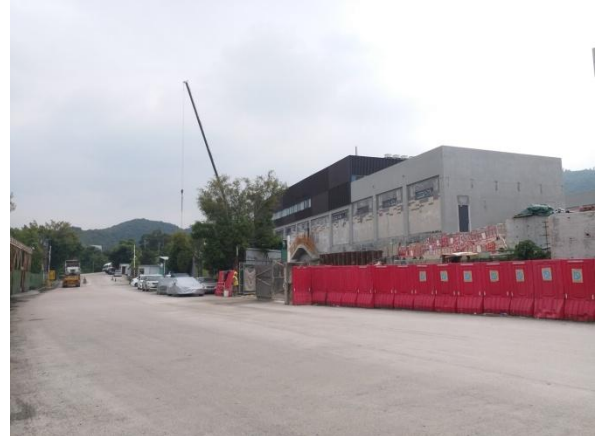
Figure 1	Figure 2

<p>Most of the trees are removed at the eastern boundary</p>	<p>Trees located adjacent to our site (outside site)</p>

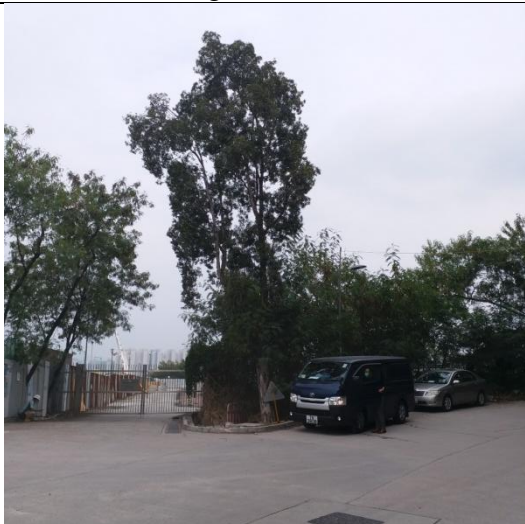
Figure 3	Figure 4

Condition of trees at the entrance of the existing treatment plant	Existing trees at the site entrance
Figure 5	Figure 6

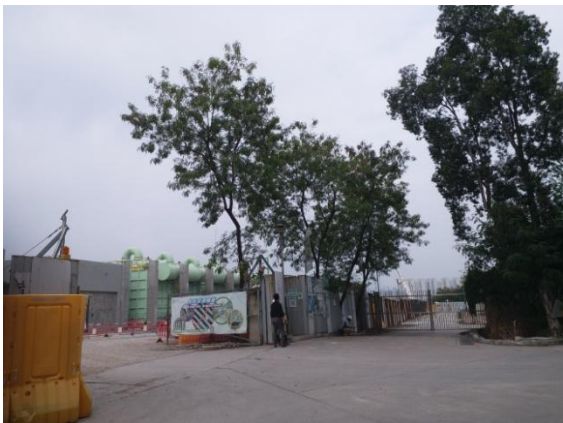
Existing trees at the site entrance near the hoarding fence	The tree (outside site) near the site boundary is drying and has peeling bark. It is in poor health condition. There is high risk of tree felling.
