CONTRACT NO. DC/2013/10 - DESIGN,
BUILD AND OPERATE SAN WAI
SEWAGE TREATMENT WORKS –
PHASE 1

**MONTHLY EM&A REPORT
NO. 46**

(01 FEBRUARY – 28 FEBRUARY 2021)

Report No.: ENA10982

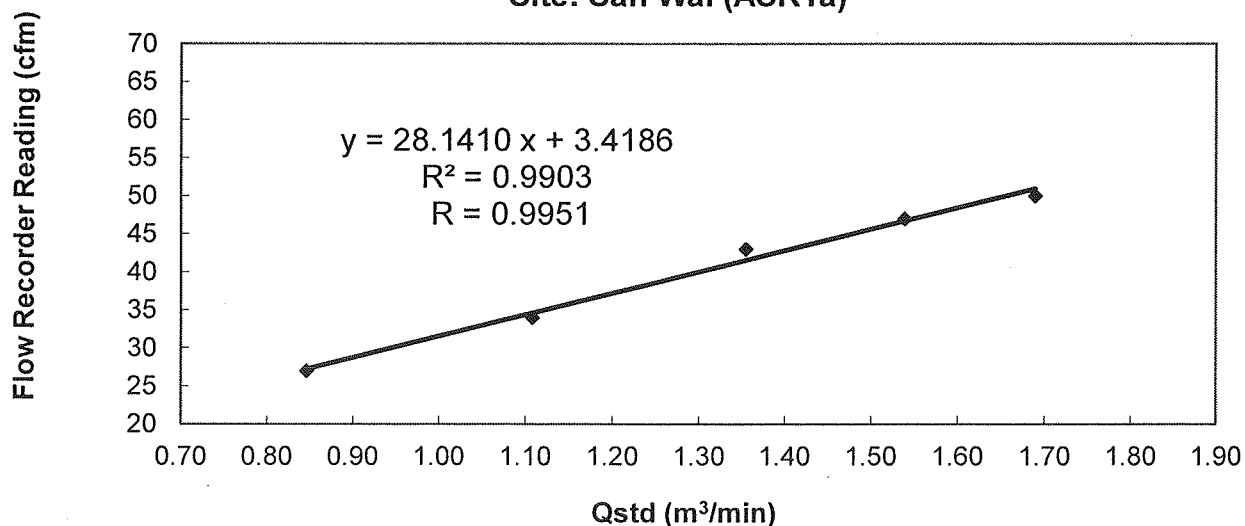
Sampler 1934 Calibration Curve
Site: San Wai (ASR1a)

Flow recorder reading (cfm)	50	47	43	34	27
Qstd (Actual flow rate, m ³ /min)	1.69	1.54	1.35	1.11	0.85
Pressure :	760.56 mm Hg		Temp. :	291 K

Acceptance Criteria : Correlation coefficient (r) of the calibration curve greater than 0.990 after a 5-point calibration.

The high volume sampler complies* / ~~does not comply~~* with the specified requirements and is deemed acceptable* / unacceptable* for use.

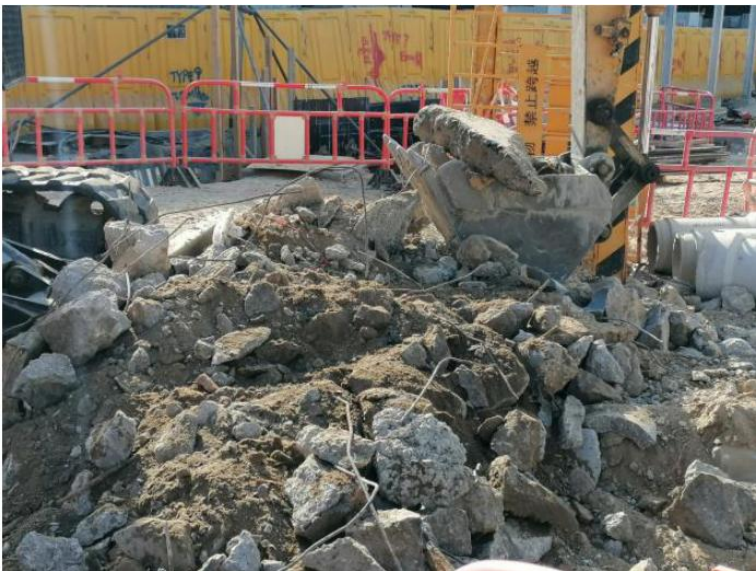
<p>Unsorted materials were discarded near site entrance.</p>	To sort the concrete debris and steel properly	210205_001	Yes	09/02/2021

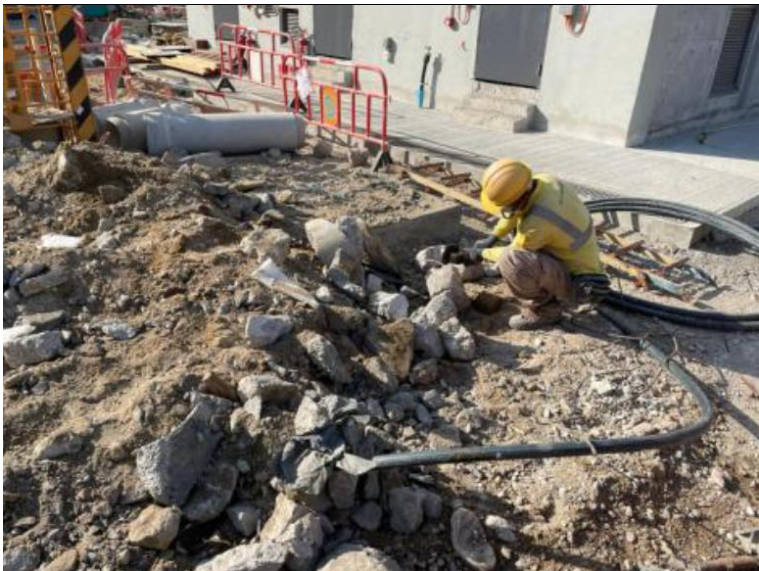
<p>Follow up action to item 1 on 05/02/2021, the concrete debris and steel were sorted.</p>	--	210209_001	No	--

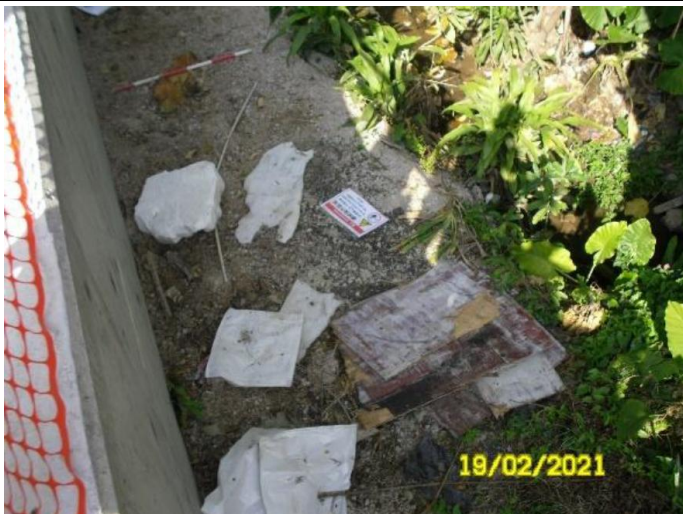
<p>General refuse were observed near Northern side.</p>	To collect the general refuse properly	210219_001	Yes	25/02/2021
2

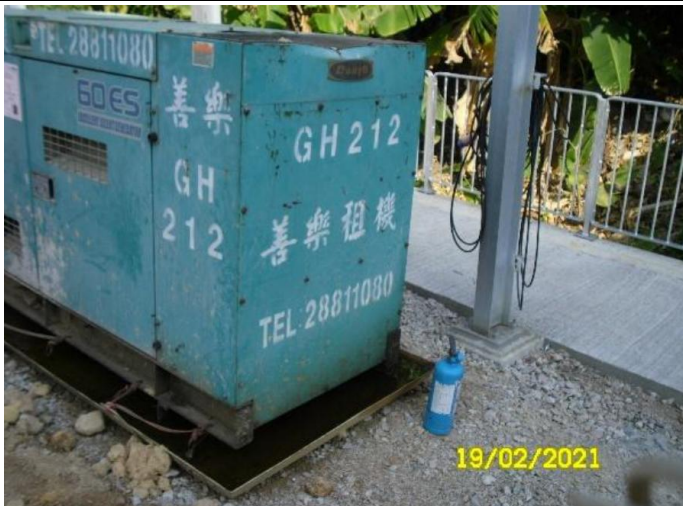
<p>Stagnant water in the drip tray were observed near Northern side.</p>	To clear the stagnant water	210219_002	Yes	25/02/2021

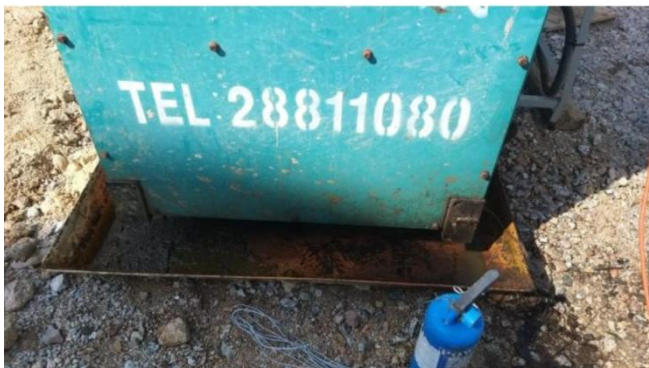
<p>Follow up action to item 2 on 19/02/2021, stagnant water in the drip tray were observed near Northern side.</p>	--	210227_002	No	--

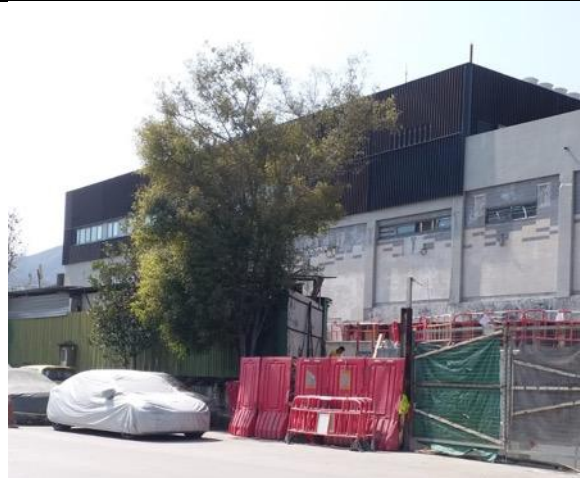
<p>Most of the trees are removed at the eastern boundary</p>	<p>Trees located adjacent to our site (outside site)</p>

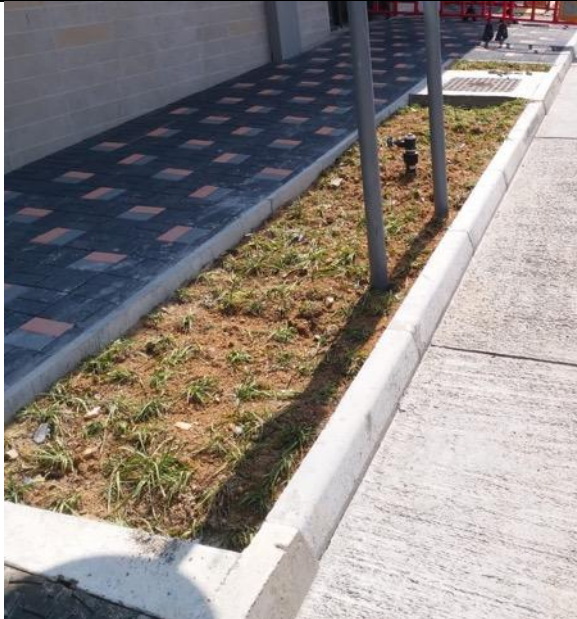
Soiling works at CB	Maintenance of plantings is required at the planter along WS and AB building
Figure 11

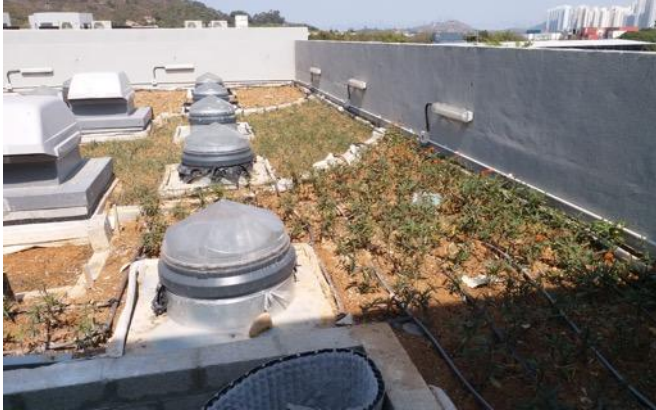
Plant installing in progress and drip irrigation installed
