ATAL-DEGREMONT-CHINA HARBOUR JOINT VENTURE

CONTRACT NO. DC/2013/10 - DESIGN, BUILD AND OPERATE SAN WAI SEWAGE TREATMENT WORKS – PHASE 1

> MONTHLY EM&A REPORT NO. 47

(01 MARCH - 31 MARCH 2021)

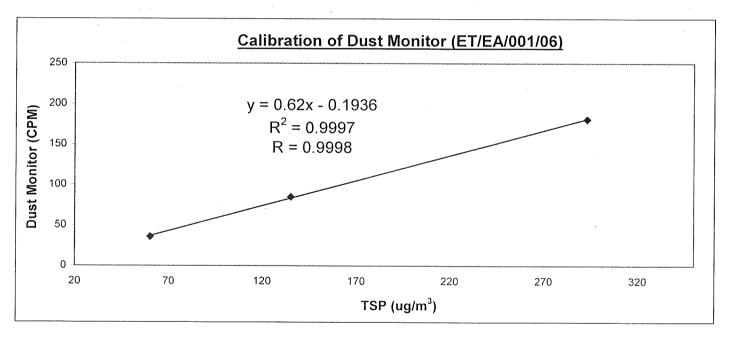
Dust Monitor (CPM)	36	85	181
TSP (ug/m ³)	60	135	293
High Volume Air Sampler, Serail No.: 1177	7 Calibratic	on Due Date: 29 Nov	2020

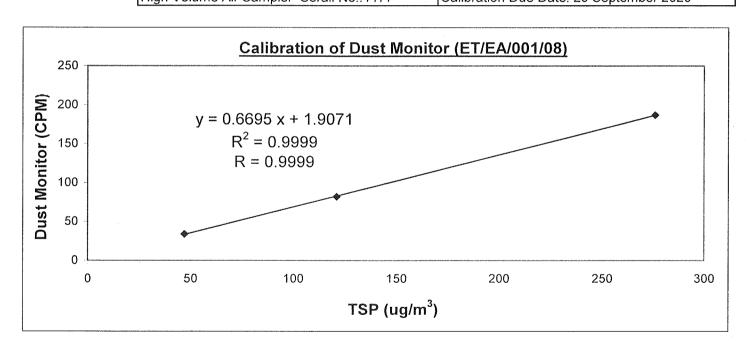
Dust Monitor (CPM)	34	82	187
TSP (ug/m³)	47	121	276
High Volume Air Sampler, Serail No.:11	77 Calibratio	on Due Date: 29 Ser	otember 2020

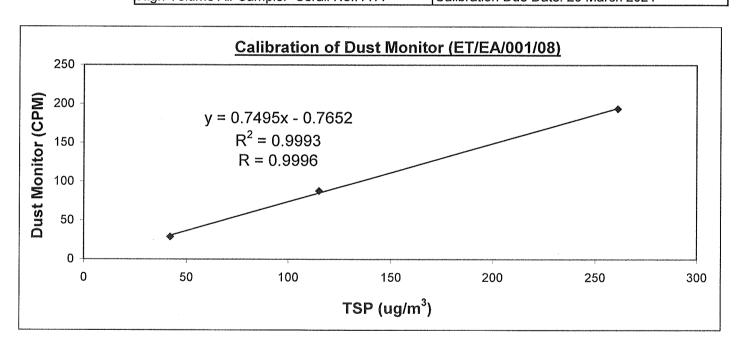
Dust Monitor (CPM)	29	88	194
TSP (ug/m³)	42	115	261
High Volume Air Sampler, Serail	No :1177 Colibrati	on Duo Doto: 20 Ma	rob 2021

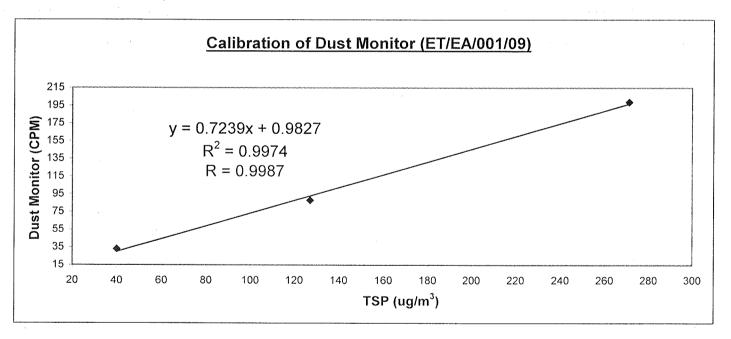
Dust Monitor (CPM)	33	88	199	
TSP (ug/m³)	40	127	271	
High Volume Air Sampler Serail No.: 1177	Calibration Due Date: 29 Nov 2020

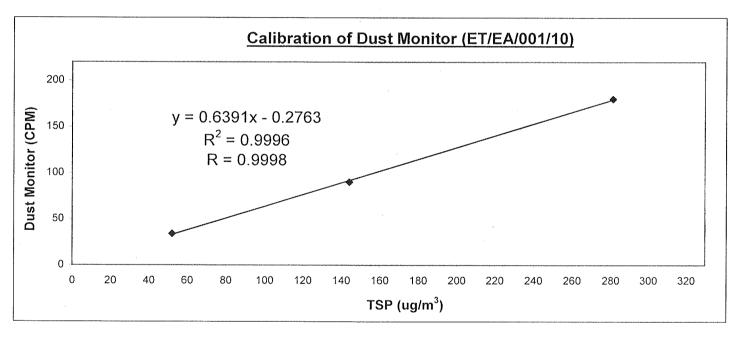
Dust Monitor (CPM)	34	90	180
TSP (ug/m ³)	52	144	281
High Volume Air Sampler Sorail No : 1177	Calibration	a Duo Data: 20 Nov	rombor 2020

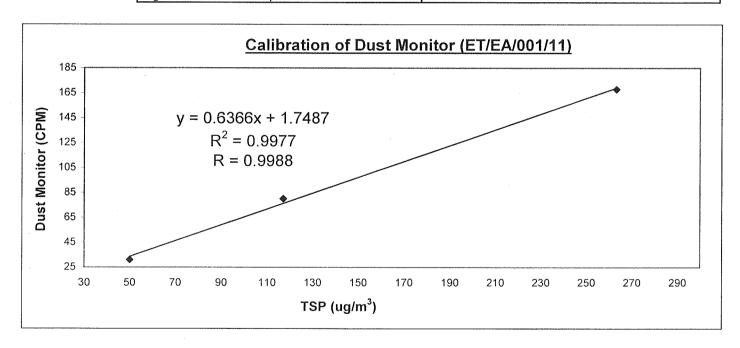
Dust Monitor (CPM)	31	80	168
TSP (ug/m³)	50	117	263
High Volume Air Sampler Serail No.:1177	Calibratio	on Due Date: 21 Dec	ember 2020

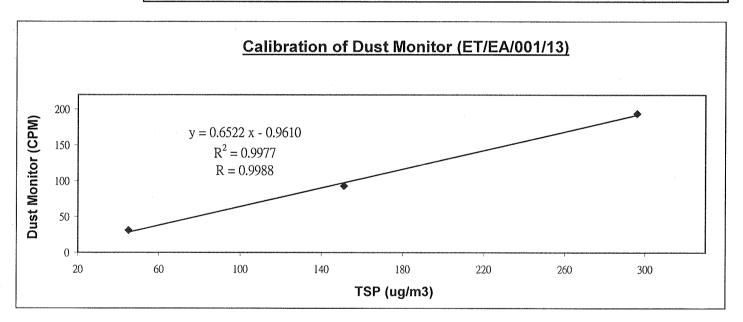
:	Dust Monitor (CPM)	31	93	194
	TSP (ug/m³)	45	151	296
	High Volume Air Sampler Serail No.	: 1177 Calibratio	n Due Date: 29 Ja	anuary 2021

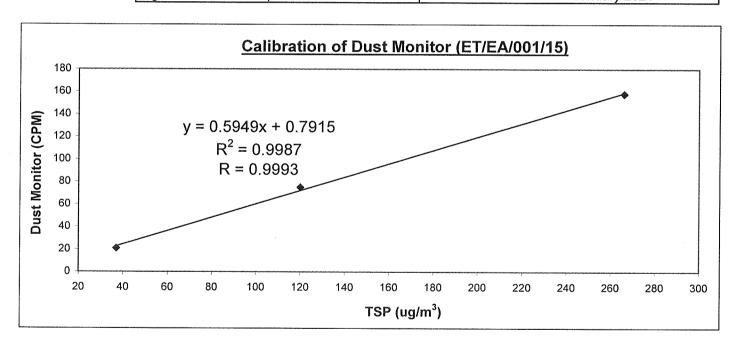
Dust Monitor (CPM)	21	75	158
TSP (ug/m³)	37	120	266
High Volume Air Sampler Serail No.: 1177	Calibratio	n Due Date: 29 Janı	uarv 2021

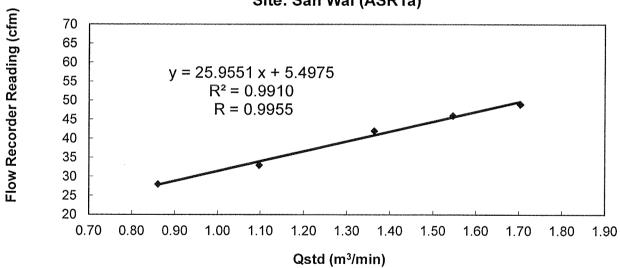
Sampler 1934 Calibration Curve Site: San Wai (ASR1a)

Flow recorder reading	49	46	42	33		28		
Qstd (Actual flow rate, m³/min)			1.70	1.55	1.36	1.10	0	.86
Pressure :	760.56	mm	Hg	Temp.:		291	K

Acceptance Criteria: Correlation coefficient (r) of the calibration curve greater than 0.990 after a 5-point calibration.

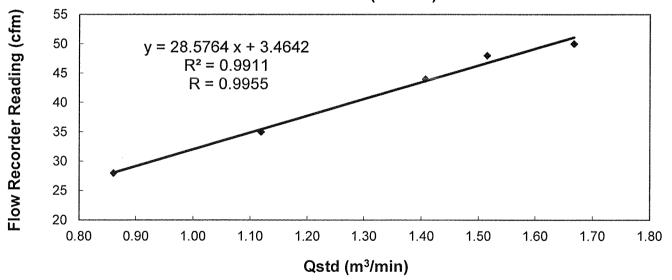
Sampler 9998 Calibration Curve Site: San Wai (ASR2a)

Flow recorder	reading (cfm)	50	48	44	35	28
Qstd (Actual fle	ow rate, m³/min)	1.67	1.51	1.41	1.12	0.86
Pressure :	760.56 mm Hg		Temp. :	291	K

Acceptance Criteria: Correlation coefficient (r) of the calibration curve greater than 0.990 after a 5-point calibration.

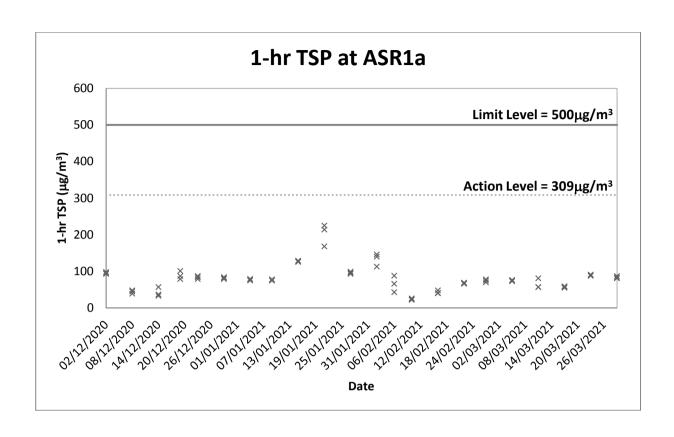
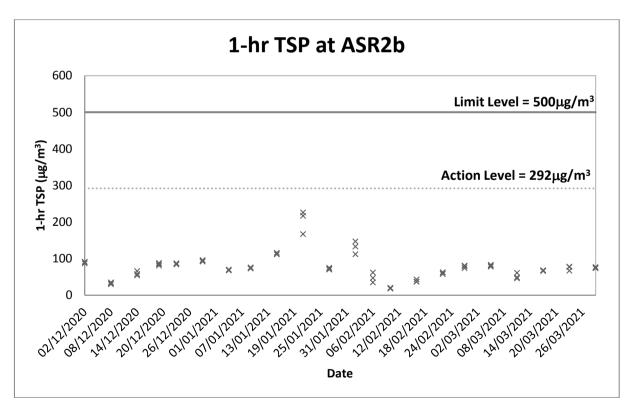
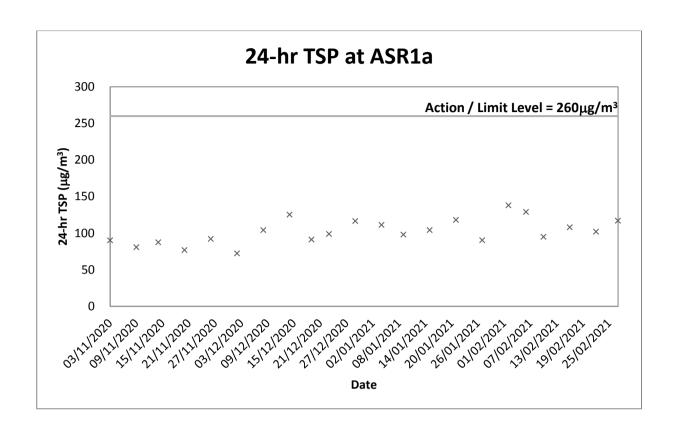
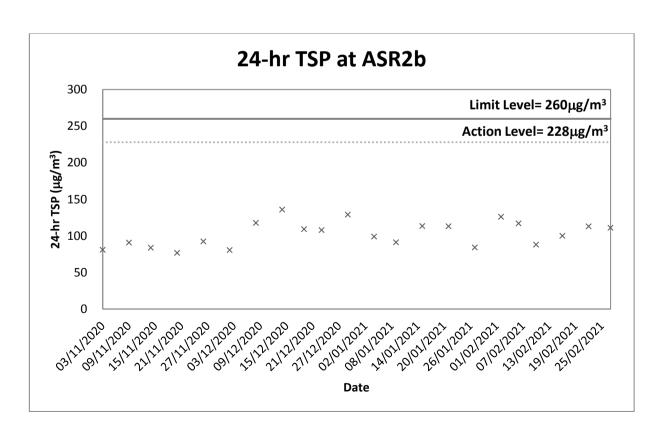
Graphical Plots of Impact Air Quality Monitoring Results

Generally, 1-hour TSP and 24-hour TSP monitoring results fluctuated well below the Action Level in this reporting period. The major dust source observed near the monitoring stations was mainly from vehicles passing by the container yards and general earth works. It can be concluded that the contractor implemented sufficient dust mitigation measures during this reporting month.

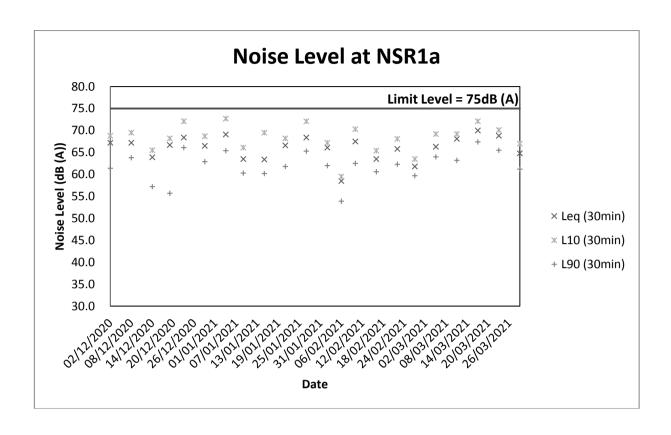
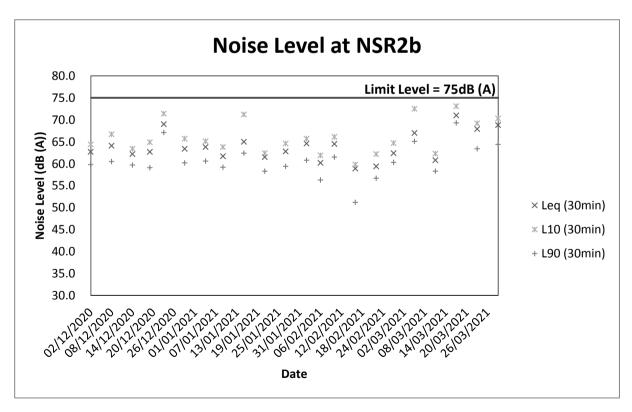
Graphical Plots of Impact Noise Monitoring Data

The noise monitoring data were found to be lower than the limit level. The major noise source during the monitoring event was the vehicles passing through the container yard entrance and the general earth works inside the construction site.

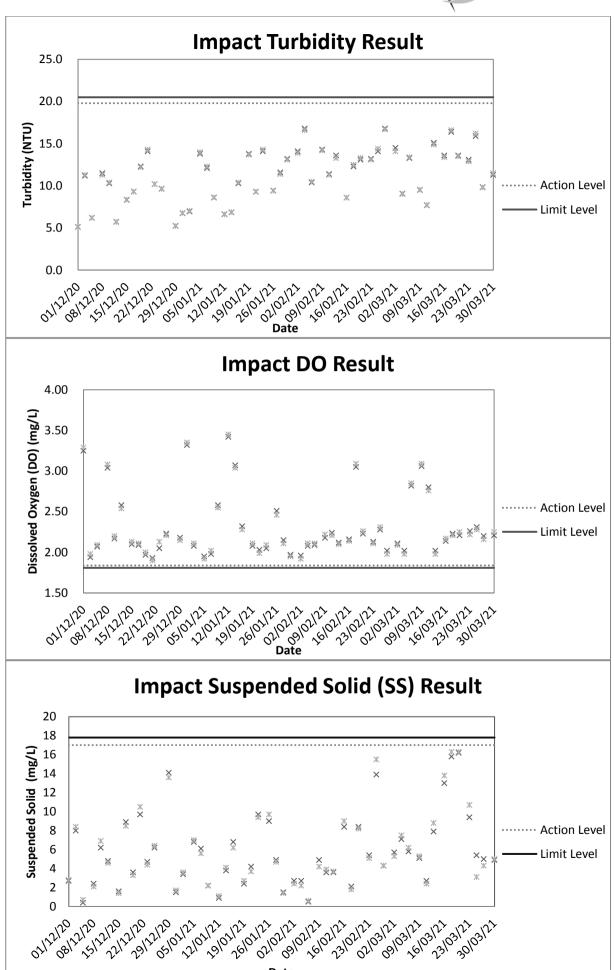
Graphical Plots of Impact Water Quality Monitoring Data

Generally, the turbidity and suspended solids were found to be lower than the action level. Besides, all results of dissolved oxygen measured in this reporting month were higher than the action level.

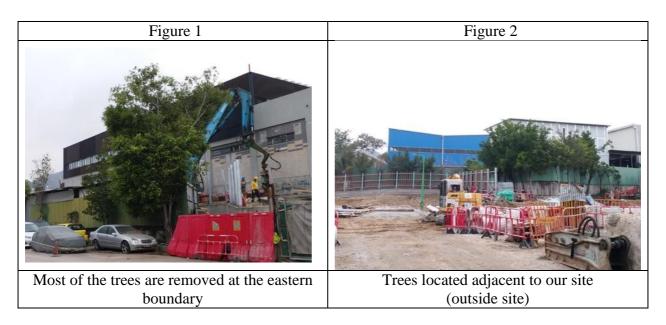
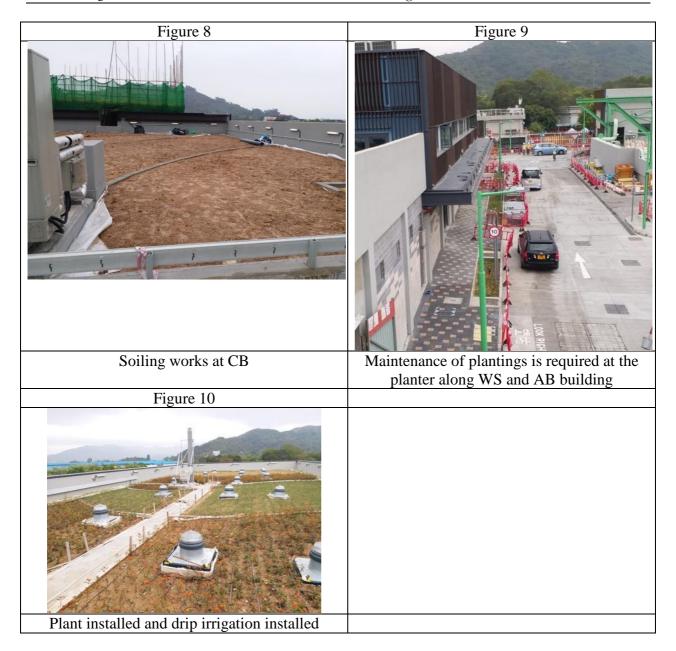
Photo Record:

Figure 3	Figure 4
Condition of trees at the entrance of the existing treatment plant	Existing trees at the site entrance
Figure 5	
Existing trees at the site entrance near the hoarding fence	
Figure 6	Figure 7
Soiling works at RW	Soiling works at SDB

- 1. Contractor was reminded to provide TPZ with robust fence, whenever possible, at the drip line of all retained trees unless the trees are well beyond the extend of construction activities.
- 2. Contractor was reminded not to disturb trees outside site along the boundary.
- 3. The contractor is required to prepare for the soft landscape installation works

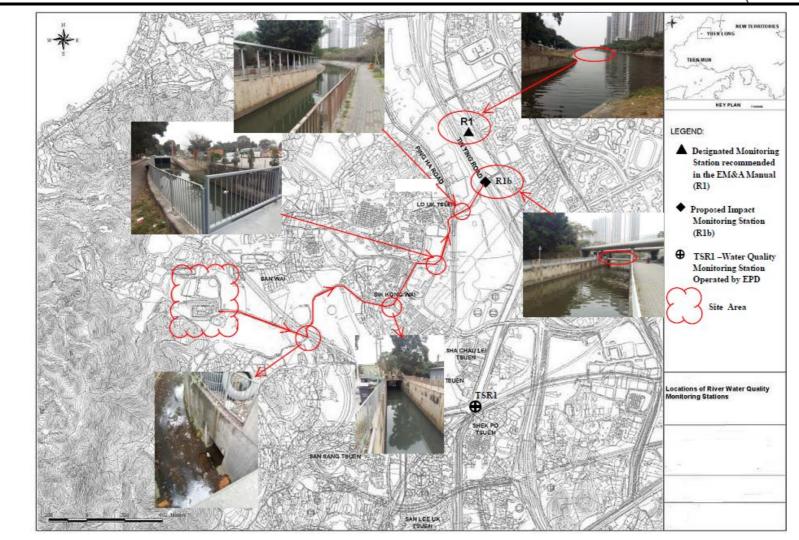
4.1.1. Water quality was monitored in the reporting month in accordance with the EM&A Manual at one alternative water quality monitoring station, R1b (at Tin Shui Wai Nullah) which shown in **Figure 2**.

Project: Contract No. DC/2013/10 - Design, Build and Operate San Wai Sewage Treatment Works – Phase 1 Figure 2 Locations of Water Quality Monitoring Station

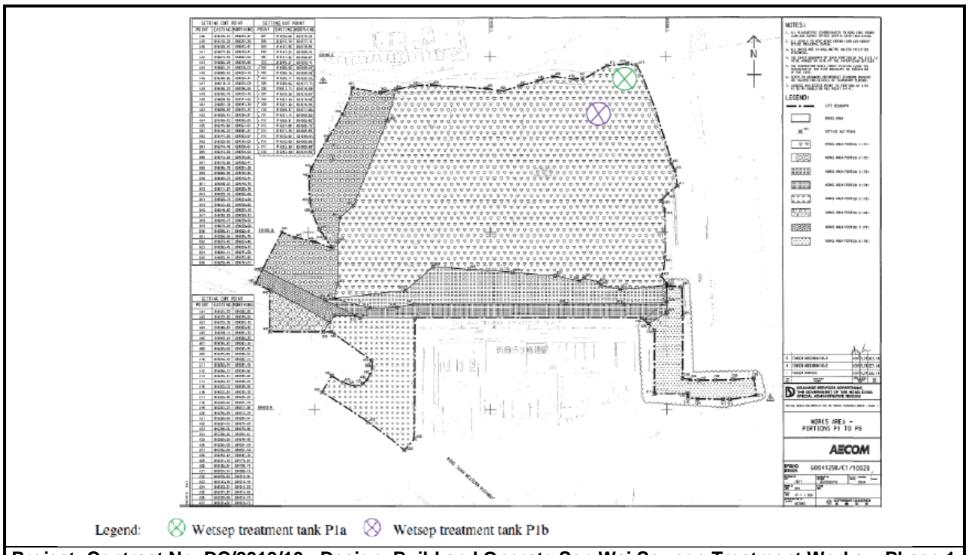
Project: Contract No. DC/2013/10 - Design, Build and Operate San Wai Sewage Treatment Works – Phase 1 Figure 3 Location Plan for the Wetsep Treatment Tank
