CONTRACT NO. DC/2013/10 - DESIGN, BUILD AND OPERATE SAN WAI SEWAGE TREATMENT WORKS – PHASE 1

> MONTHLY EM&A REPORT NO. 48

(01 APRIL - 30 APRIL 2021)

Report No.: ENA12036

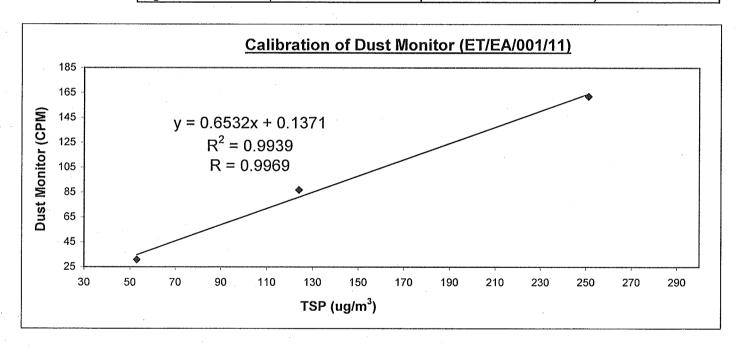
Dust Monitor (CPM)	31	87	162
TSP (ug/m³)	53	124	251
High Volume Air Sampler Serail No.:1177	Calibratio	n Due Date: 29 May	2021

Correlation coefficient (r) of the calibration curve greater than 0.990 after a three-point calibration

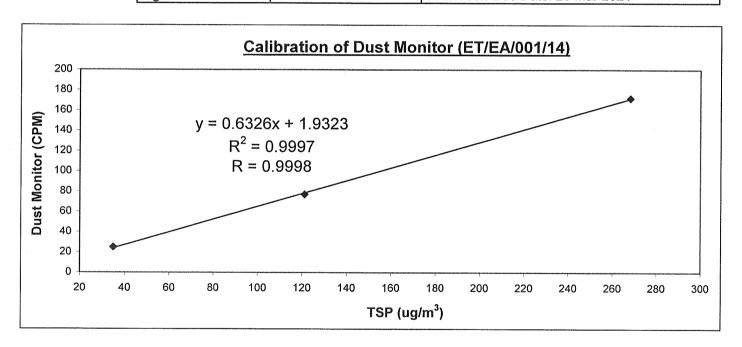
Dust Monitor (CPM)		25	77	172		
TSP (ug/m³)		35	121	268		
High Volume Air Sampler Serail	No : 1177	Calibration Due Date: 29 Mar 2021

Correlation coefficient (r) of the calibration curve greater than 0.990 after a three-point calibration

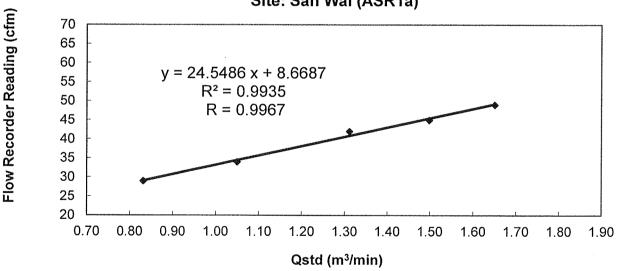
Sampler 1934 Calibration Curve Site: San Wai (ASR1a)

Flow recorder reading	49	45	42	34	29		
Qstd (Actual flow rate	1.65	1.50	1.31	1.05	0.83		
Pressure :	762.06	mm	Hg	Temp. :		303	K

Acceptance Criteria: Correlation coefficient (r) of the calibration curve greater than 0.990 after a 5-point calibration.

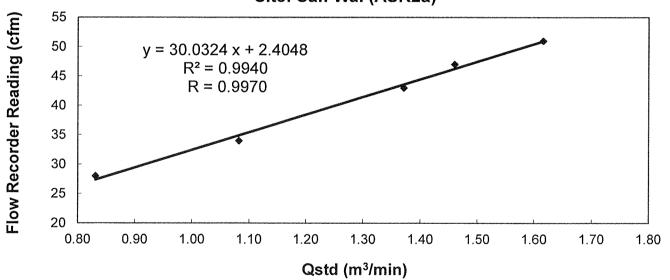
Sampler 9998 Calibration Curve Site: San Wai (ASR2a)

Flow recorder	reading (cfm)	51	47	43	34	28
Qstd (Actual fl	ow rate, m³/min)	1.62	1.46	1.37	1.08	0.83
Pressure :	762.06 mm Hg		Temp. :	303	K

Acceptance Criteria: Correlation coefficient (r) of the calibration curve greater than 0.990 after a 5-point calibration.

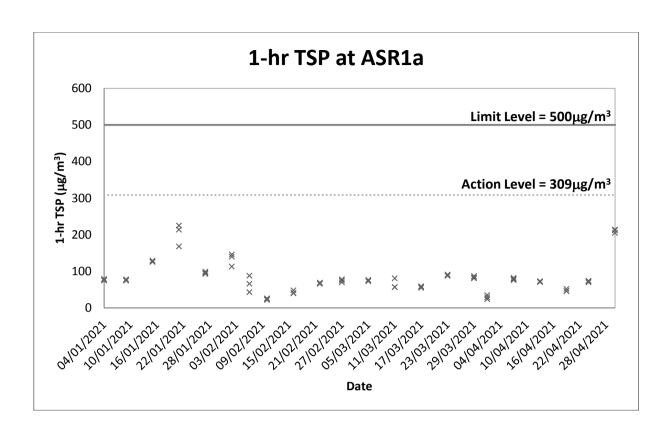
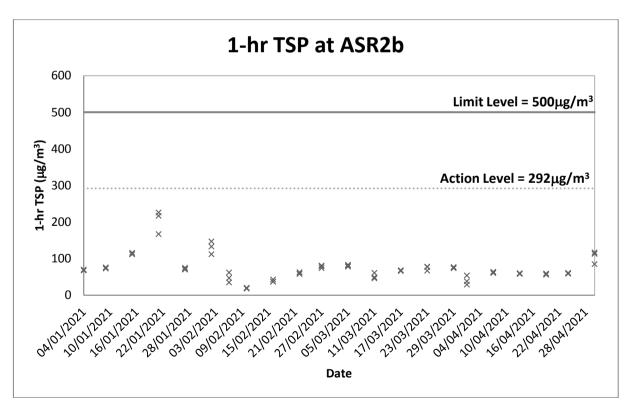
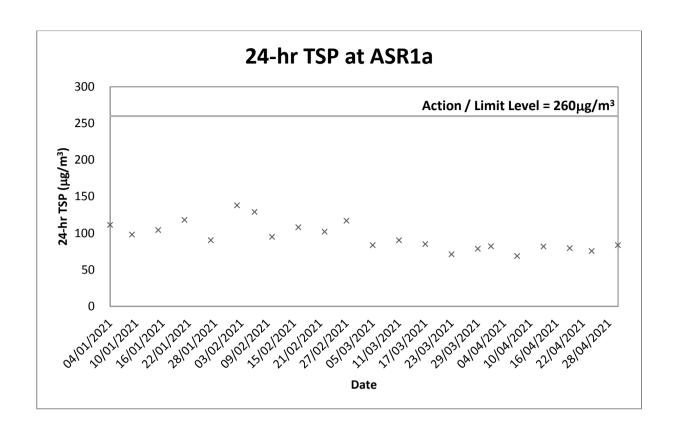
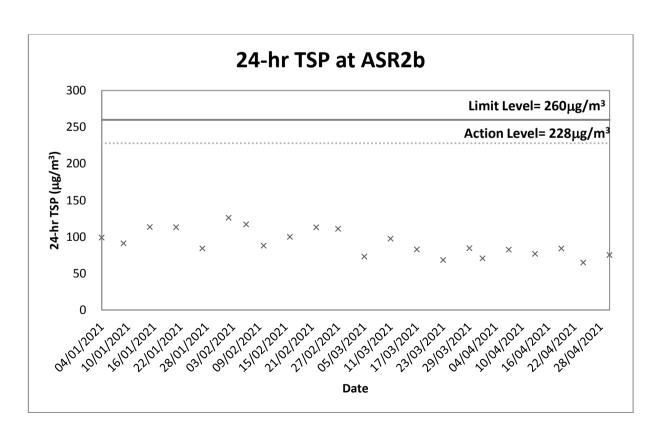
Graphical Plots of Impact Air Quality Monitoring Results

Generally, 1-hour TSP and 24-hour TSP monitoring results fluctuated well below the Action Level in this reporting period. The major dust source observed near the monitoring stations was mainly from vehicles passing by the container yards and general earth works. It can be concluded that the contractor implemented sufficient dust mitigation measures during this reporting month.

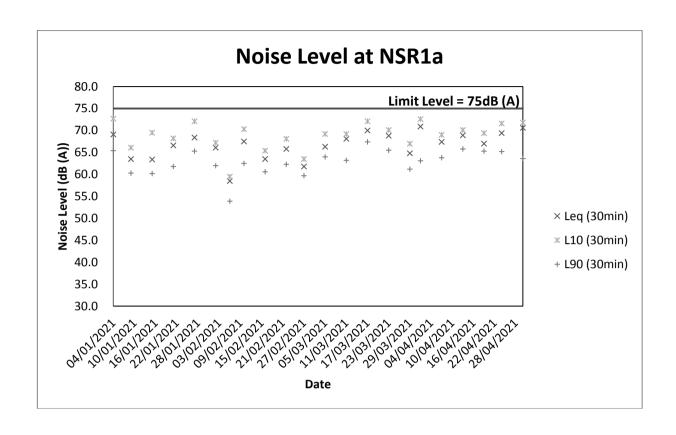
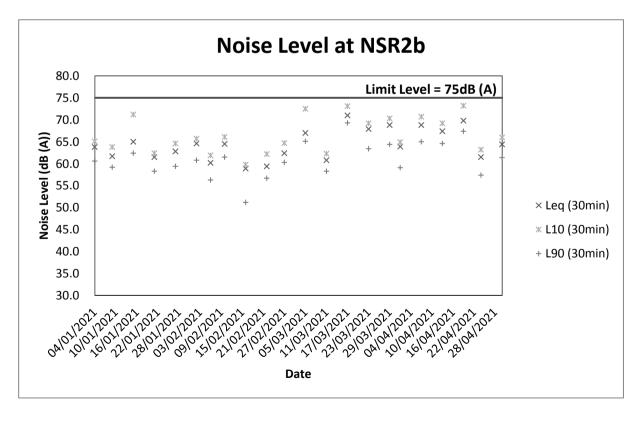
Graphical Plots of Impact Noise Monitoring Data

The noise monitoring data were found to be lower than the limit level. The major noise source during the monitoring event was the vehicles passing through the container yard entrance and the general earth works inside the construction site.

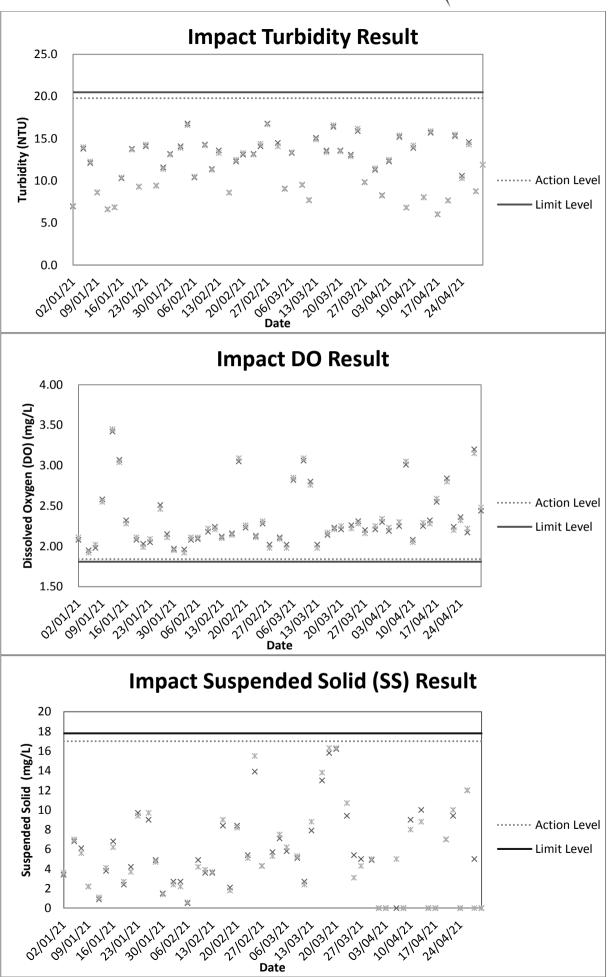
Graphical Plots of Impact Water Quality Monitoring Data

Generally, the turbidity and suspended solids were found to be lower than the action level. Besides, all results of dissolved oxygen measured in this reporting month were higher than the action level.

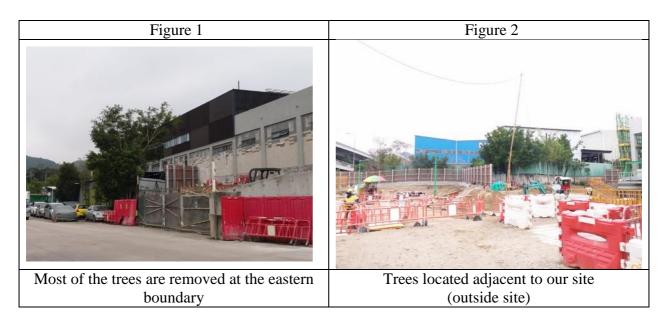
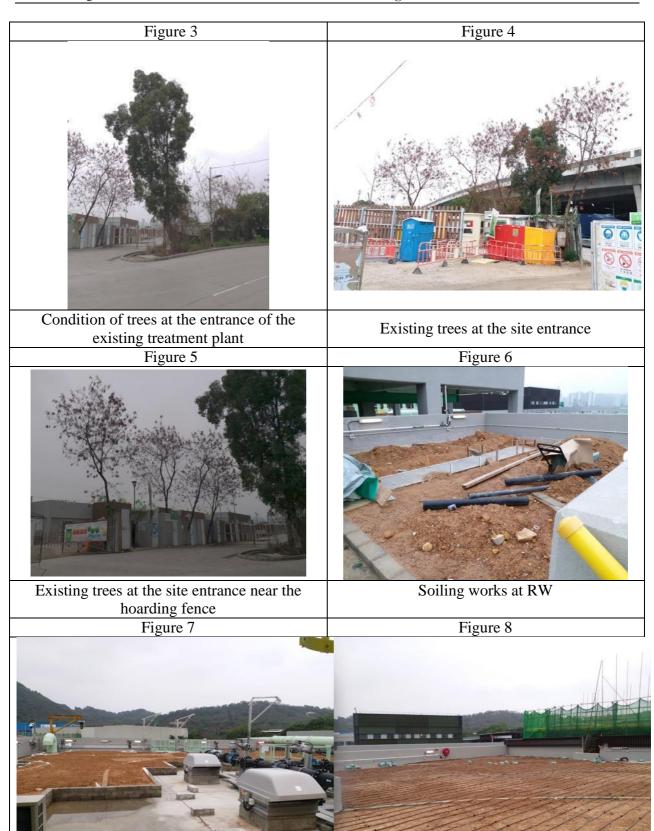
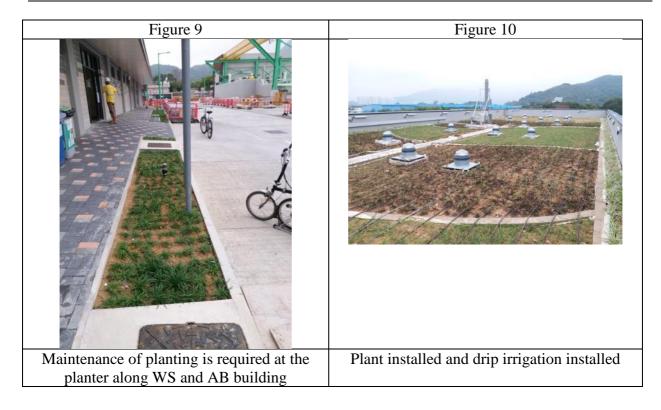
Soiling works at SDB

Soiling works at CB

- 1. Contractor was reminded to provide TPZ with robust fence, whenever possible, at the drip line of all retained trees unless the trees are well beyond the extend of construction activities.
- 2. Contractor was reminded not to disturb trees outside site along the boundary.
- 3. The contractor is required to prepare for the soft landscape installation works

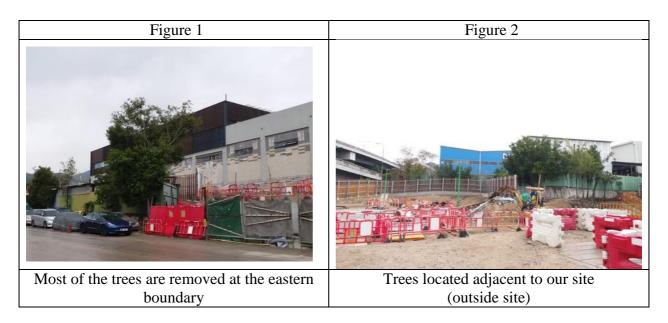
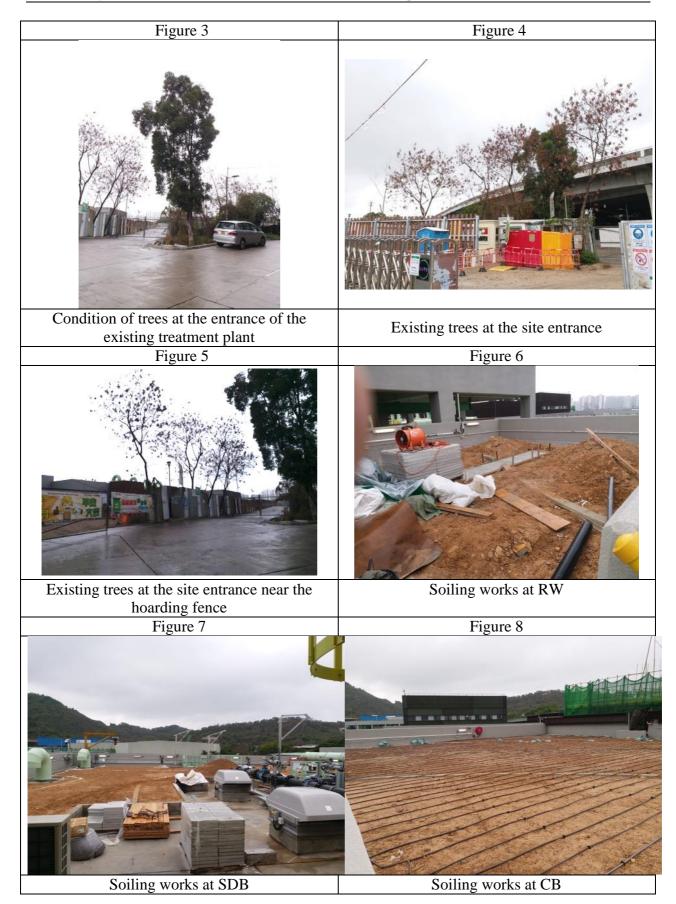
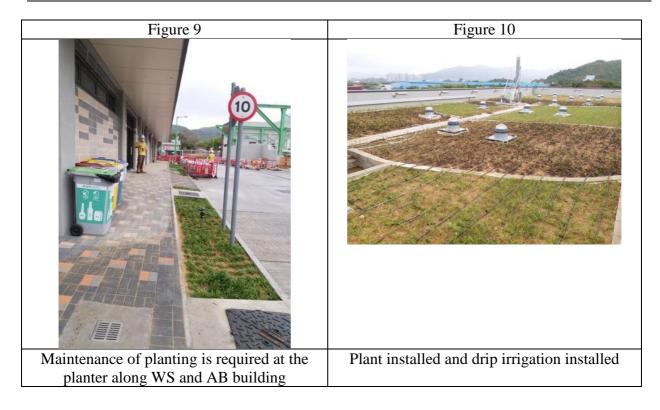
Photo Record:

- 1. Contractor was reminded to provide TPZ with robust fence, whenever possible, at the drip line of all retained trees unless the trees are well beyond the extend of construction activities.
- 2. Contractor was reminded not to disturb trees outside site along the boundary.
- 3. The contractor is required to prepare for the soft landscape installation works
