## **ATAL-DEGREMONT-CHINA HARBOUR JOINT VENTURE**

CONTRACT NO. DC/2013/10 - DESIGN,  
BUILD AND OPERATE SAN WAI  
SEWAGE TREATMENT WORKS –  
PHASE 1

**MONTHLY EM&A REPORT  
NO. 49**

**(01 MAY – 31 MAY 2021)**

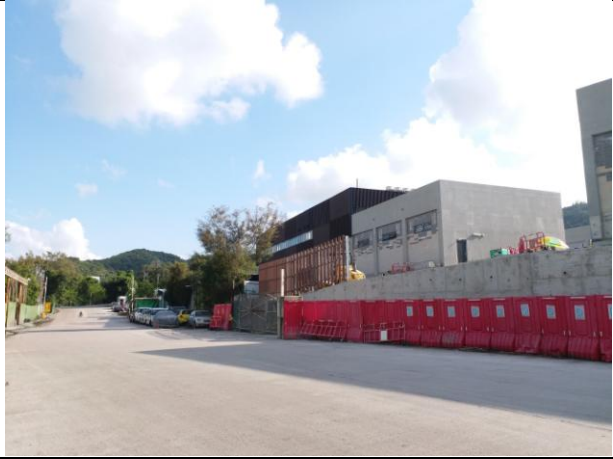
| Figure 1 | Figure 2 |

| Figure 1 | Figure 2 |
|---|---|
| Works are carried out at the eastern boundary | Trees located adjacent to our site (outside site) |

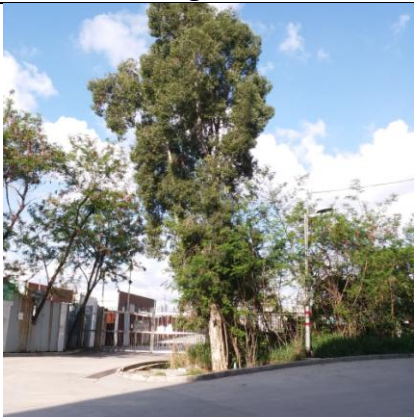
| <p>Figure 3</p> <p>Condition of trees at the entrance of the existing treatment plant</p> | <p>Figure 4</p> <p>Existing trees at the site entrance</p> |

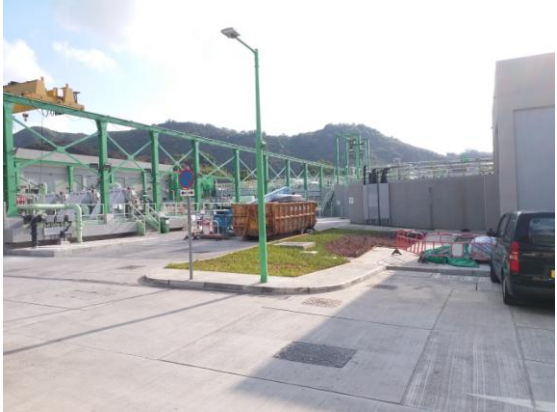
| <p>Figure 5</p> <p>Existing trees at the site entrance near the hoarding fence</p> | <p>Figure 6</p> <p>Planting works opposite to WS &amp; AB building</p> |

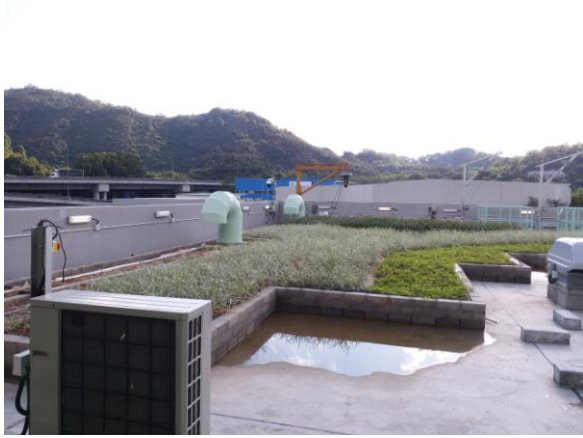
| <p>Figure 7</p> <p>Planting works at SDB</p> | <p>Figure 8</p> <p>Planting works at CB</p> |

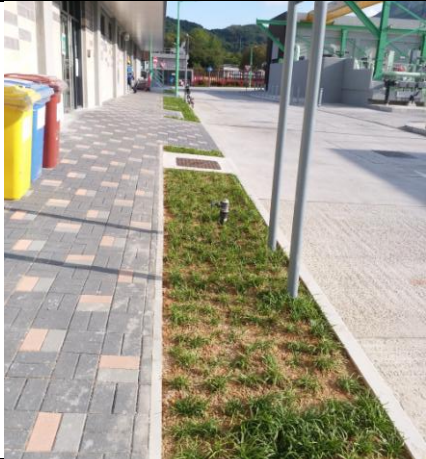
| Figure 9 | Figure 10 |

| Figure 9 | Figure 10 |
|---|---|
| Maintenance of planting is required at the planter along WS and AB building | Plant installed and drip irrigation installed |

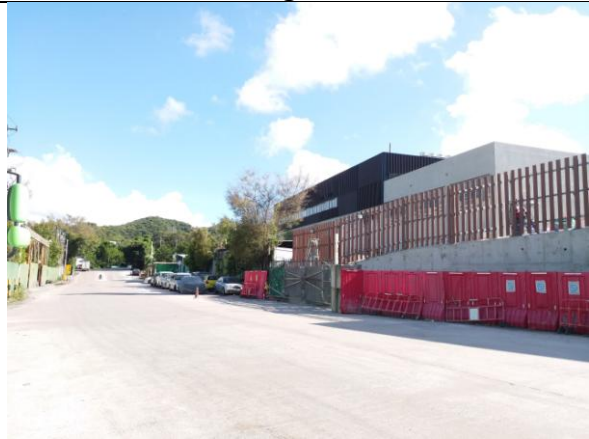
| Figure 1 | Figure 2 |

| Figure 1 | Figure 2 |
|---|---|
| Works are carried out at the eastern boundary | Trees planting are carried out at the western end of the site |

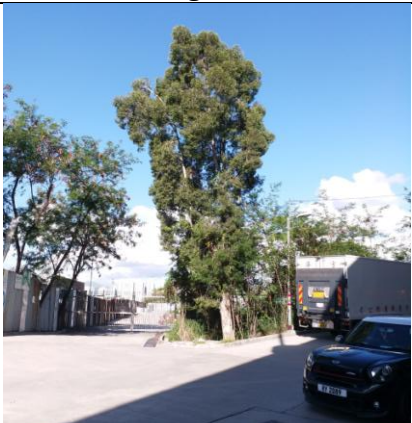
| <p>Figure 3</p> | <p>Figure 4</p> |

| <p>Condition of trees at the entrance of the existing treatment plant</p> | <p>Existing trees at the site entrance</p> |

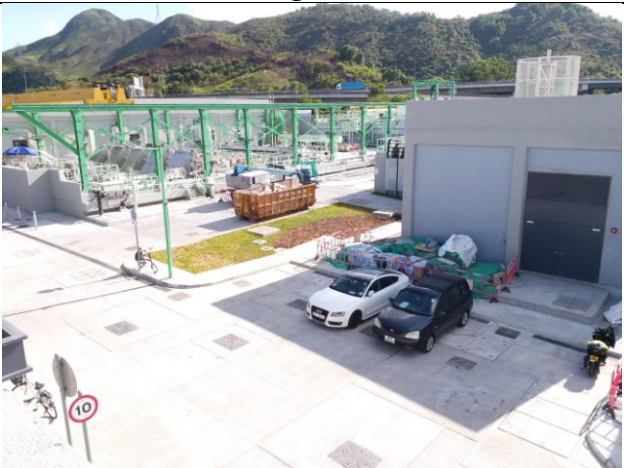
| <p>Figure 5</p> | <p>Figure 6</p> |

| <p>Existing trees at the site entrance near the hoarding fence</p> | <p>Planting works opposite to WS &amp; AB building</p> |

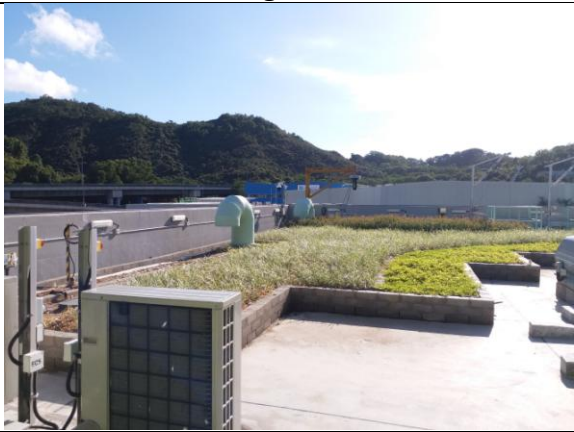
| <p>Figure 7</p> | <p>Figure 8</p> |

| <p>Planting works at SDB</p> | <p>Planting works at CB</p> |

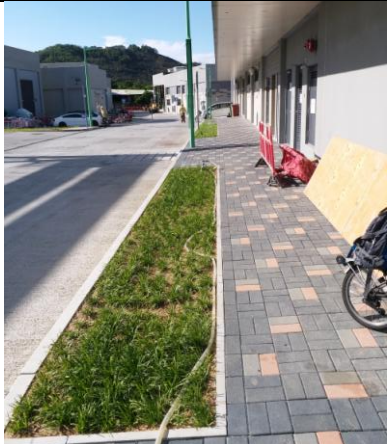
| Figure 9 | Figure 10 |

| Figure 9 | Figure 10 |
|---|---|
| Maintenance of planting is required at the planter along WS and AB building | Plant installed and drip irrigation installed |
